MINERALS PROGRAM INSPECTION REPORT
PHONE: (303) 866-3567

MINE NAME: Cottonwood Pit	MINE/PROSPECTING ID#: M-1986-010	MINERAL: Sand and gravel	COUNTY: Fremont
INSPECTION TYPE: Monitoring	INSPECTOR(S): Timothy A. Cazier	INSP. DATE: April 27, 2017	INSP. TIME: 13:15
OPERATOR: Fremont County	OPERATOR REPRESENTATIVE: Sterling Rife	TYPE OF OPERATION: 112c - Construction Regular Operation	
REASON FOR INSPECTION: Normal I&E Program	BOND CALCULATION TYPE: None	BOND AMOUNT: \$0.00	
DATE OF COMPLAINT: NA	POST INSP. CONTACTS: Colorado State Land Board	JOINT INSP. AGENCY: None	
WEATHER: Cloudy	INSPECTOR'S SIGNATURE:

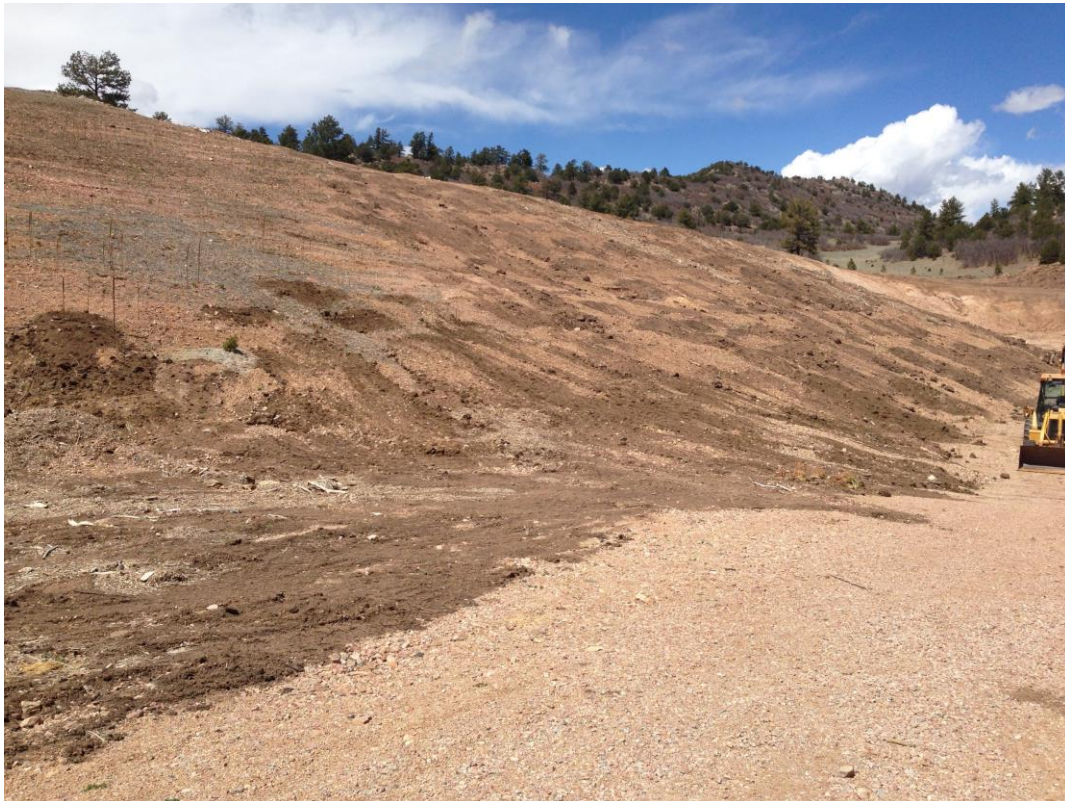
Photo 1. Reclamation on west face (looking north).

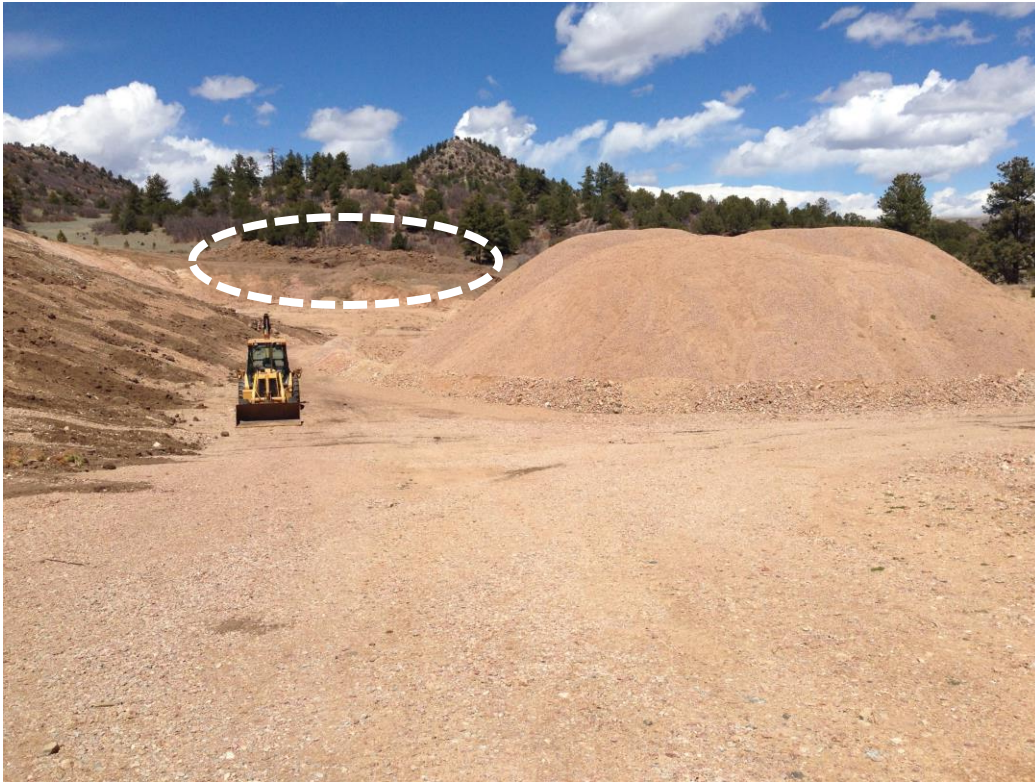
Gen. Compliance with Mine Plan: The operation appeared to be in compliance with the approved mine plan. Google Earth was used to measure the disturbed area, which was estimated to be approximately 8.3 acres based on June 16, 2016 satellite imagery. The maximum allowed disturbed area is 48.4 acres. High walls were at approximately 3H:1V slopes and appeared stable (see **Photo 1**). Mr. Rife indicated they are beginning to move north for the direction of future mining. A topsoil stockpile on the north end of the pit (see **Photo 2**) will need to be moved prior to advancing mining towards the north.

Photo 2. Stockpiles: Topsoil circled, product on right (looking north).

Topsoil: The aforementioned topsoil stockpile on the north end will be moved prior to mining north per Mr. Rife.

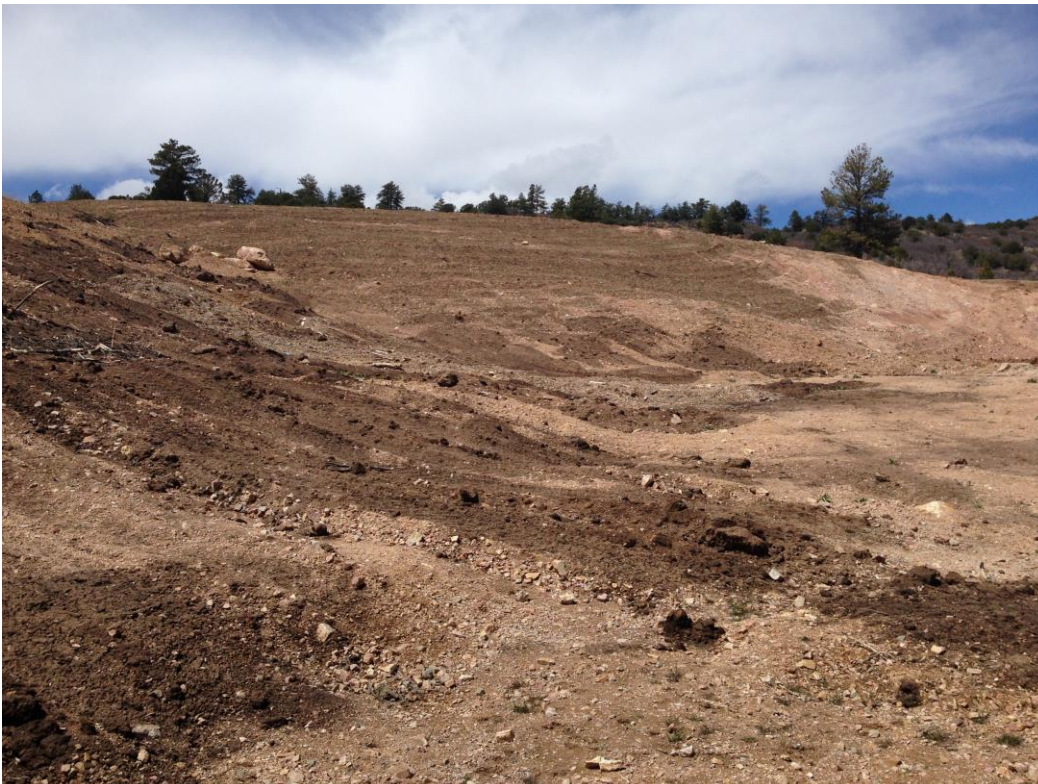
Reclamation Success: The County is in the process of topsoiling and seeding the west side of the pit (see **Photo 3**).

Photo 3. Topsoiling and seeding the west side of the pit (looking NW).

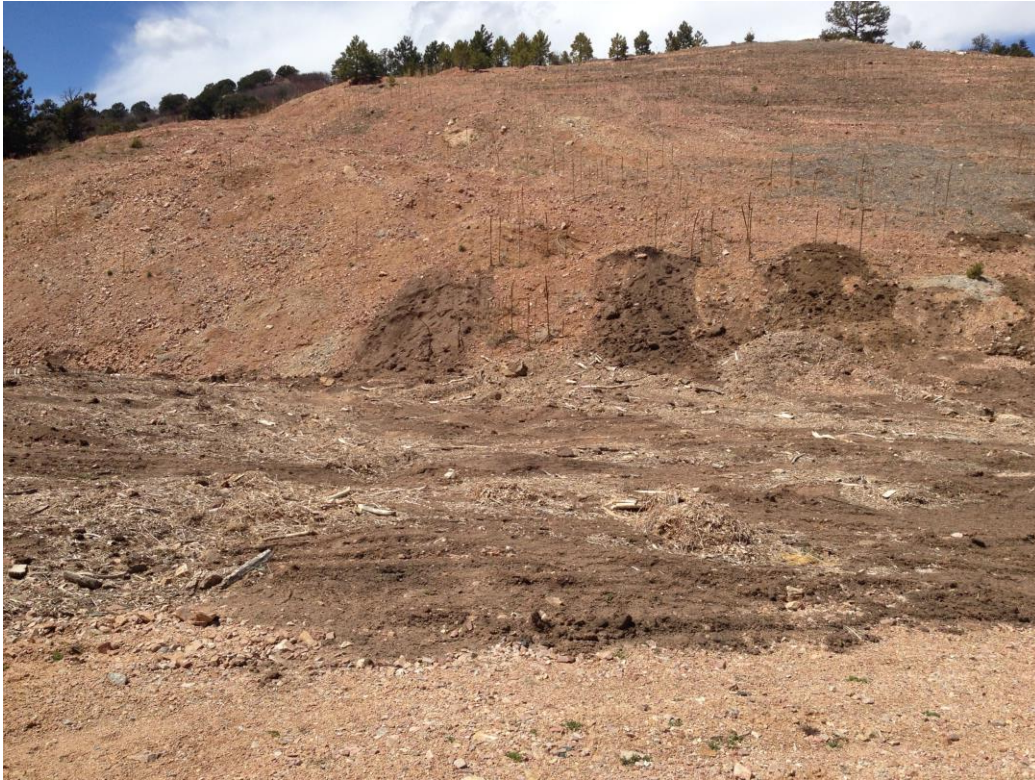
Revegetation: Mr. Rife indicated the west face had been seeded. Some amount of Common Mullein was observed (see **Photo 4**). This is a noxious weed List C species, so it was not cited as a problem. However, the Operator should implement a weed control program to reduce the number of mullein plants on site.

Photo 4. Mulein towards the south end of the pit (west side, looking west).

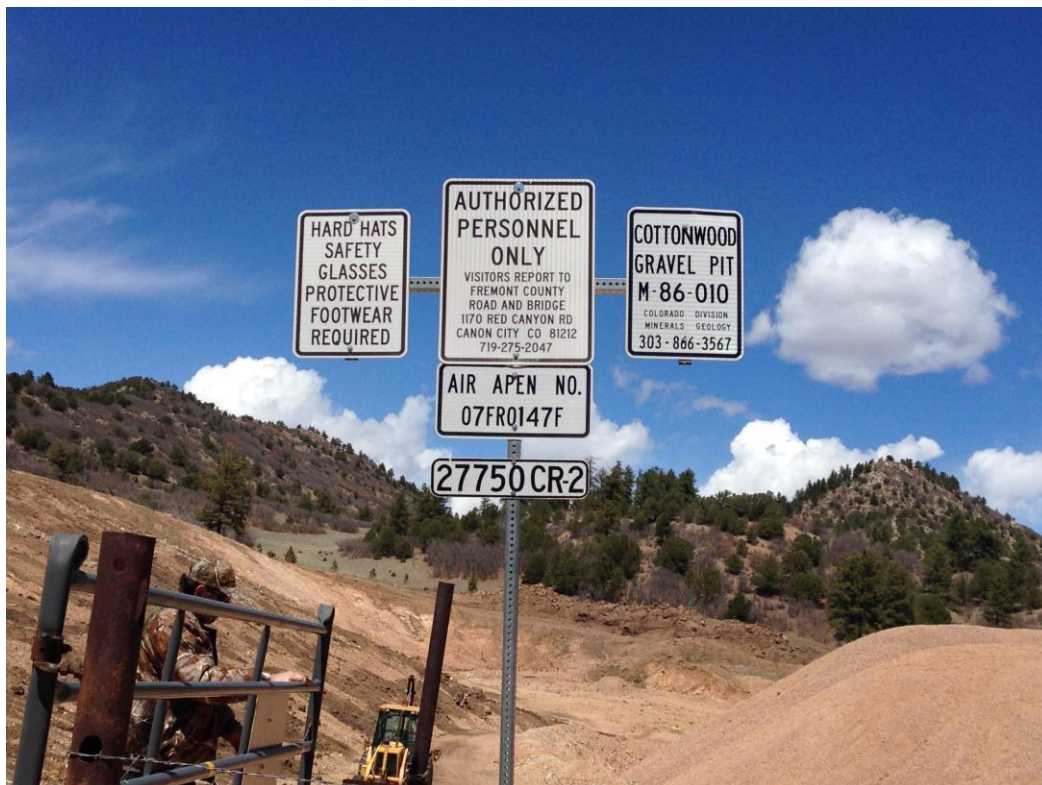
Signs and Markers: The permit sign was properly posted (see **Photo 5**). A fence along the county road marks the southern boundary. Markers on the north and west mark those boundaries.

Photo 5. Permit sign.

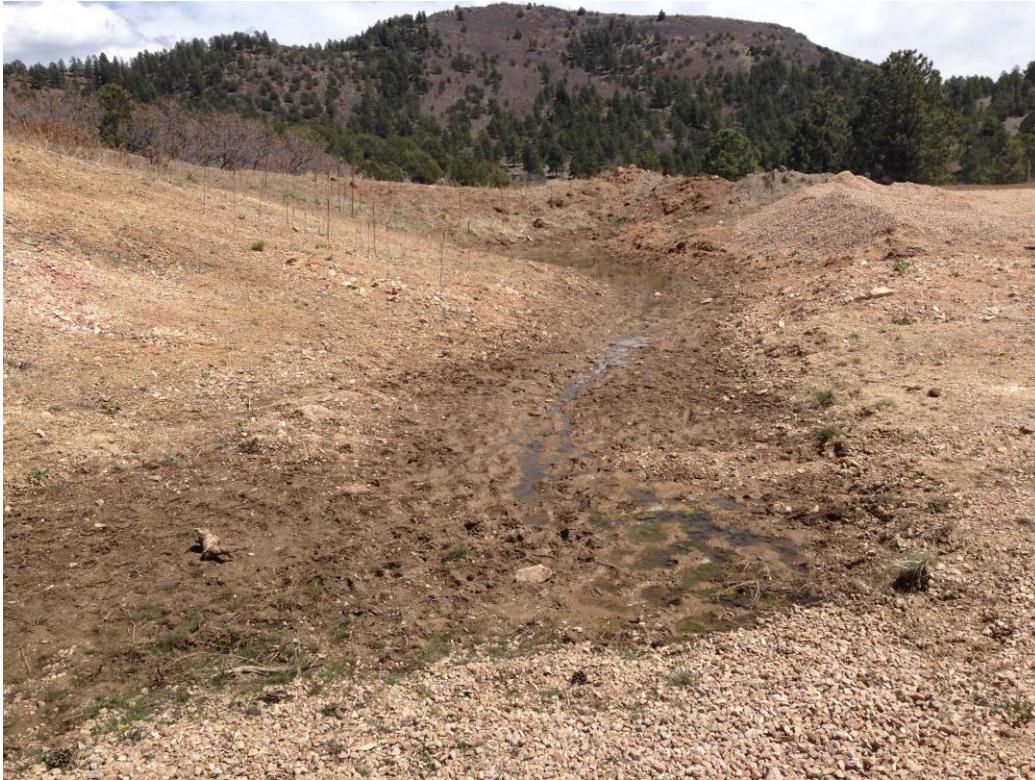
Storm Water MGT Plan: No oil or fuel spills observed. Stormwater drains to sediment ponds (see **Photo 6**) prior to being discharged from the site.

Photo 6. Sediment pond, northeast corner (looking east).
