MINERALS PROGRAM INSPECTION REPORT

MINE NAME: Antero Gravel	MINE/PROSPECTING ID#: M-2000-088	MINERAL: Sand, aggregate, gravel	COUNTY: Park
INSPECTION TYPE: Monitoring	INSPECTOR(S): Michael A. Cunningham	INSP. DATE: July 10, 2017	INSP. TIME: 12:30
OPERATOR: R & R/Regester Enterprises, Incorporated	OPERATOR REPRESENTATIVE: Kevin Schramek	TYPE OF OPERATION: 112c - Construction Regular Operation	
REASON FOR INSPECTION: Normal I&E Program	BOND CALCULATION TYPE: Complete Bond	BOND AMOUNT: \$15,809.11	
DATE OF COMPLAINT: NA	POST INSP. CONTACTS: None	JOINT INSP. AGENCY: None	
WEATHER: Clear	INSPECTOR'S SIGNATURE:

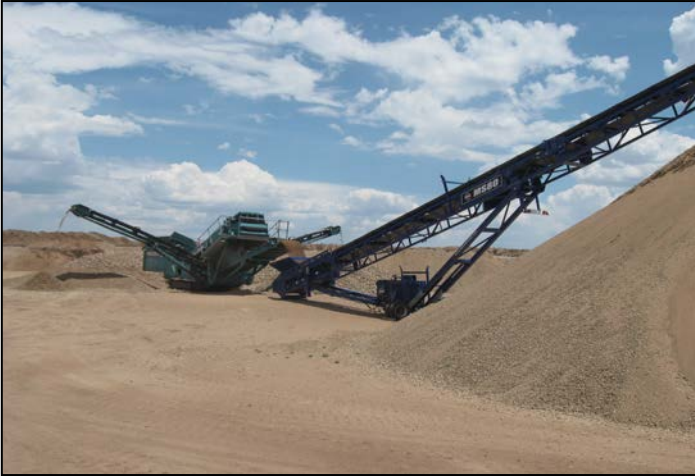
1. Screening of sand and gravel on pit floor.

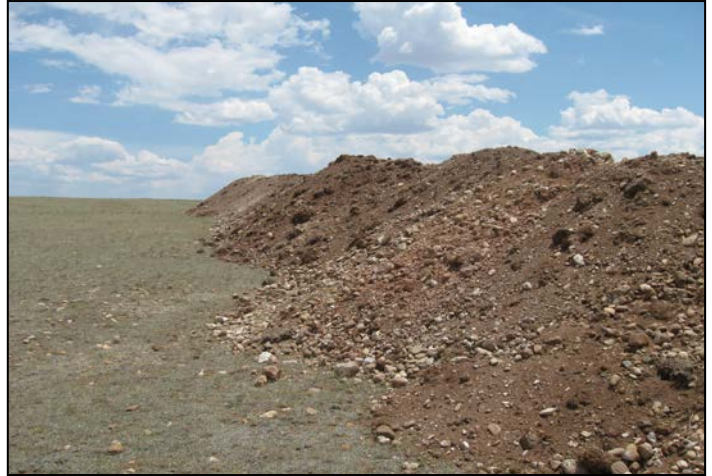
All available topsoil has been salvaged and windrowed along the top of the excavation. The Division did not observe any groundwater within the excavated area. However, the water table in the area is shallow and the Operator was reminded that no exposure of groundwater was allowed.

2. Topsoil stockpile along perimeter of mining Cell A.

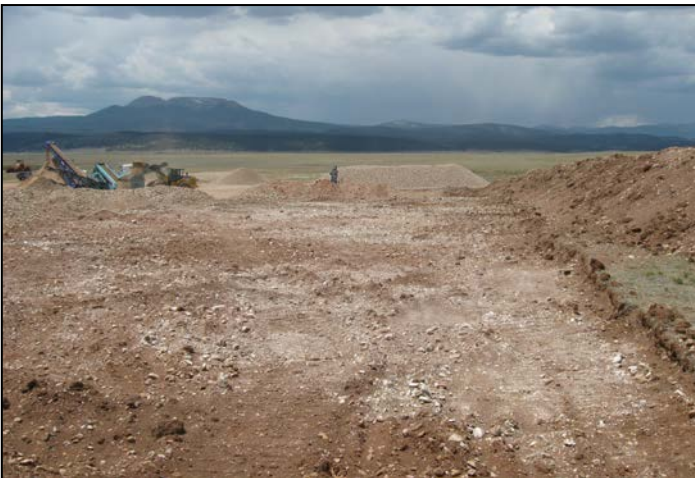
3. Area stripped of topsoil.

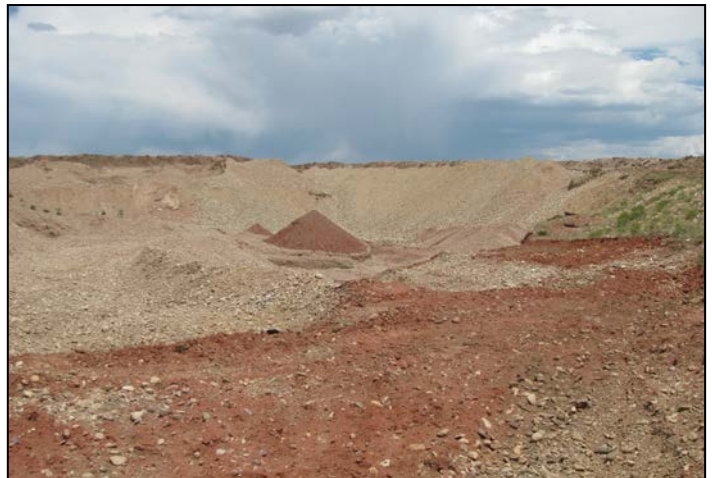
The site was operational at the time of the inspection. The mining operation is comprised of 8 phases (A-H) which are each 5 acres in size. Mining operations are currently being conducted in Phase A and mining is progressing in a northerly direction. The Operator has excavated the pit to a depth of 10' to 12'. The sand and gravel is screened on the pit floor and then loaded into trucks. The pit wall slopes ranged between 3H:1V and 1H:1V. The approved Mining Plan specifies that the pit walls will be mined at 3H:1V. Following the inspection, the Operator submitted photographs showing the pit walls had been graded to 3H:1V. Failure to maintain the pit walls at 3H:1V in the future will result in a problem citation.

4. Pit walls along perimeter of mining Cell A.
