**COLORADO**Division of Reclamation,
Mining and Safety

MINERALS PROGRAM INSPECTION REPORT**PHONE: (303) 866-3567**

MINE NAME: Schuler Construction Pit # 1	MINE/PROSPECTING ID#: M-2005-002	MINERAL: Gravel	COUNTY: El Paso
INSPECTION TYPE: Monitoring	INSPECTOR(S): Timothy A. Cazier	INSP. DATE: October 11, 2016	INSP. TIME: 14:50
OPERATOR: Schuler Construction	OPERATOR REPRESENTATIVE: None	TYPE OF OPERATION: 110c - Construction Limited Impact	
REASON FOR INSPECTION: Normal I&E Program	BOND CALCULATION TYPE: Partial Bond	BOND AMOUNT: \$10,000.00	
DATE OF COMPLAINT: NA	POST INSP. CONTACTS: None	JOINT INSP. AGENCY: None	
WEATHER: Cloudy	INSPECTOR'S SIGNATURE:

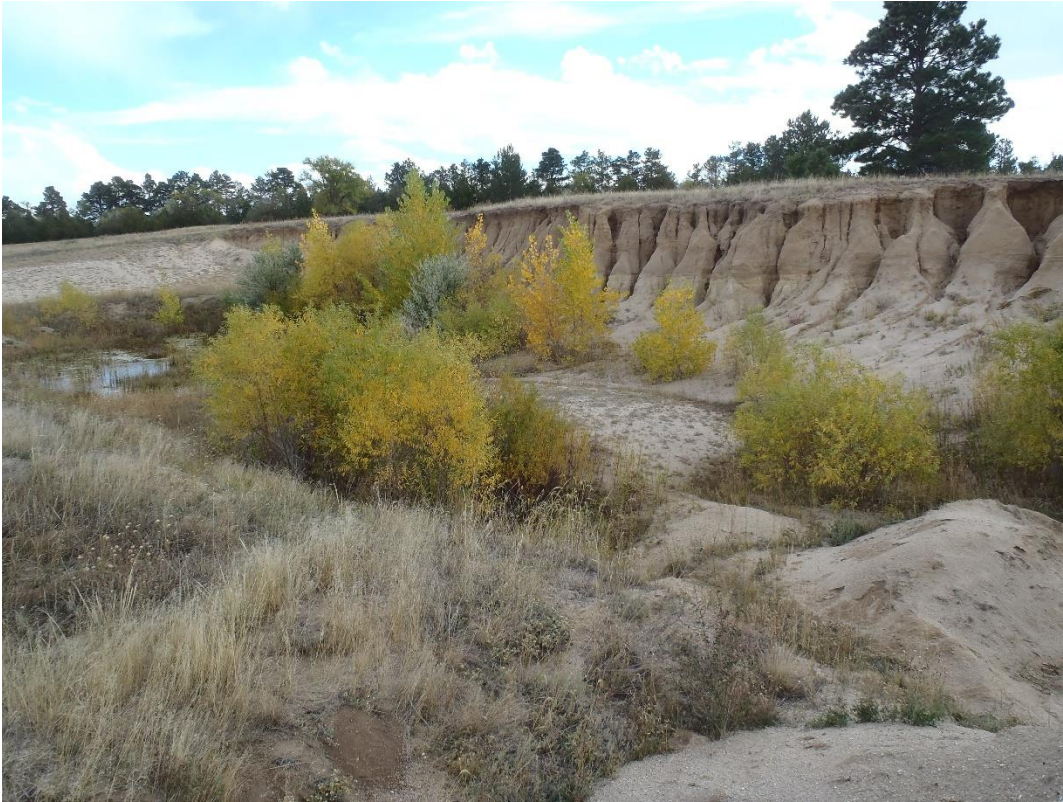
Backfilling and Grading: Backfill will be necessary to complete reclamation for the existing highwall and filling in the standing water in the pit bottom (see **Photo 1**). The water may be groundwater – see "Hydrologic Balance" discussion below. No backfill material appeared to be available. However, there appears to be sufficient unaffected area south of the highwall and within the permit boundary to push material down to achieve the required 3H:1V reclaimed slopes.

Photo 1. West highwall with erosion gullies and standing water in pit bottom (looking SE).

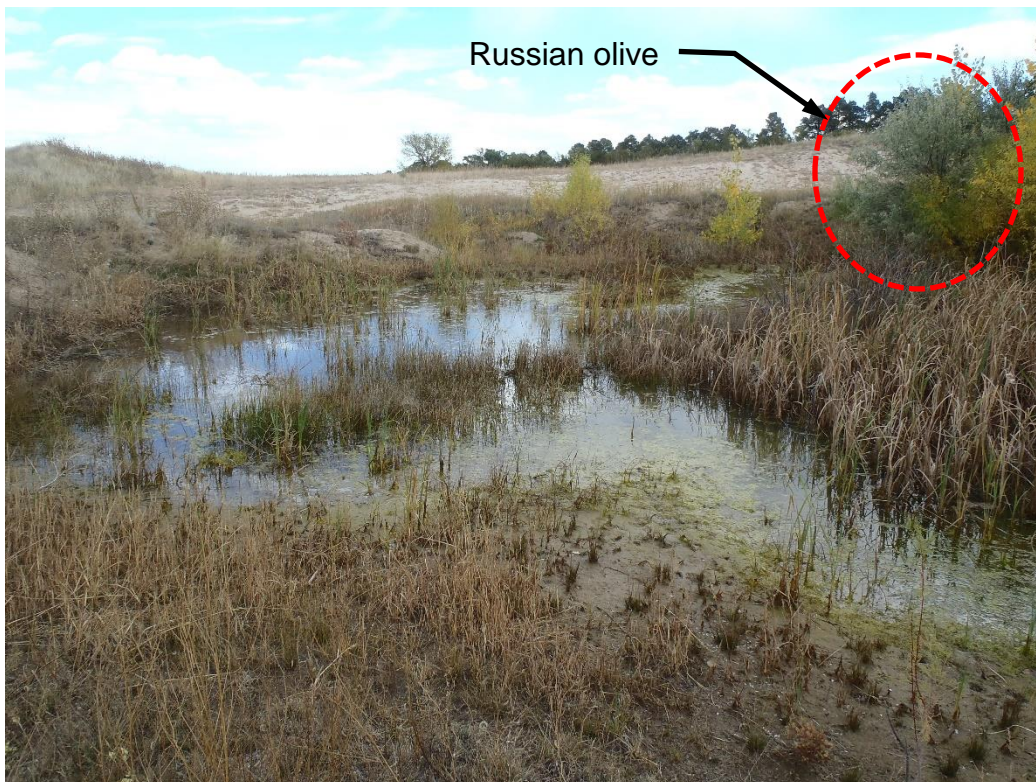
PROBLEM/POSSIBLE VIOLATION No. 1: Problem: The Division has no evidence that the operator has a valid well permit, substitute water supply plan, or approved water augmentation plan for the exposed groundwater at the site. This is a problem related to 34-32.5-116(4)(h) of the Colorado Revised Statutes and 3.1.6(1)(a) of the Construction Materials Rules and Regulations governing injury to existing water rights.

PROBLEM/POSSIBLE VIOLATION No. 3: Problem: Russian olive trees are present within or have volunteered into the permit area and are becoming established. This is a problem for failure to employ weed control methods for a state listed noxious weed species within the permitted area, and to reduce the spread of weeds to nearby areas as required by Section 3.1.10 (6) of the rule.

Hydrologic Balance: Standing water was observed in the pit. It was not certain if this water was exposed

groundwater or retained stormwater runoff. However, based on the marsh-type vegetation and the cottonwood trees (see **Photo 2**) that were not observed during the previous inspection, this inspector believes the water is rather permanent and therefore likely exposed groundwater. **The presence of exposed suspected groundwater is cited as Problem No. 1 on p. 1 of this report.**

Revegetation: Two Russian olive trees were observed in the pit bottom near the standing water. These trees are a List B species on Colorado's noxious weed list. **The presence of the Russian olive trees on site is cited as Problem No. 3 on p. 2 of this report.**

Photo 2. Marsh-type vegetation, Russian olive, and the cottonwood trees in pit bottom.

CORRECTIVE ACTIONS: The operator shall demonstrate that the operation is in compliance with the Office of the State Engineer, show evidence that the operator is taking measures to bring the site into compliance with the SEO, or backfill the pits to at least two feet above the groundwater surface by the corrective action date specified.

CORRECTIVE ACTIONS: The operator shall either implement the existing weed control plan, or develop a weed control and management plan in accordance with Section 3.1.10 (6) of the Rule. This plan should be developed in consultation with the county extension agency, or weed control district office and should include specific control measures to be applied, a schedule for when control measures will be applied and a post-treatment monitoring plan. This weed control plan shall be submitted to the Division as a Technical Revision to the approved plan with the appropriate Technical Revision fee of \$216.00 by the corrective action date.

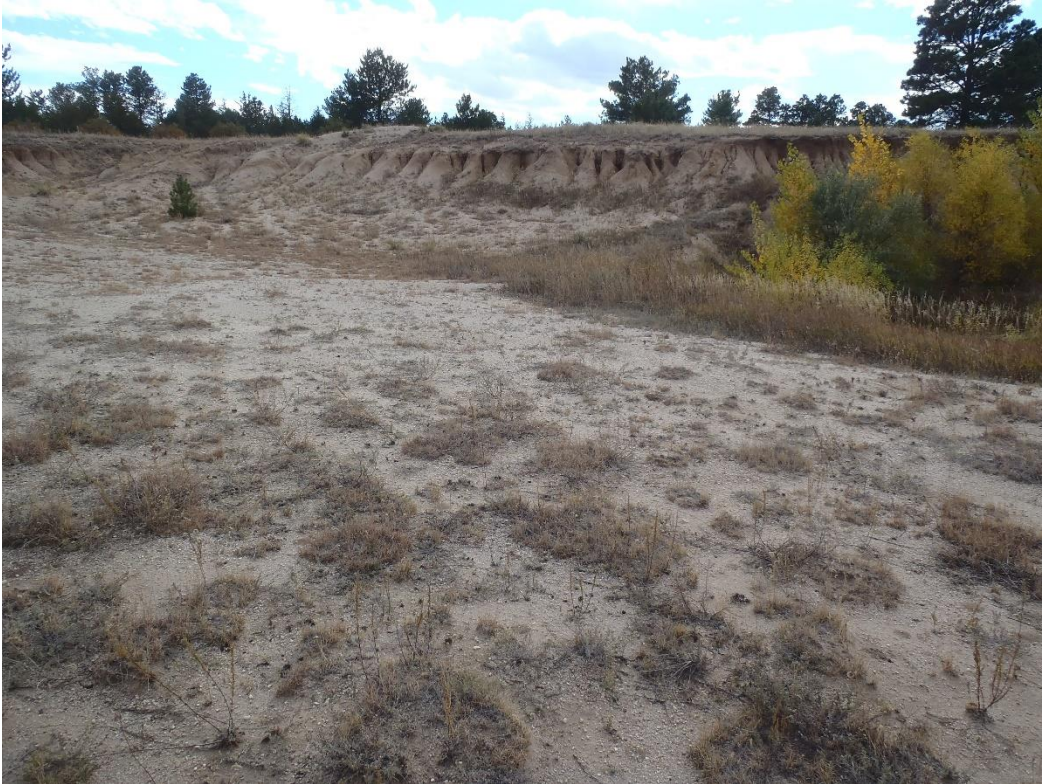
PROBLEM/POSSIBLE VIOLATION No. 2: Problem: Erosion gullies and ruts were observed on-site. This is a problem at this time for failure to protect the affected land from erosion pursuant to C.R.S. 34-32.5-116 (4) (j).

Gen. Compliance with Mine Plan: Google Earth was used to measure the disturbed area, which was estimated to be approximately 1.5 acres. The approved Mine Plan (Exhibit C of the permit) indicates the highwalls are to left at 3H:1V or flatter. High walls were near vertical in most areas and estimated to vary between 4 and 10 feet in height (see **Photos 1** and **3**) with significant erosion and some small tension cracks near the crest (see **Photo 4**). **The unstable highwalls are cited as Problem No. 2 on p. 1 of this report.**

Photo 3. East (shorter) portion of highwall with erosion gullies (looking SW).

CORRECTIVE ACTIONS: The operator shall provide photo documentation to the Division verifying erosion gullies and ruts have been repaired, and that the site has have been reconstructed and stabilized to prevent erosion damage by the corrective action date.

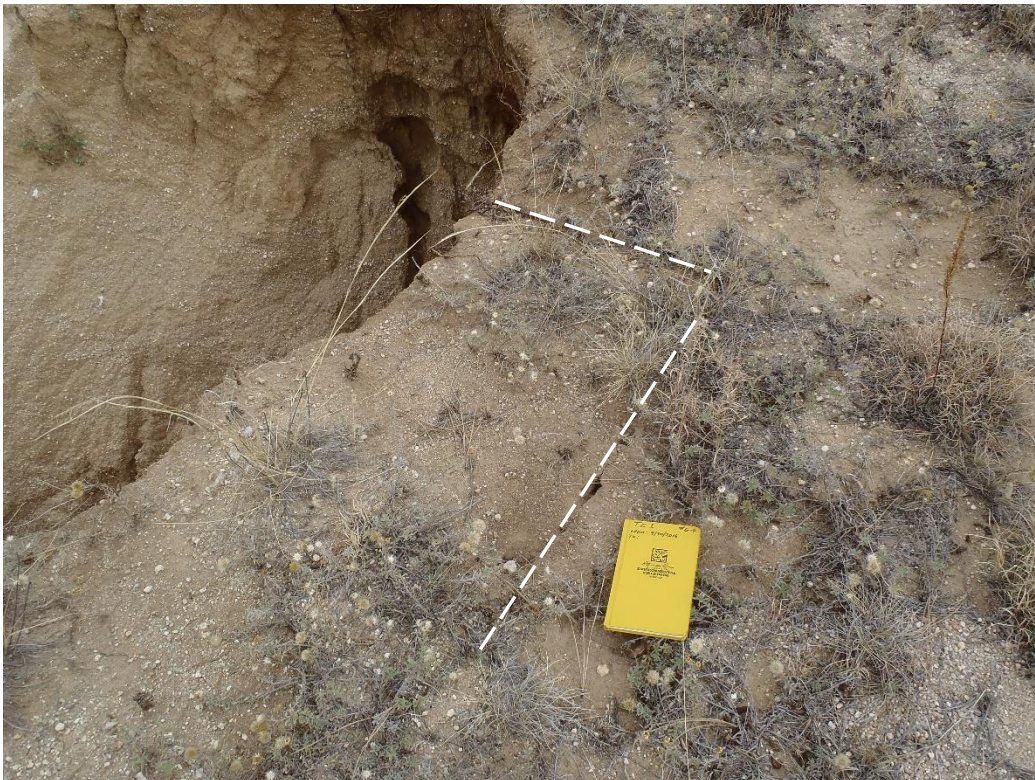
Sediment Control: The highwalls were experiencing significant erosion. However, sediment appeared to be trapped in the pit bottom by vegetation and the observed standing water. The highwall needs to be stabilized as discussed in the "Gen. Compliance with Mine Plan" above.

Photo 4. Small tension cracks near the crest and erosion feature.

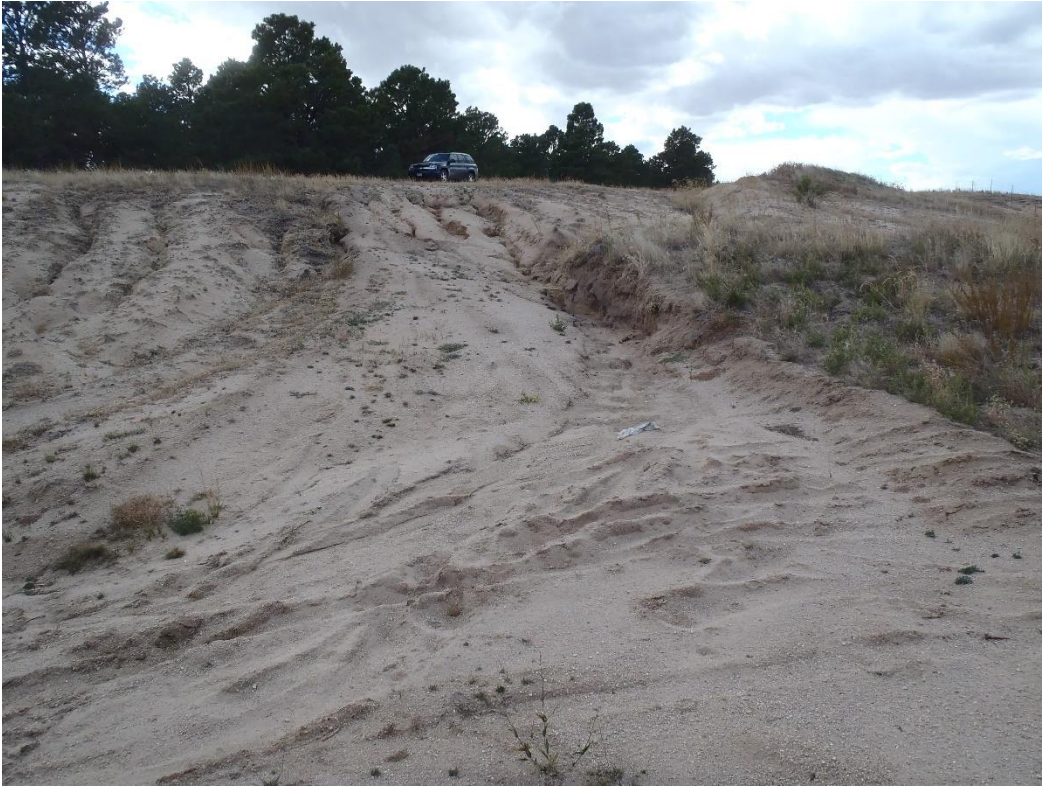
Off-site Damage: Based on Google Earth imaging (see **Figure 1**) and the permit boundary map provided with the 2005 permit application, it appears there may have been some error in delineating the original permit boundary unless the disturbed area on the west end (see **Photo 5**) of the site is related to the original site road and not the mine. This disturbance is closer to the Ramah Hwy than the west permit boundary which has been delineated as 896.85 feet from the highway. Without a Schuler Construction representative to point out permit boundary markers nor discuss what disturbances might be related to the original road, this could not be discerned during the inspection.

Photo 5. Disturbed area on the west end: pit development or original road? (NW corner, looking SW).

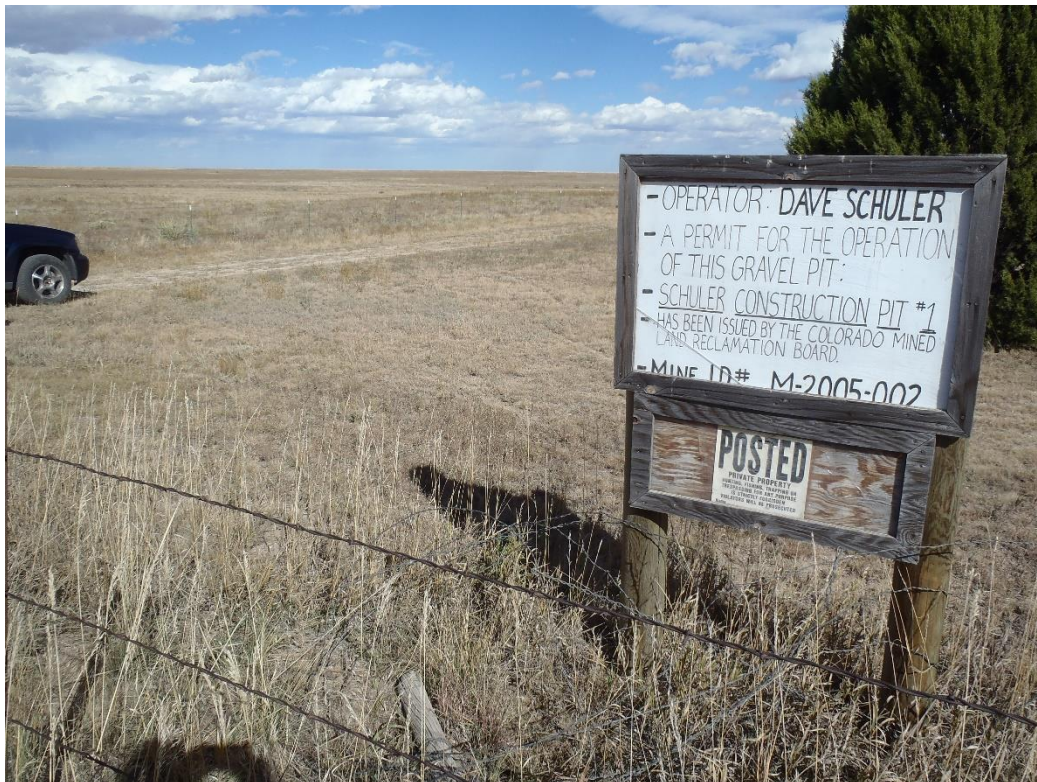
Signs and Markers: The permit sign was properly posted (see **Photo 6**). This inspector could not locate boundary markers other than possibly the fence on the north side of the site. Permit boundary markers should be clearly visible.

Photo 6. Permit sign (looking NE).

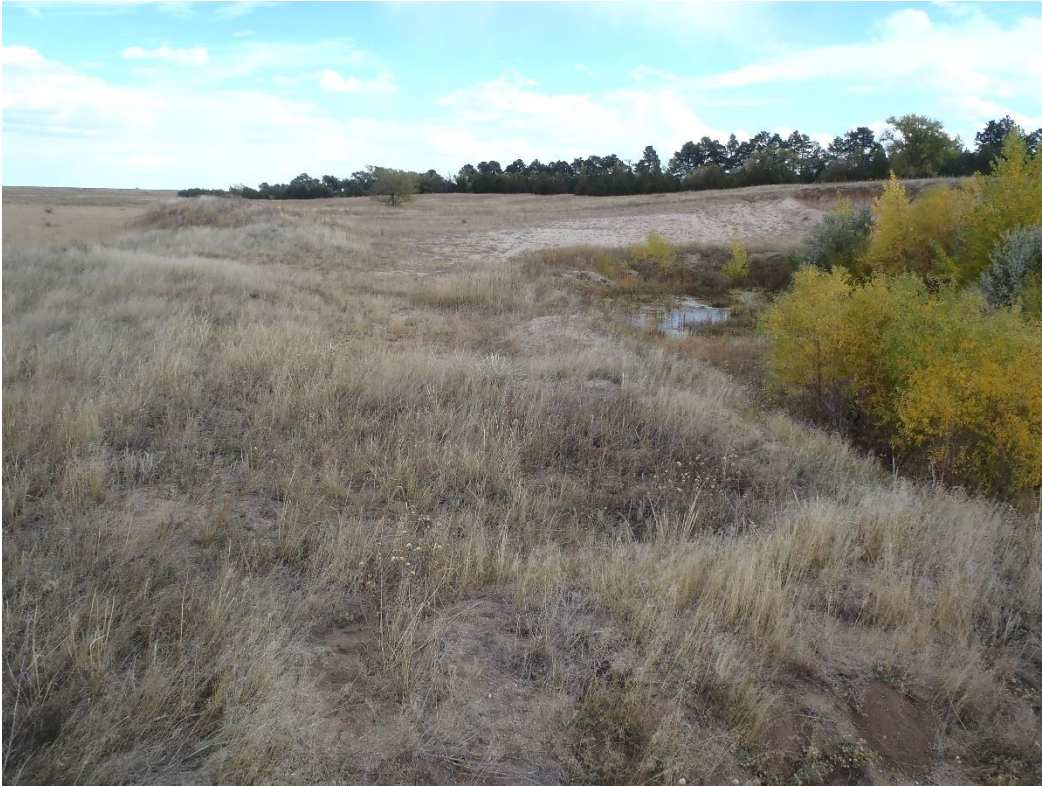
Topsoil: The previous inspection report (2012) indicated a topsoil stockpile was located on the west side of the permit area. A small pile was observed on the west end. There is a well vegetated berm along the north side of the affected area that might be topsoil (see **Photo 7**).

Photo 7. Vegetated berm along the north side of the affected area (looking east).
