**U.S. DEPARTMENT OF INTERIOR
BUREAU OF LAND MANAGEMENT
ROYAL GORGE FIELD OFFICE
3600 INSPECTION REPORT**

MINE NAME:	Midland Pit
OPERATOR:	City of Cripple Creek
MAIN COMMODITY:	Road base
TYPE OF OPERATION:	3600 Sand and Gravel FUP
COUNTY:	Teller
LOCATION:	T14S, R69W, section 32
INSPECTOR(S)/ OP. REP PRESENT:	William Jenkins (BLM), Stephanie Frint (City of Cripple Creek), and Steve Pickmello (Operator)
INSPECTION DATE:	4/14/2016
DATE OF COMPLAINT, if applicable:	N/A

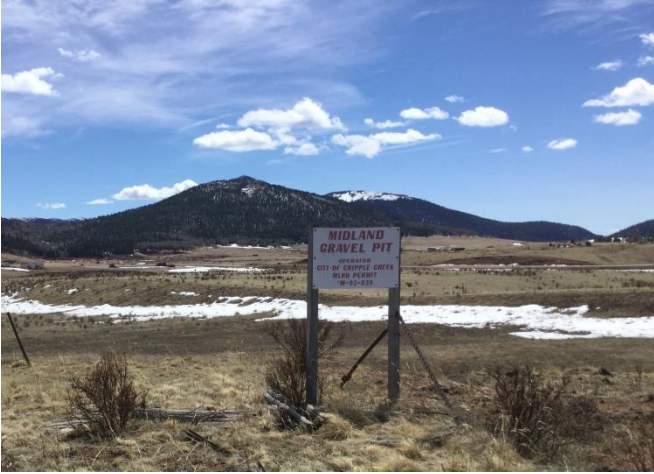
Photo 1: The sign (With DRMS #)
posted at the entrance to the site.

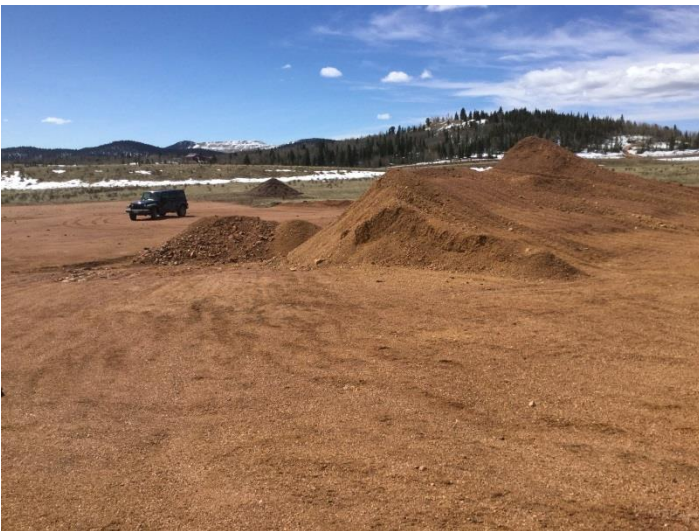
Photo 2: The current pit floor, where
the operator stockpiles their material.

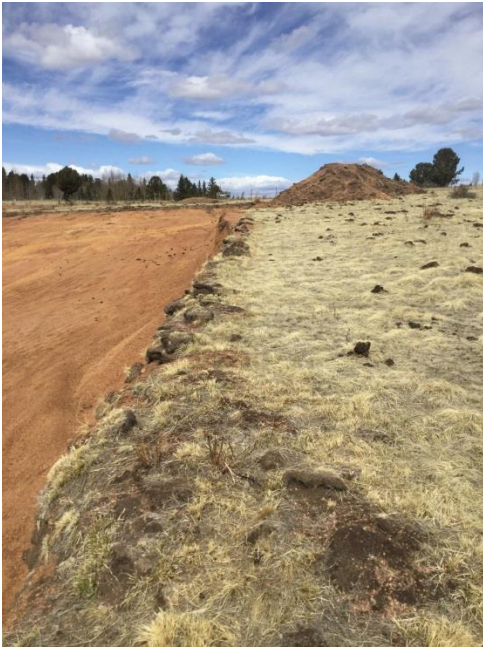
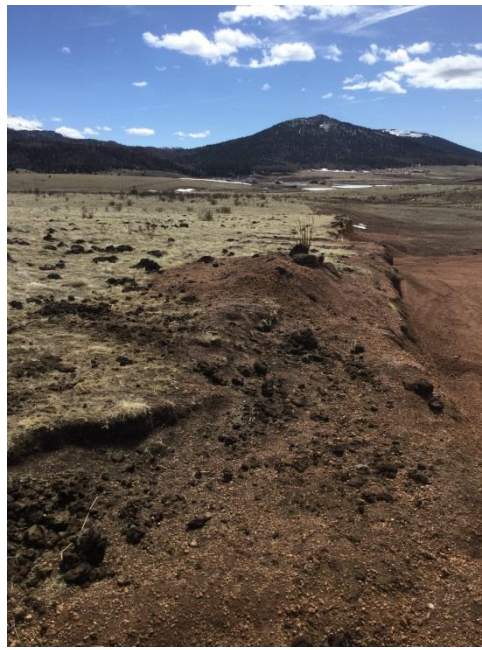
Photo 3: Photos taken along the pit's current highwall (~10 ft high), which the operator intends to reclaim.

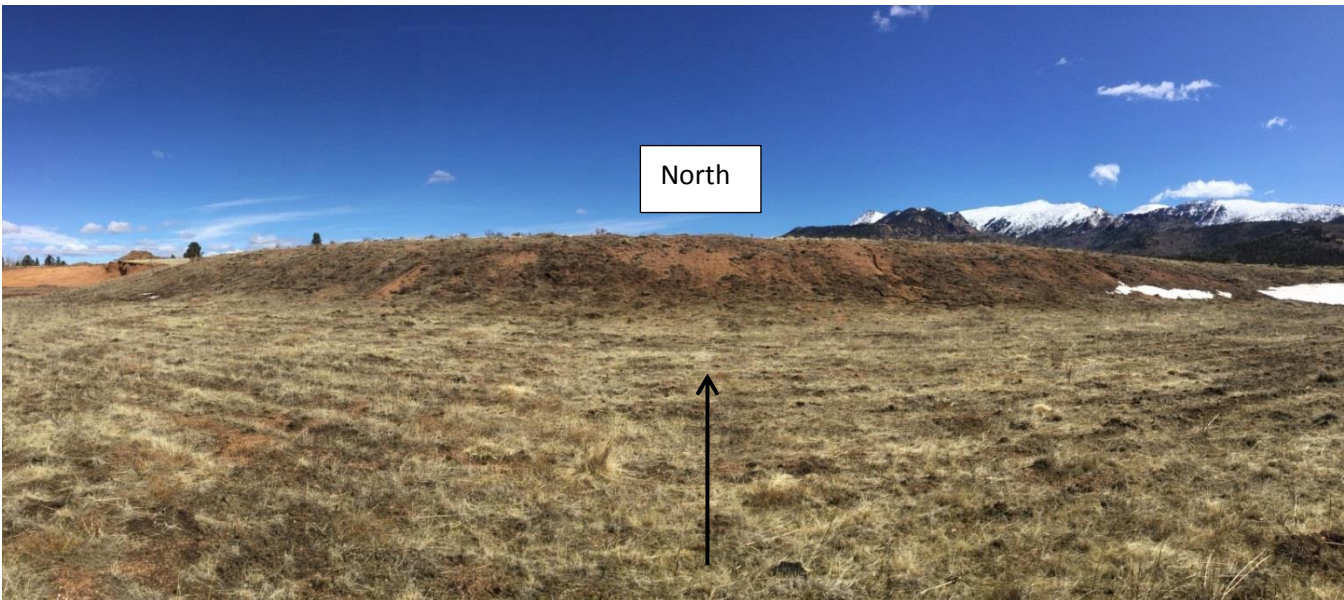
Photo 4: The proposed working face, which the operator intends to push 200 feet to the north.

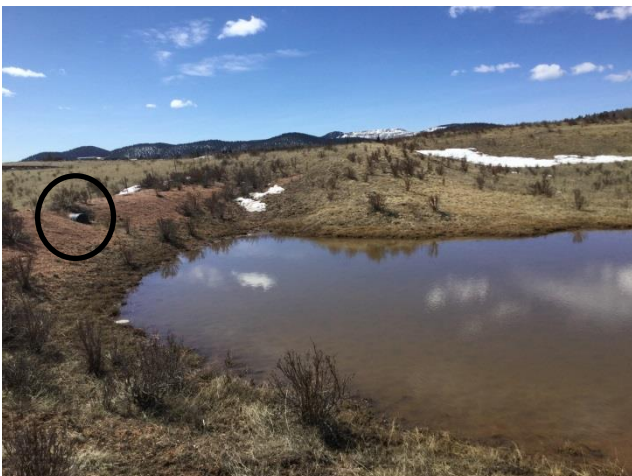
Photo 5: The pit's check dam with culvert (circled) located on the eastern side of their permitted boundary, it should be noted that the water is from recent rains and snow melt.

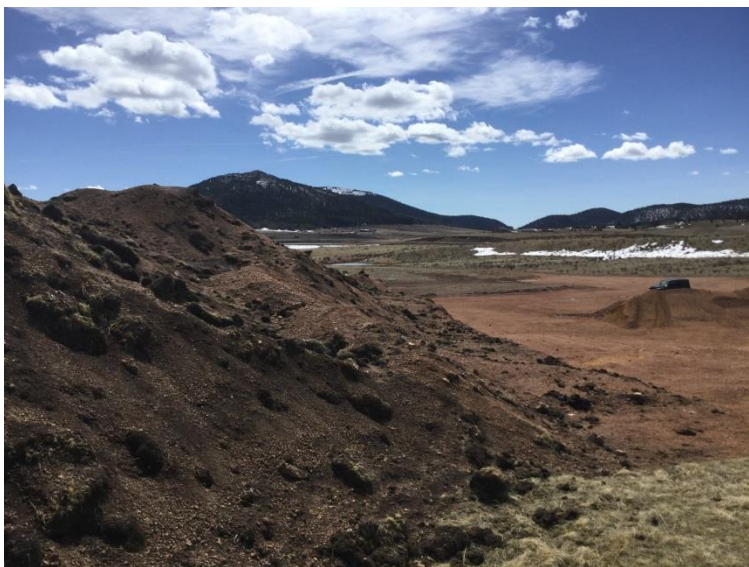
Photo 6: The operator's topsoil stockpile, located north/northeast of the access road.

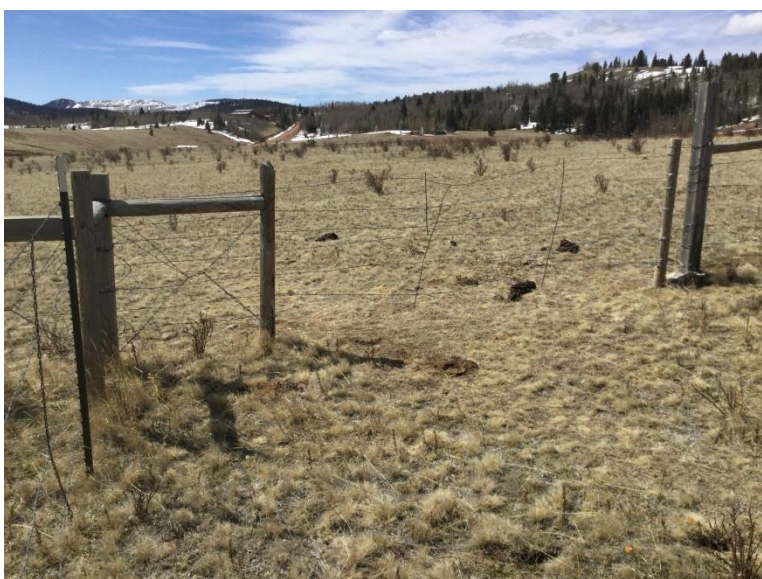
Photo 7: The barbed wire gate at the southeastern corner post of the boundary fence.

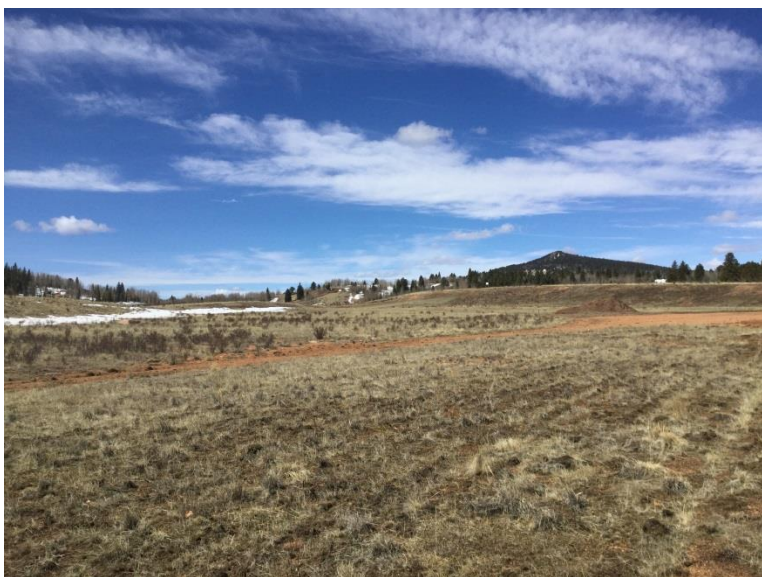
Photo 8: The 10 acres of reclaimed land to the south of the operator's working area.
