Mineral Materials Site Inspection
U.S. Department of the Interior
Bureau of Land Management
Royal Gorge Field Office

Date:04/19/2017 Time: 9:20 - 9:45 a.m. Weather: Clear Inspection Purpose: General	Project Name: Midland Pit Operator: City of Cripple Creek Location: Cripple Creek, CO BLM COC #: 077694 CDRMS Permit #: M-1993-039
Attendees BLM: William Jenkins Operator(s): Steve DiCamillo, Stephanie Frint Other(s):	Project Status:Active Commodity: Roadbase Type of Operation: Free Use Permit Contract Acres/Amount: 21.89 acres Contract Expiration Date: 02/01/2026
General Compliance Compliance with the approved Mine and Reclamation Plan per the requirements outlined in 43 CFR §3601.40-42.	In general, the operation is in compliance with the Mine and Reclamation Plan on file with BLM. x Yes <input type="checkbox"/> No <input type="checkbox"/> N/A In general, the operation and disturbances on site coincide with the method of mining, reclamation, and access described in the Mine and Reclamation Plan. x Yes <input type="checkbox"/> No <input type="checkbox"/> N/A

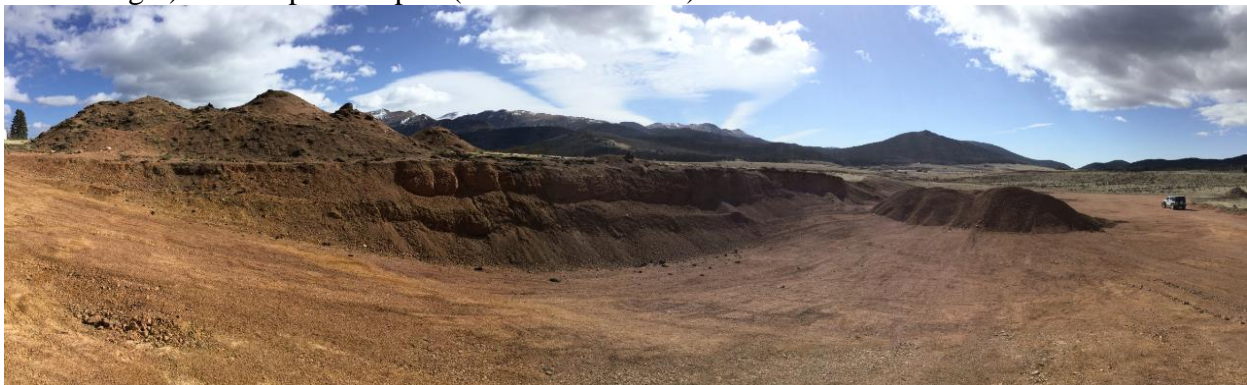
Photo 1. Panorama taken from the site's entrance. Note the working face, topsoil stockpiles (far left and right) and the product pile (left of the vehicle).

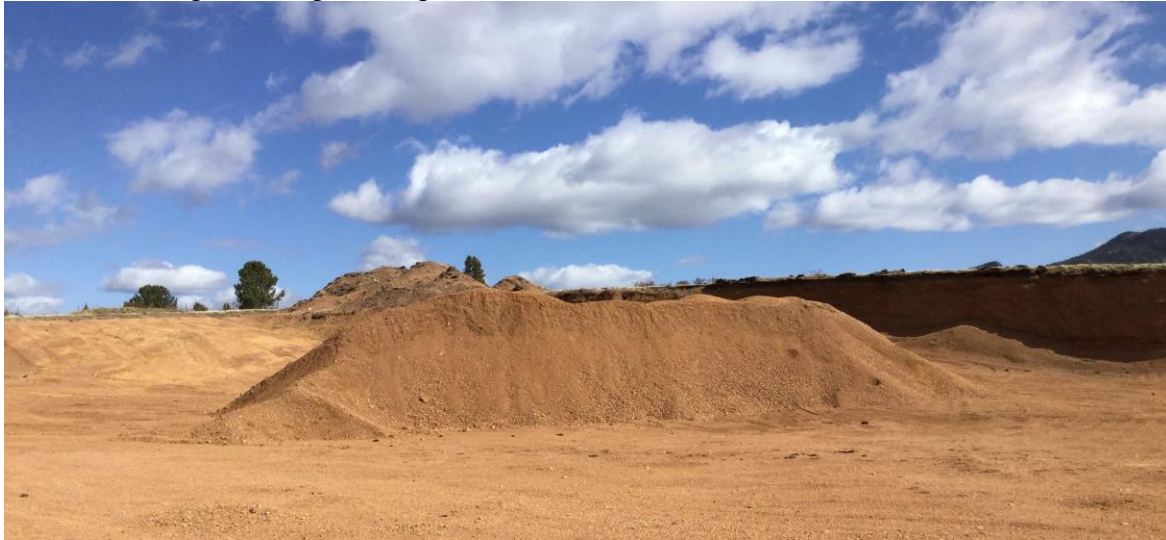
Photo 2. The operator's product pile.

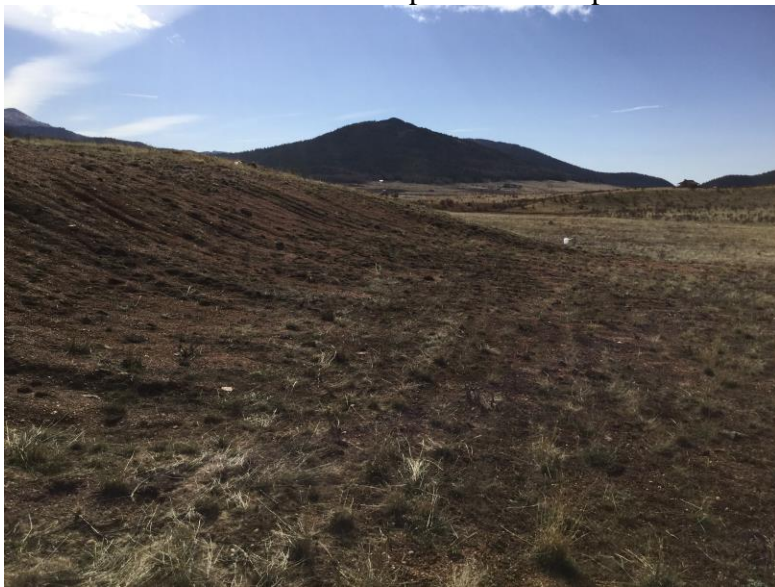
Photo 3. The reclaimed eastern portion of the pit.

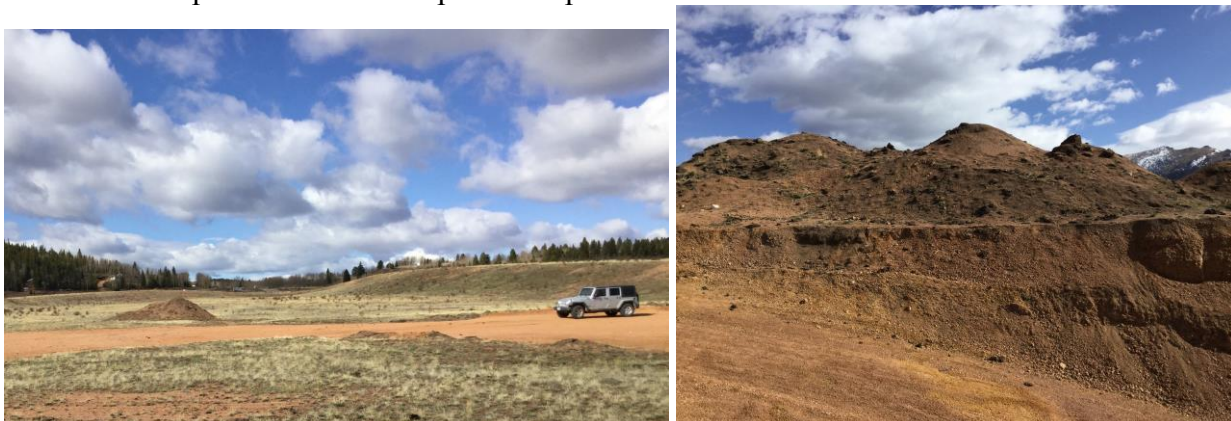
Photo 4. The operator's two stockpiles of topsoil.

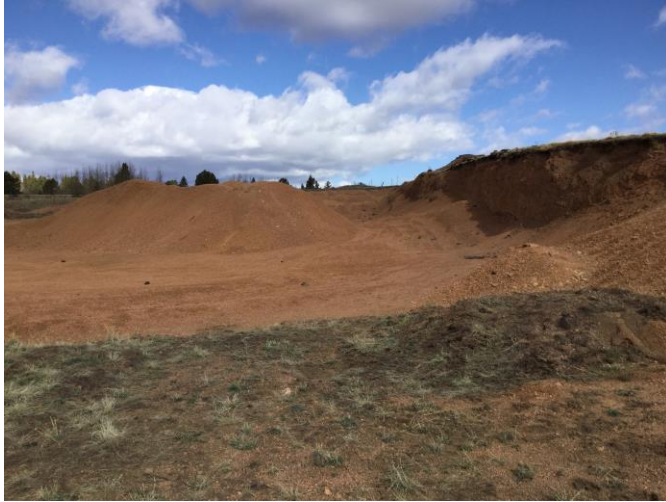
Photo 5. The highwall and product pile.

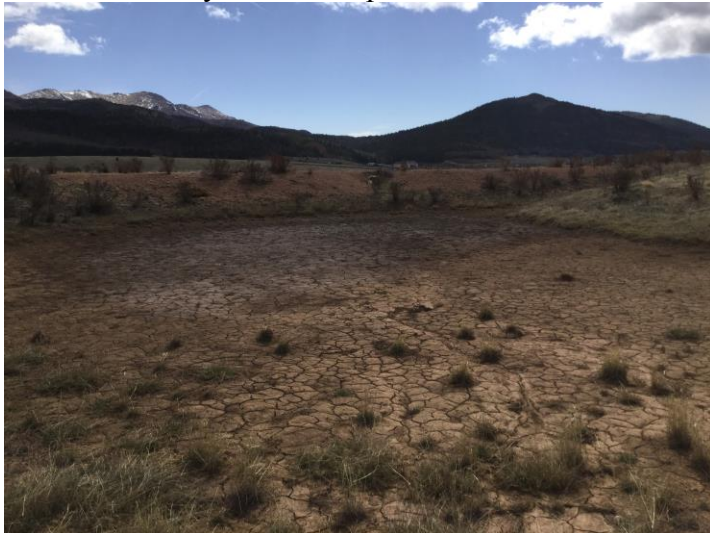
<p style="text-align: center;"><u>Water Management</u></p> <p><input type="checkbox"/> Dust Mitigation (water trucks)</p> <p><input type="checkbox"/> Mitigation Measures (exposed groundwater, dewatering/pumps, sediment containment, stormwater runoff controls)</p>	<p><input type="checkbox"/> N/A</p> <p>An earthen dam captures surface runoff, and allows for water infiltration into the ground. At the time of the inspection, this catchment was dry.</p>

Photo 6. The dry catchment pond and earthen dam on the site's eastern side.
