**COLORADO**Division of Reclamation,
Mining and Safety

MINERALS PROGRAM INSPECTION REPORT**PHONE: (303) 866-3567**

MINE NAME: Gold Hill Mill	MINE/PROSPECTING ID#: M-1994-117	MINERAL: Gold and silver	COUNTY: Boulder
INSPECTION TYPE: Monitoring	INSPECTOR(S): Amy Eschberger, Wally Erickson	INSP. DATE: August 1, 2017	INSP. TIME: 10:25
OPERATOR: Colorado Milling Company, LLC	OPERATOR REPRESENTATIVE: Mark Steen	TYPE OF OPERATION: 110(2) - Hard Rock Limited Impact

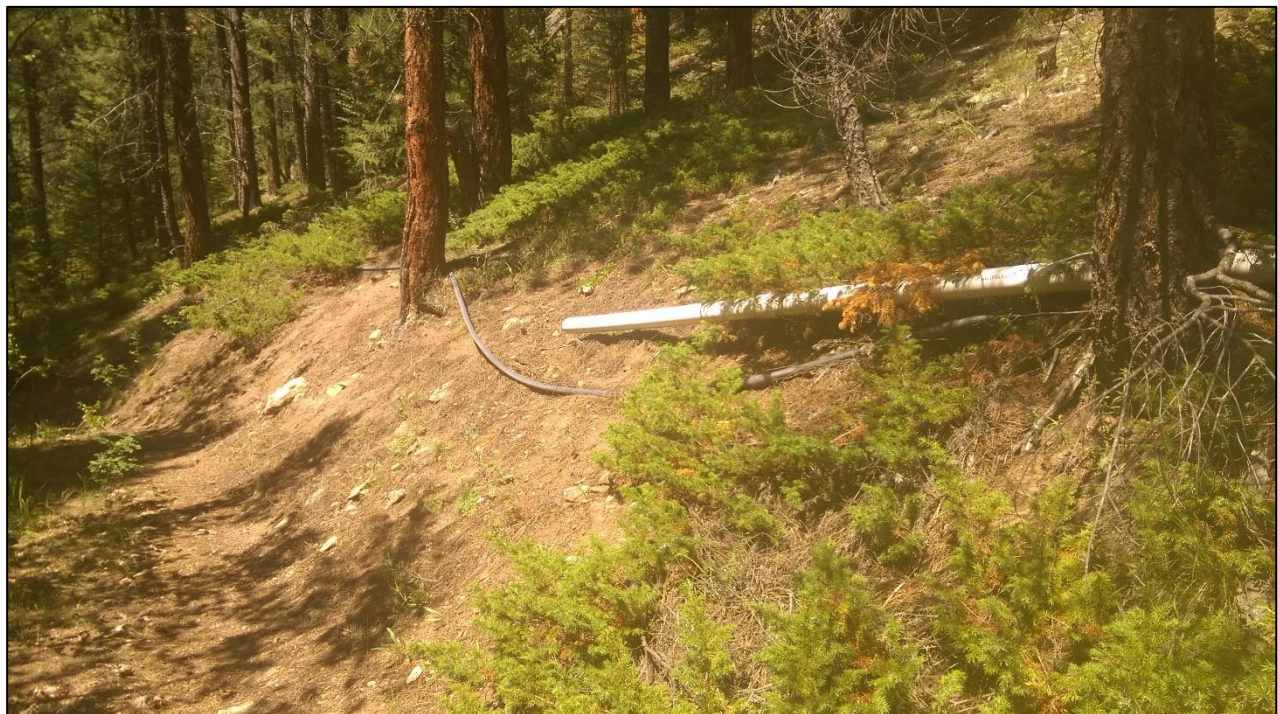
pipe, and a larger (approximately 4 inch) PVC pipe. According to Mr. Steen, the PVC pipe was installed by himself in the 1980's to support the newly constructed mill. This pipe was later disconnected. The black HDPE pipe was installed by a previous mill operator in the 1990's. Mr. Steen indicated he intends to remove both pipelines and install a new pipe to run from the creek to the historic mine workings uphill, over a total of approximately 3,900 horizontal feet and approximately 1,000 vertical feet. Mr. Steen indicated the pipeline would be installed on Boulder County property for which he holds a legal easement. Mr. Steen showed the Division portions of the new pipe he intends to install, which is currently being stored on top of the large ore stockpile adjacent to the mill (**Photo 11**). This pipe is a black two inch HDPE pipe with a thickness of approximately 0.5 inch. Mr. Steen indicated he intends to install the new pipe within the month if possible. He also intends to install a longer culvert through the Times Mine adit once the subsidence has been repaired and stabilized.

Photo 8. View looking downhill along trail following Lick Skillet Gulch, showing two existing pipelines present along edge of trail. According to Mr. Steen, PVC pipe was installed by him when mill was first constructed in 1980's, and smaller black HDPE pipe was installed by previous operator in 1990's. Note PVC pipe disconnected.

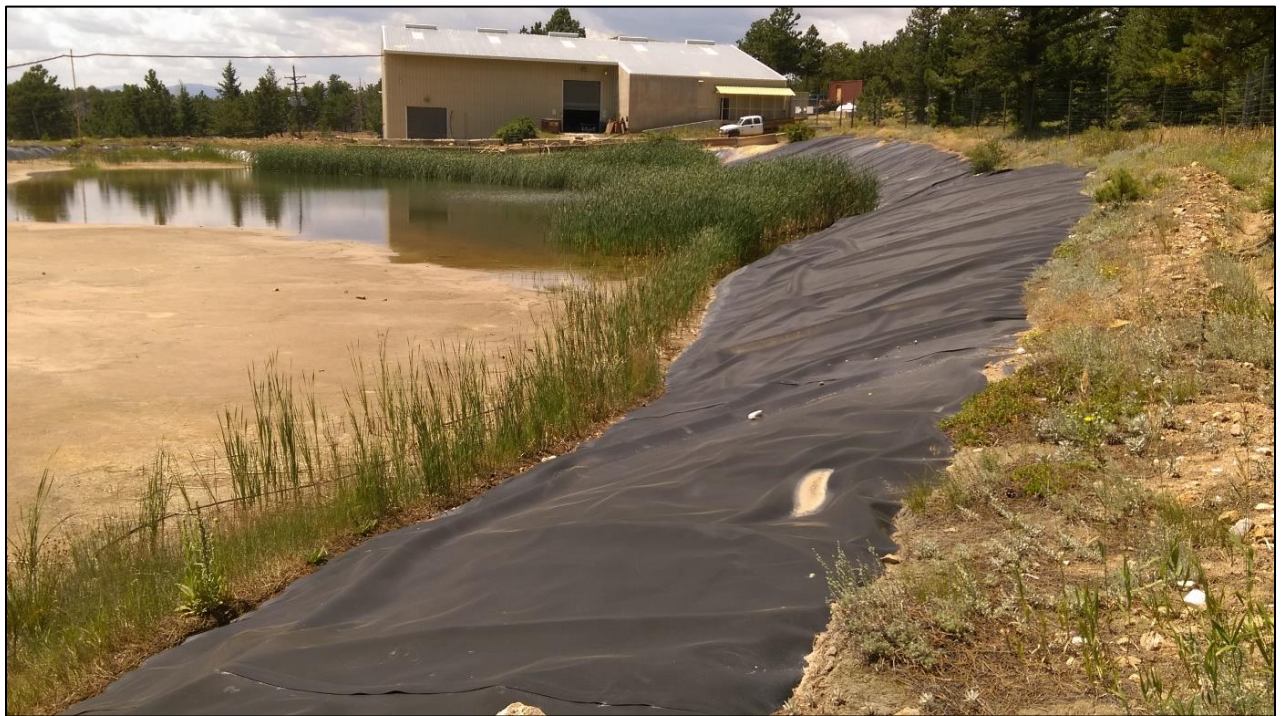
Photo 29. View looking across northern edge of lined tailings impoundment showing available freeboard exceeds the required two feet.

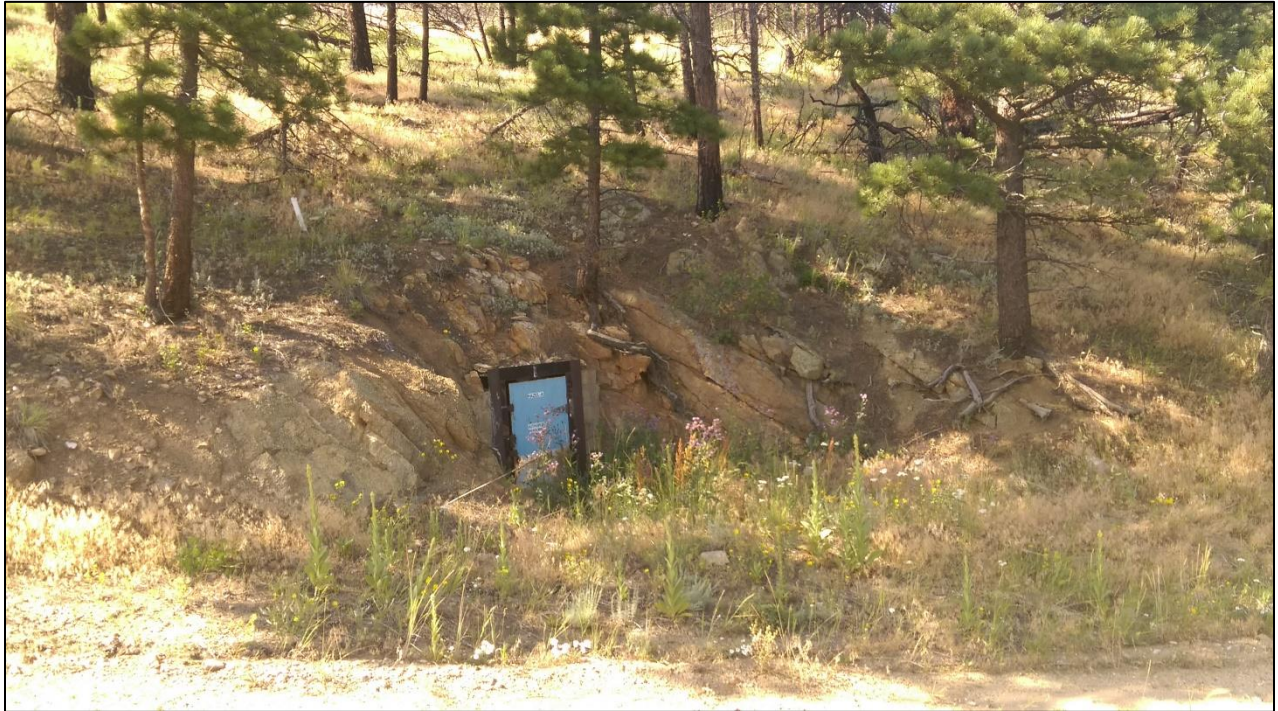
The Division inspected the entrance to the Hazel A Mine adit (**Photos 34 and 35**), located south of and downhill from the permitted mill site. This portal is located adjacent to a dirt haul road that connects the mill site to the operator's Cash and Who Do Mines to the south (Permit No. M-1983-141). Originally, the Hazel A

Photo 34. View of Hazel A Mine entrance located approximately 0.25 mile southeast and downhill from mill site off main access road that connects mill site to Cash and Who Do Mines (Permit No. M1983-141).

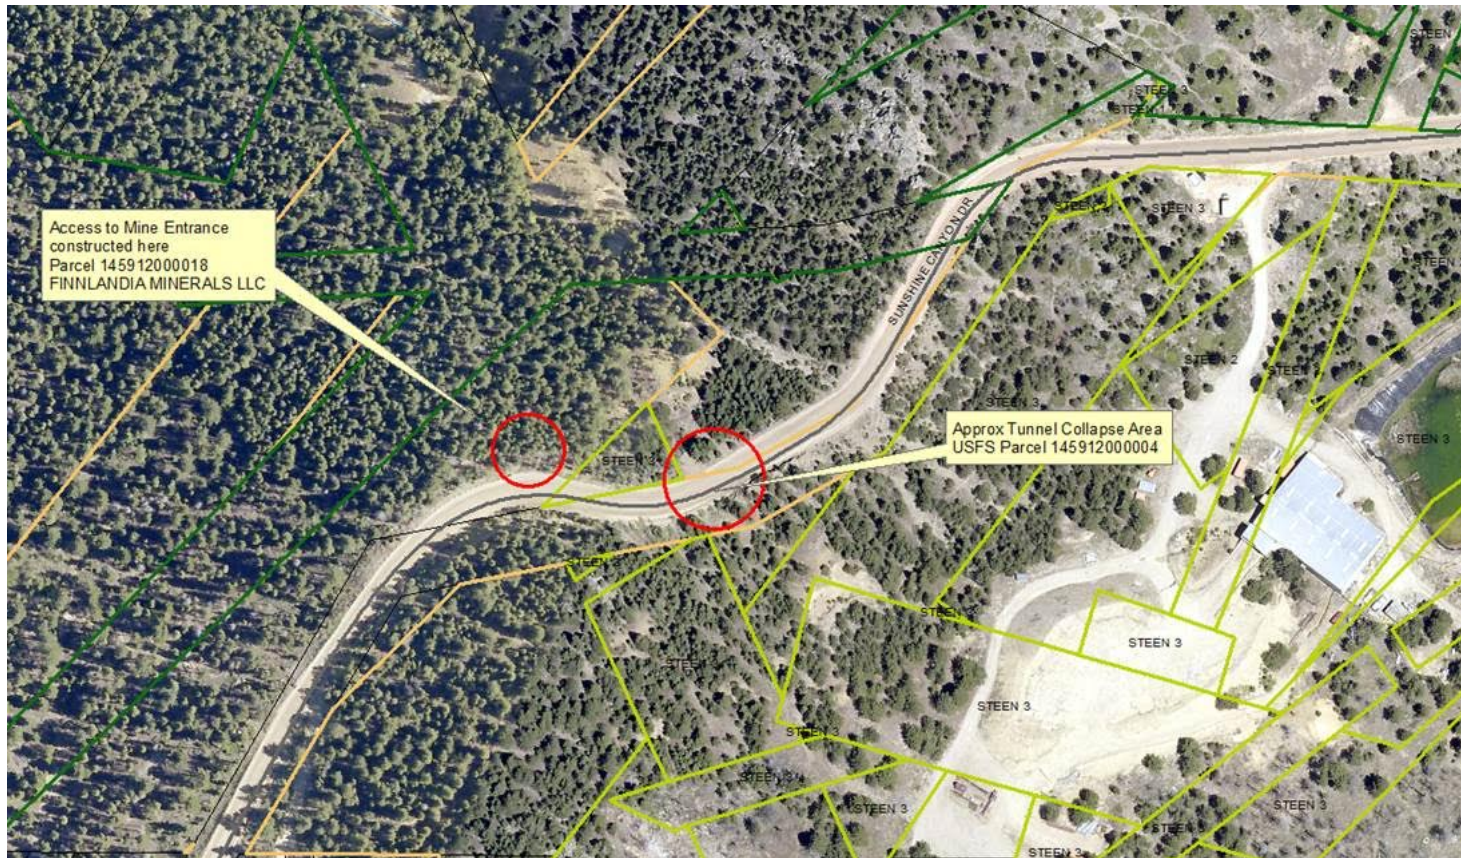
Map #1

The location the tunnel caved under Sunshine Canyon Drive is shown generally on Map #1. Mr. Steen has been working with our Transportation Department on this, and has since installed structures (out of the right of way) to help stabilize the tunnel. Transportation is still working with Mr. Steen on this issue.

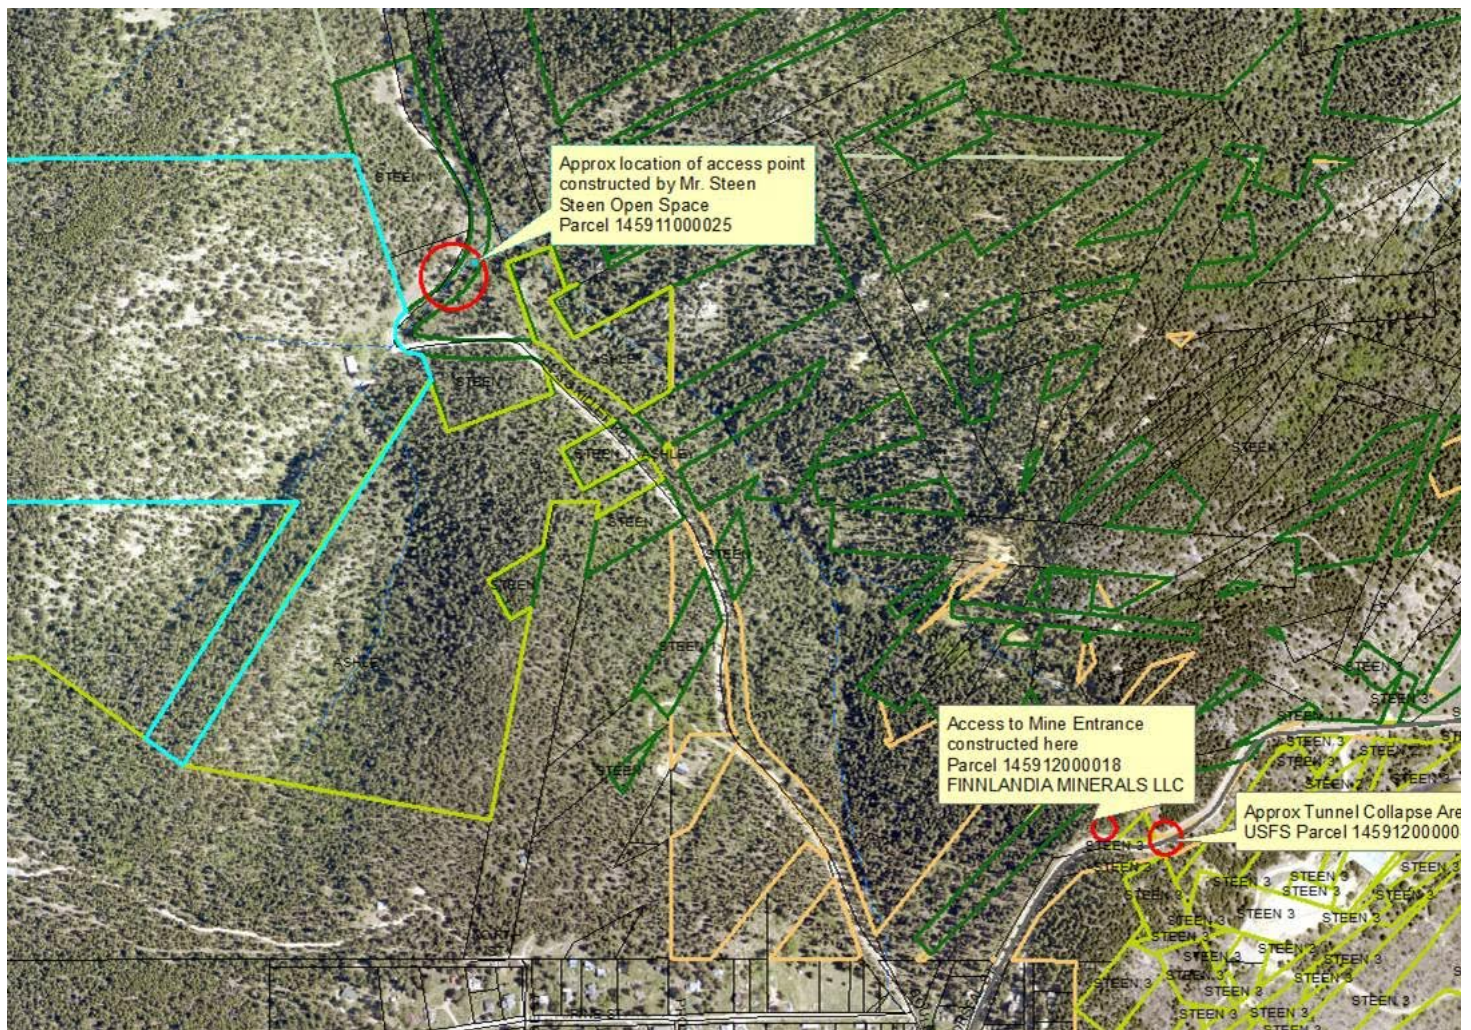
Map #2

An access point to something related to the mine was constructed off of Licksillet Rd and appears to be on open space, generally shown on Map #2.
