MINERALS PROGRAM INSPECTION REPORT
PHONE: (303) 866-3567

MINE NAME: Black Snag	MINE/PROSPECTING ID#: M-1995-010	MINERAL: Gravel	COUNTY: Dolores
INSPECTION TYPE: Monitoring	INSPECTOR(S): Lucas J. West	INSP. DATE: August 22, 2017	INSP. TIME: 10:25
OPERATOR: Dolores County	OPERATOR REPRESENTATIVE: None	TYPE OF OPERATION: 110c - Construction Limited Impact	
REASON FOR INSPECTION: Normal I&E Program	BOND CALCULATION TYPE: None	BOND AMOUNT: \$0.00	
DATE OF COMPLAINT: NA	POST INSP. CONTACTS: None	JOINT INSP. AGENCY: None	
WEATHER: Clear	INSPECTOR'S SIGNATURE:

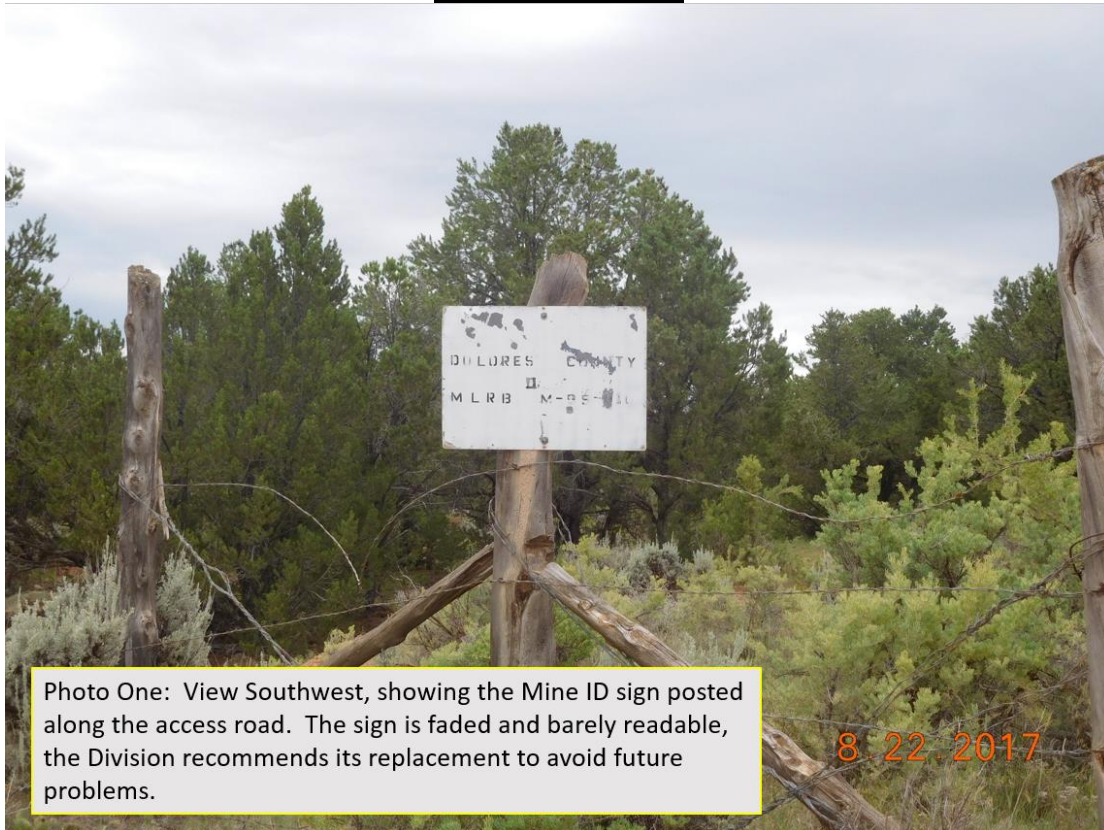
In attempt to gain access to the site, it was found that County Road 241F has been washed out in recent storm events and is impassible by vehicle. The proper mine identification sign was located along the access road, however it is faded and barely readable shown in Photo One. The Division suggests that the Operator replace the sign soon so that it is more visible. The permit boundaries are clearly marked with a series of T-posts and berms. The access road is beginning to show signs of erosion in response to recent precipitation events, the Division suggests the Operator monitor this to prevent significant damage in the future. No equipment was observed on site and the site was not active during the day of the inspection. The main pit area appears to be stable and in good condition as shown in Photos Two and Three. Several stockpiles including overburden, topsoil and useable materials were located on the pit floor, examples of the stockpiles are shown in Photo Four and Five. The slopes around the pit area appear to have been graded at approximately 3H: 1V and appear to be stable. No signs of erosion on the pit slope areas were noted during the inspection. Several storm water control structures were observed on site and appeared to be functioning as designed and can be seen in Photo Three.

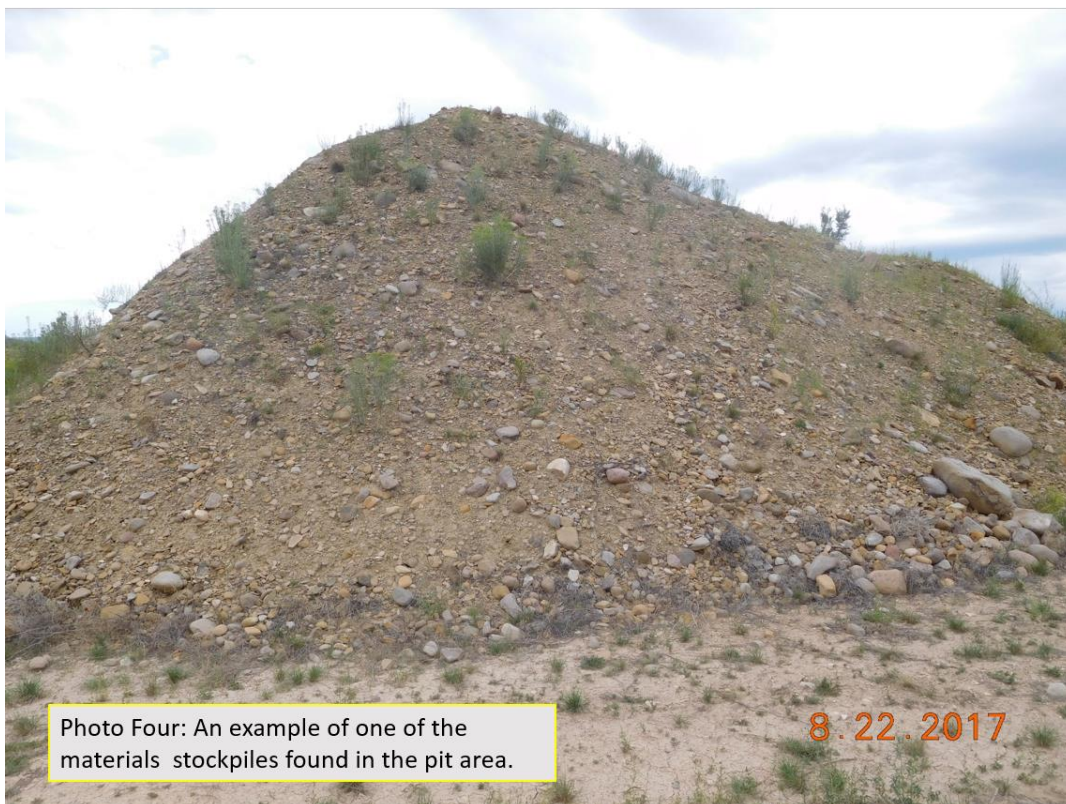
The entire site has begun to revegetate itself with volunteer species from the surrounding areas. Almost all of the site, an estimated 95%, contains Halogeton, a C List species on the Colorado Noxious Weeds lists. Although it is not uncommon to see Halogeton in this area it may inhibit future reclamation efforts and will need to be monitored and possibly treated in the future. Several populations of Canada thistle exist on site, and was mentioned to the Operator that the site will require attention for the noxious weeds this fall.
