Locatable Minerals Site Inspection
U.S. Department of the Interior
Bureau of Land Management
Royal Gorge Field Office

Date: 04/11/2017 Time: 11:35 a.m. - 12:15 p.m. Weather: Clear Inspection Purpose: General	Project Name: Destiny Mine Case Number: COC 073930 Operator: Boyd Astemborski Location: Fairplay, CO DRMS #: M2009056
Attendees BLM: William Jenkins, Stephanie Carter Operator(s): Other(s):	Project Status: Active Project Type: Plan of Operations Occupancy: None (at present)
General Compliance Compliance with the filed Plan of Operations, and 43 CFR 3809 (in particular the performance standards outlined in 3809.420).	In general, the operation is in compliance with the Plan on file with BLM. x Yes <input type="checkbox"/> No <input type="checkbox"/> N/A In general, the operation and disturbances on site coincide with the method of prospecting, mining, and access described in the Plan of Operations. x Yes <input type="checkbox"/> No <input type="checkbox"/> N/A

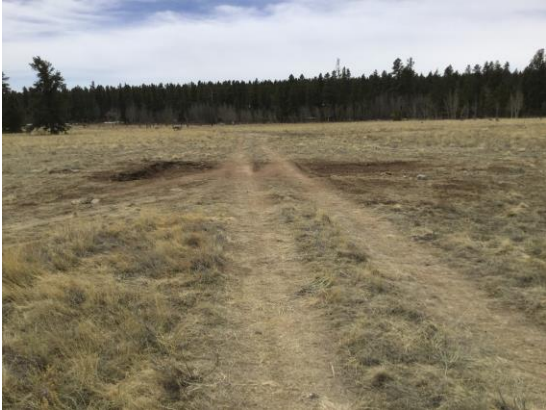
Photo 1. The current access road leading from Thompson Park road. This will be re-directed when mining operations initiate on the site.

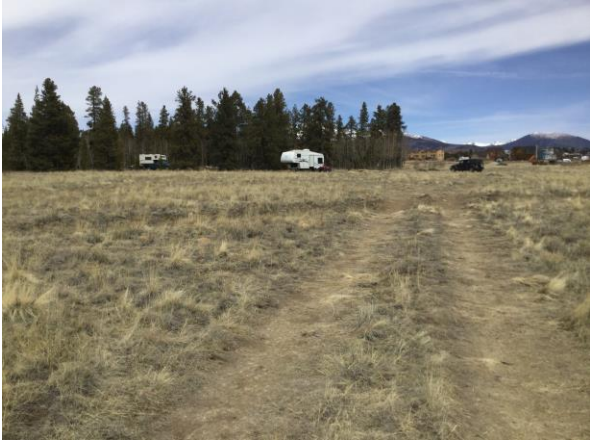
Photo 2. Facing the approved mine boundary from the current access road.
