**MINERALS PROGRAM INSPECTION REPORT**  
**PHONE: (303) 866-3567**

<b>MINE NAME:</b> Nelson Pit	<b>MINE/PROSPECTING ID#:</b> M-1974-070	<b>MINERAL:</b> Sand and gravel	<b>COUNTY:</b> Weld
<b>INSPECTION TYPE:</b> Surety Release Inspection	<b>INSPECTOR(S):</b> Peter S. Hays	<b>INSP. DATE:</b> August 25, 2017	<b>INSP. TIME:</b> 09:00
<b>OPERATOR:</b> Lafarge West, Inc. c/o Lafarge North America	<b>OPERATOR REPRESENTATIVE:</b> Christine Felz	<b>TYPE OF OPERATION:</b> 112c - Construction Regular Operation	
<b>REASON FOR INSPECTION:</b> Surety Release Requested	<b>BOND CALCULATION TYPE:</b> Complete Bond	<b>BOND AMOUNT:</b> \$37,815.00	
<b>DATE OF COMPLAINT:</b> NA	<b>POST INSP. CONTACTS:</b> None	<b>JOINT INSP. AGENCY:</b> None	
<b>WEATHER:</b> Clear	<b>INSPECTOR'S SIGNATURE:</b>

**The Division will deny the final financial and performance release request (SL-02) due to the lack of well-established reclamation vegetation.**

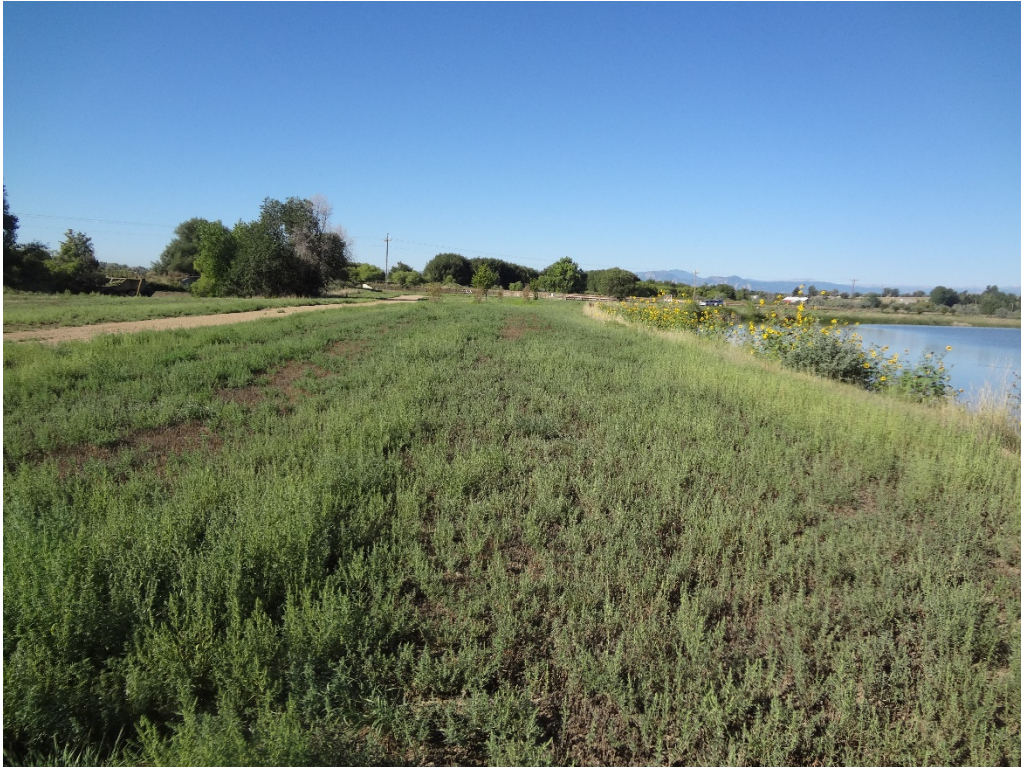
The area was stable and no erosion features were observed. The vegetation in the area was dominated by kochia on both sides of the roads with the exception of the south lake shoreline. The Division recommends consulting with Arnold's Custom Seeding to develop a plan to establish the reclamation grass throughout the area.

Area 3 looking south along the east shoreline of the south lake

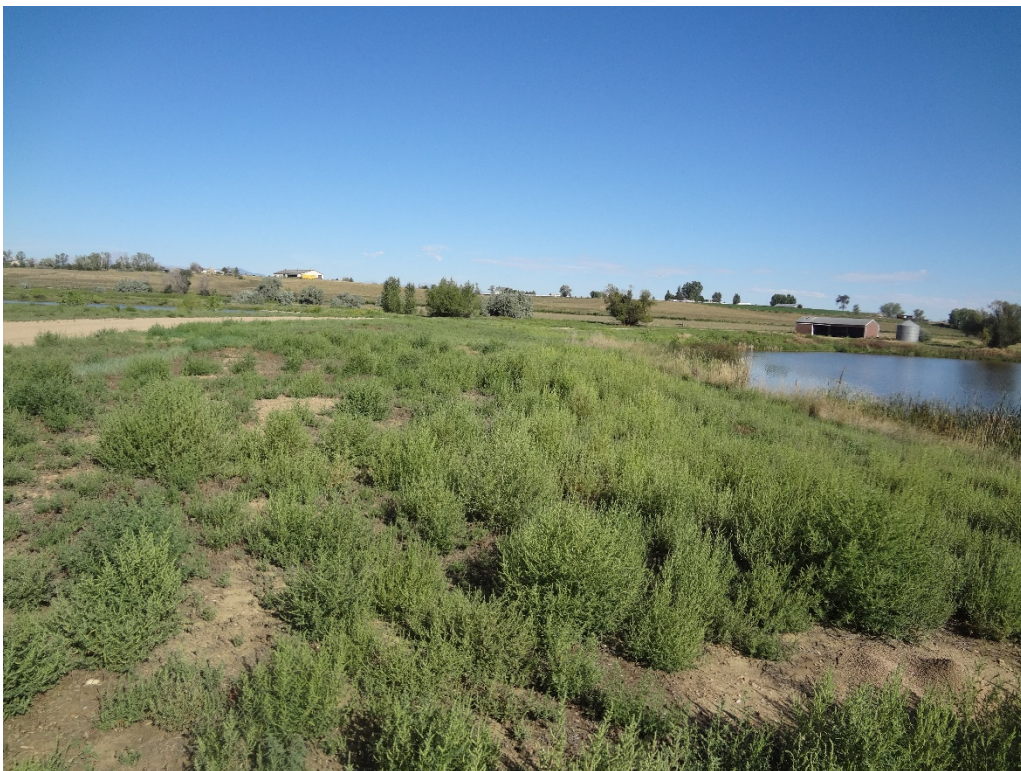
Area 3 looking west along the south shoreline of the north lake

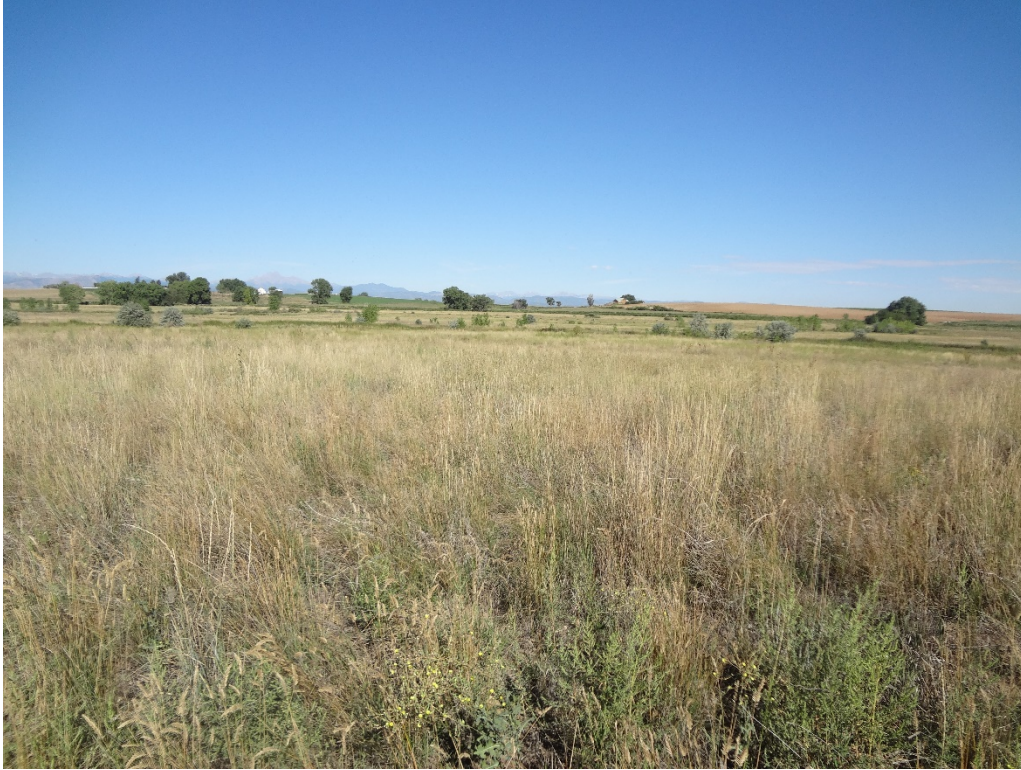
Area 2 looking west at the south portion of the area

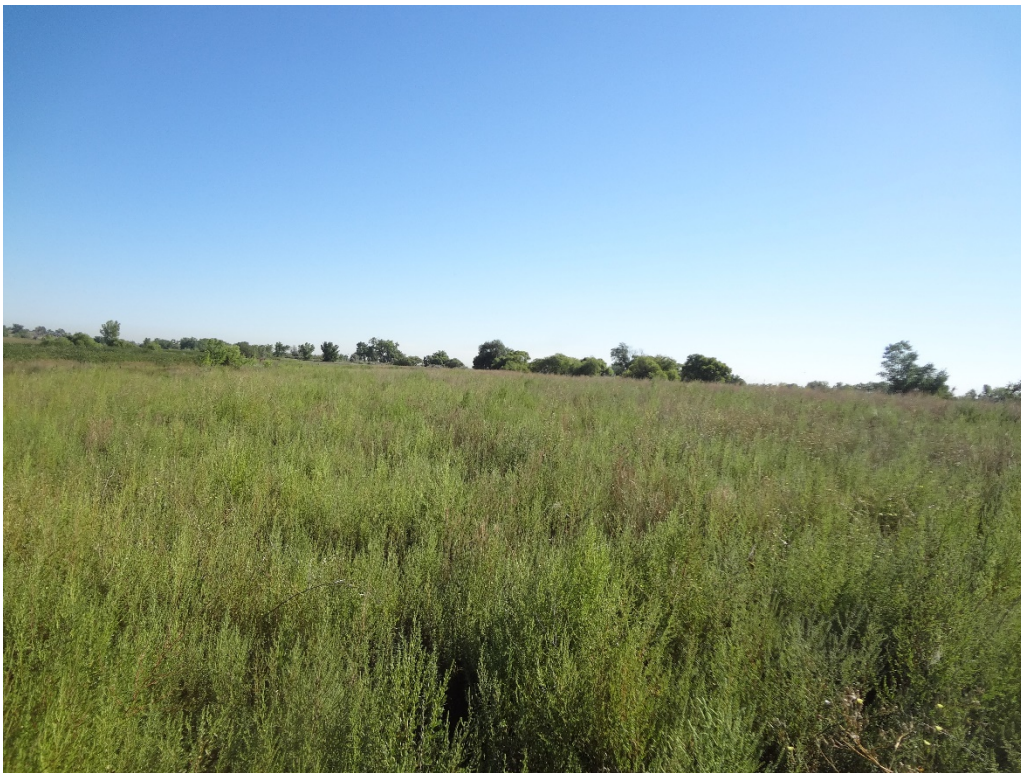
The area was inspected in three sections; south, middle and north. The vegetation in the south portion of the south area was well established with only a few patches of weeds. The vegetation in the middle portion of the area was dominated by kochia and other annual weeds. A strip of good vegetation was observed east of the road paralleling the road. The vegetation in the north portion of the area was dominated by kochia with only pockets of reclamation grasses observed. The Division recommends consulting with Arnold's Custom Seeding to develop a plan to establish the reclamation grass throughout the area.

Area 2 looking north at the middle portion of the area

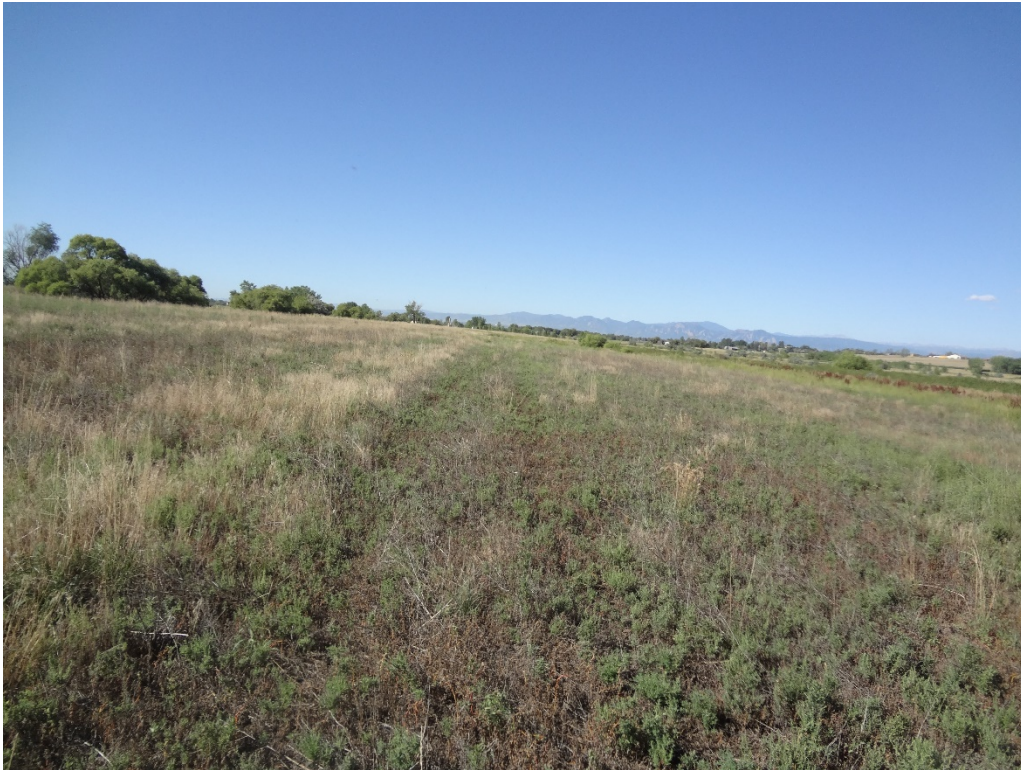
Area 2 looking south at the north portion of the area

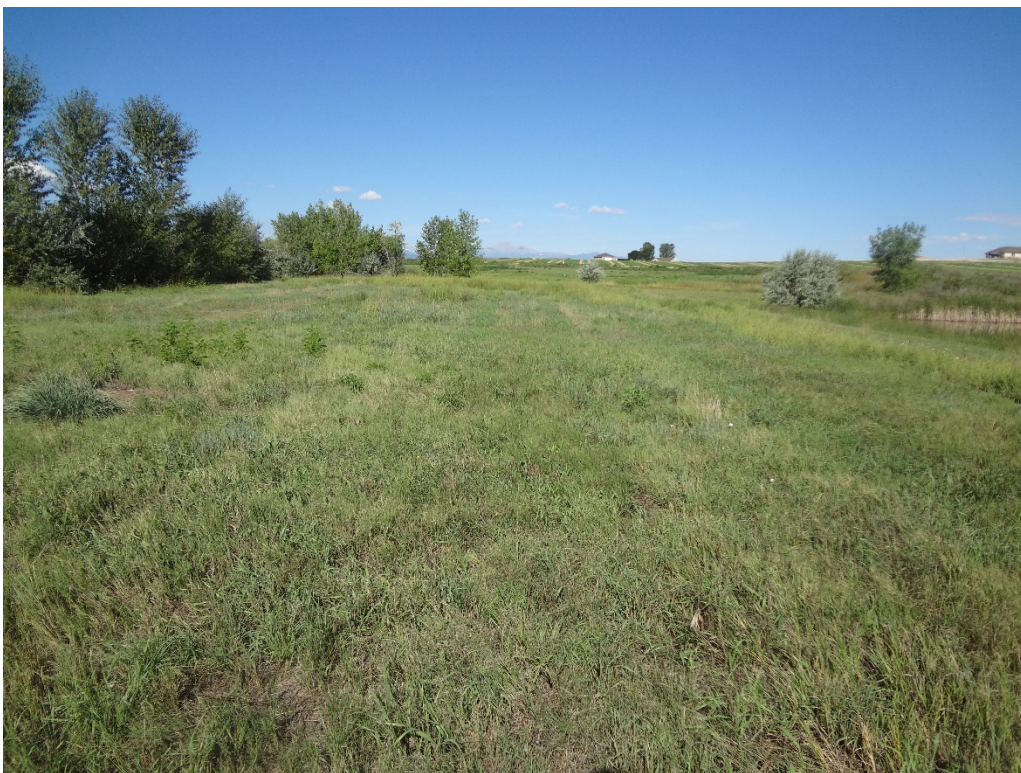
The area was stable and the vegetation was well established except for a patch of kochia at the west end of the area. The Division recommends continued monitoring and weed control measures to allow the existing reclamation grasses to out compete the kochia.

Area 1 looking west from the east side of the area
