MINERALS PROGRAM INSPECTION REPORT

MINE NAME: Pribble Pit	MINE/PROSPECTING ID#: M-2008-020	MINERAL: Sandstone (silica, st quartzite)	COUNTY: Dolores
INSPECTION TYPE: Monitoring	INSPECTOR(S): Lucas J. West	INSP. DATE: August 22, 2017	INSP. TIME: 13:09
OPERATOR: Dolores County	OPERATOR REPRESENTATIVE: Cody Curtis	TYPE OF OPERATION: 110c - Construction Limited Impact

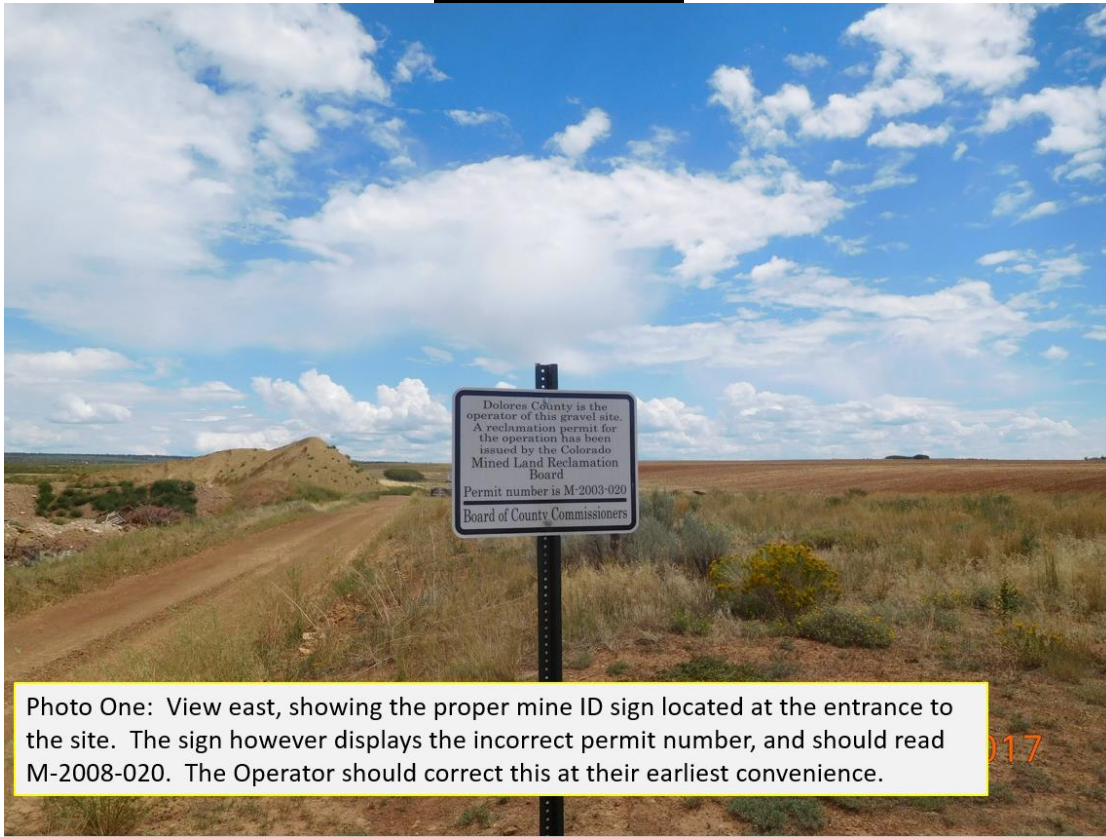
The proper mine identification signage was posted at the entrance to the site, and can be seen in Photo One. The sign however reads the incorrect Permit Number, and is recommended that the Operator correct the sign at their earliest convenience. The permit boundaries are clearly marked with berms around the permitted area. No equipment was onsite and the site was not active the day of the inspection. Several stockpiles are located within the permitted area and an example of those stockpiles can be seen in Photo Two. All stockpiles that are on site appear to be stable and are in good condition. None show signs of settling, slumping or erosion. In the main pit area, a small amount of impounded storm water was noted in response to recent precipitation events.

Photo One: View east, showing the proper mine ID sign located at the entrance to the site. The sign however displays the incorrect permit number, and should read M-2008-020. The Operator should correct this at their earliest convenience.

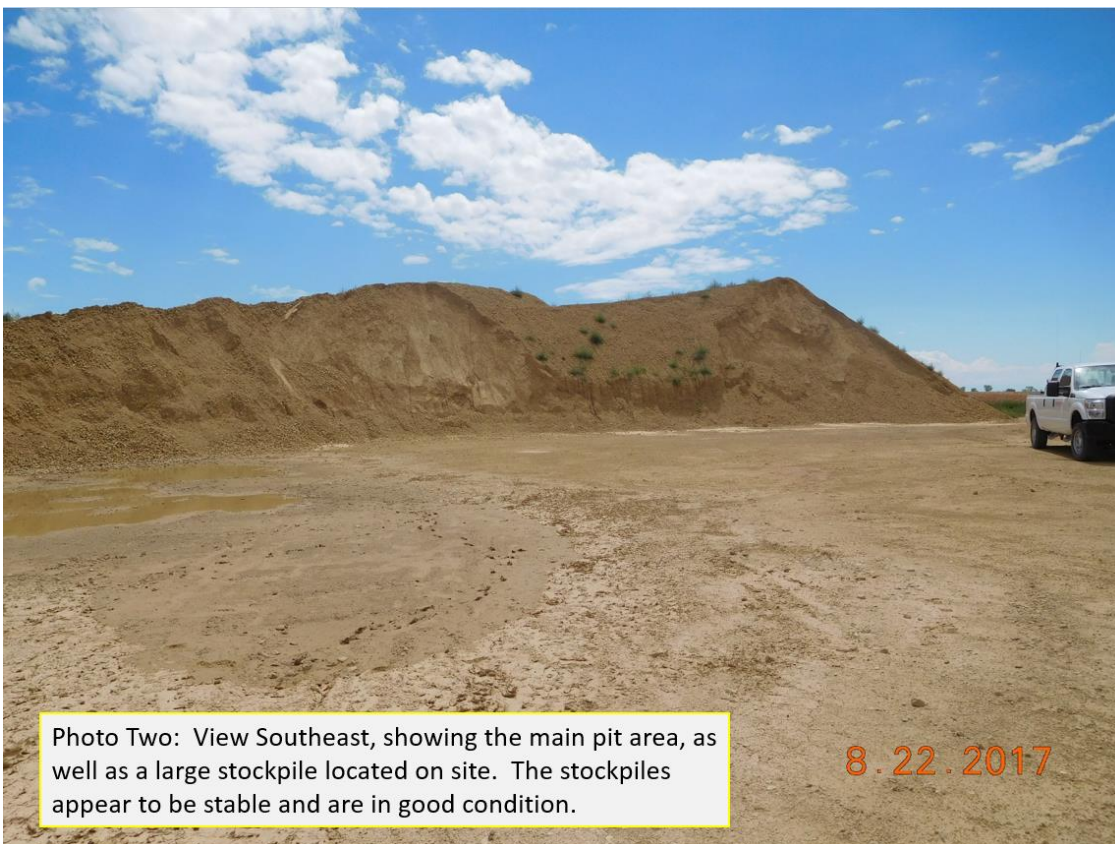
Photo Two: View Southeast, showing the main pit area, as well as a large stockpile located on site. The stockpiles appear to be stable and are in good condition.

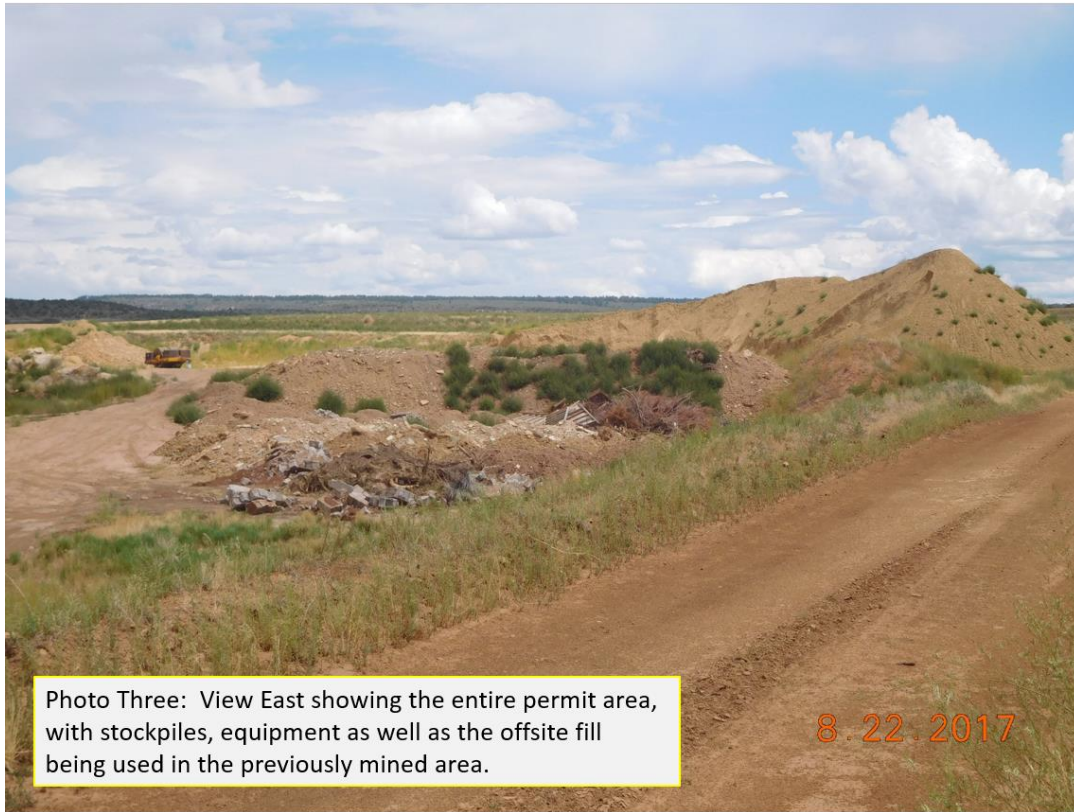
PROBLEM/POSSIBLE VIOLATION: Problem: The site is utilizing off-site fill without prior approval by the Division per 3.1.5(9) of the Rule.

In the previously mined area of the pit, the Operator has begun to use offsite fill material to backfill the open pit. The material includes broken up concrete and cinder blocks and can be seen in Photo Three. The importation of offsite fill has not been approved by the Division. To allow for the importation of offsite fill material the operator must submit a Technical Revision with a signed affidavit, stating that the fill is, in fact, inert and addressing all requirements pursuant to Rule 3.1.5(9), which describes the intended use of inert/off-site fill by the corrective action date. The affidavit should list the materials to be imported, and commit to burying the material a minimum of three feet below final grade, with all protruding rebar or structural elements having been removed. The Technical Revision cover sheet is enclosed with this report, should be filled out and submitted to the Division's Denver office with the signed affidavit as well as the required fee of \$216.00 within 60 days of the date of this letter. All elements of the Technical Revision should be received by the Division no later than **Tuesday October 31, 2017**. If the Operator has any questions about the required Technical Revision, please feel free to contact me. Also, note that during the inspection, a large pile of brush, old pallets and wooded debris was noted in the previously mined area. This material will not be approved for use as backfill material as over time the organic material will decay and could cause subsidence features to develop. However if this material is burned, the ashes may be disposed of in the pit area.

Photo Three: View East showing the entire permit area, with stockpiles, equipment as well as the offsite fill being used in the previously mined area.

CORRECTIVE ACTIONS: To allow for the importation of offsite fill material the operator must submit a Technical Revision with a signed affidavit, stating that the fill is, in fact, inert and addressing all requirements pursuant to Rule 3.1.5(9), which describes the intended use of inert/off-site fill by the corrective action date.
