**COLORADO**Division of Reclamation,
Mining and Safety

MINERALS PROGRAM INSPECTION REPORT**PHONE: (303) 866-3567**

MINE NAME: Bartley Gravel Pit	MINE/PROSPECTING ID#: M-1984-155	MINERAL: Sand and gravel	COUNTY: Dolores
INSPECTION TYPE: Monitoring	INSPECTOR(S): Lucas J. West	INSP. DATE: August 22, 2017	INSP. TIME: 13:30
OPERATOR: Dolores County	OPERATOR REPRESENTATIVE: Cody Curtis	TYPE OF OPERATION: 112c - Construction Regular Operation	
REASON FOR INSPECTION: Normal I&E Program	BOND CALCULATION TYPE: None	BOND AMOUNT: \$0.00	
DATE OF COMPLAINT: NA	POST INSP. CONTACTS: None	JOINT INSP. AGENCY: None	
WEATHER: Clear	INSPECTOR'S SIGNATURE:

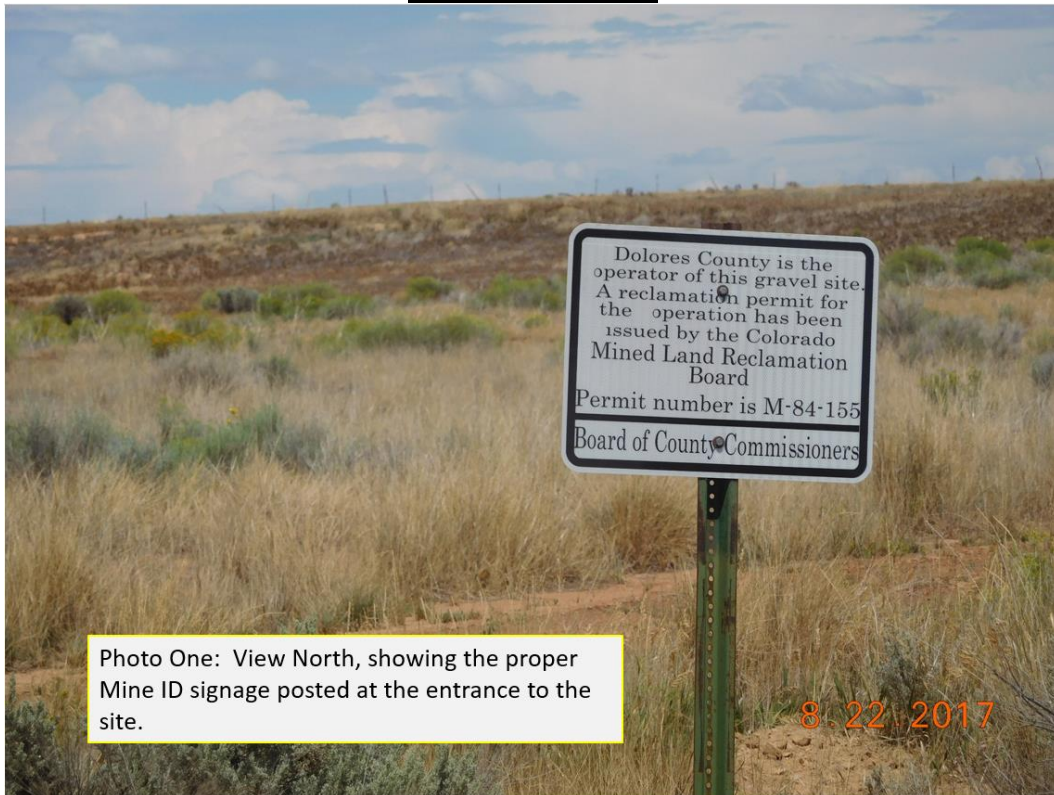
The proper mine identification sign was located at the entrance to the site and can be seen in Photo One. The permit boundaries are clearly marked with a series of T-posts and berms. No equipment was observed on site and the site was not active during the day of the inspection. The main pit area appears to be stable and in good condition as shown in Photos Two. Several stockpiles including overburden, topsoil and useable materials were located on the pit floor, examples of the stockpiles are shown in Photo Three and Four. The slopes around the pit area appear to have been graded at approximately 3H: 1V and appear to be stable. No signs of erosion on the pit slope areas were noted during the inspection. The area of current disturbance has begun to revegetate itself with volunteer species from the surrounding areas.

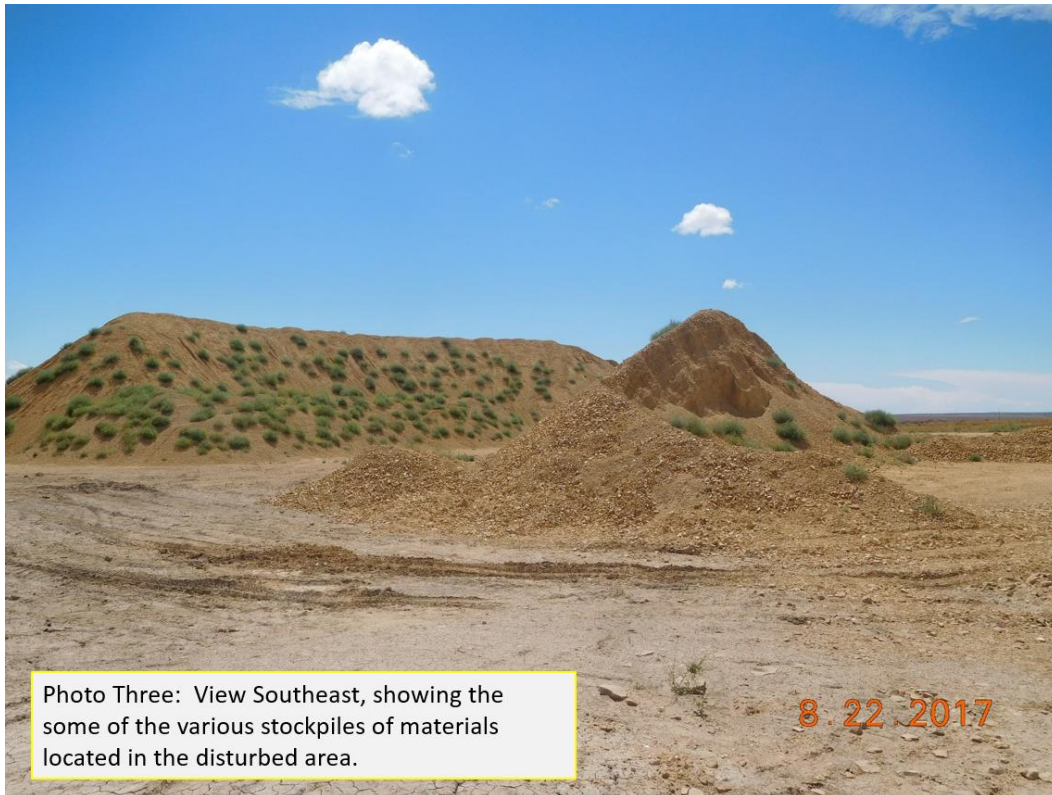
Photo Three: View Southeast, showing the some of the various stockpiles of materials located in the disturbed area.

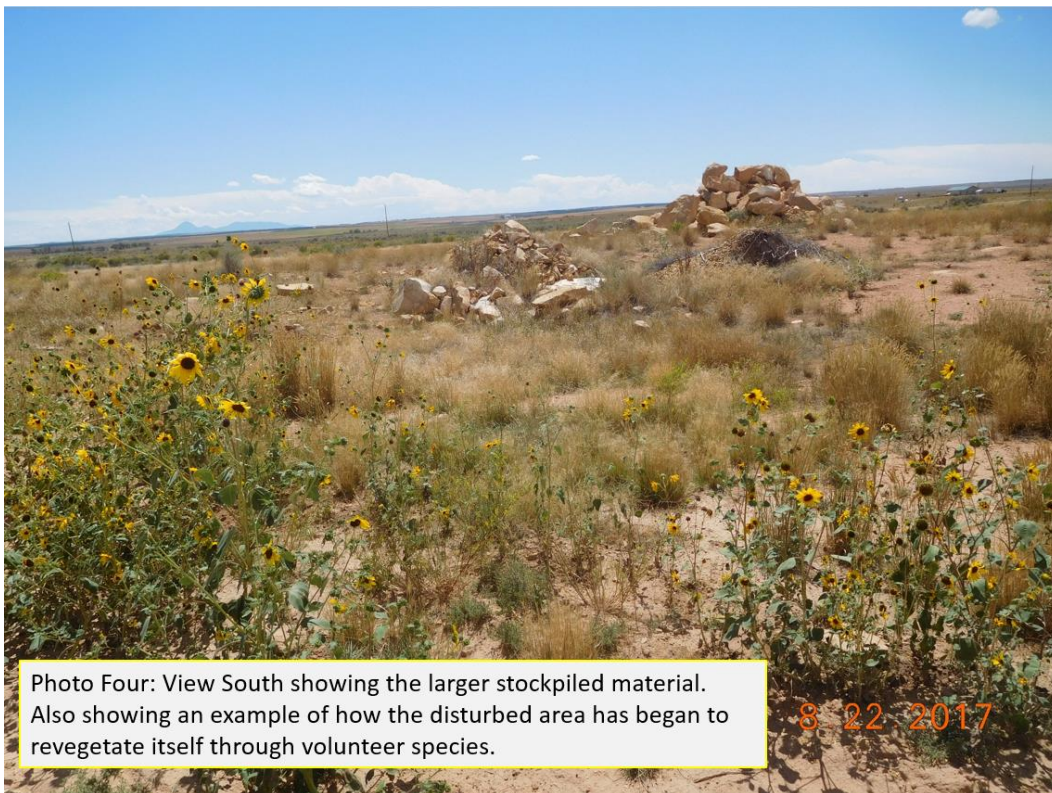
Photo Four: View South showing the larger stockpiled material. Also showing an example of how the disturbed area has begun to revegetate itself through volunteer species.
