MINERALS PROGRAM INSPECTION REPORT
PHONE: (303) 866-3567

MINE NAME: Purple Hill	MINE/PROSPECTING ID#: P-2012-004	MINERAL: GEM, QTZ	COUNTY: Jefferson
INSPECTION TYPE: Surety Release Inspection	INSPECTOR(S): Michael A. Cunningham	INSP. DATE: August 10, 2017	INSP. TIME: 12:30
OPERATOR: Thomas G. Milller	OPERATOR REPRESENTATIVE: None	TYPE OF OPERATION: MP - Mineral Prospecting	
REASON FOR INSPECTION: Normal I&E Program	BOND CALCULATION TYPE: Complete Bond	BOND AMOUNT: \$100.00	
DATE OF COMPLAINT: NA	POST INSP. CONTACTS: None	JOINT INSP. AGENCY: U.S.Forest Service	
WEATHER: Clear	INSPECTOR'S SIGNATURE:

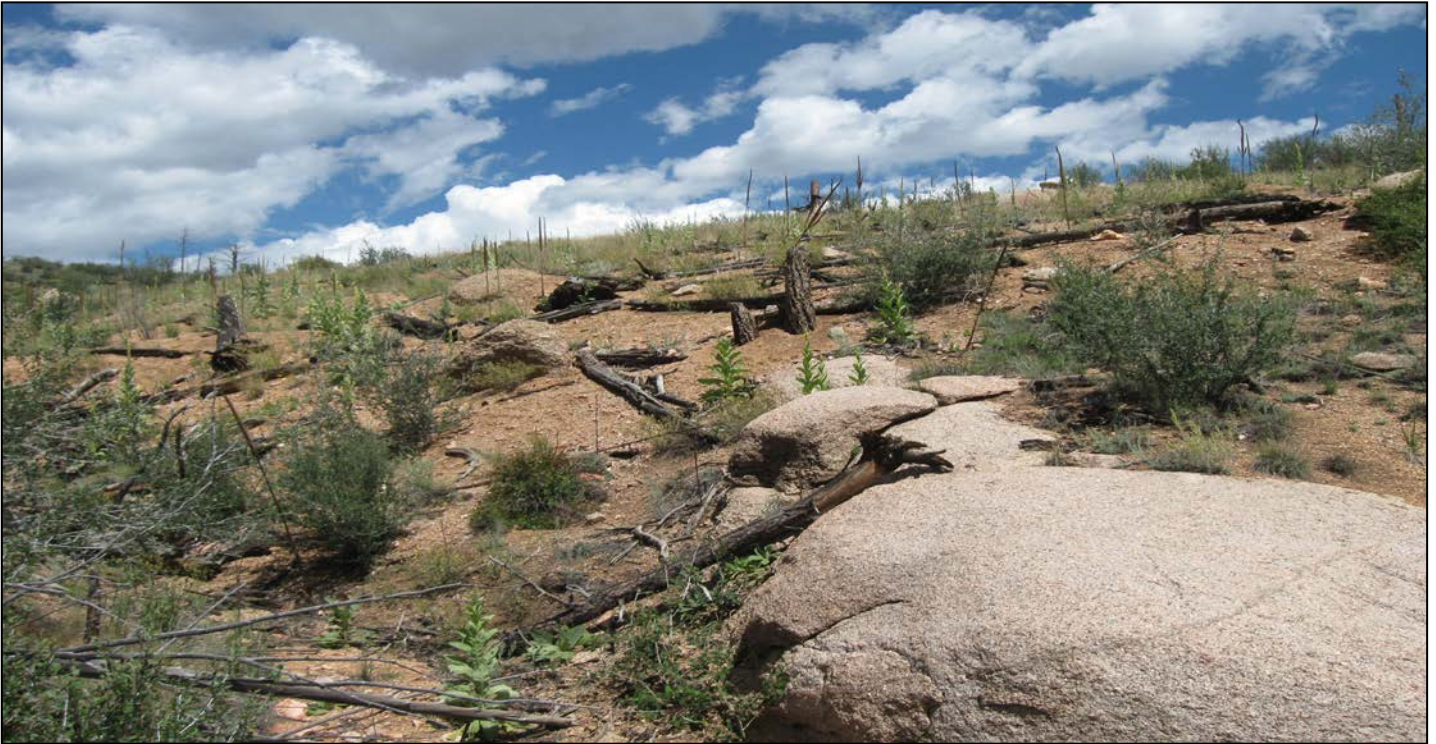
1. Overview of reclaimed area.

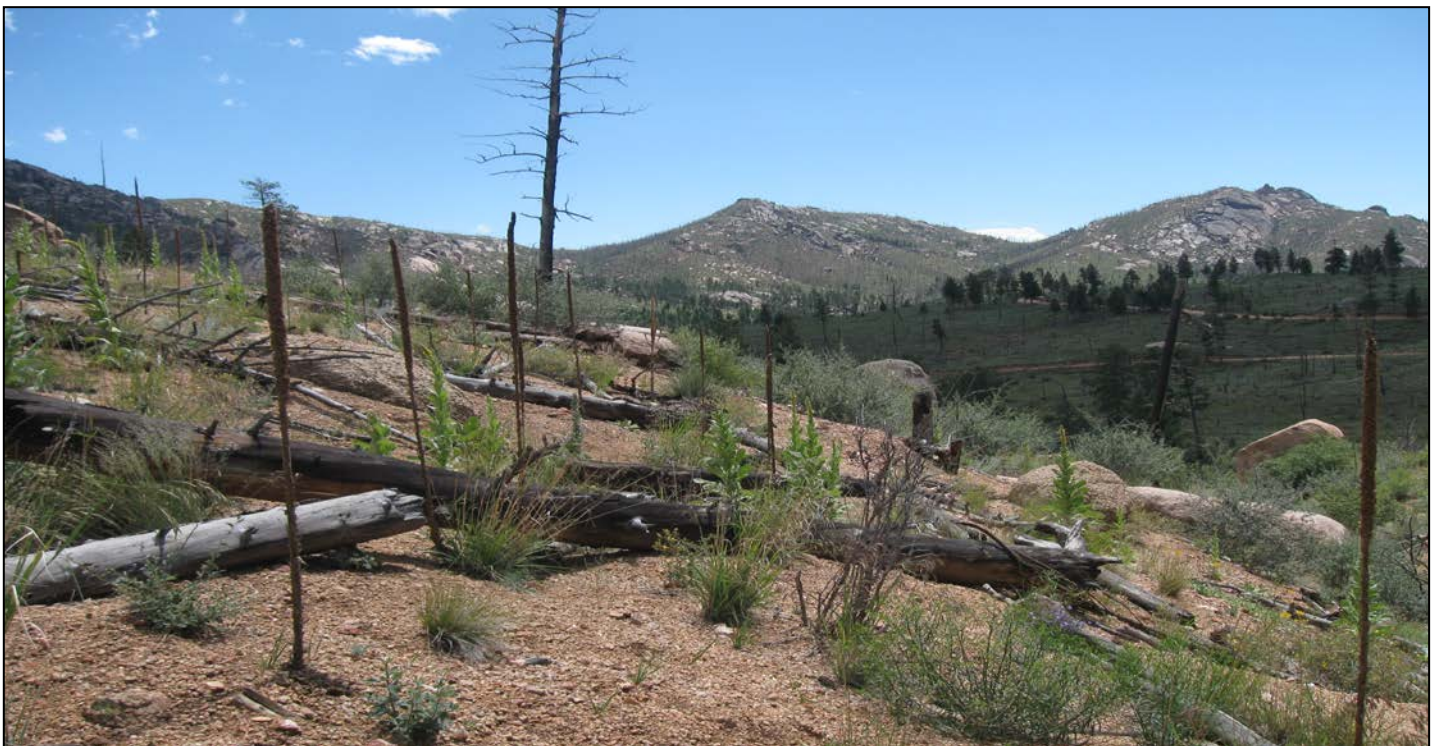
2. Overview of reclaimed area.

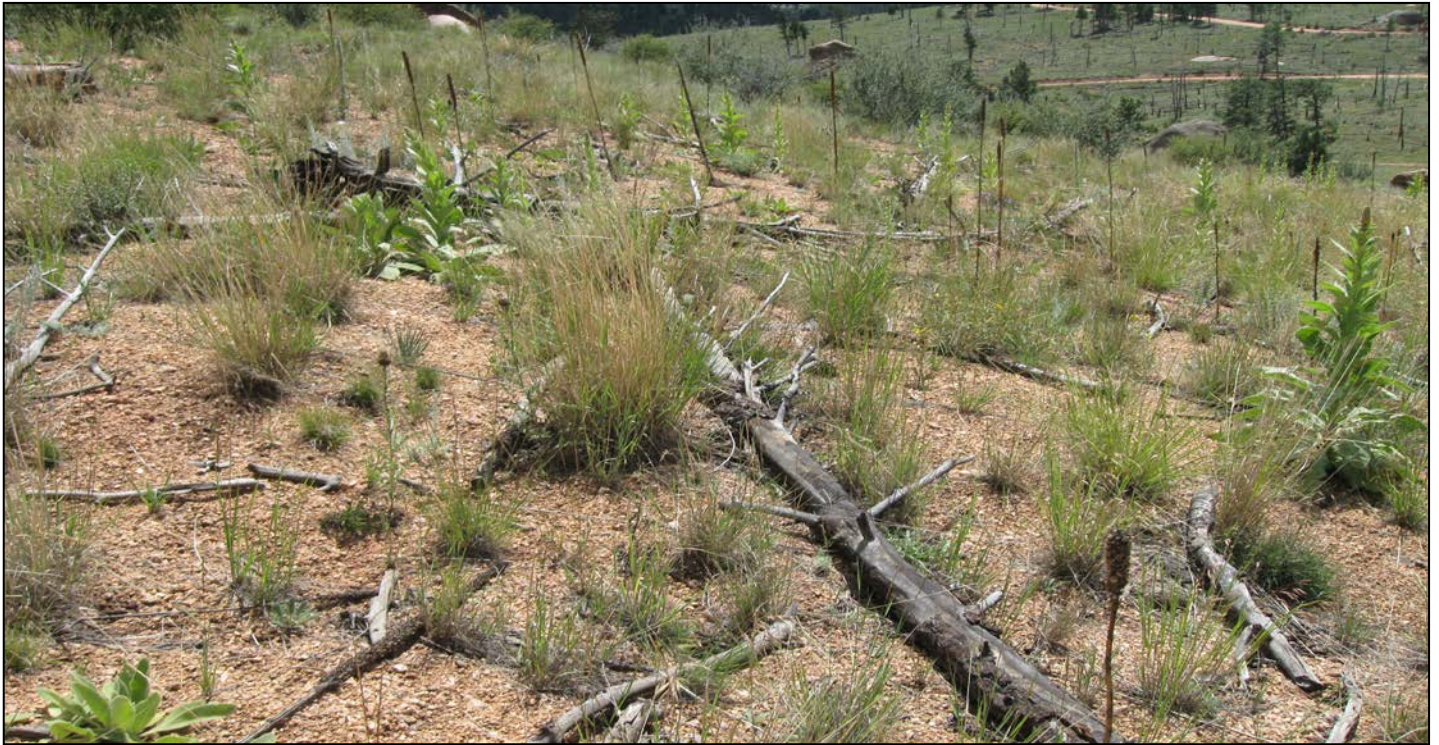
3. Overview of reclaimed area.
