**COLORADO**Division of Reclamation,
Mining and Safety

MINERALS PROGRAM INSPECTION REPORT**PHONE: (303) 866-3567**

MINE NAME: Sprague Red Lyons	MINE/PROSPECTING ID#: M-1981-057	MINERAL: Sandstone (silica, stone, quartzite)	COUNTY: Boulder
INSPECTION TYPE: Monitoring	INSPECTOR(S): Amy Eschberger	INSP. DATE: July 11, 2017	INSP. TIME: 09:45
OPERATOR: Arkins Park Stone Corporation	OPERATOR REPRESENTATIVE: David Sprague, Chad Theis	TYPE OF OPERATION: 112c - Construction Regular Operation

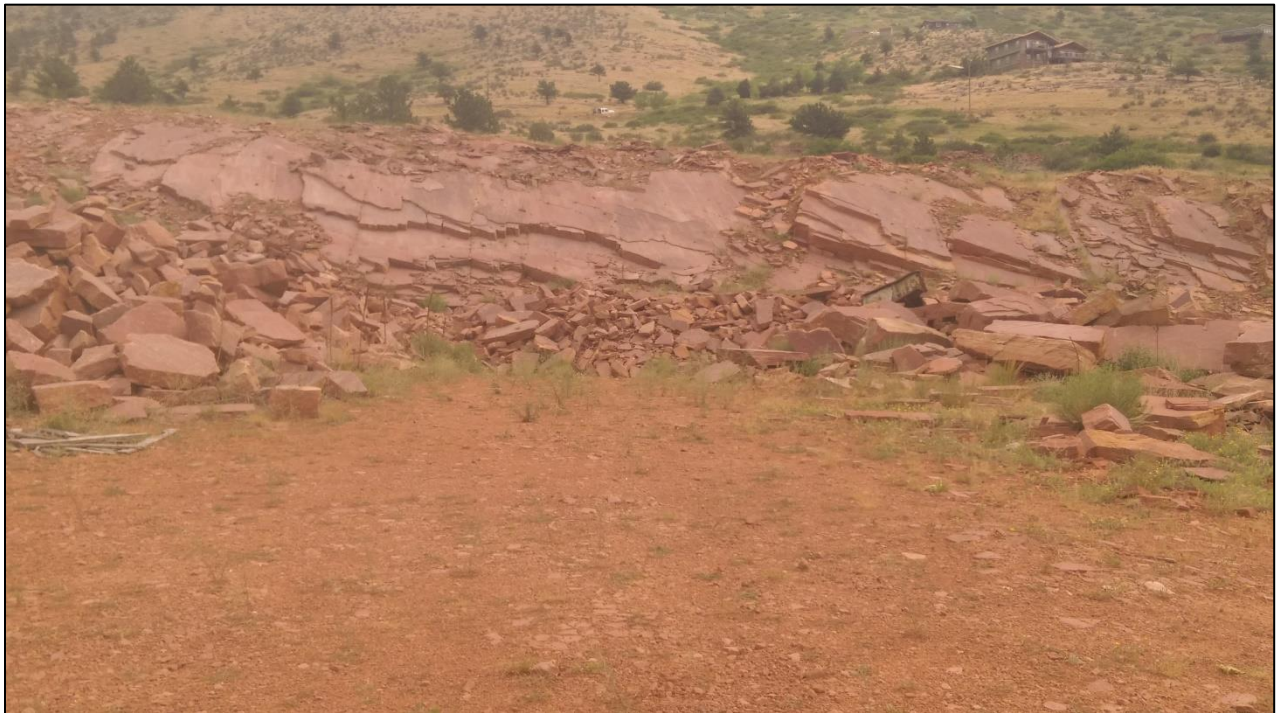
Photo 1. View of primary working face present along northeastern edge of Quarry 3.

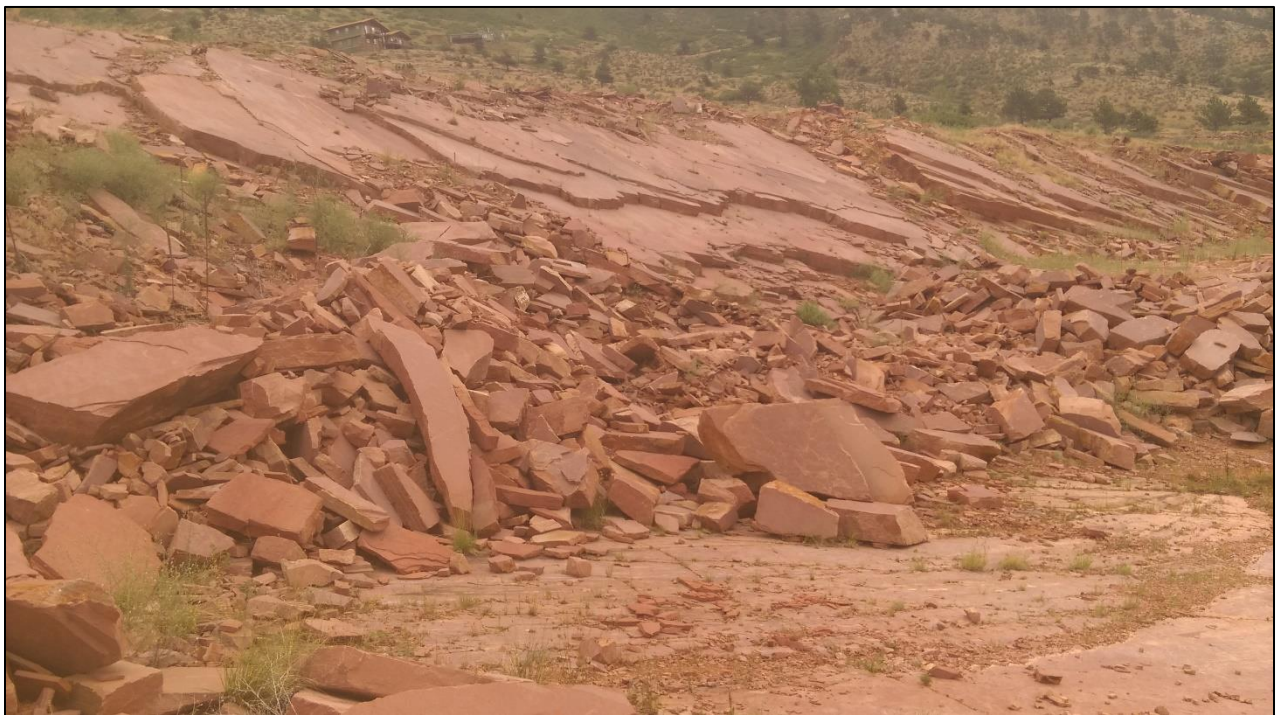
Photo 2. View of primary working face present along northeastern edge of Quarry 3, showing slope gradients of approximately 3H:1V.

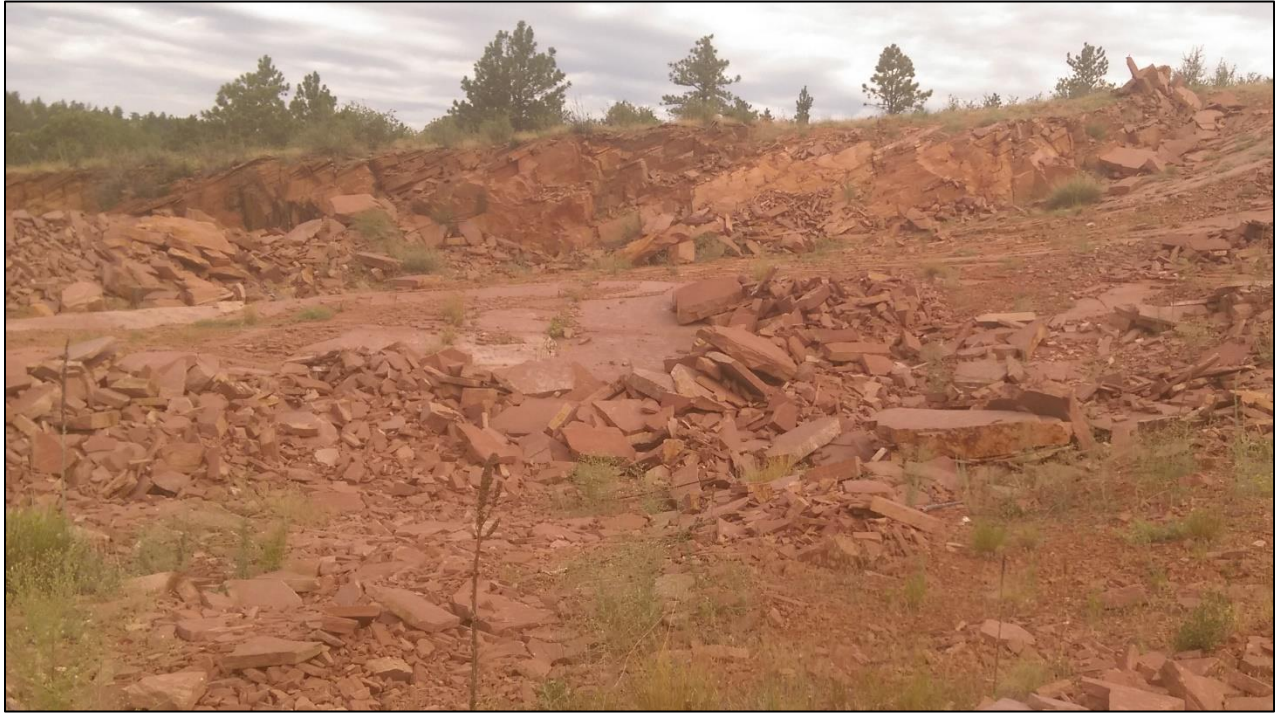
Photo 3. View of working face present along southwestern edge of Quarry 3, with slope gradients of near vertical.

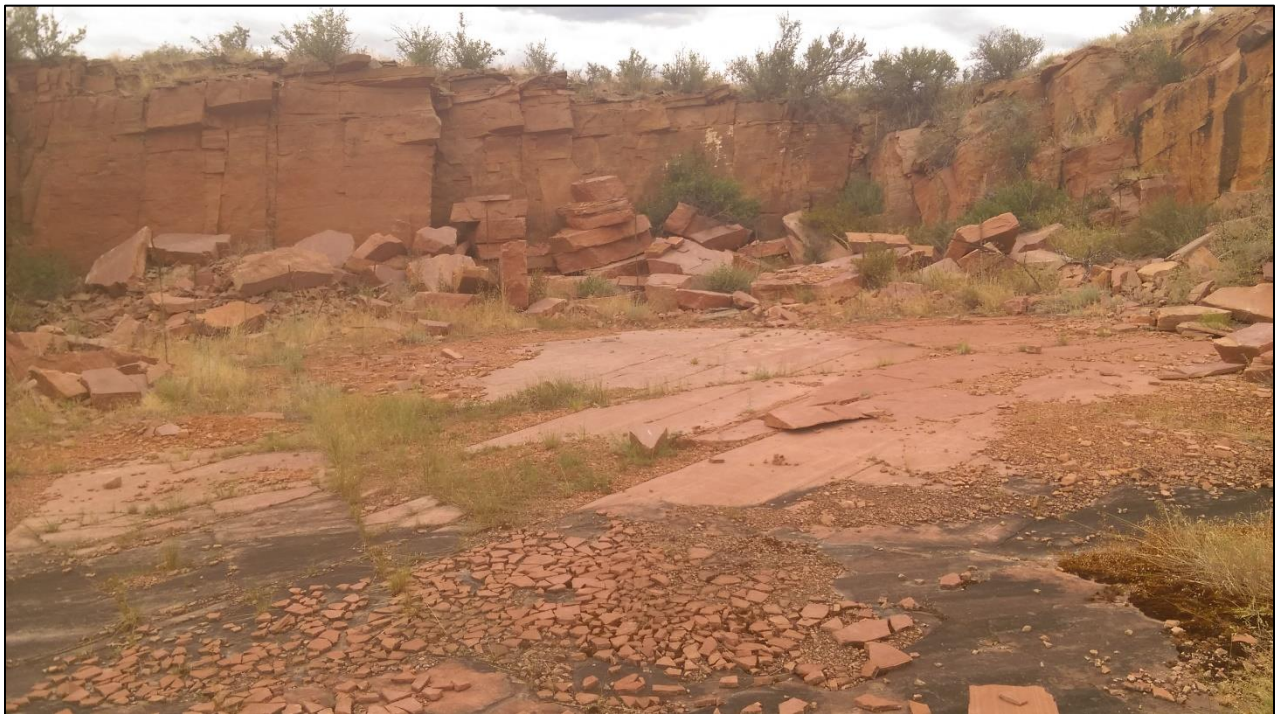
Photo 4. View of working face present along northwestern edge of Quarry 3, with slope gradients of near vertical.

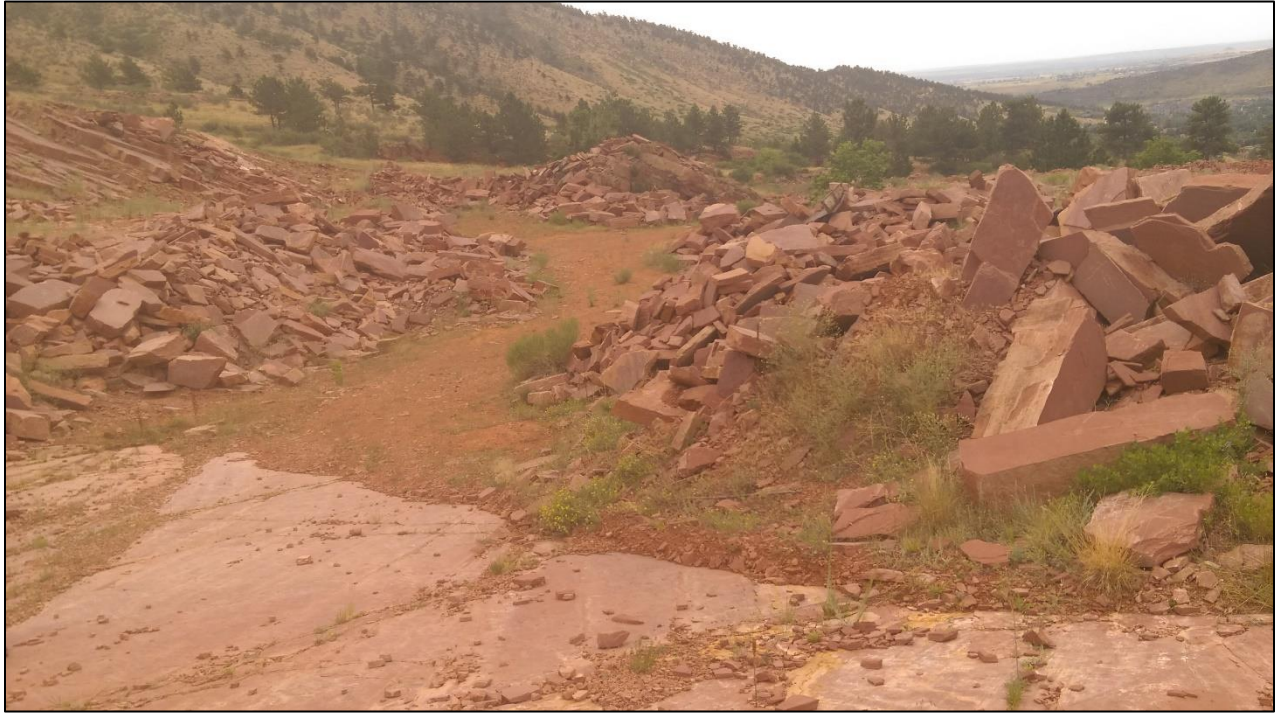
Photo 5. View showing piles of loose stone stored on floor of Quarry 3.

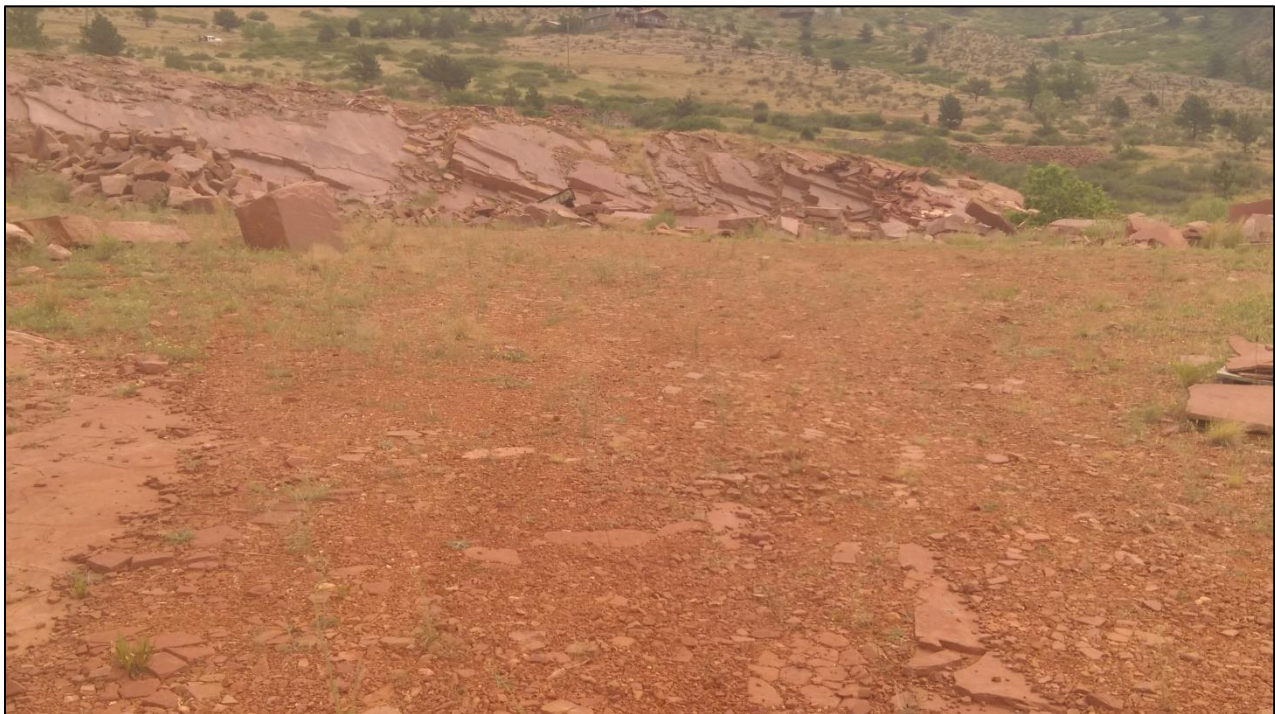
At the time of the inspection, it was partly cloudy and warm, and the ground was dry. An appropriate permit sign was posted at the entrance to the mine site. The affected land boundary was delineated with white PVC pipes. The Division first inspected Quarry 3 located at the south end of the permit area. According to Mr. Sprague, this quarry has not been active for at least five years. The Division estimates disturbance in Quarry 3 to consist of approximately 4.75 acres. The primary working face is along the northeastern edge of the quarry (**Photos 1 and 2**). The Division estimates this mined wall to be approximately 25-30 feet in height, with slope gradients of approximately 3H:1V. Two shorter mining faces approximately 10-12 feet in height are present along the western edge of Quarry 3 (**Photos 3 and 4**). The slope gradient of these mining faces is at near vertical. The Division estimates the lengths of these highwalls to be approximately 100 feet and 120 feet. Loose stones are piled on the quarry floor (**Photo 5**) which Mr. Sprague indicated to be saleable product. A relatively flat work deck/staging area composed of waste rock was constructed in the western portion of Quarry 3 (**Photo 6**).

Photo 6. View looking east across work deck/staging area present in western portion of Quarry 3.

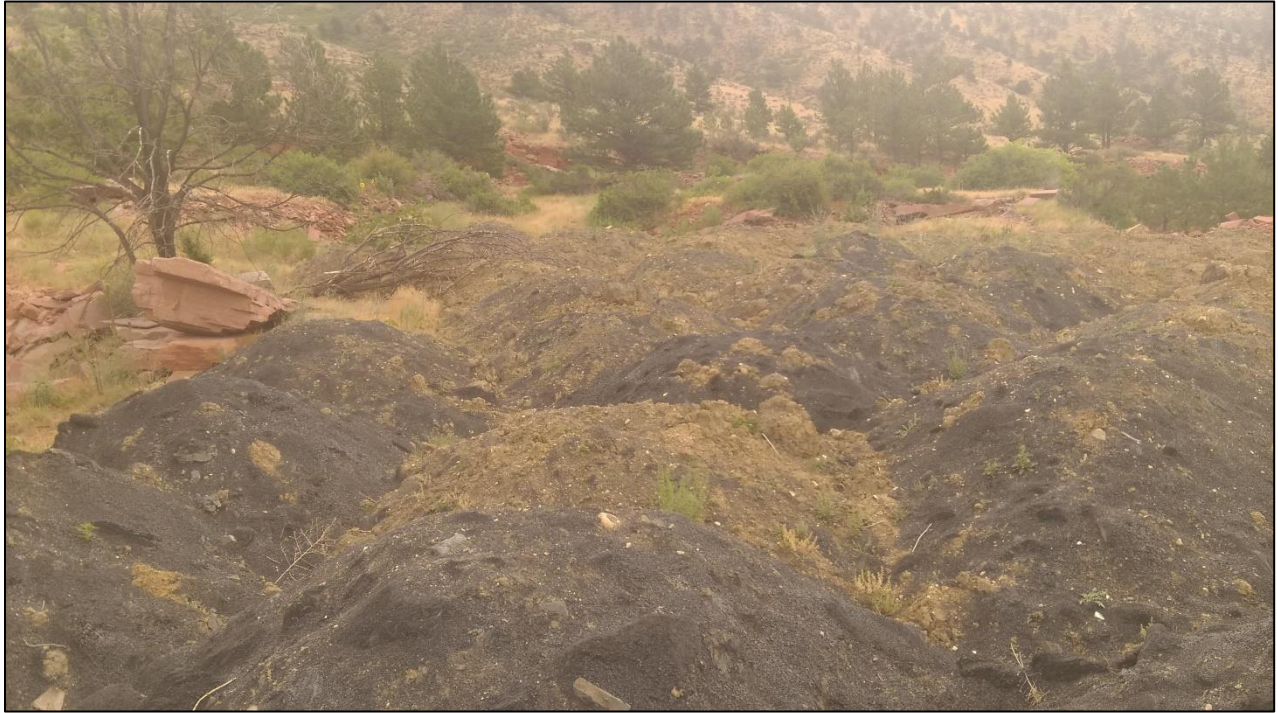
PROBLEM: Failure to follow approved reclamation plan, or current reclamation plan needs to be updated and clarified pursuant to C.R.S. 34-32.5-116(1). Specifically, the operator has imported material to the site to be used as a growth medium for reclamation. This activity is not part of the approved reclamation plan.

The Division observed stockpiles of dark colored material stored at the southeastern edge of the quarry area, which appeared to be composed of crushed shale and schist (**Photo 7**). Mr. Sprague said this material was brought to the site fairly recently. The operator hopes to use this material as a growth medium for reclamation. In review of the approved permit file, the Division was unable to find any mention of importing growth medium to the site for reclamation. Therefore, the operator will need to submit a Technical Revision to revise the reclamation plan for the site (see enclosed form). The revision should include a description of any growth medium to be used for reclamation (including existing material and material to be imported), type(s) of material, source(s) for the material, approximate storage location(s) of the material, estimated volume(s) of the material, and the anticipated minimum depth of application of the material. Additionally, an updated mining plan map should be provided with the revision, which shows the location(s) where existing growth medium is stockpiled (if different than current approved map), and location(s) proposed for stockpiling any future imported growth medium. If the material is to be used for backfill rather than growth medium, the operator will need to include in the revision all information required by Rule 3.1.5(9) (see enclosed Rule). Pursuant to Rule 3.1.5(9), if an operator intends to backfill inert structural fill generated outside of the approved permit area, it is the operator's responsibility to provide the Division notice of any proposed backfill activity not identified in the approved reclamation plan. This notice must be submitted as a Technical Revision. A problem is cited in this report (see page 1), requiring the operator to submit a revision within 60 days.

Photo 7. View of dark material (possibly crushed shale and schist) imported to site and stored in southern portion of Quarry 3.

CORRECTIVE ACTIONS: The operator shall submit a Technical Revision, with the required \$216 revision fee, to update and clarify the current approved reclamation plan to reflect existing and proposed activities. The revision should include a description of any growth medium to be used for reclamation (including existing material and material to be imported), type(s) of material, source(s) for the material, approximate storage location(s) of the material, estimated volume(s) of the material, and the anticipated minimum depth of application of the material. If the material is to be used for backfill rather than growth medium, the operator will need to include in the revision all information required by Rule 3.1.5(9) [see enclosed]. Additionally, an updated mining plan map should be provided with the revision, which shows the location(s) where existing growth medium is stockpiled (if different than current approved map), and location(s) proposed for stockpiling any future imported growth medium.

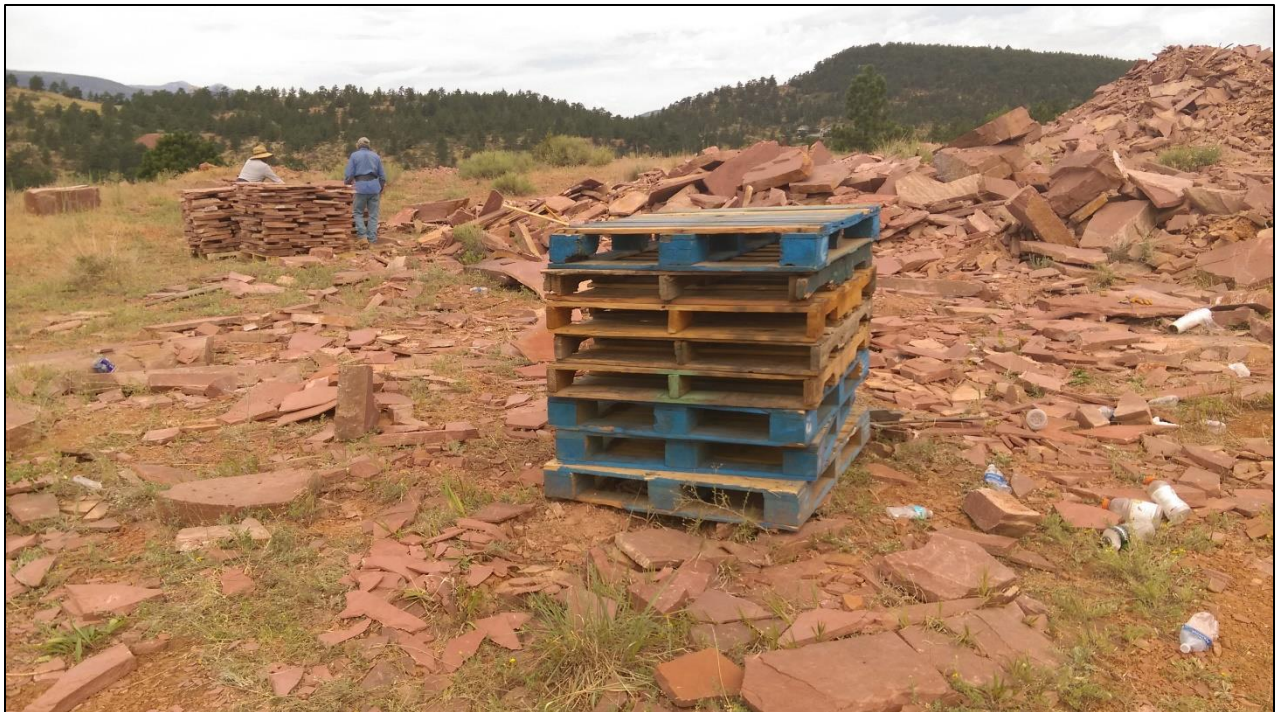
Photo 8. View showing mine personnel working stone in Quarry 1 during inspection.

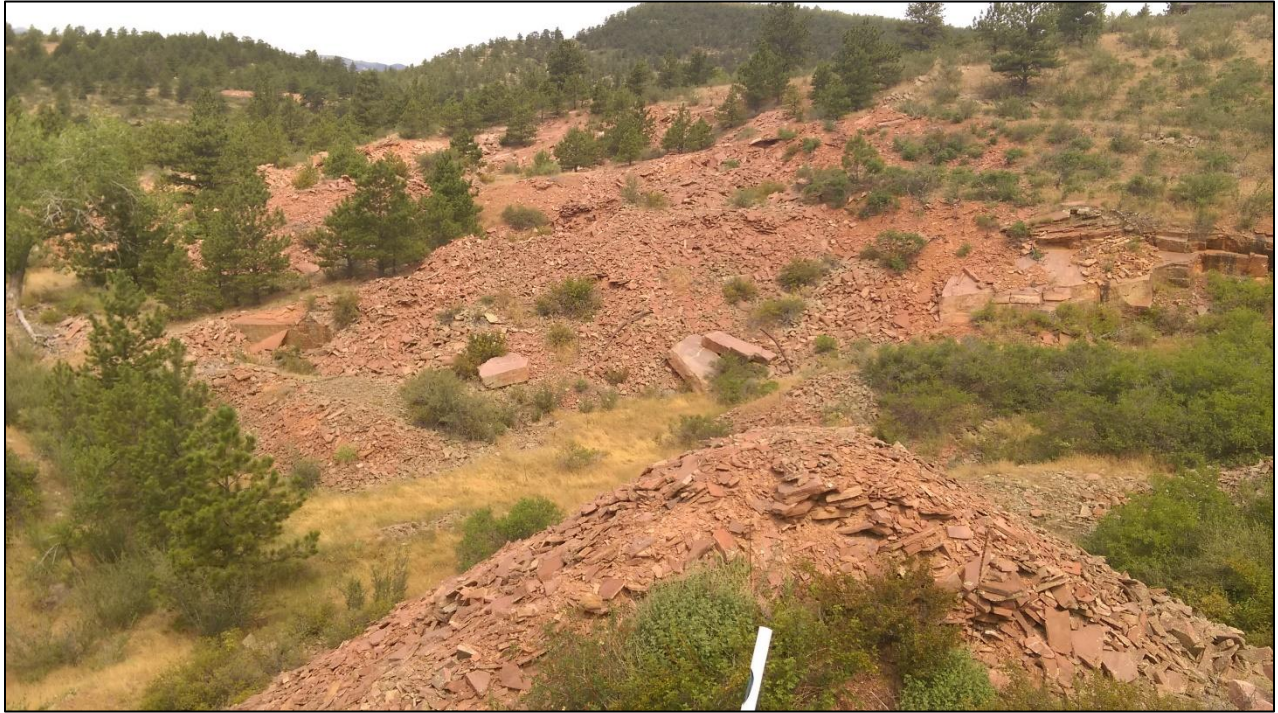
Photo 9. View of historic quarry rubble piles located immediately west of Quarry 1. These areas will not require reclamation as long as the operator does not redisturb them.

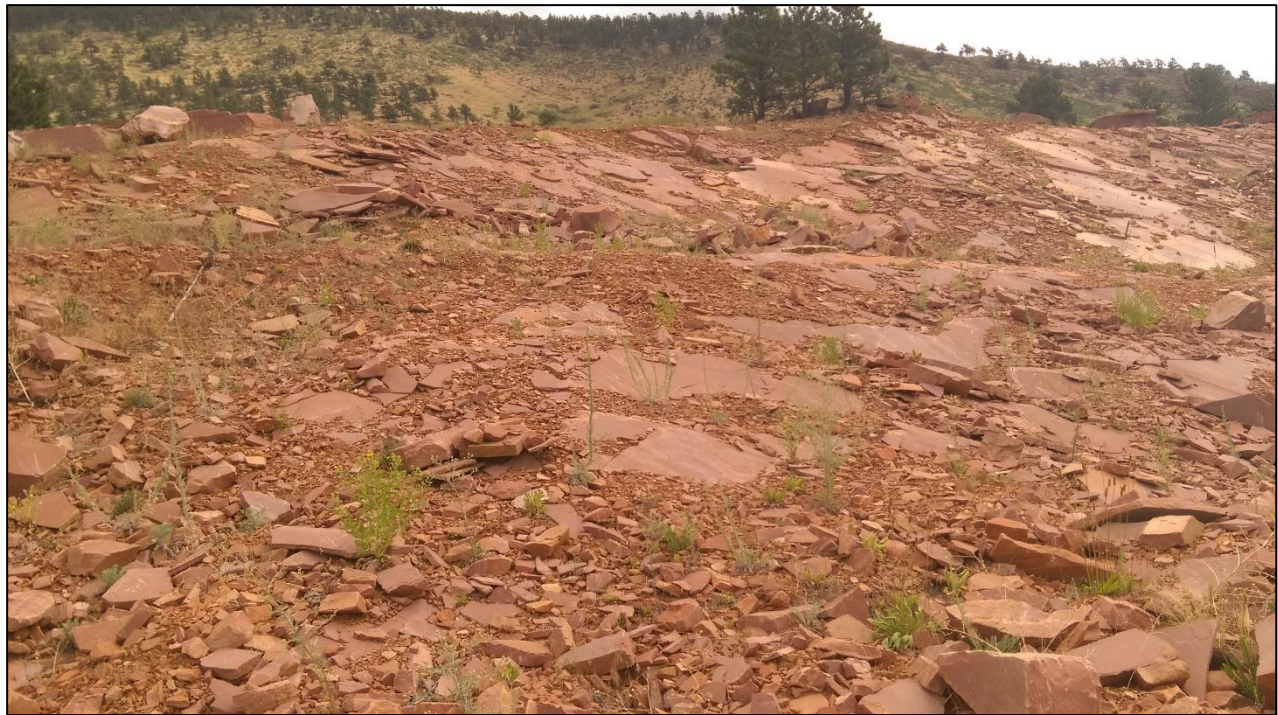
Photo 10. View of primary working face present along northeastern edge of Quarry 2.

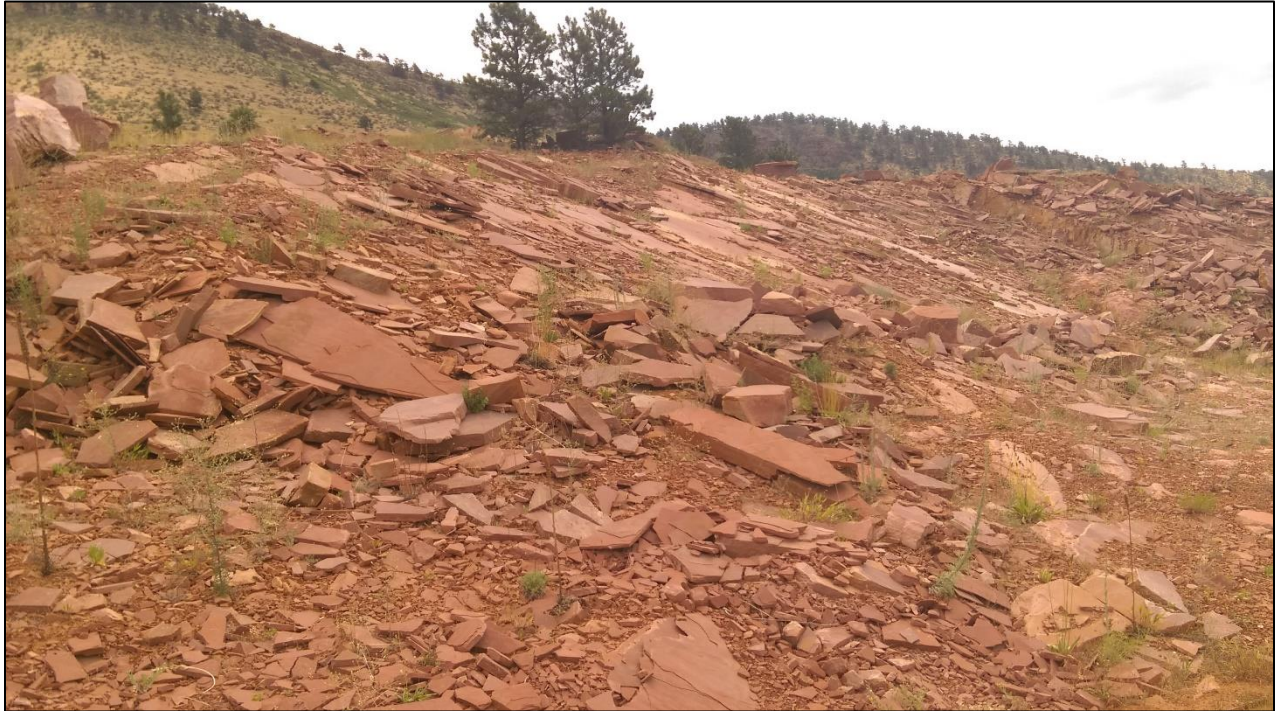
Photo 11. View of primary working face present along northeastern edge of Quarry 2, showing slope gradients of approximately 3H:1V

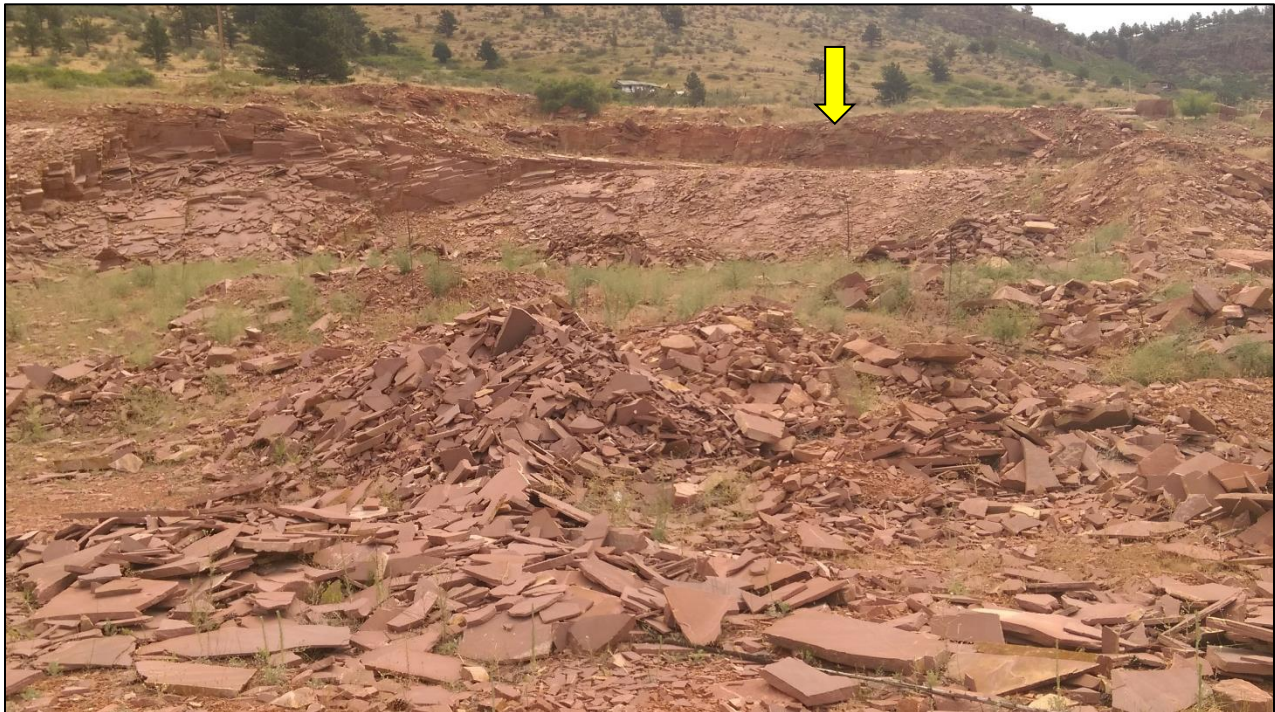
Photo 12. View of primary working face present along northeastern edge of Quarry 1. Also note more recently mined wall at top (indicated) with near vertical slope gradient.

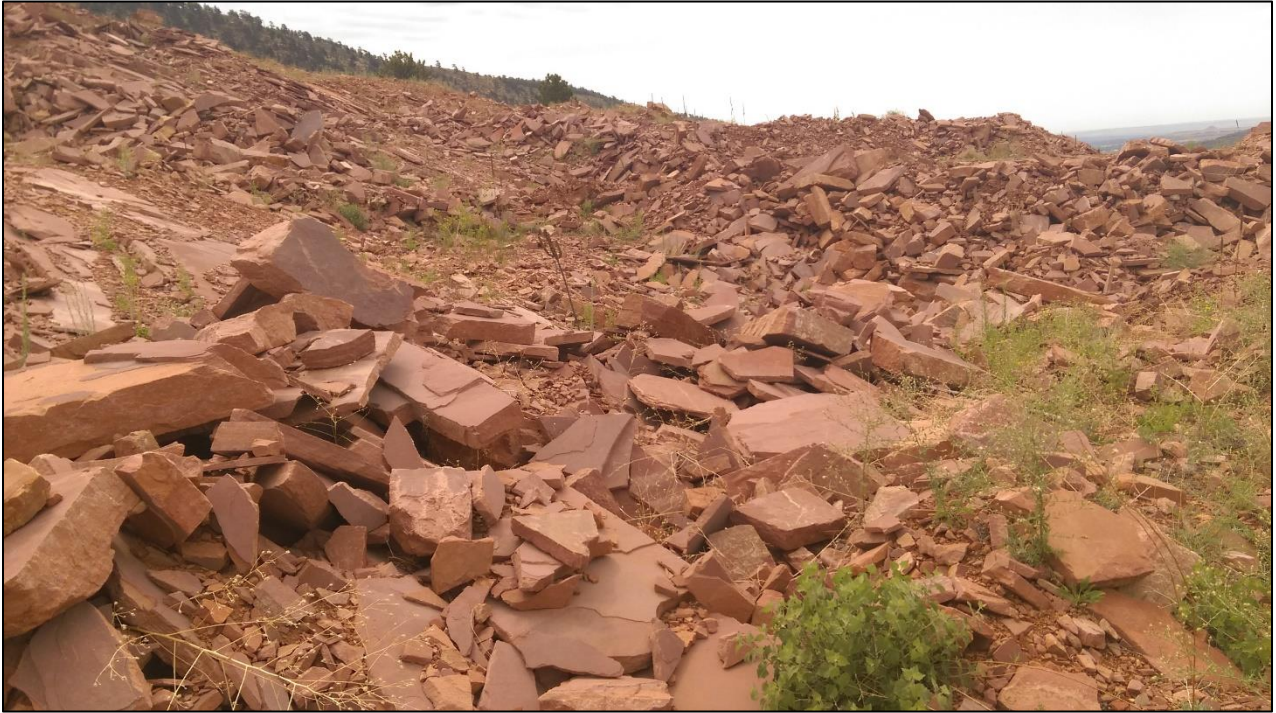
Photo 13. View of loose stones piled on floor of Quarry 2.

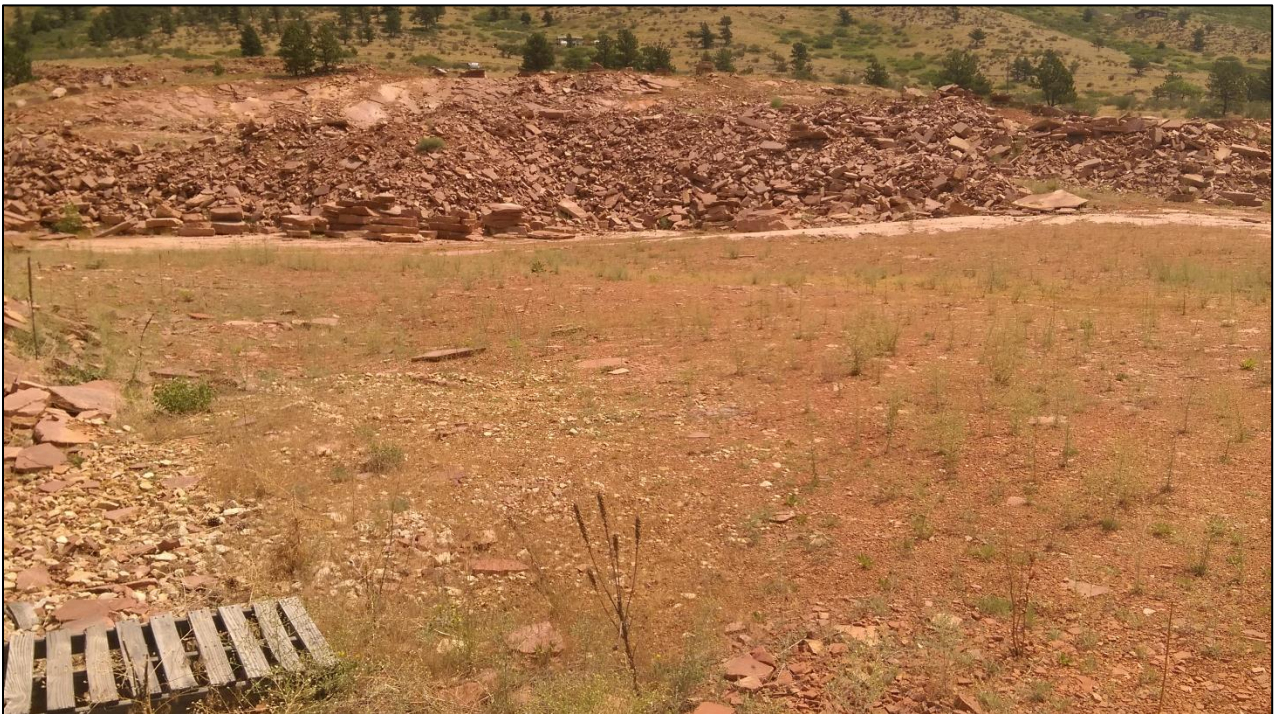
Photo 14. View of loose stones piled adjacent to primary working face in Quarry 2.

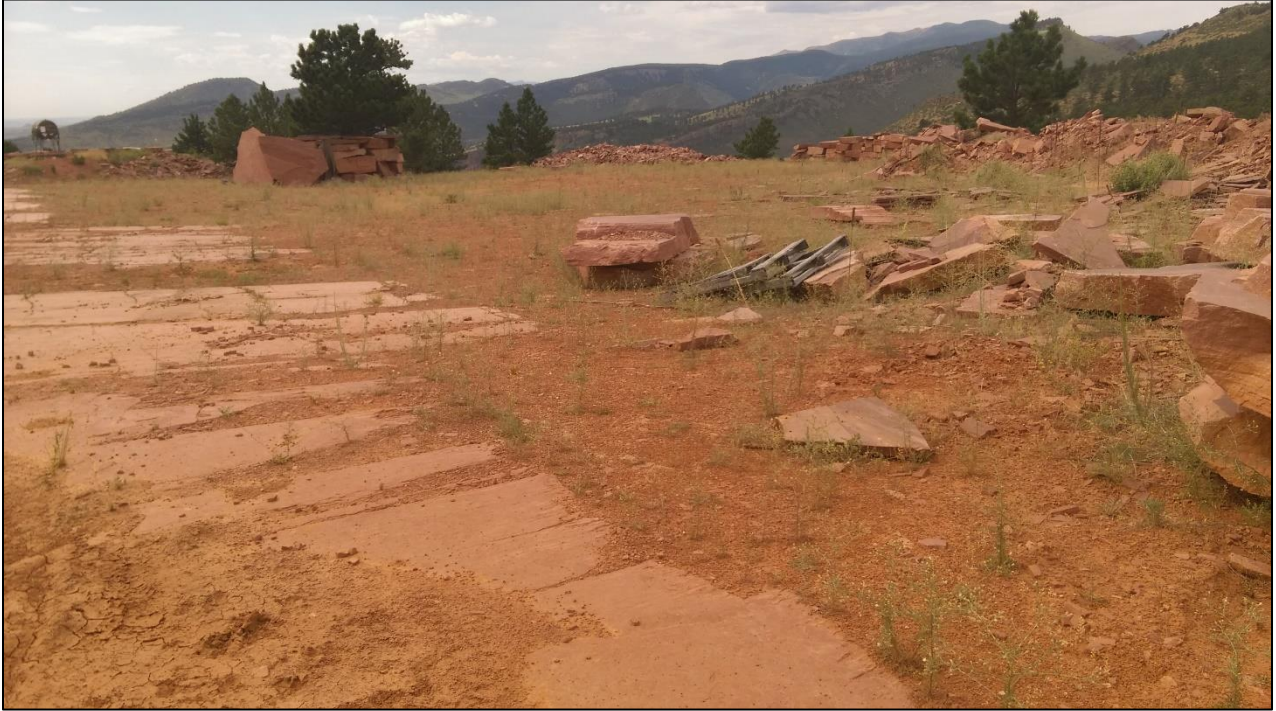
The Division next inspected Quarries 1 and 2, which were connected in the early 2000's as Quarry 2 was expanded northeastward. These quarries were active during the inspection. A few men were on site splitting and stacking stone (**Photo 8**). The Division estimates disturbance in Quarries 1 and 2 to consist of approximately 9.95 acres combined. Rubble piles located between the western edge of Quarry 1 and Steamboat Valley Road (**Photo 9**) were not included in the disturbance, as the permit file shows them to have existed prior to permitting. If the operation redisturbs these historic rubble piles, they will need to be included in the disturbed area to be reclaimed. The primary working faces are along the northeastern edges of the quarries (**Photos 10-12**). The mining walls range in height from 15-30 feet, and have slope gradients of roughly 3H:1V. A shorter mining wall is present above the eastern primary working face in Quarry 1 (shown in **Photo 12**), with a height of approximately 10-12 feet. This mining wall is approximately 100 feet in length with slope gradients of near vertical. Loose stones are piled on the quarry floors (**Photos 13 and 14**). According to Mr. Sprague, much of this material is saleable product. Relatively flat work deck/staging areas composed of waste rock material were constructed in the western portions of the quarry areas (**Photos 15-17**).

Photo 15. View of work deck/staging area present in western portion of Quarry 2.

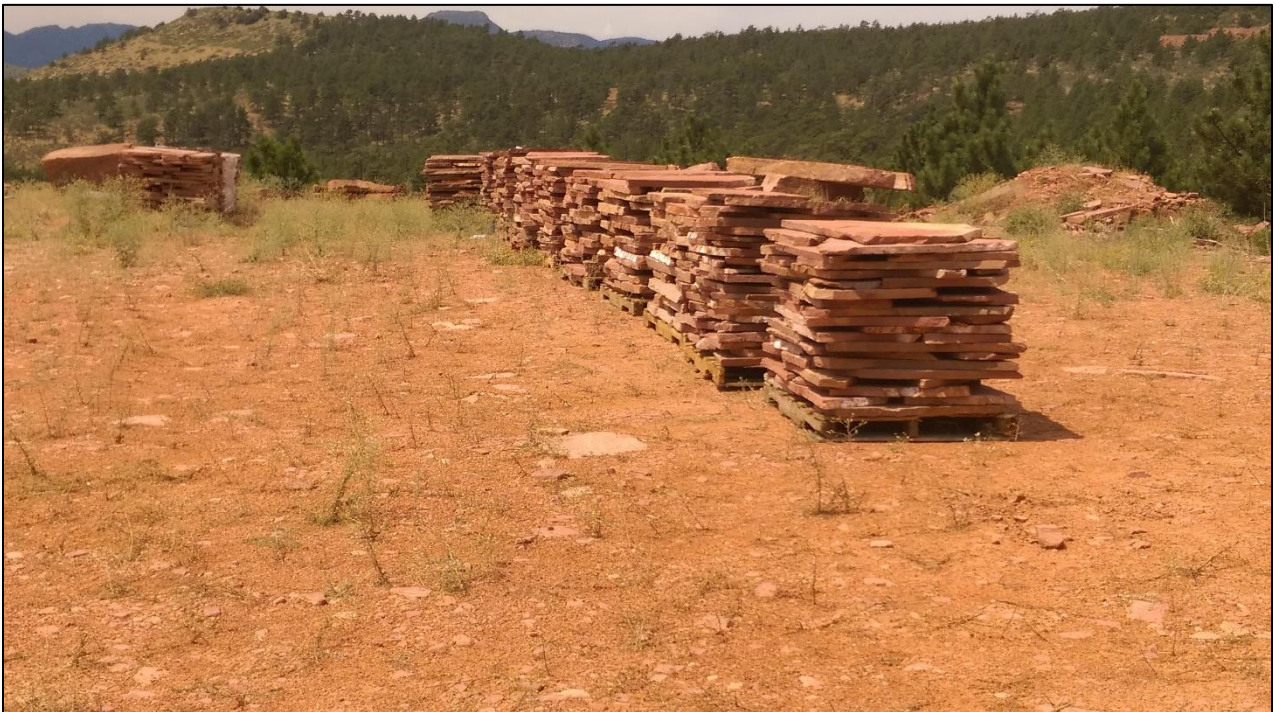
Photo 16. View of work deck/staging area present in southern portion of Quarry 2.

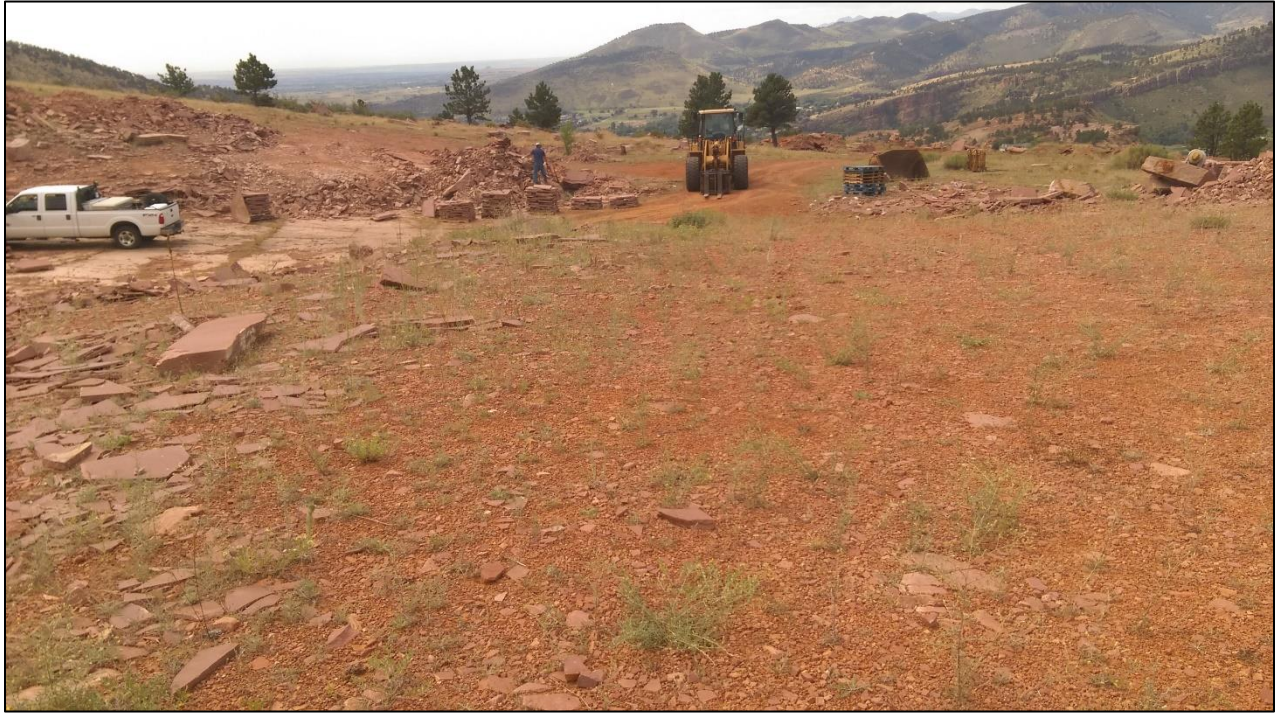
Photo 17. View of work deck/staging area present in western portion of Quarry 1.

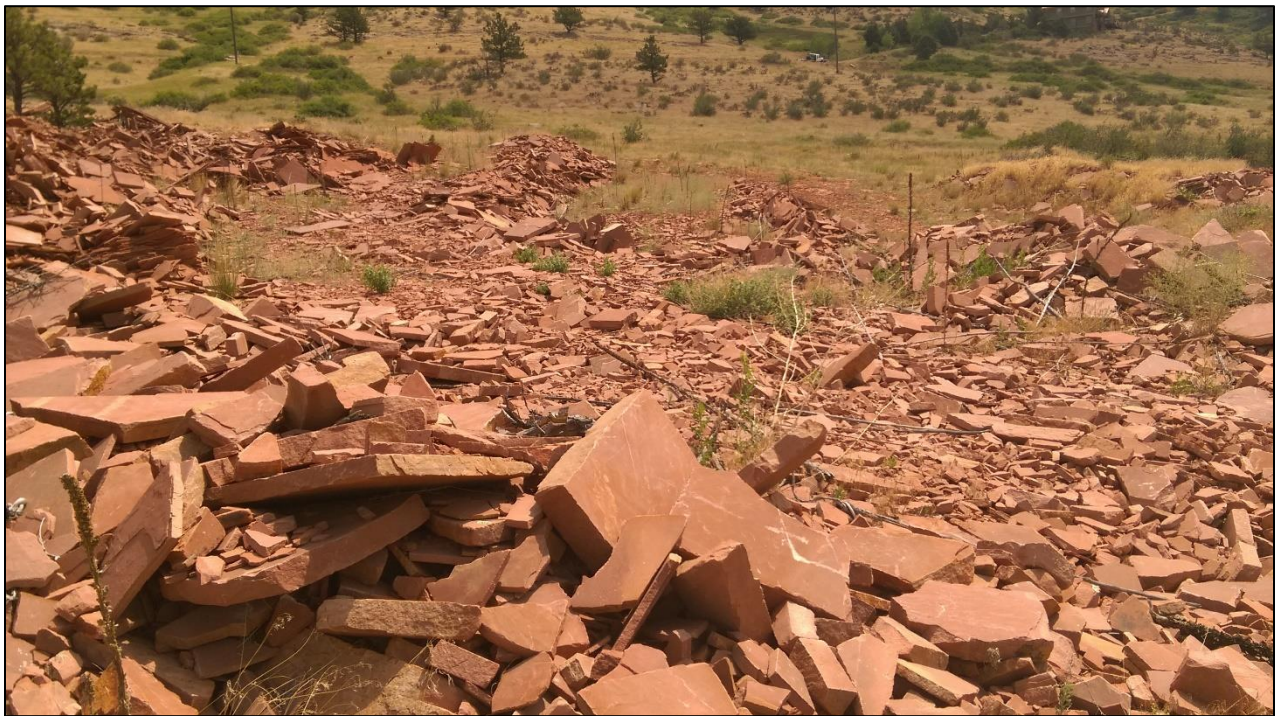
The Division observed a small area of disturbance approximately 0.25 acre in size located between Quarries 2 and 3 (**Photo 18**). The disturbance consisted of piles of quarried stone. One of the piles forms a half circle along

the southern edge. This pile appears to have been present for many years, and is possibly historic disturbance due to the amount of vegetation covering the pile. However, the other piles appear to have been dumped in more recent times due to lack of vegetation or moss growing on the rocks, minimal weathering, and the presence of a few wooden pallets in the area. For reclamation, the rocks in this area would need to be spread out and graded to blend with surrounding topography, and the area retopsoiled and revegetated.

Photo 18. View of 0.25 acre disturbance area located between Quarries 2 and 3, consisting of piles of quarried stone.

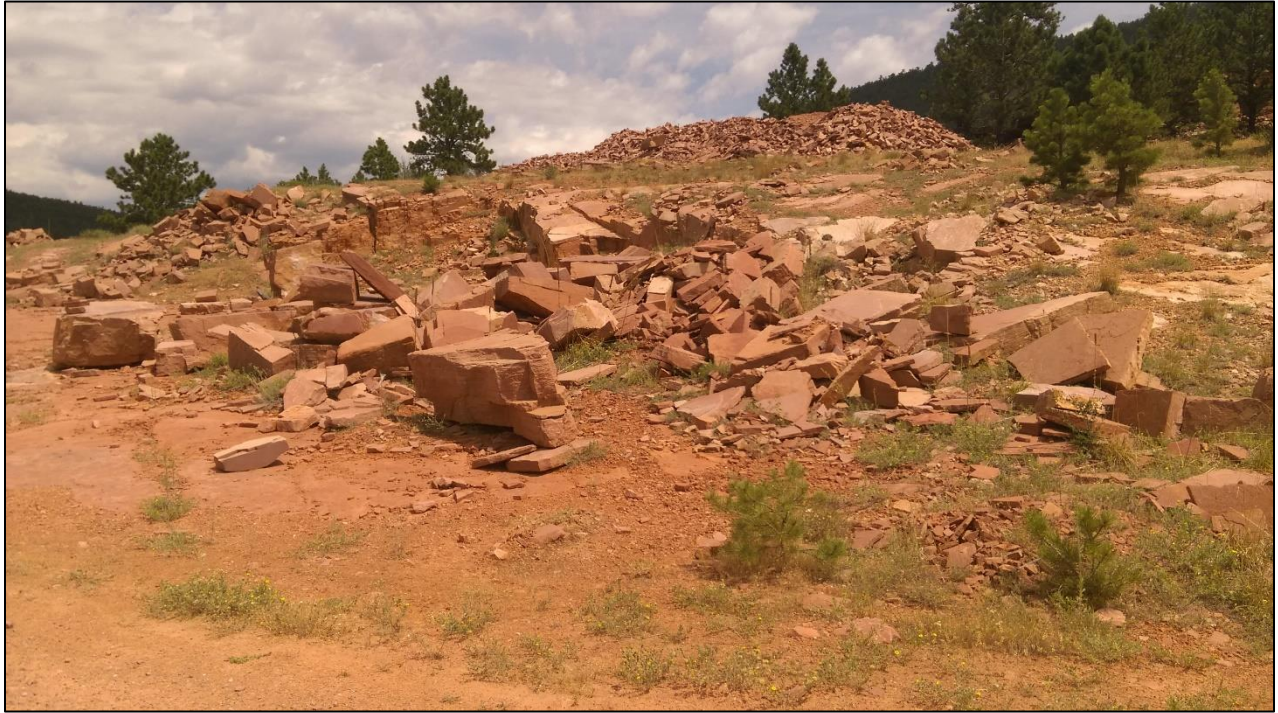
In driving north on Steamboat Valley Road, the Division observed a small working face at the southwestern edge of Quarry 2, adjacent to the road (**Photo 19**). The working face in this area was no more than 5 feet in height, with a near vertical slope gradient. Slabs of quarried stone were piled in front of the working face. Due to its location, this disturbance was included in the disturbed area for Quarry 2. While on Steamboat Valley Road, the Division also observed the rubble that was pushed off the western edge of the road prior to 1999 (**Photos 20-22**). The drop-off from Steamboat Valley Road down to Eagle Canyon is steep. The Division estimates the footprint of the rubble piles closer to Quarries 1 and 2 to be approximately 1.93 acres in size, and the footprint of the rubble piles closest to Quarry 3 to be approximately 0.19 acre in size. Much of the rubble piles closer to Quarries 1 and 2 have some vegetative cover consisting of grasses, shrubs, and some pine trees. The rubble pile closer to Quarry 3 has only a few shrubs growing across it. As mentioned above, the operator has committed to not pushing any additional rock over the edge of the road. The rubble piles appear to have assumed an angle of repose at approximately 1.5H:1V.

Photo 19. View of small working face and piles of quarried stone present adjacent to Steamboat Valley Road, southwest of Quarry 2. This area was included with Quarry 2 disturbance.

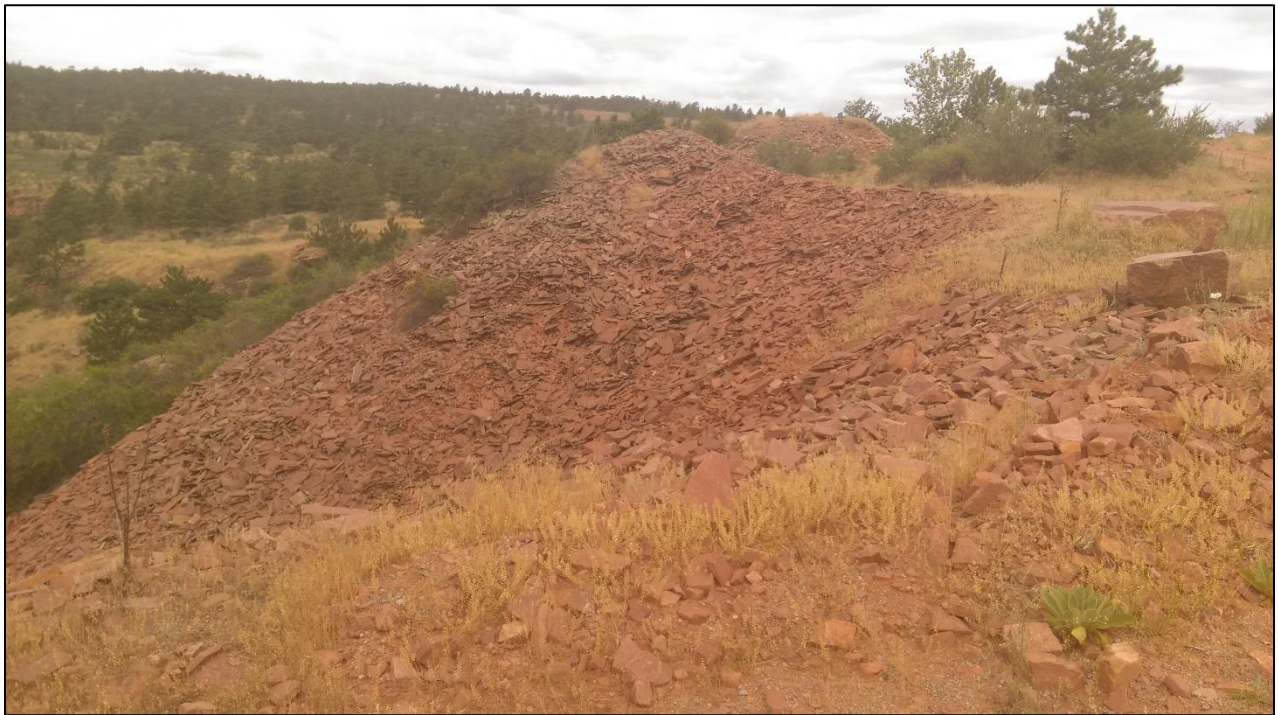
Photo 20. View of rubble pile that was dumped off western edge of Steamboat Valley Road, across from Quarry 3. This pile will not require reclamation as long as the operator does not redisturb the area.

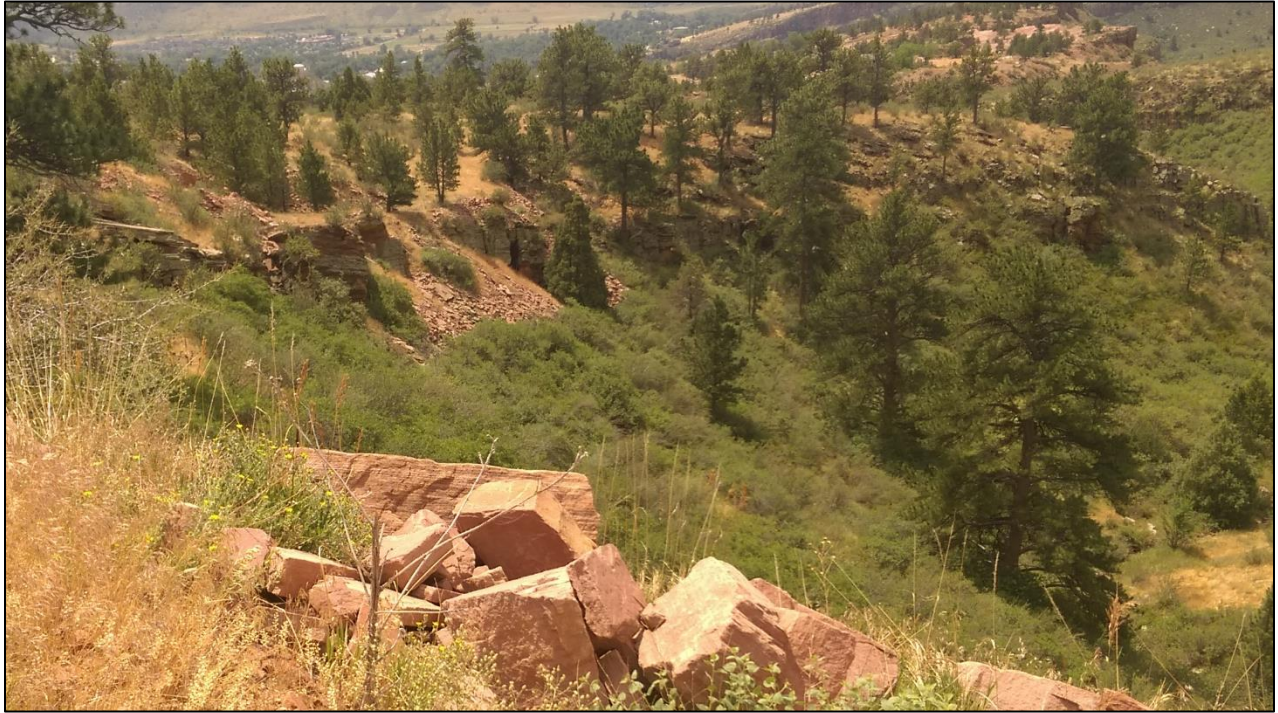
Photo 21. View of rubble piles that were dumped off western edge of Steamboat Valley Road, across from Quarries 1 and 2. These piles will not require reclamation as long as the operator does not redisturb the areas.

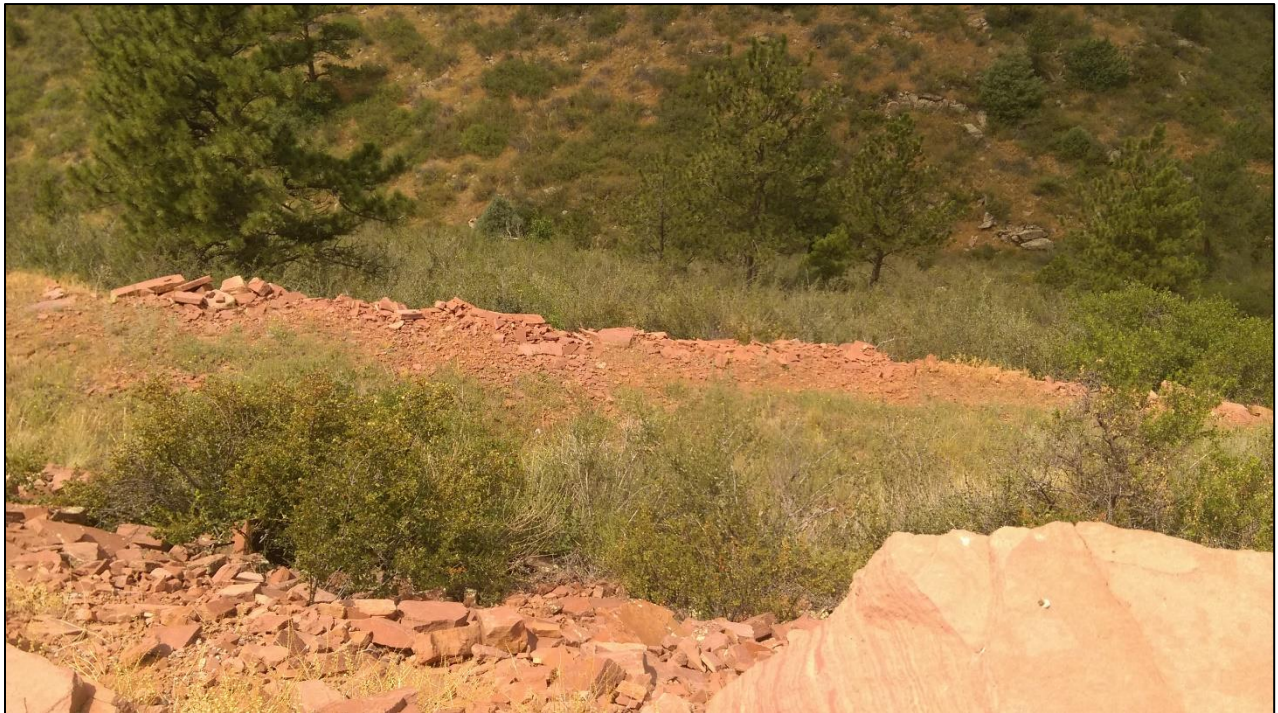
Photo 22. View looking off western edge of Steamboat Valley Road across from Quarry 2, showing portion of rubble piles dumped in Eagle Canyon.
