MINERALS PROGRAM INSPECTION REPORT
PHONE: (303) 866-3567

MINE NAME: C & D Farms No. 2	MINE/PROSPECTING ID#: M-1999-043	MINERAL: Sand and gravel	COUNTY: Lincoln
INSPECTION TYPE: Monitoring	INSPECTOR(S): Timothy A. Cazier	INSP. DATE: August 23, 2017	INSP. TIME: 9:12
OPERATOR: Lincoln County	OPERATOR REPRESENTATIVE: Trey James	TYPE OF OPERATION: 110c - Construction Limited Impact	
REASON FOR INSPECTION: Normal I&E Program	BOND CALCULATION TYPE: None	BOND AMOUNT: \$0.00	
DATE OF COMPLAINT: NA	POST INSP. CONTACTS: None	JOINT INSP. AGENCY: None	
WEATHER: Cloudy	INSPECTOR'S SIGNATURE:

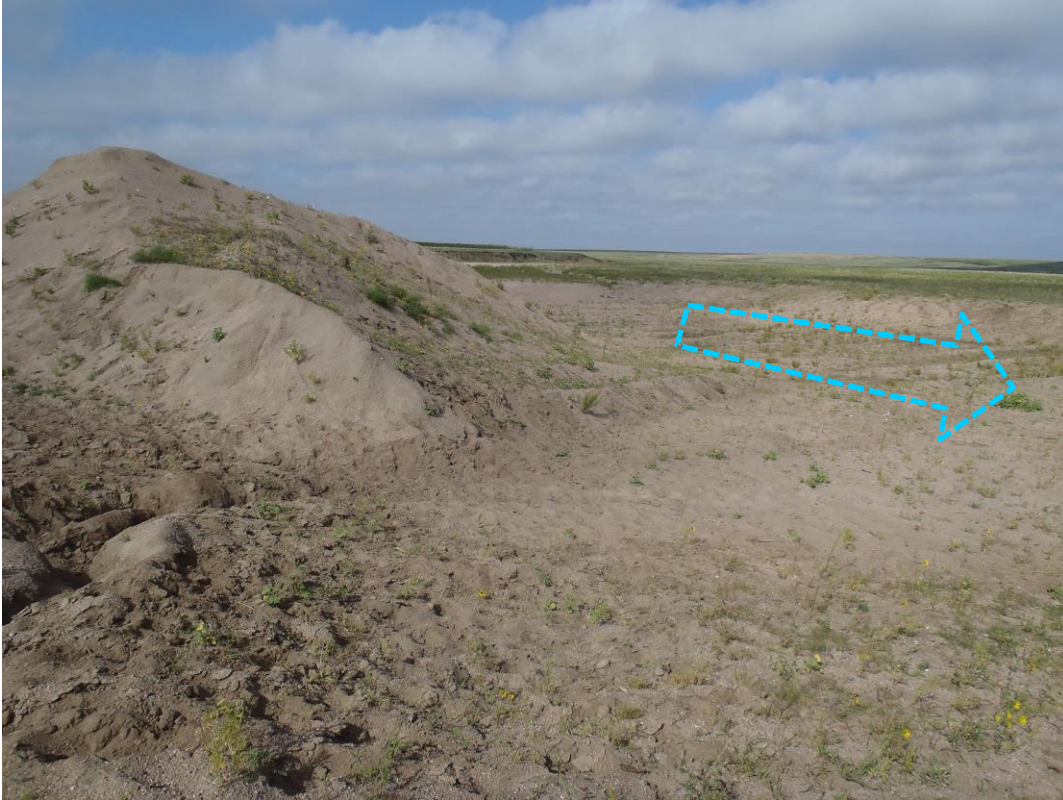
Backfilling and Grading: The approved plan is to mine the bed and banks of the Arikaree River (see **Photo 1**) with the concept that occasional flows will replenish the mined material.

Photo 1. Arikaree River bottom (right) and material stockpile (left) (looking west).
Arrow shows river flow direction

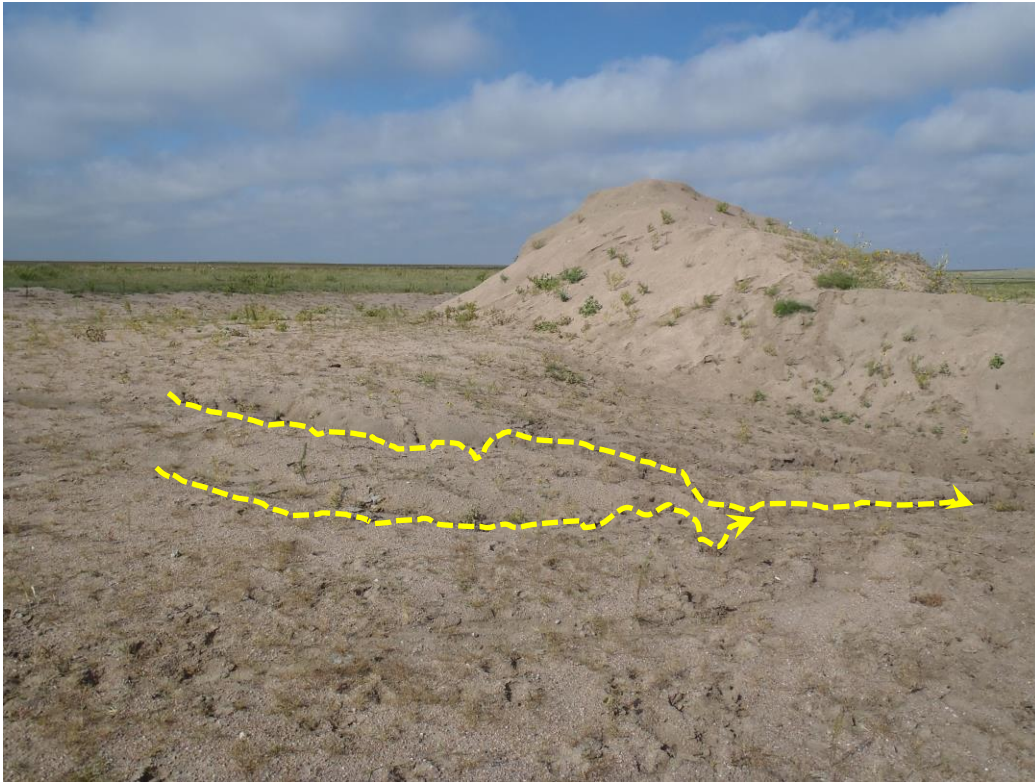
Sediment Control: Some erosion rills were observed (see **Photo 2**), however no BMPs appeared necessary at the time of the inspection.

Photo 2. Erosion rills – south side (material stockpile beyond – looking west).

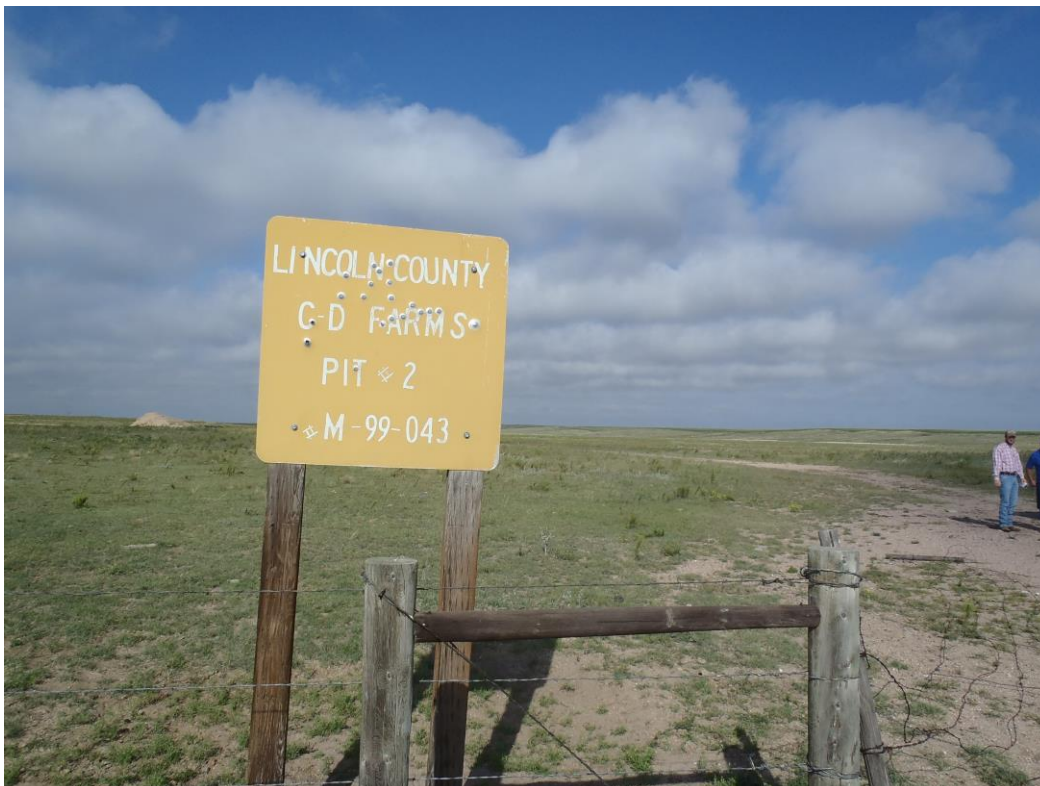
Signs and Markers: The permit sign was properly posted (see **Photo 3**) and boundary markers were observed to delineate the permit boundary (see **Photo 4**).

Photo 3. Permit sign.

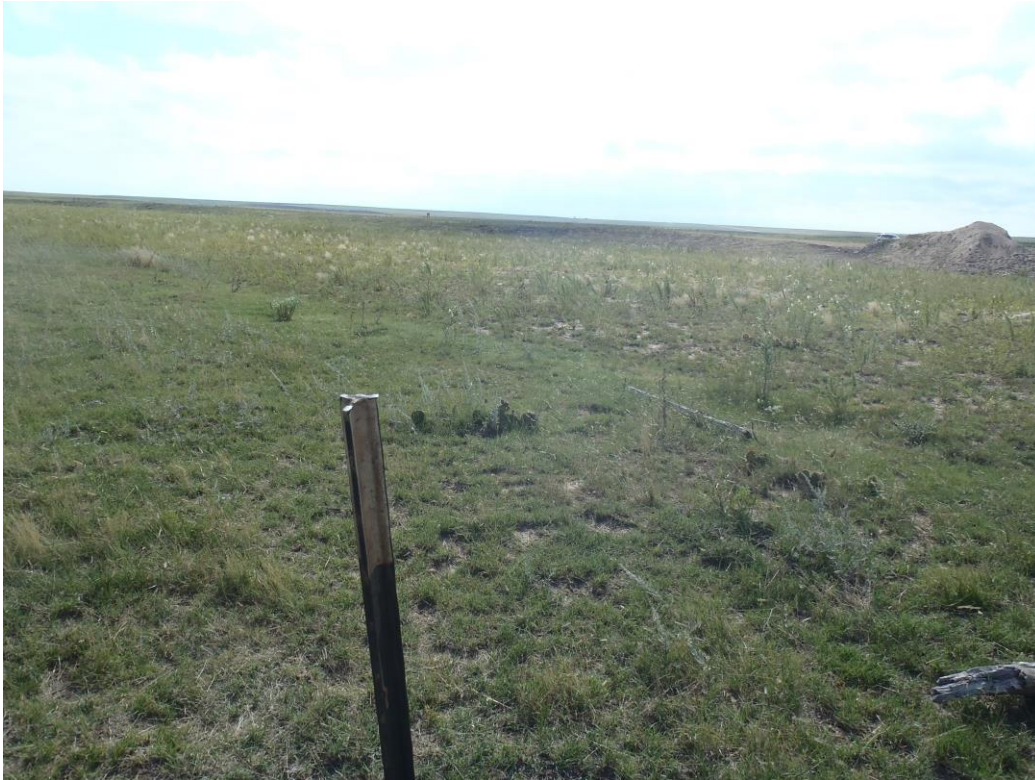
Photo 4. Typical permit boundary marker (NW corner, looking SE).
