**MINERALS PROGRAM INSPECTION REPORT**  
**PHONE: (303) 866-3567**

<b>MINE NAME:</b> H & H Quarry #2	<b>MINE/PROSPECTING ID#:</b> M-1998-080	<b>MINERAL:</b> Sandstone (silica, st quartzite)	<b>COUNTY:</b> Dolores
<b>INSPECTION TYPE:</b> Surety-Related Inspection	<b>INSPECTOR(S):</b> Lucas J. West	<b>INSP. DATE:</b> August 22, 2017	<b>INSP. TIME:</b> 16:15
<b>OPERATOR:</b> H & H Stone	<b>OPERATOR REPRESENTATIVE:</b> Marty and Andrea Holley	<b>TYPE OF OPERATION:</b> 110c - Construction Limited Impact	
<b>REASON FOR INSPECTION:</b> Surety Related	<b>BOND CALCULATION TYPE:</b> Complete Bond	<b>BOND AMOUNT:</b> \$6,347.00	
<b>DATE OF COMPLAINT:</b> NA	<b>POST INSP. CONTACTS:</b> None	<b>JOINT INSP. AGENCY:</b> None	
<b>WEATHER:</b> Clear	<b>INSPECTOR'S SIGNATURE:</b>

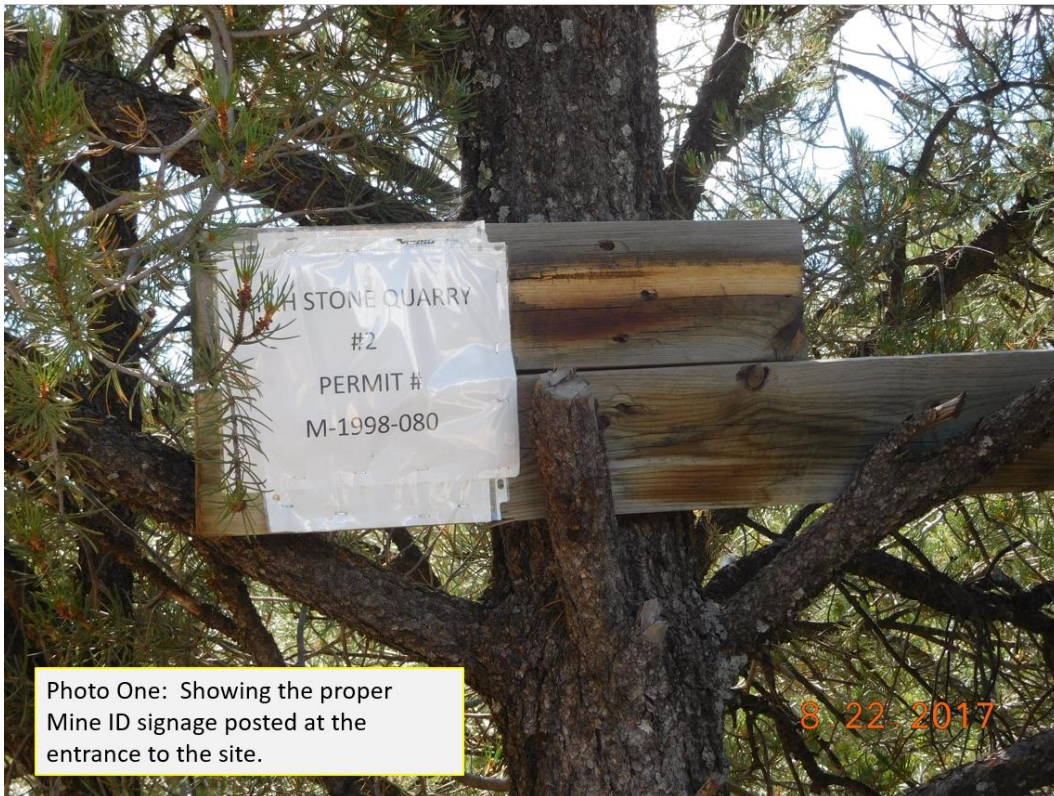
The proper mine identification signage was observed shown in Photo One, as well as the permit boundary markers. All disturbances were contained within the permitted areas. The site was not active during the inspection however some equipment was on site. Discussions with the Operator indicate that they have been active the last few months in performing the partial reclamation, other site maintenance as well as processing and selling material.

Photo One: Showing the proper Mine ID signage posted at the entrance to the site.

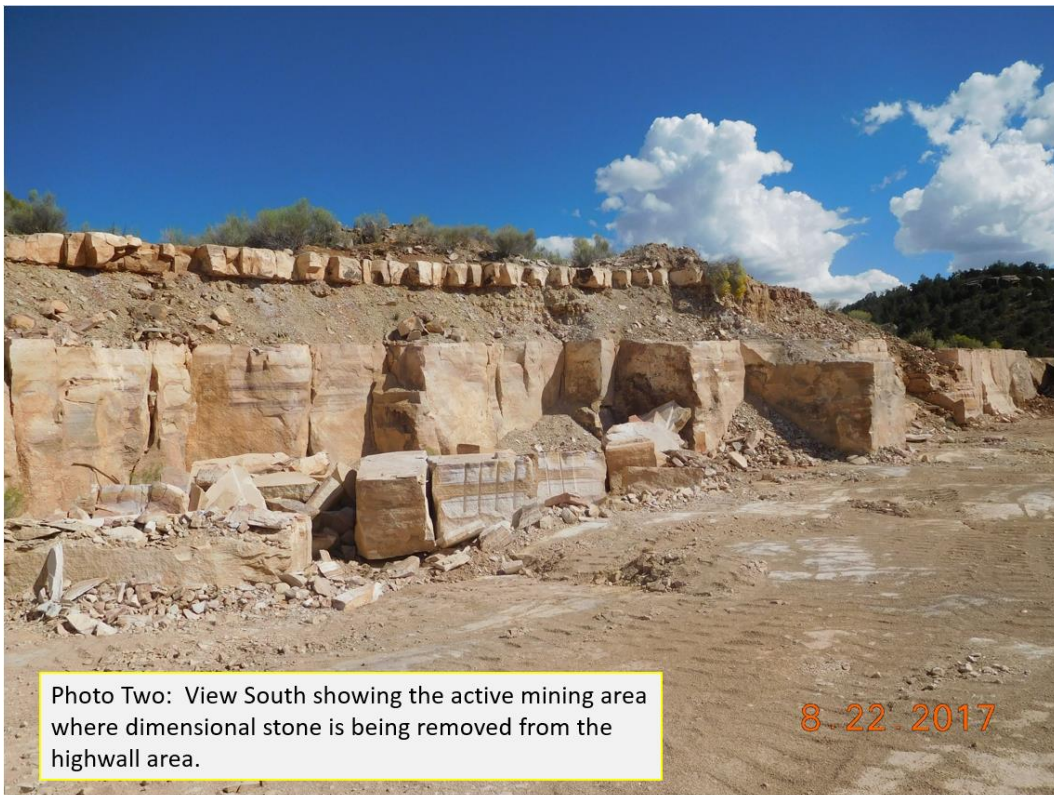
The site consists of two pit areas, one historic and one where the mining activity has been concentrated. The main active pit, consists of a highwall ranging from 20 to 30 feet tall. The highwall appears to be stable and in good condition and can be seen in Photos Two and Three. Dimensional sandstone is periodically cut from the exposed highwall, and split into smaller pieces for removal from the site and sale. Stockpiles of the stone can also be seen in Photos Two and Three. Approximately 15 feet behind the exposed highwall has been stripped future extraction activities. The floor of the main pit area is also in good condition and appears to be stable.

Photo Two: View South showing the active mining area where dimensional stone is being removed from the highwall area.

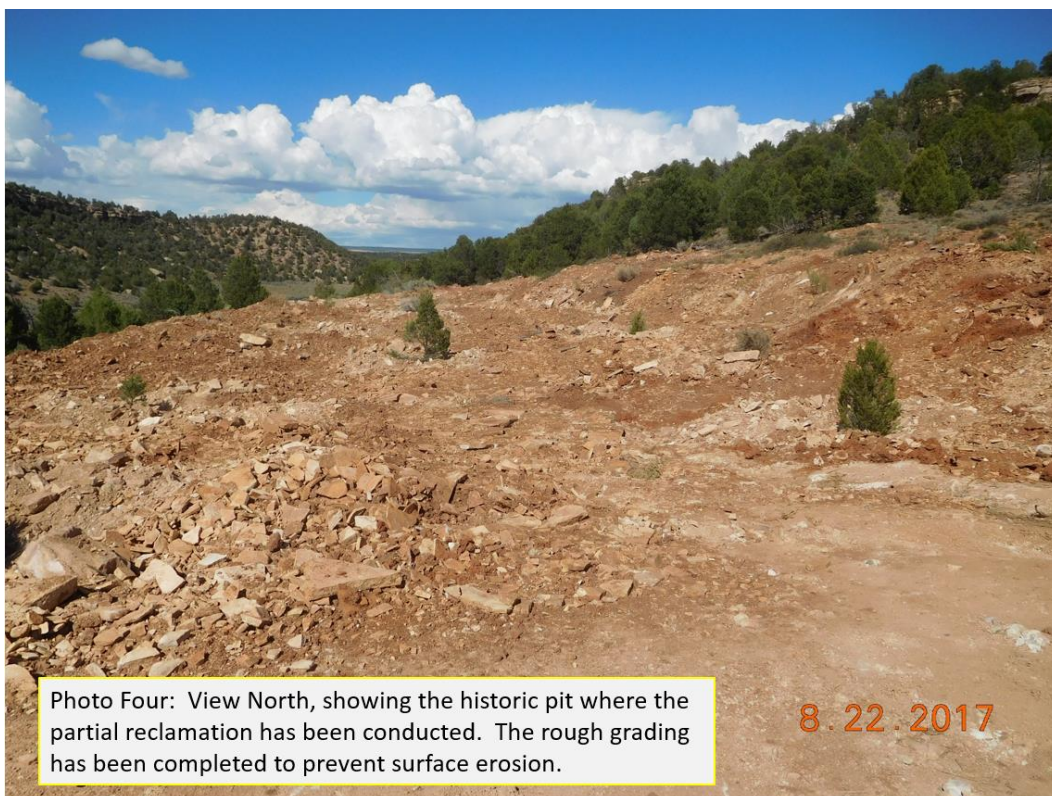
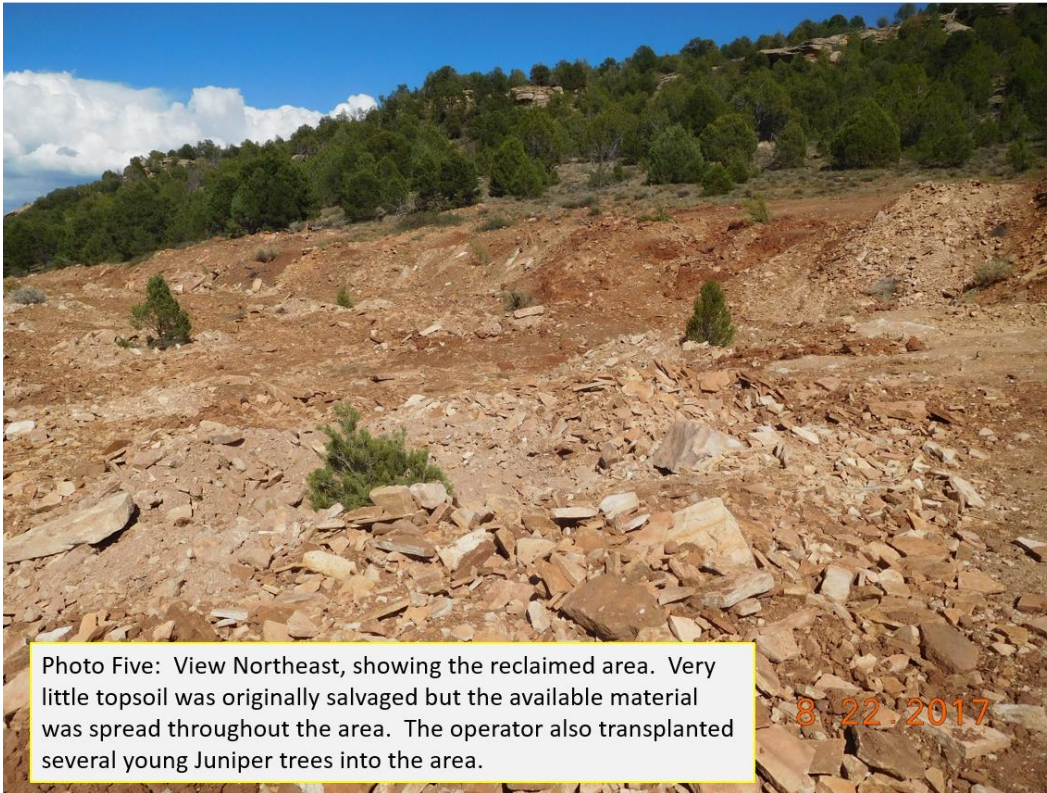
The historic pit is where the Operator elected to conduct reclamation in lieu of posting the additional required surety. The reclamation efforts are shown in Photos Four and Five. The pit has been backfilled and rough graded that has created an undulating surface to prevent future erosion. The grading was done in a way that over time it will retain moisture and aid in the reclamation efforts. What little topsoil was on site from historic stripping activities has been spread over the backfilled area. Seeding will take place in the coming months, as the Operator wished to gain Division approval of the grading work prior to conducting the seeding. The Operator has also gone above and beyond by transplanting young Juniper trees as well as sage brush through the reclaimed area.
