MINERALS PROGRAM INSPECTION REPORT
PHONE: (303) 866-3567

MINE NAME: Duck Creek Mine	MINE/PROSPECTING ID#: M-2013-022	MINERAL: Oil shale	COUNTY: Rio Blanco
INSPECTION TYPE: Monitoring	INSPECTOR(S): Travis H. Marshall	INSP. DATE: August 15, 2017	INSP. TIME: 13:45
OPERATOR: Shale Tech International Services LLC	OPERATOR REPRESENTATIVE: Ed Cooley	TYPE OF OPERATION: 110(2) - Hard Rock Limited Impact	
REASON FOR INSPECTION: Normal I&E Program	BOND CALCULATION TYPE: Complete Bond	BOND AMOUNT: \$395,882.86	
DATE OF COMPLAINT: NA	POST INSP. CONTACTS: None	JOINT INSP. AGENCY: None	
WEATHER: Raining	INSPECTOR'S SIGNATURE:

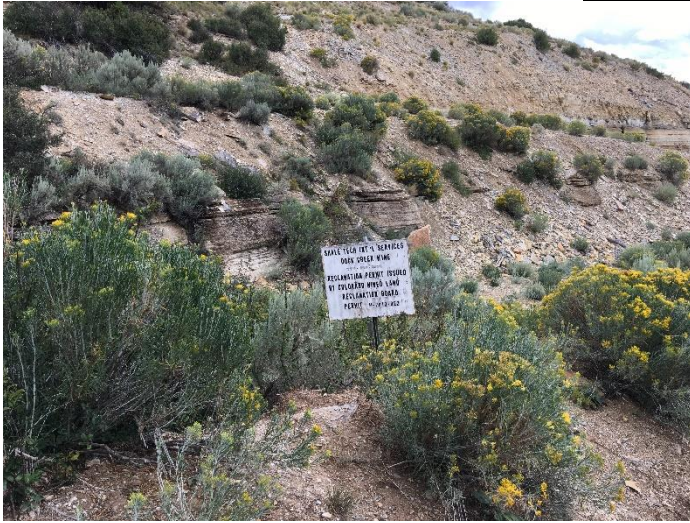
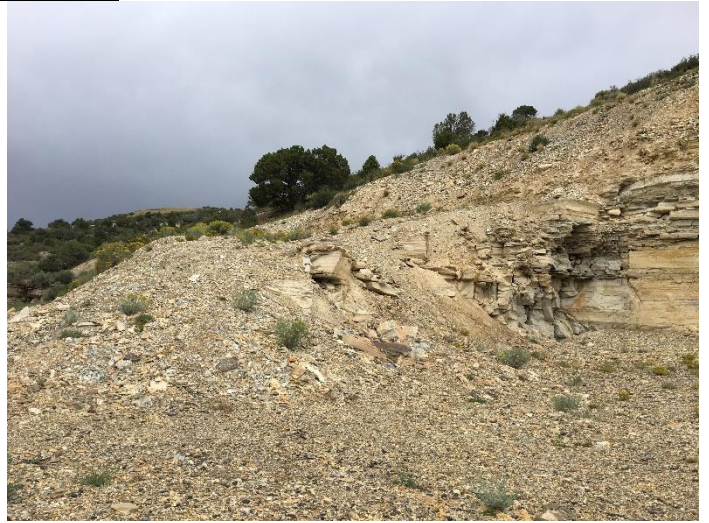
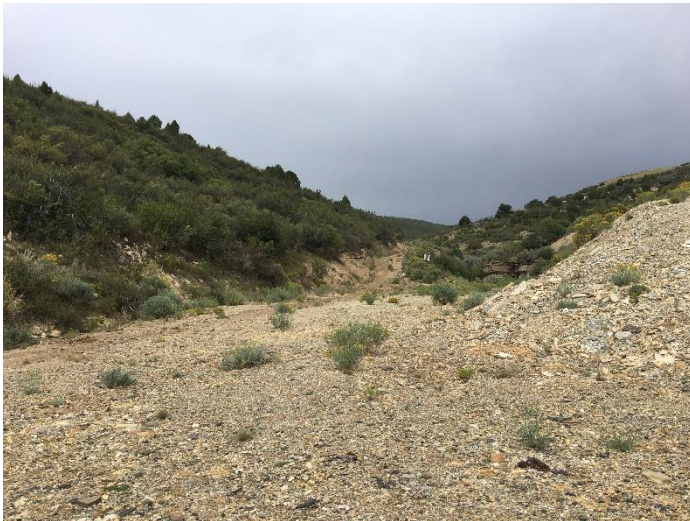
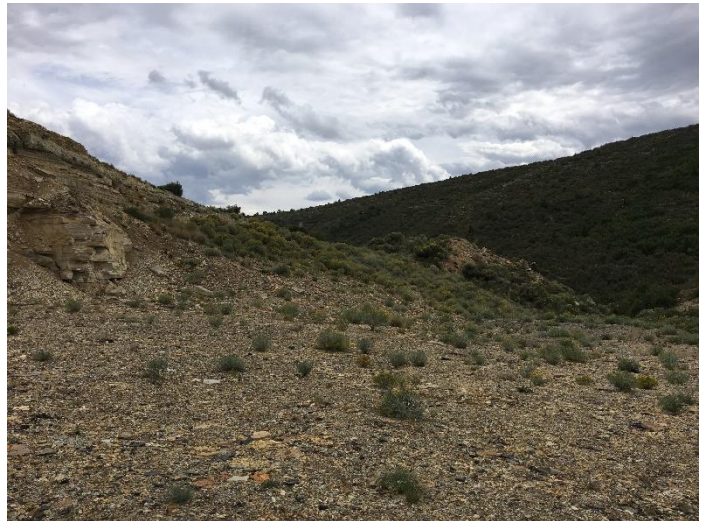
The site conditions observed during the inspection consisted of an oil shale high wall adjacent to a reclaimed and revegetated slope with re-graded slopes no steeper than the required steepness of approximately 2.5H:1V (adjacent non-disturbed slopes vary from 2H:1V-4H:1V).

No erosional issues were observed during the inspection.
