**MINERALS PROGRAM INSPECTION REPORT**  
**PHONE: (303) 866-3567**

<b>MINE NAME:</b> Cortez Pit	<b>MINE/PROSPECTING ID#:</b> M-1976-059	<b>MINERAL:</b> Sandstone (silica, st quartzite)	<b>COUNTY:</b> Montezuma
<b>INSPECTION TYPE:</b> Monitoring	<b>INSPECTOR(S):</b> Lucas J. West	<b>INSP. DATE:</b> August 23, 2017	<b>INSP. TIME:</b> 07:05
<b>OPERATOR:</b> PEPS Transport of Colorado LLC	<b>OPERATOR REPRESENTATIVE:</b> Marty	<b>TYPE OF OPERATION:</b> 112c - Construction Regular Operation	
<b>REASON FOR INSPECTION:</b> Normal I&E Program	<b>BOND CALCULATION TYPE:</b> Complete Bond	<b>BOND AMOUNT:</b> \$18,838.00	
<b>DATE OF COMPLAINT:</b> NA	<b>POST INSP. CONTACTS:</b> None	<b>JOINT INSP. AGENCY:</b> None	
<b>WEATHER:</b> Clear	<b>INSPECTOR'S SIGNATURE:</b>

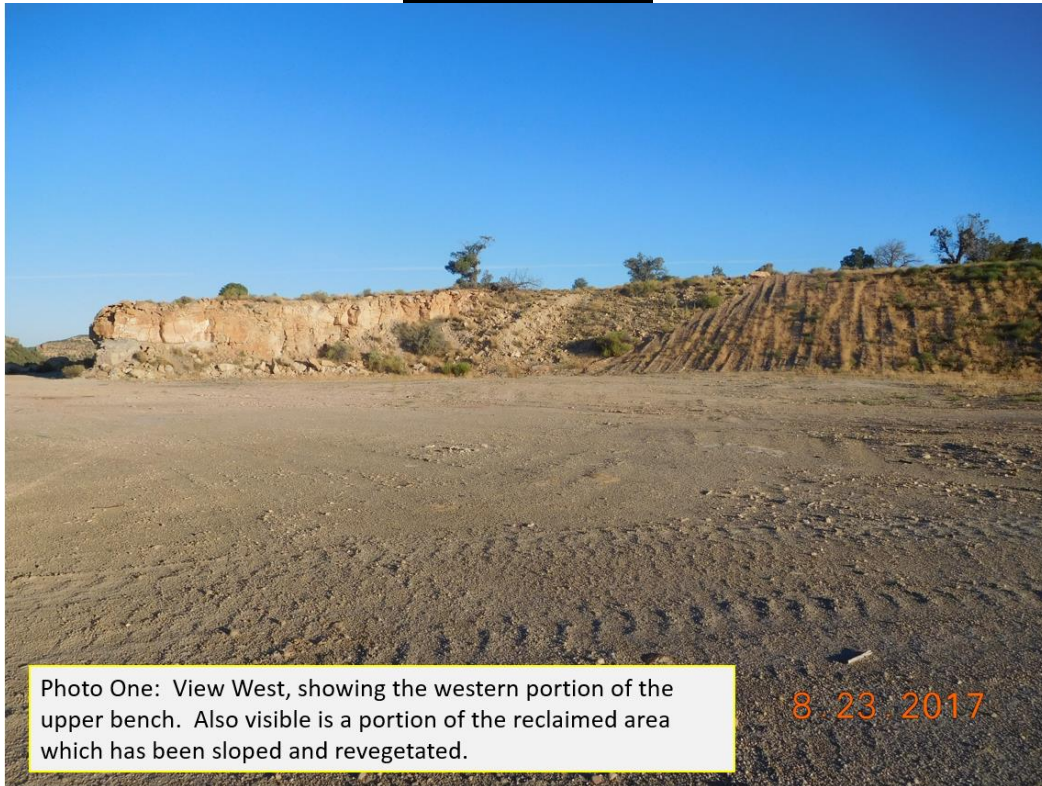
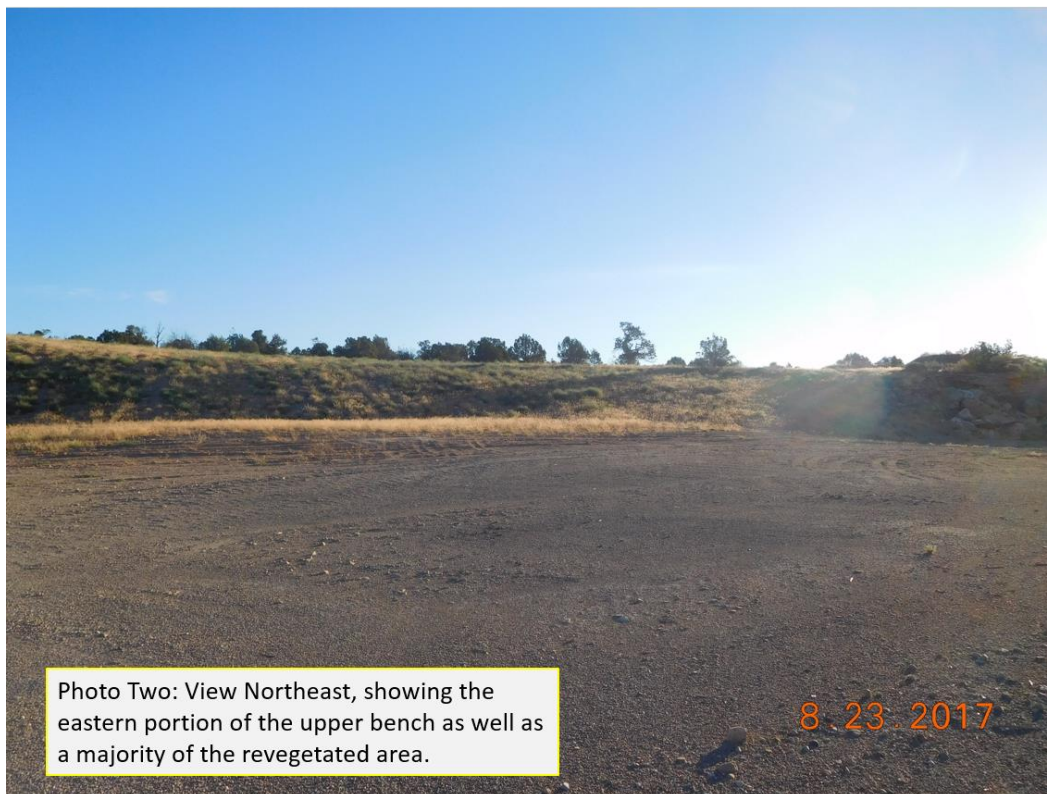
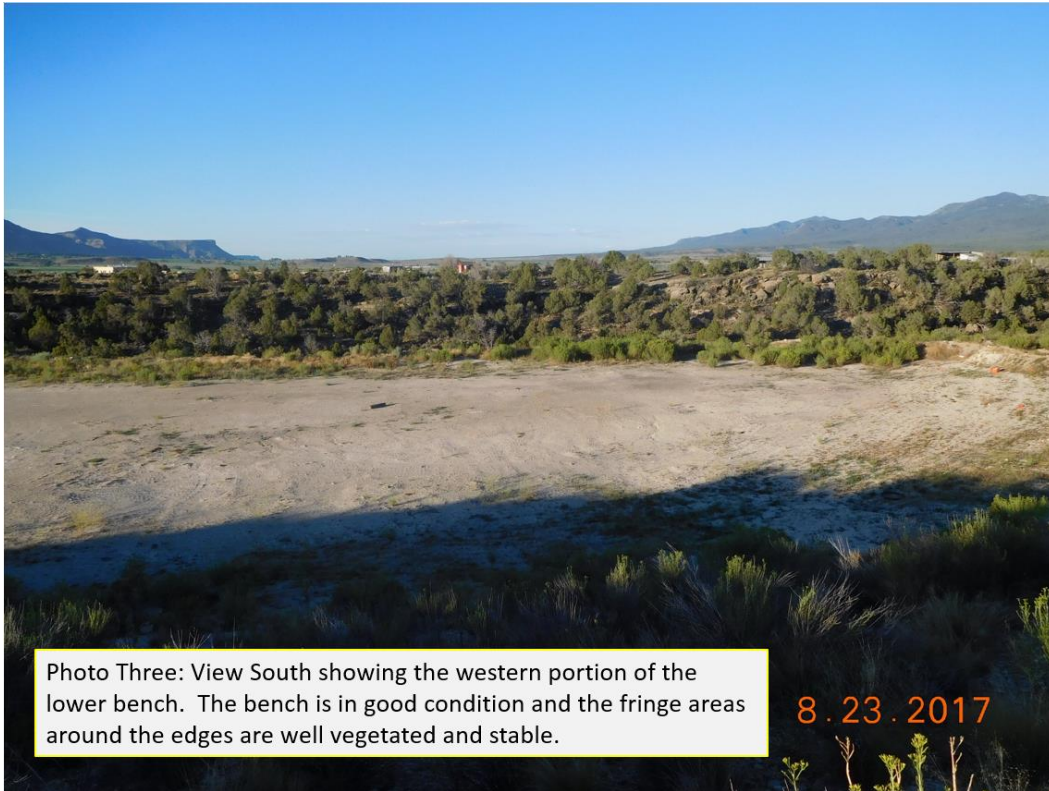
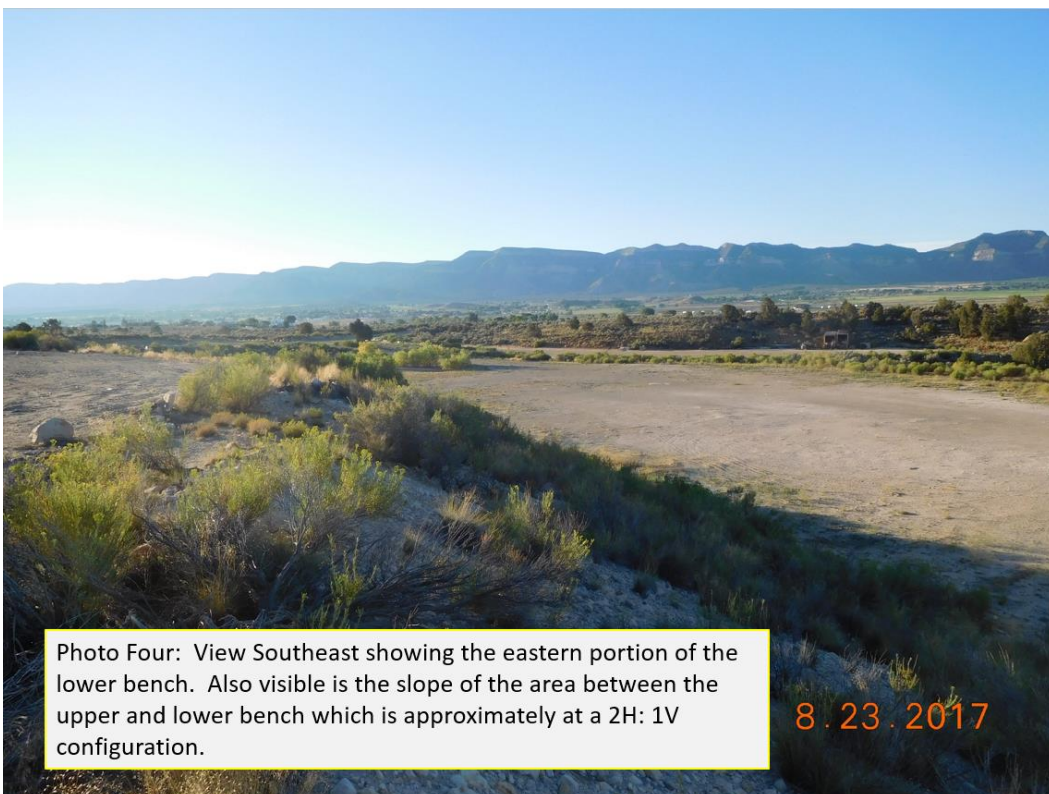
Proper mine identification signage was posted at the entrance to the site and the permit boundary was clearly marked with T-posts around the perimeter. The site has been approved for intermittent operations and according to the annual reports provided by the Operator the last date of excavation was in 2012. Prior to the sale of the property Skanska had completed the reclamation of the site. The approved reclamation plan calls for two large benches to be graveled and used as a lay down yard with an Industrial/ Commercial post mining land use. Photos One and Two show the upper bench which appears to be stable and in good condition. Also visible in Photos One and Two are the sloped areas along the northern edge of the upper bench. The slopes have been relaxed to approximately a 2H: 1V configuration and have been revegetated. The slopes appear to be stable and are not showing any signs of settling, slumping or erosion. The lower bench can be seen in Photos Three and Four. It also has been graveled and graded to be used as a lay down yard and is in good condition. The area between the two benches has been sloped and revegetated as well. The reclamation has been conducted in accordance with the Act and Rules as well as the approved reclamation plan. The vegetation in the reseeded areas appears to be adequate in both density and diversity and the graveled benches are stable. Site maintenance including monitoring and treatment of noxious weeds, erosion control and general monitoring will be necessary for the continued life of the permit.

The overall footprint of the site is in good condition and is free from trash and debris. The site is free draining and no impounded storm water or signs of erosion were noted during the inspection. Evidence of chemical treatment of noxious weeds was observed, and no new growth was noted. All responses to this report should be directed to Lucas West at the Colorado Division of Reclamation, Mining and Safety at 1313 Sherman Street, Room 215, Denver CO 80203, by phone at (970)-243-6368 or by email at [lucas.west@state.co.us](mailto:lucas.west@state.co.us).
