MINERALS PROGRAM INSPECTION REPORT
PHONE: (303) 866-3567

MINE NAME: Ormiston Gravel Pit	MINE/PROSPECTING ID#: M-1999-077	MINERAL: Aggregate	COUNTY: Dolores
INSPECTION TYPE: Monitoring	INSPECTOR(S): Lucas J. West	INSP. DATE: August 23, 2017	INSP. TIME: 09:00
OPERATOR: Montezuma County	OPERATOR REPRESENTATIVE: Randy Smith, Rob Englehart	TYPE OF OPERATION: 112c - Construction Regular Operation	
REASON FOR INSPECTION: Normal I&E Program	BOND CALCULATION TYPE: None	BOND AMOUNT: \$0.00	
DATE OF COMPLAINT: NA	POST INSP. CONTACTS: None	JOINT INSP. AGENCY: None	
WEATHER: Clear	INSPECTOR'S SIGNATURE:

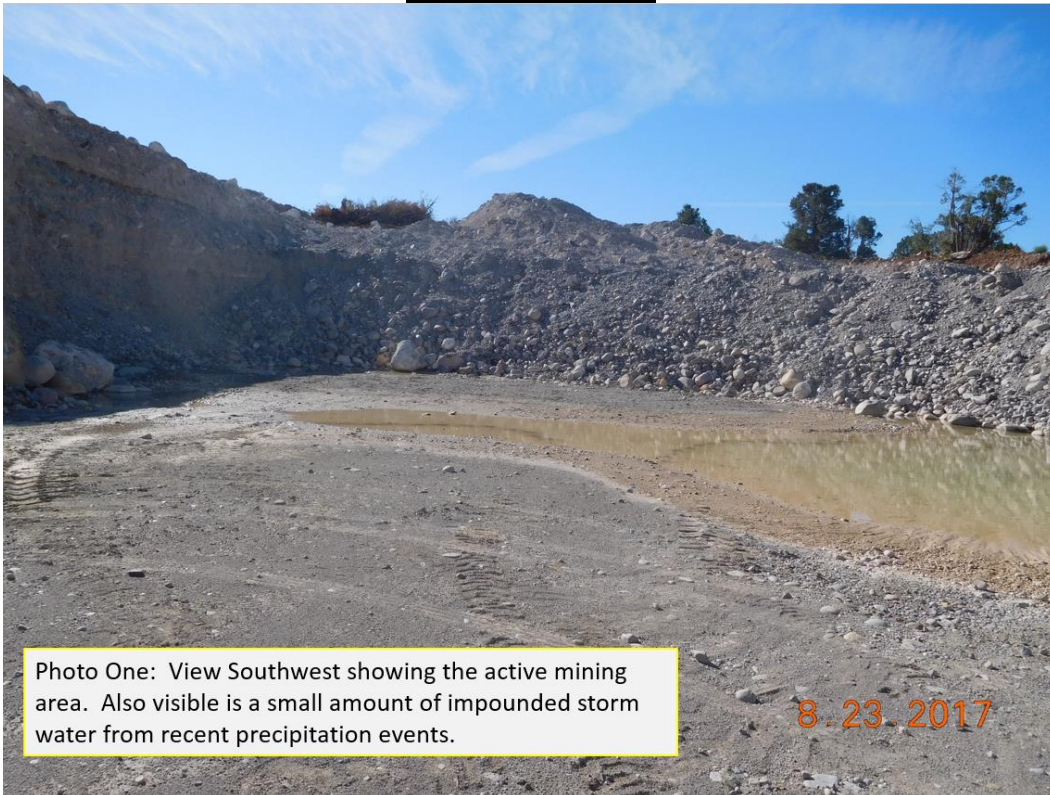
Photo One: View Southwest showing the active mining area. Also visible is a small amount of impounded storm water from recent precipitation events.

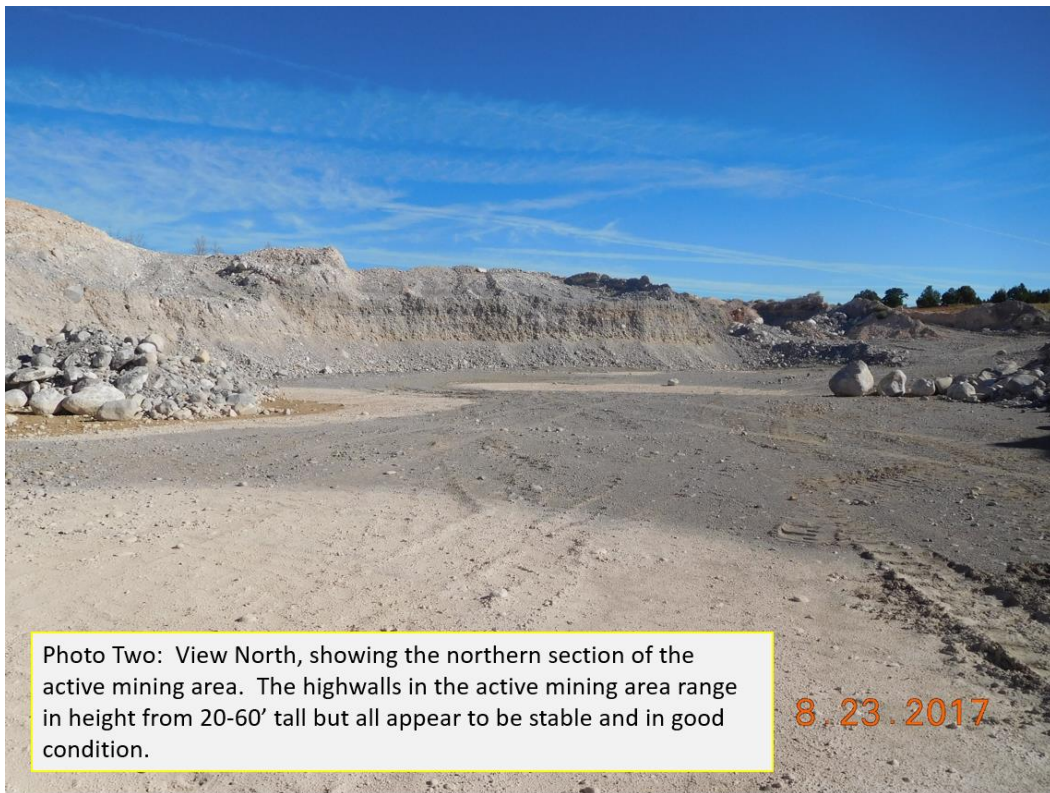
Photo Two: View North, showing the northern section of the active mining area. The highwalls in the active mining area range in height from 20-60' tall but all appear to be stable and in good condition.

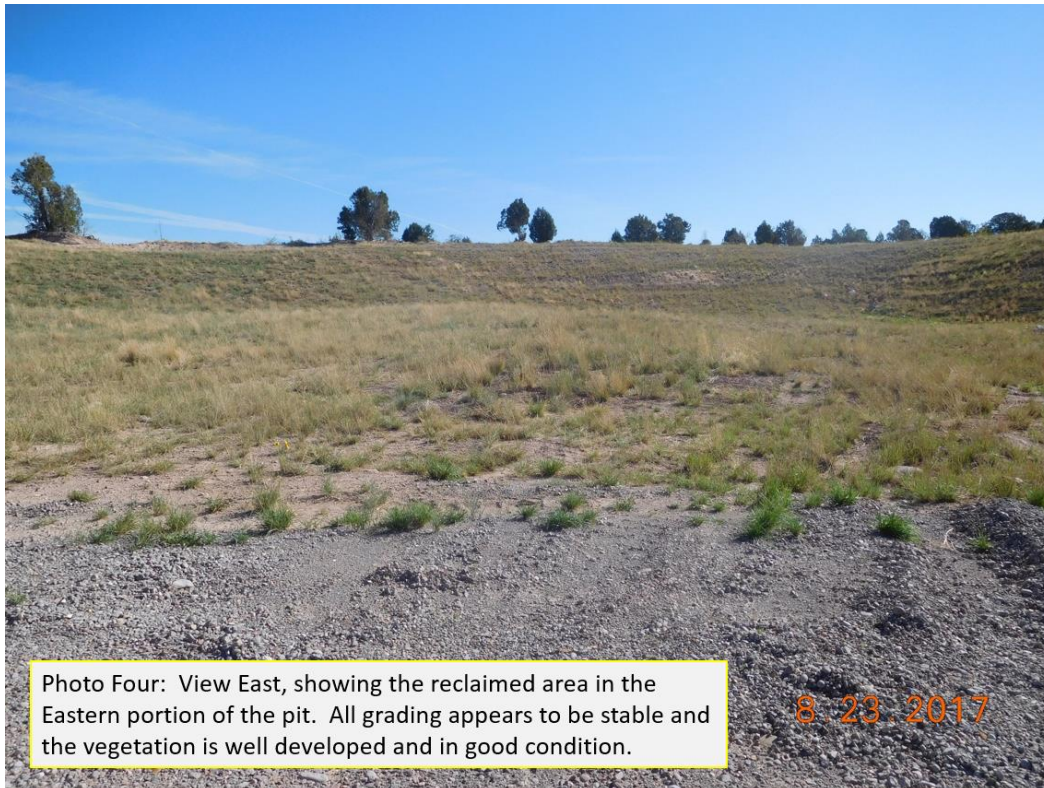
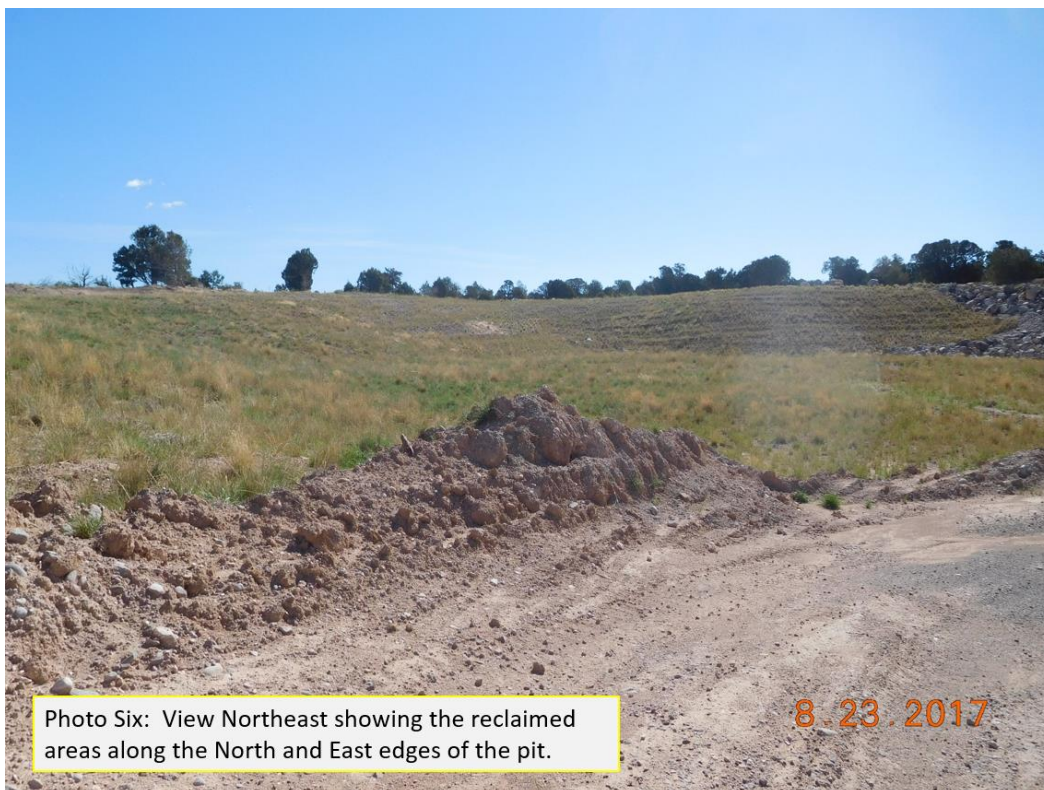
A large portion of the pit along the northern edge, as well as the eastern section and southern edge has undergone contemporaneous reclamation. Examples of the reclamation efforts can be seen in Photos Five and Six. These areas have all been sloped to an approximate 2H: 1V or 3H: 1V configuration. All grading along these areas appears to be stable, showing no signs of settling, slumping or erosion. The areas have also been revegetated and are showing signs of multiple years growth indicating that the vegetation is now self-sufficient. The vegetation is adequate in both density and diversity. Evidence of chemical treatment of noxious weeds was observed throughout the site. The Division would like to commend Montezuma County on their diligent and aggressive treatment of noxious weeds.
