**MINERALS PROGRAM INSPECTION REPORT****PHONE: (303) 866-3567**

<b>MINE NAME:</b> Perkins Sandstone	<b>MINE/PROSPECTING ID#:</b> M-2006-016	<b>MINERAL:</b> Sandstone (silica, stone quartzite)	<b>COUNTY:</b> Dolores
<b>INSPECTION TYPE:</b> Monitoring	<b>INSPECTOR(S):</b> Lucas J. West	<b>INSP. DATE:</b> August 23, 2017	<b>INSP. TIME:</b> 12:09
<b>OPERATOR:</b> McStone Aggregates, LLC	<b>OPERATOR REPRESENTATIVE:</b> None	<b>TYPE OF OPERATION:</b> 112c - Construction Regular Operation

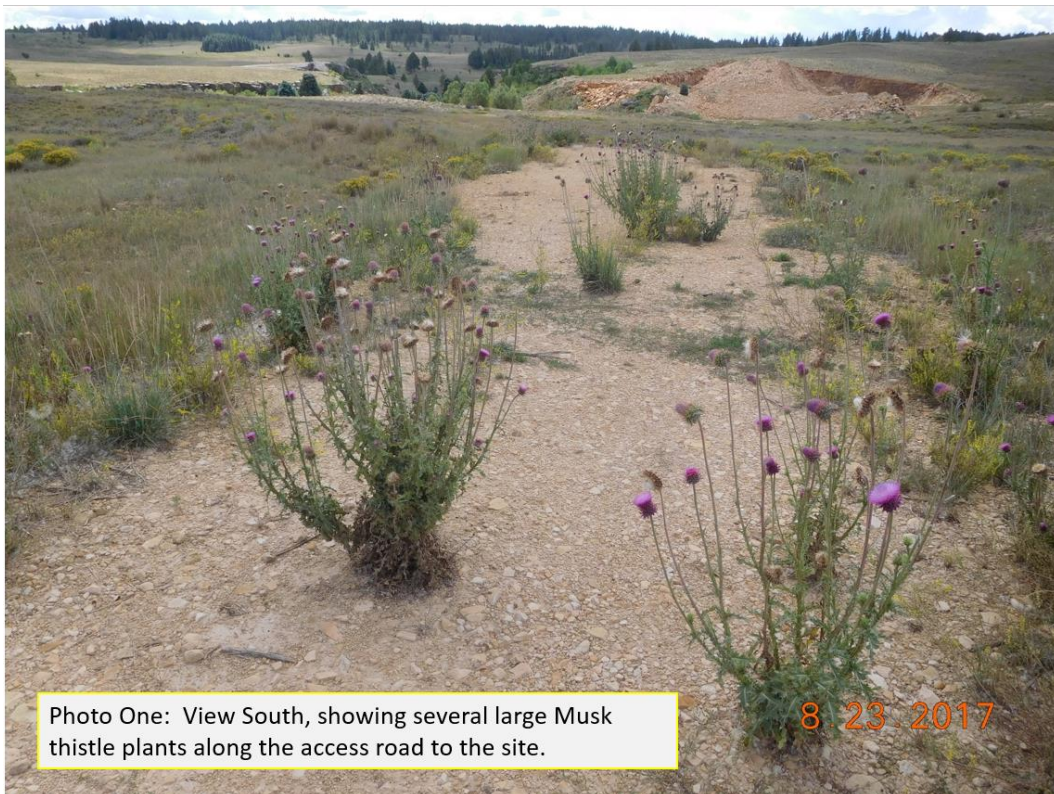
**PROBLEM/POSSIBLE VIOLATION:** Problem: There are state-listed noxious weeds present on site including large populations of Musk thistle, a B List species. This is a problem for failure to employ weed control methods for state listed noxious weed species within the permitted area, and to reduce the spread of weeds to nearby areas as required by Section 3.1.10 (6) of the rule.

Photo One: View South, showing several large Musk thistle plants along the access road to the site.

**CORRECTIVE ACTIONS:** Implement approved weed control plan and provide proof to the Division that this has been done. If a weed control plan is not already in place, the operator shall develop a weed control and management plan in accordance with Section 3.1.10 (6) of the Rule. This plan should be developed in consultation with the county extension agency, or weed control district office and should include specific control measures to be applied, a schedule for when control measures will be applied and a post-treatment monitoring plan. This weed control plan shall be submitted to the Division as a Technical Revision to the approved plan with the appropriate Technical Revision fee of \$216.00 or photo documentation of implementation of the current weed control plan should be received no later than Tuesday October 31, 2017.

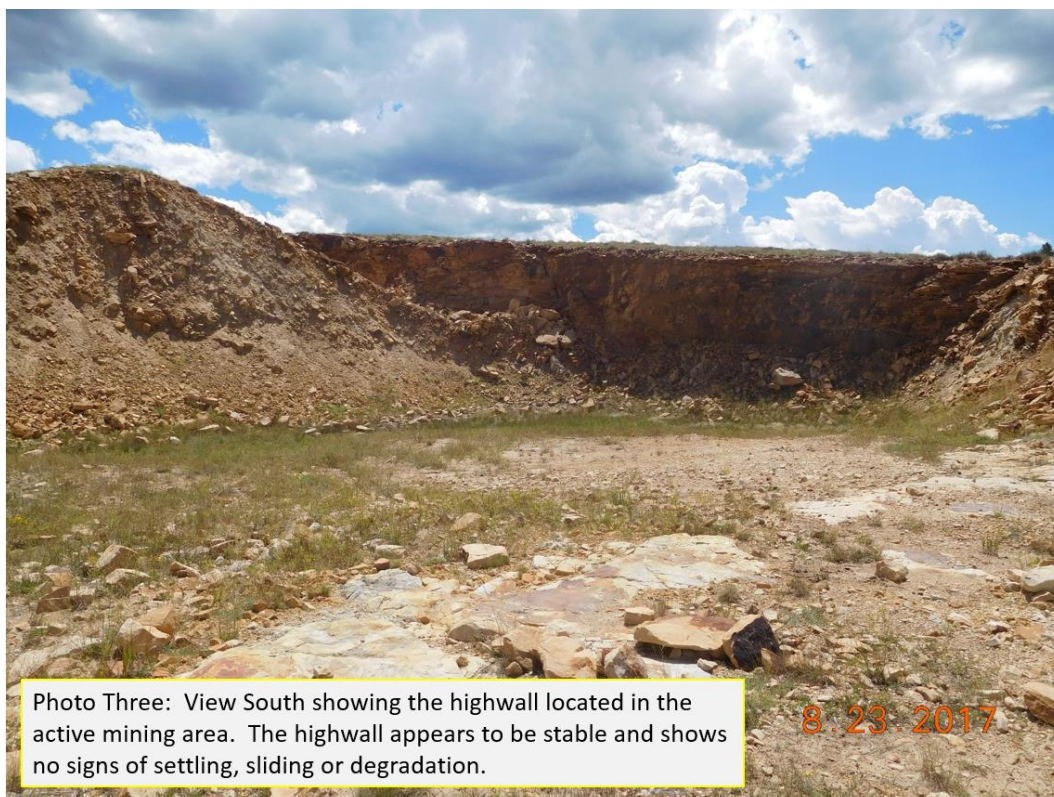
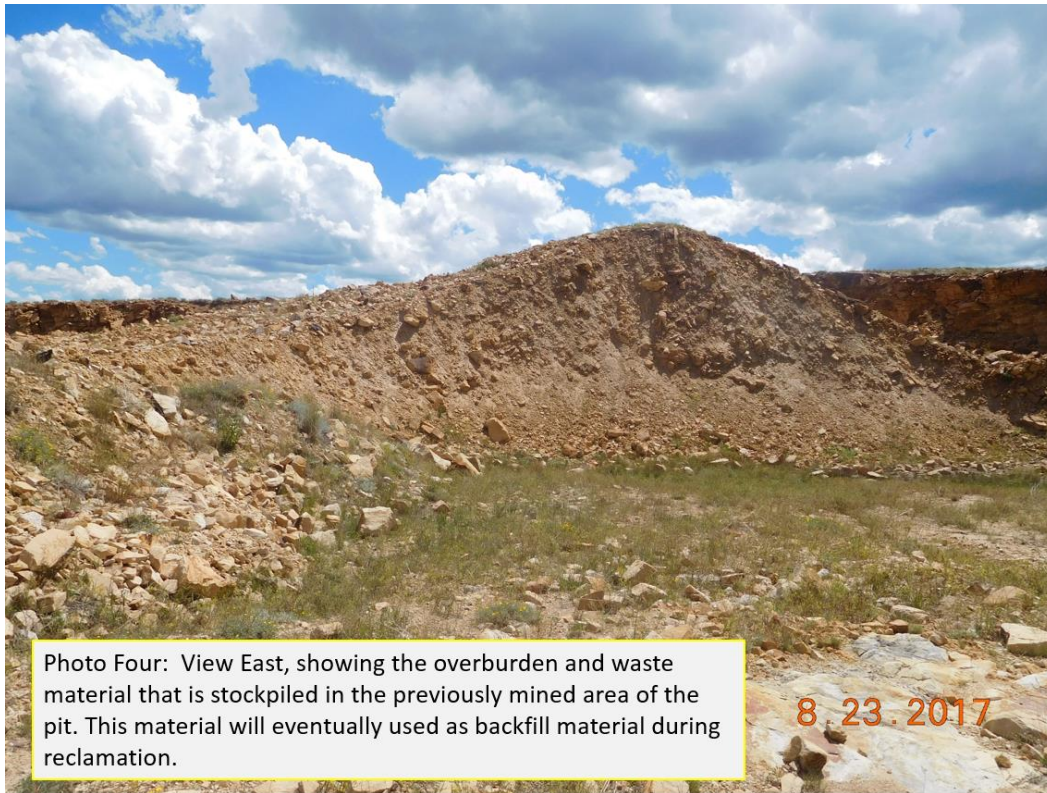
The mining activities appear to be concentrated to a small are of the pit with an active highwall that is approximately 40 feet tall and 80 feet long. The highwall and active excavation area can be seen in Photos Three and Four. The area appears to be stable and in good condition with no evidence of settling, sliding or erosion observed. The adjacent area is the previously mined pit, which is used to store overburden and waste

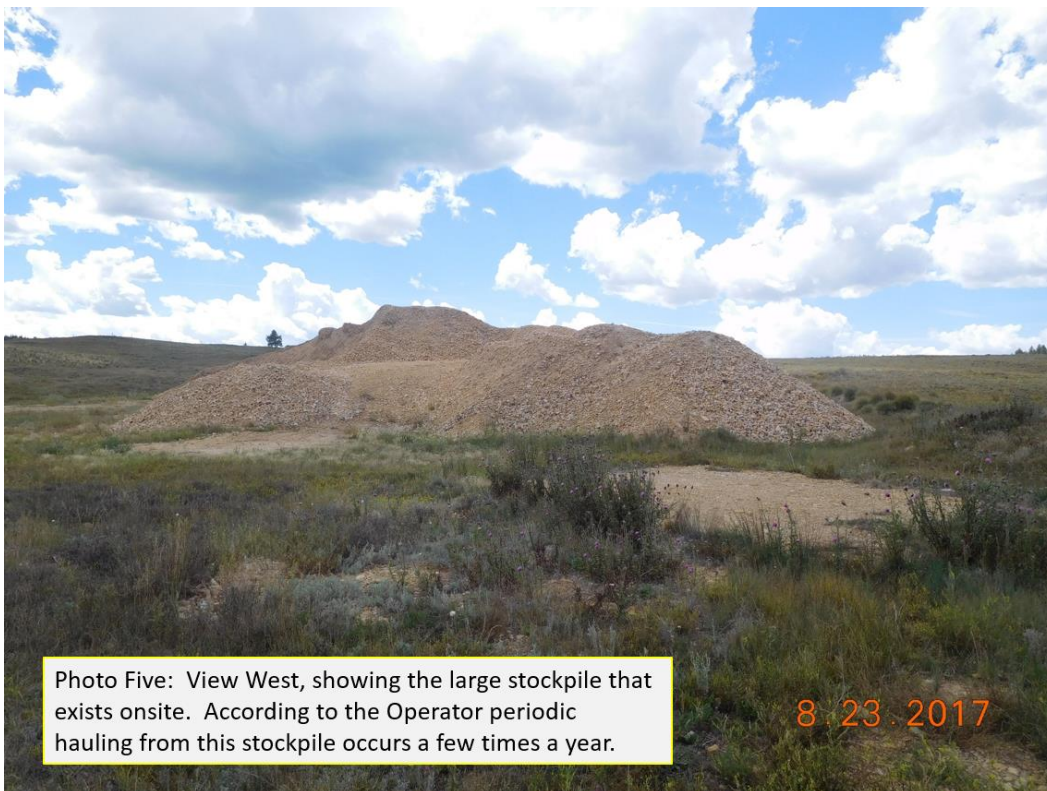
material that will eventually be used as backfill materials. Near the main excavation area is a stockpile area with a large stockpile. The stockpile can be seen in Photo Five, and appears to be stable and in good condition. Discussions with the Operator indicate that the stockpile was crushed some time ago, and periodic removal of material is ongoing.
