MINERALS PROGRAM INSPECTION REPORT
PHONE: (303) 866-3567

MINE NAME: New Hay Camp Pit	MINE/PROSPECTING ID#: M-2013-031	MINERAL: Sand and Gravel	COUNTY: Montezuma
INSPECTION TYPE: Monitoring	INSPECTOR(S): Lucas J. West	INSP. DATE: August 23, 2017	INSP. TIME: 13:30
OPERATOR: McStone Aggregates	OPERATOR REPRESENTATIVE: Casey McClellan	TYPE OF OPERATION: 112c - Construction Regular Operation	
REASON FOR INSPECTION: Normal I&E Program	BOND CALCULATION TYPE: Complete Bond	BOND AMOUNT: \$32,067.45	
DATE OF COMPLAINT: NA	POST INSP. CONTACTS: None	JOINT INSP. AGENCY: None	
WEATHER: Clear	INSPECTOR'S SIGNATURE:

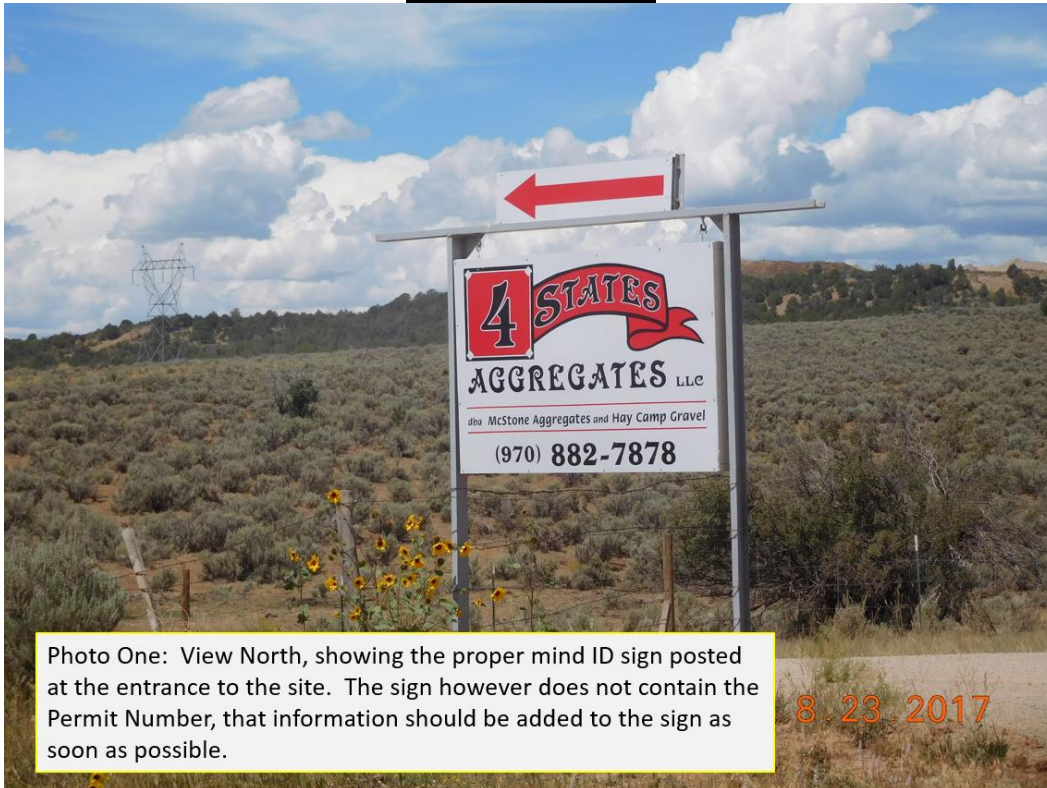
The proper mine identification signage was posted at the entrance to the site and can be seen in Photo One. Although the sign is posted it does not contain the issued MLRB Permit Number. The Operator should add a hanger to bottom of the sign that displays the Permit Number of the site. This is not being cited as a problem but should be done as soon as the Operator is able. The permit boundaries are clearly marked with a series of berms, T posts and fence lines. All disturbances are contained within the permitted area. Several pieces of equipment were on site and the site was active the day of the inspection. The active mining and stockpile area can be seen in Photos Two and Three. The various stockpiles along the pit floor all appear to be stable and in good condition. No evidence of settling slumping or erosion was noted on the stockpiles. The active mining area consists of a short highwall, which also appears to be stable. A secondary mining area has been used on the Western end of the disturbed area. A small highwall, approximately 15 feet tall exists in this area as well as a small stockpile of material. This area can be seen in Photo Four, and discussions with the Operator indicate that it was used for a special CDOT project during the last year and will eventually be overtaken by the actual mining operations.
