MINERALS PROGRAM INSPECTION REPORT
PHONE: (303) 866-3567

MINE NAME: Wallace Pit	MINE/PROSPECTING ID#: M-1983-028	MINERAL: Sand and gravel	COUNTY: Montezuma
INSPECTION TYPE: Monitoring	INSPECTOR(S): Lucas J. West	INSP. DATE: August 23, 2017	INSP. TIME: 14:08
OPERATOR: Stone Sand & Gravel, LLC	OPERATOR REPRESENTATIVE: Daren Stone	TYPE OF OPERATION: 112c - Construction Regular Operation	
REASON FOR INSPECTION: Normal I&E Program	BOND CALCULATION TYPE: Complete Bond	BOND AMOUNT: \$45,081.66	
DATE OF COMPLAINT: NA	POST INSP. CONTACTS: None	JOINT INSP. AGENCY: None	
WEATHER: Clear	INSPECTOR'S SIGNATURE:

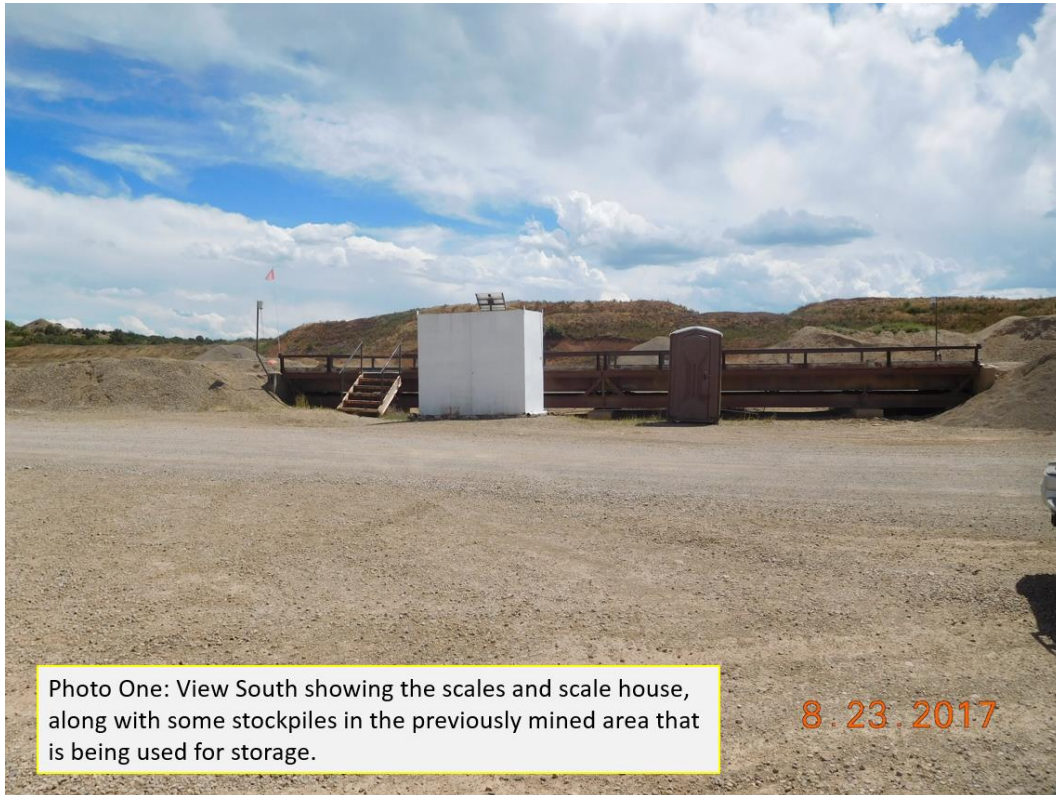
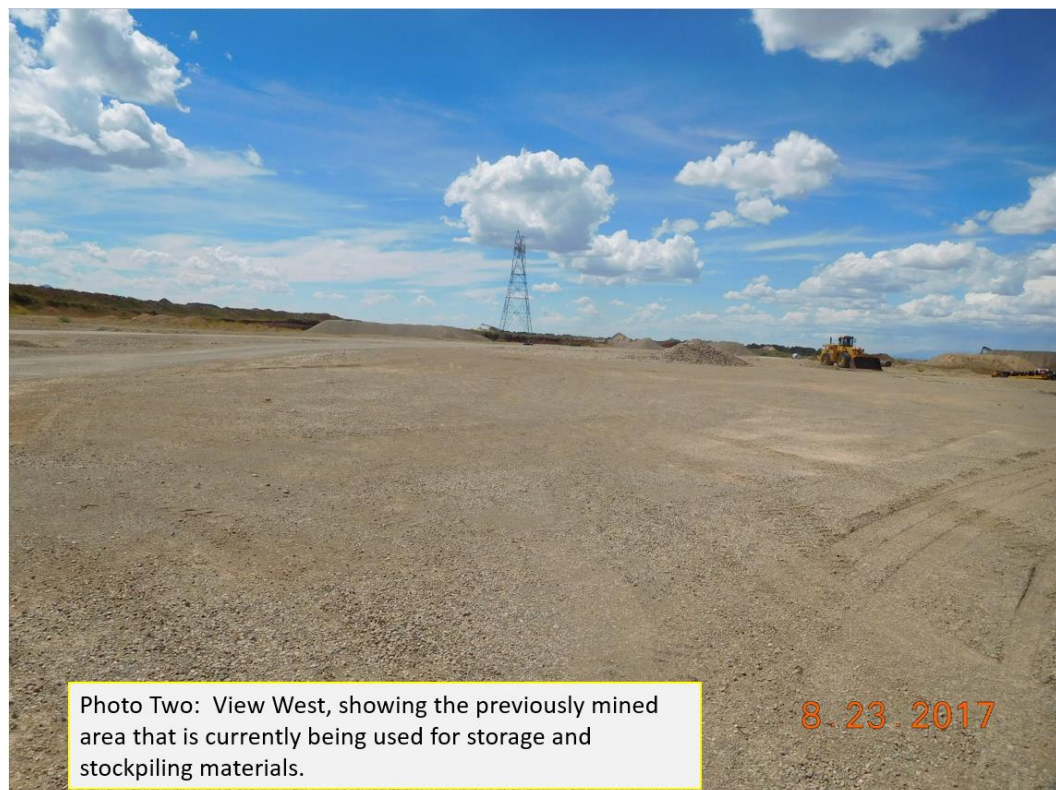
The proper mine identification signage was posted at the entrance to the site, and the boundaries are clearly marked with a series of berms and fence lines. The site shares its northern boundary with the Hay Camp Pit, Operated by Montezuma County, and it's southern boundary with the New Hay Camp Pit, Operated by McStone Aggregates. The site was active during the inspection, and Daren Stone of Stone Sand and Gravel was present. The Eastern portion of the pit, which has been previously mined is currently being used as a lay down yard, stockpile area as well as miscellaneous storage. Photos One and Two show the area. All stockpiles that are stored in that area appear to be stable and in good condition. No evidence of settling, slumping, or erosion was noted. A large power tower is centered in the previously mined area, and a large setback around the tower has been maintained.

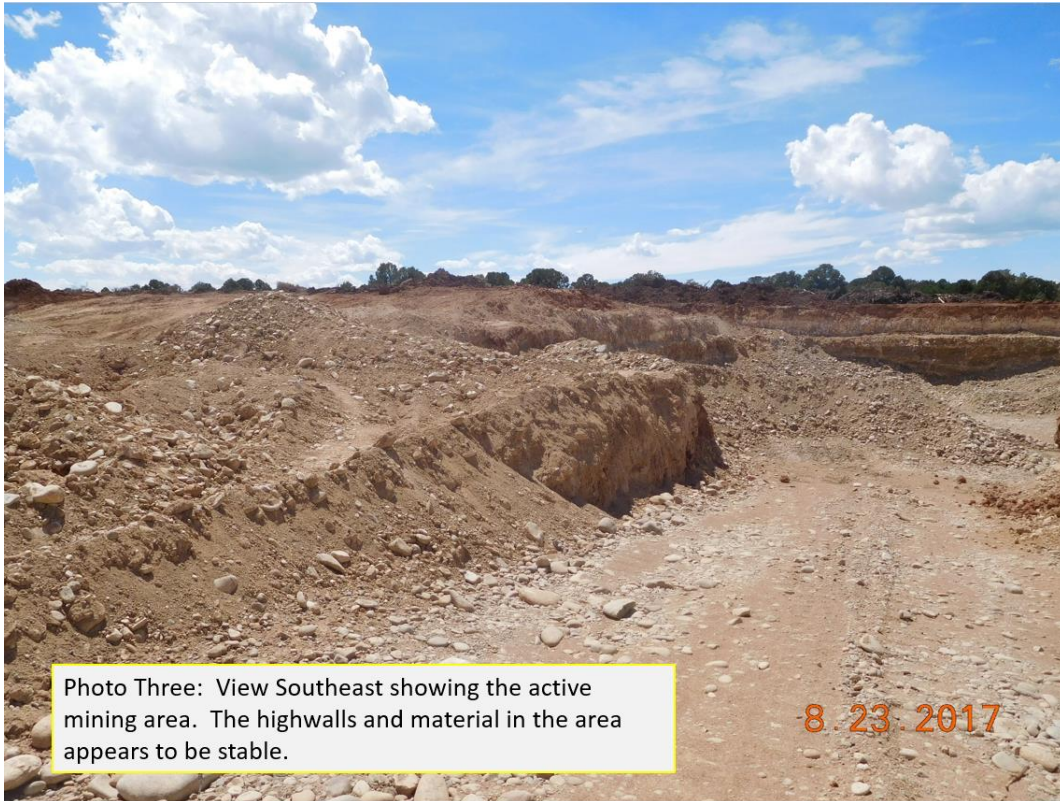
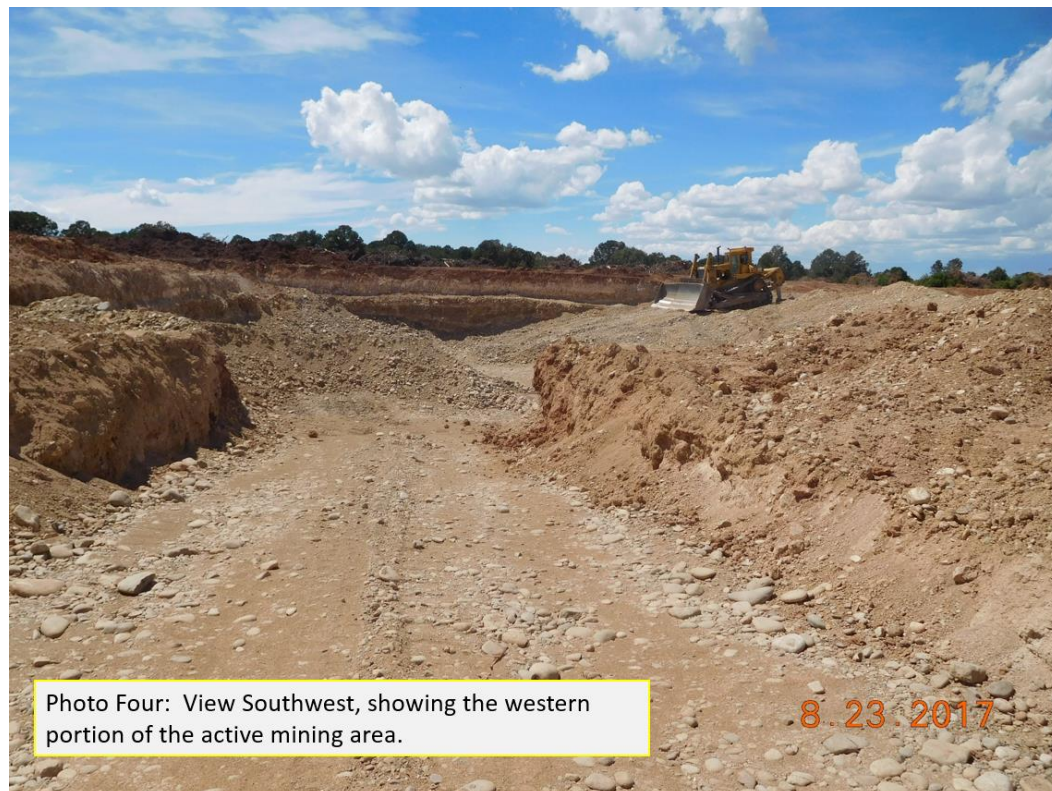
The active mining area can be seen in Photos Three and Four. Several short highwalls are present in the mining area, all of which are no more than 20 feet tall. All exposed highwalls are in good condition and appear to be stable. The site was actively crushing and stockpiling materials during the inspection. Photo Five shows the activities taking place. All stockpiles appeared to be stable as well, and showed no signs of settling slumping or erosion. The Next area to be mined has been stripped, and the vegetation has been cleared. The area can be seen in Photo Six.
