COLORADO
Division of Reclamation,
Mining and Safety
Department of Natural Resources

Permit Number: C-1996-084 Mine Name: Lorencito Canyon Mine Operator: New Elk Coal Company, LLC Operator Address: Mr. Louis Head 12250 Highway 12 Weston, CO 81091	County: Las Animas Operation Type: Surface Permit Status: Permanent Cessation Ownership: Private
	Operator Representative Present: Vince Massarotti
Operator Representative Signature: (Field Issuance Only)

Inspection Start Date: August 30, 2017 Inspection Start Time: 07:00 Inspection End Date: Inspection End Time:	Inspection Type: Coal Partial Inspection Inspection Reason: Normal I&E Program Weather: Clear		
Joint Inspection Agency: None	Joint Inspection Contacts:		
Post Inspection Agency: None	Post Inspection Contacts:		
Inspector(s): Robert D. Zuber, P.E.	<table border="0"><tr><td>Inspector's Signature:  </td><td>Signature Date: 9/5/2017</td></tr></table>	Inspector's Signature:  	Signature Date: 9/5/2017
Inspector's Signature:  	Signature Date: 9/5/2017

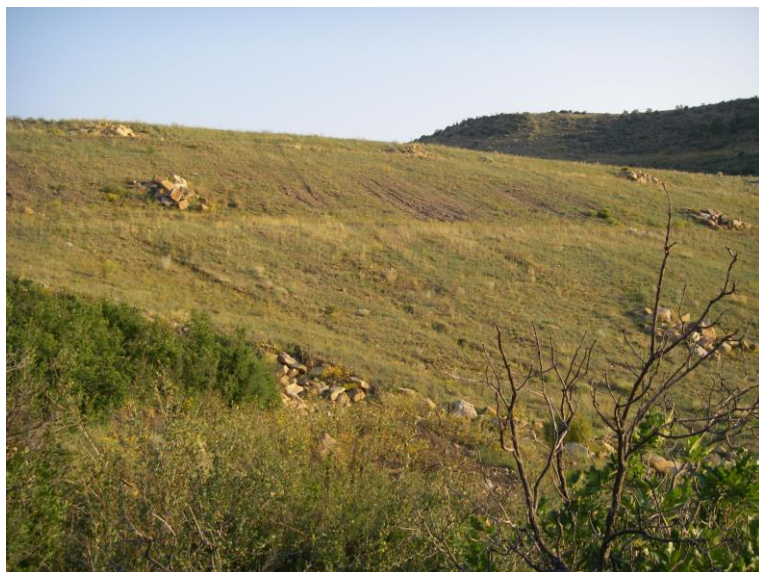
Fill 7

Fills 7, 8, and 9 were inspected. All were generally in good condition with good vegetation cover. At Fill 7, rills are healing well, and the gully near the pond has been filled with branches by NECC staff. At Fill 8, the rock work performed to address erosion at the bottom of the west channel appears to be stable since the bare bank has not experienced recent erosion. At Fill 9, additional rock work may be needed to improve the eastern side channel if the bare bank begins to erode.

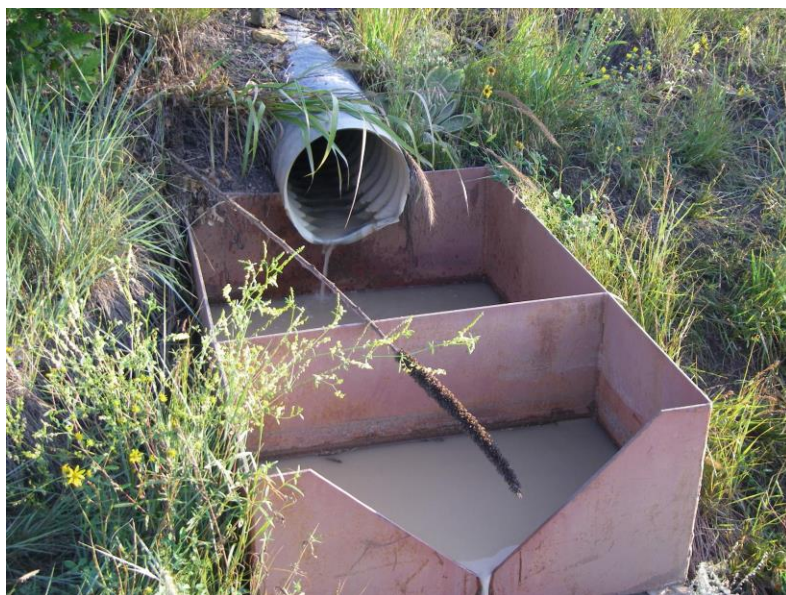
All of the ponds were inspected; this includes Ponds 5, 6, 7, 8, 9, and 9A. Three of them were discharging (Ponds 7, 8, and 9) relatively clear water, although Pond 7 discharge was somewhat turbid. Embankments and emergency spillways were in good condition. On the top of the Pond 8 dam, grass and alfalfa are emerging. As mentioned in past inspections, it appears that primary spillways at some ponds have small leaks. Preferably, the seams on these should be sealed, but at the very least NECC should pay very close attention to the pond embankments. Regarding Pond 9, it is advised that NECC discuss the erosion on banks and the unstable inlet to the pond with a representative of the landowner to see if they have any issues with this situation. It would be better to get their input now versus waiting until the bond release process.

Pond 7 discharge

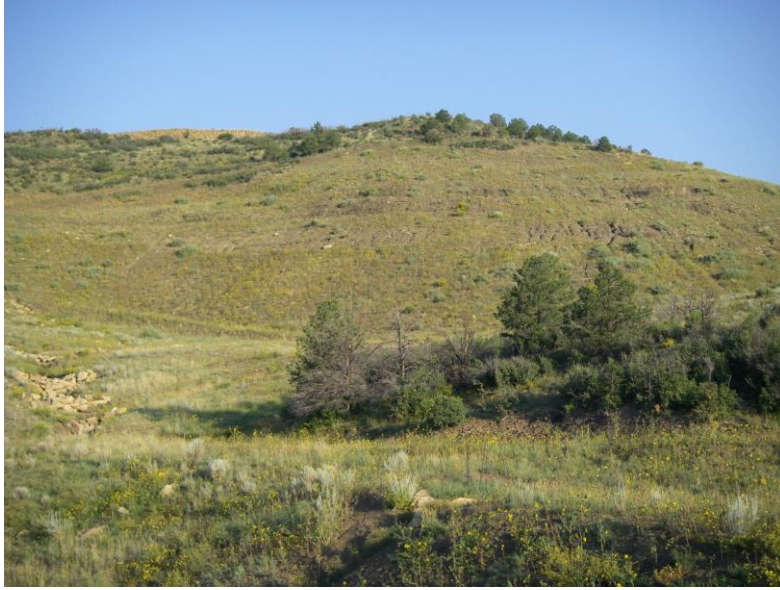
Hill above Pond 6

On the hill above Pond 6, the vegetation is growing well, but rills are in need of repair.

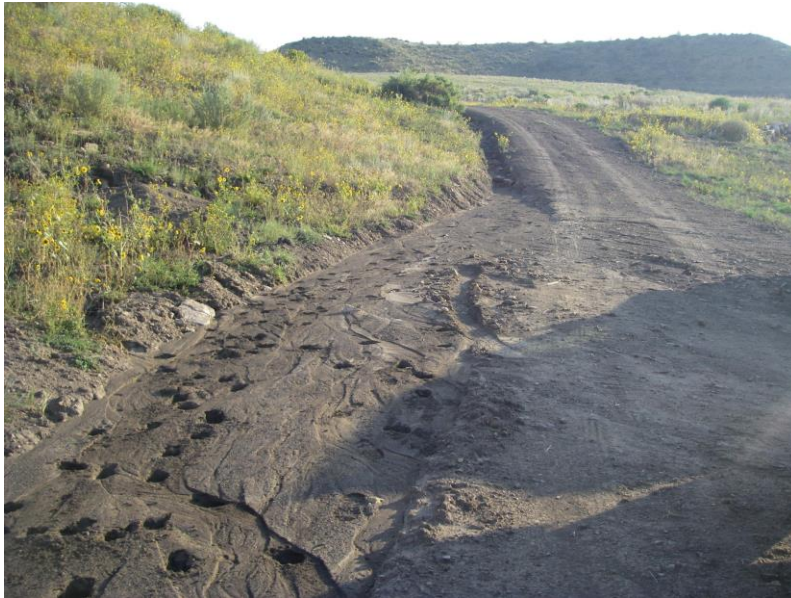
The ditch beside the road to Pond 6 needs to be cleared of sediment, and the drainage crossing needs to be graded.

Sediment on road to Pond 6

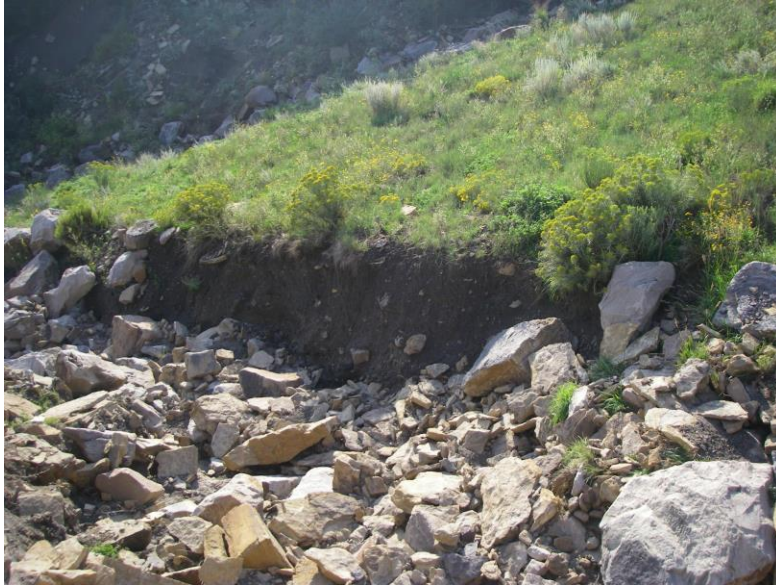
Bare bank of channel below Fill 8
