COLORADO
Division of Reclamation,
Mining and Safety
Department of Natural Resources

Permit Number: C-1981-012 Mine Name: New Elk Mine Operator: New Elk Coal Company, LLC Operator Address: Mr. Louis Head 12250 Highway 12 Weston, CO 81091	County: Las Animas Operation Type: Underground Permit Status: Active Ownership: Private
	Operator Representative Present: Vince Massarotti
Operator Representative Signature: (Field Issuance Only)

Inspection Start Date: August 28, 2017 Inspection Start Time: 11:30 Inspection End Date: August 29, 2017 Inspection End Time: 11:30		Inspection Type: Coal Complete Inspection Inspection Reason: Normal I&E Program Weather: Clear	
Joint Inspection Agency: None		Joint Inspection Contacts: 	
Post Inspection Agency: None		Post Inspection Contacts: 	
Inspector(s): Robert D. Zuber, P.E.	Inspector's Signature:

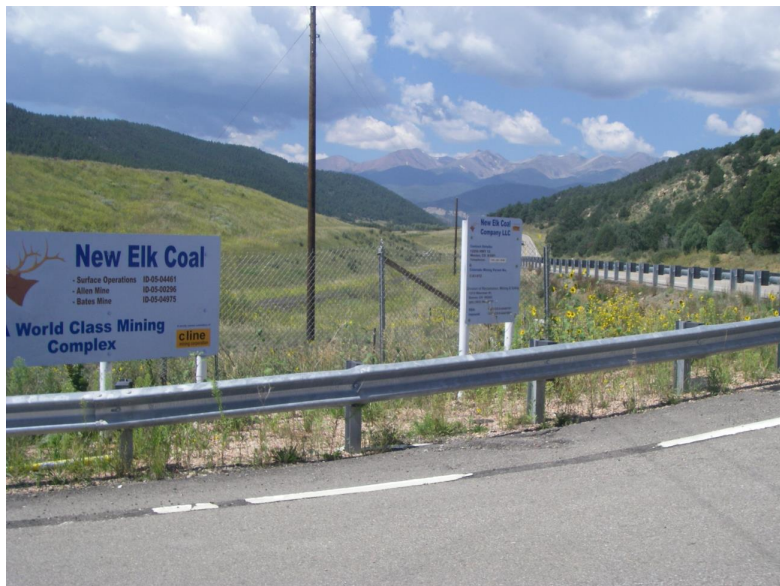
Signs at entrance

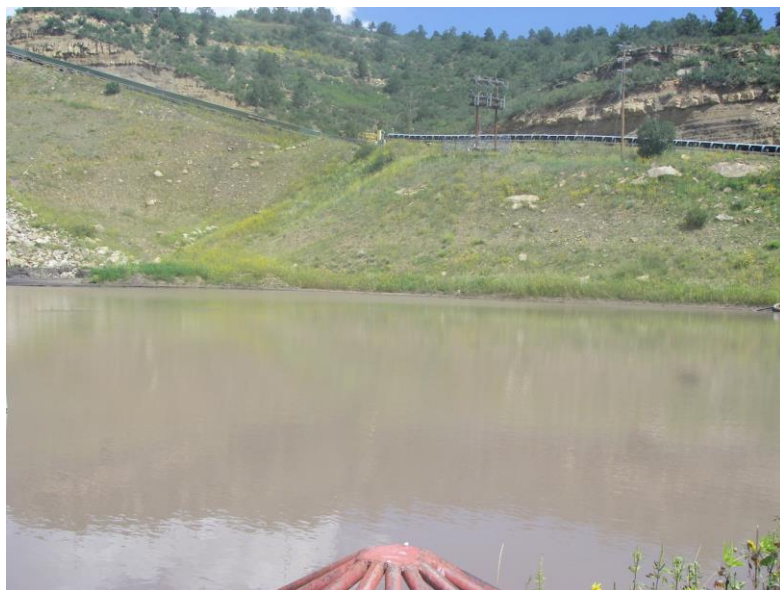
The slope above Pond 08 has seen good vegetation growth in 2017.

Hill above Pond 08

Ponds 001A, 004A, 006A, 007A, and 08 were inspected. None of them were discharging, and there was no inflow to Pond 006A. The impounded water was relatively high in all ponds (except 004A) due to rains. No significant issues were seen with the pond spillways or embankments, and the liner at Pond 001A appears to be in good shape. It would be beneficial to seed the top of Pond 08, as it is relatively bare.

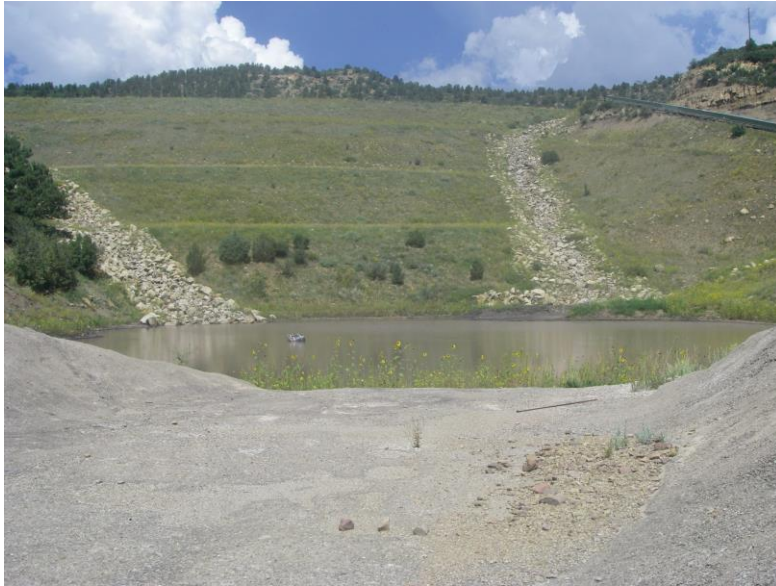
There is good vegetation cover on the reclaimed portion of the RDA, and no rills or gullies were seen on the face or in the side ditches. The ditch at the interface of the upper and lower portions was functioning and sumps were clear. Piles of refuse need to be graded by end of the season (prior to snowfall). Vince Massarotti plans to do that when he hauls pond cleanings up to the RDA.

RDA and Pond 08 spillway

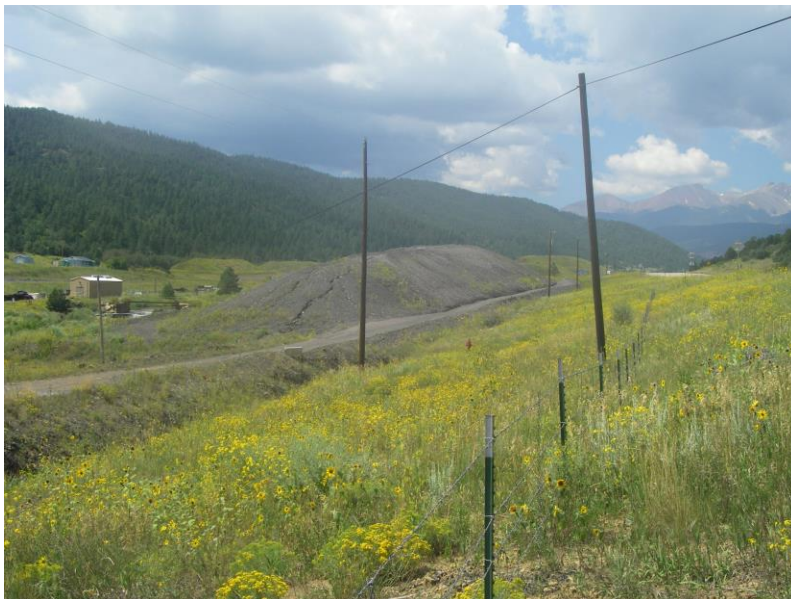
Erosion on DWDA#2 did not appear to have gotten worse in 2017, and the sump below it did not need maintenance.

East end of DWDA#2

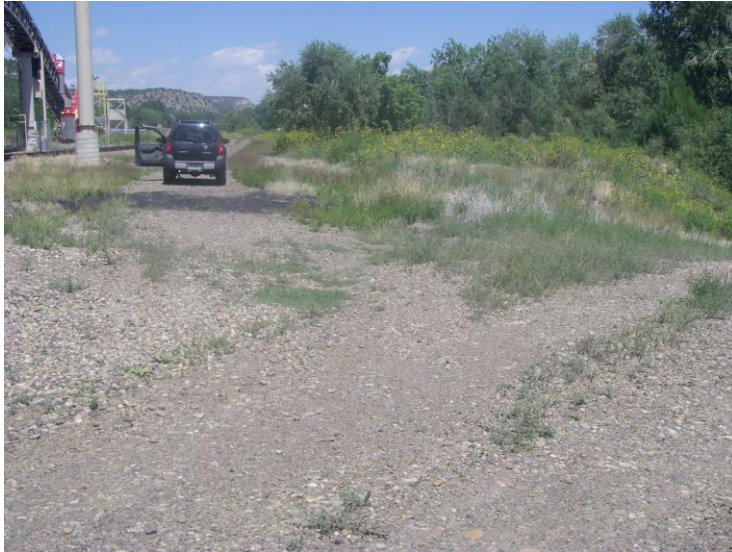
No large weed patches were seen at the Jansen Loadout, but Mullein was seen in significant numbers all around the site. At the west end of the loadout, no signs of pollutant loading onto adjacent land was seen, although some coal residue is still present. This material should be removed (and the area backfilled with clean soil) if doing so would not create other problems, such as erosion of disturbed soil.

West end of Jansen Loadout

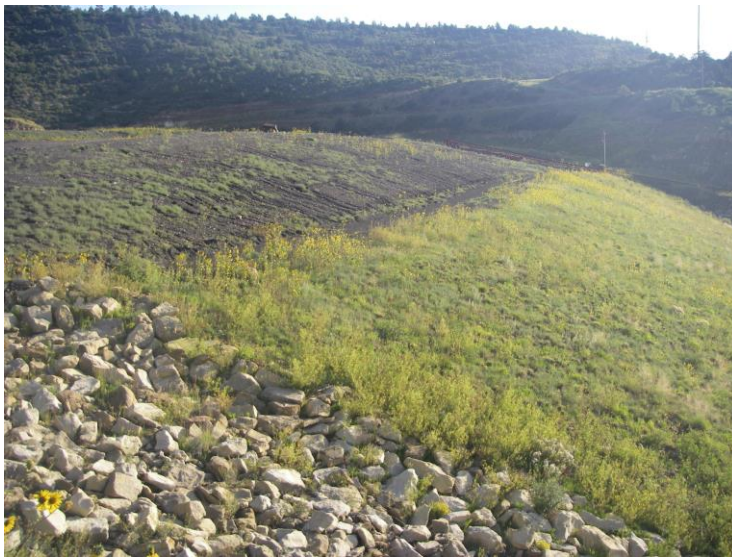
RDA – interface of upper and lower portions

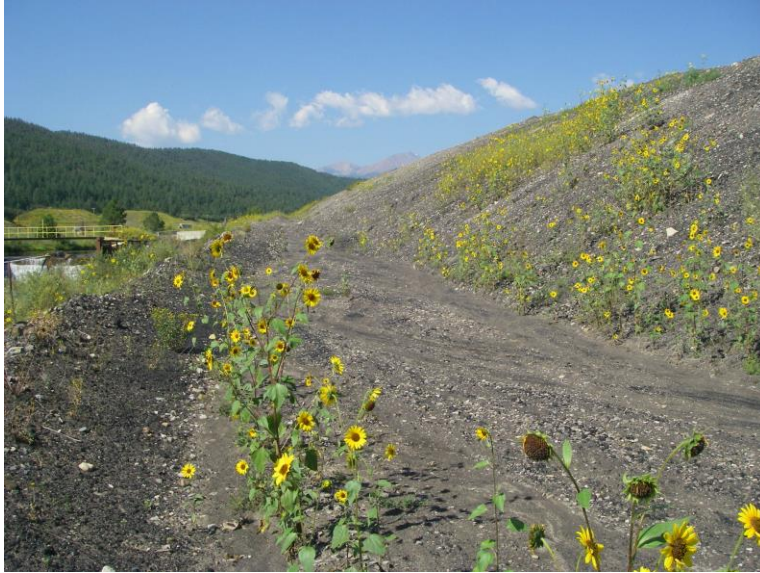
Ditches D10, D10A, D14, D24 and D32 are functioning. Culvert C11 needs to be repaired.

South side of DWDA#2 and Ditch D14

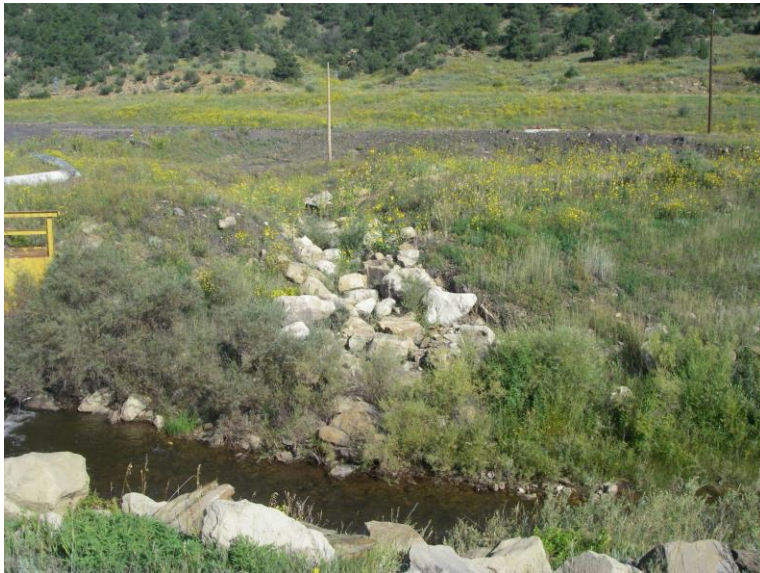
Ditch below SAE near DWDA#2
