COLORADO
Division of Reclamation,
Mining and Safety
Department of Natural Resources

Permit Number: C-1981-035 Mine Name: King Coal Mine Operator: GCC Energy, LLC Operator Address: Mr. Tom Bird 6473 County Road 120 Hesperus, CO 81326	County: La Plata Operation Type: Underground Permit Status: Active Ownership: Federal
	Operator Representative Present: Don McGovern, Wade Wymore, Jessica Luna
Operator Representative Signature: (Field Issuance Only)

Inspection Start Date: August 31, 2017 Inspection Start Time: 08:00 Inspection End Date: Inspection End Time:		Inspection Type: Coal Complete Inspection Inspection Reason: Normal I&E Program Weather: Clear	
Joint Inspection Agency: None		Joint Inspection Contacts: 	
Post Inspection Agency: None		Post Inspection Contacts: 	
Inspector(s): Robert D. Zuber, P.E.	Inspector's Signature:

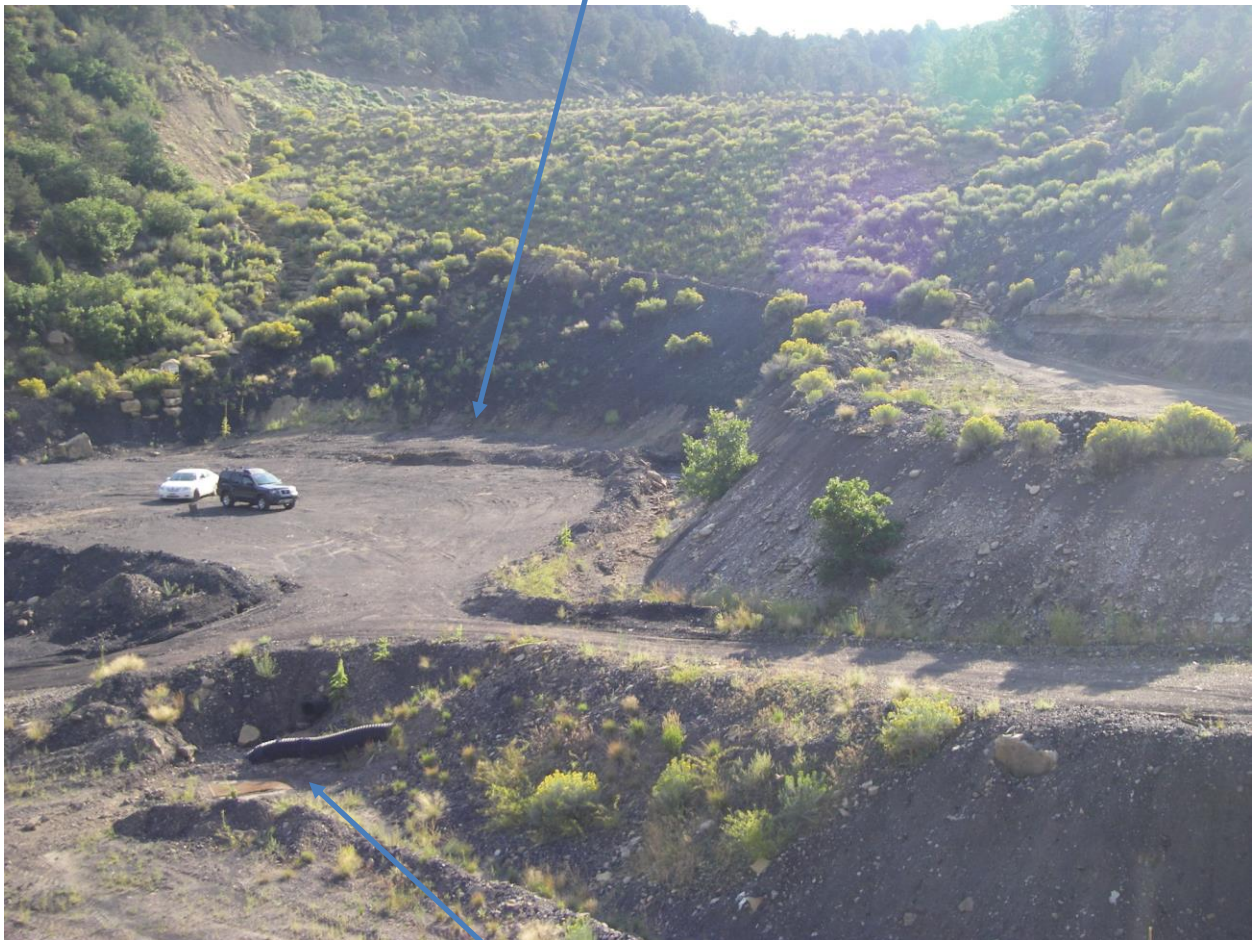
Past inspection reports indicated that GCC is adding material to the lower portion of the Refuse Pile (and extending the underdrain) because the slope of this portion is steeper than the design. Per Wade Wymore, this project has been temporarily halted to find the proper rock for the underdrain. It should be resumed soon to assure that the pile is in agreement with the design specifications.

Lower Refuse Pile where material will be added to reduce slope

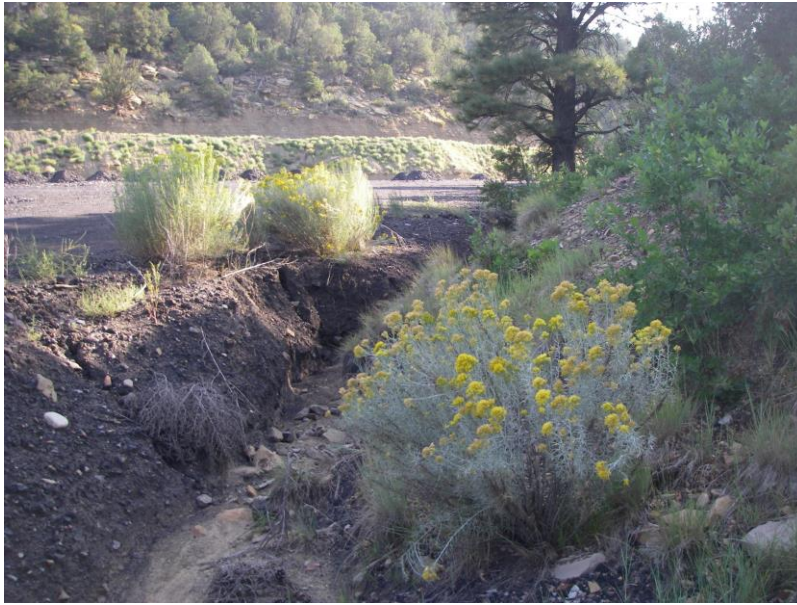
King I

*At the lower end of Reach 3, the larger holes in the pipe have been patched. Additional work is recommended (patching of smaller holes) to prevent clear water from entering the surface water system that drains to the sediment ponds.

Surface water system – area where recent maintenance was performed

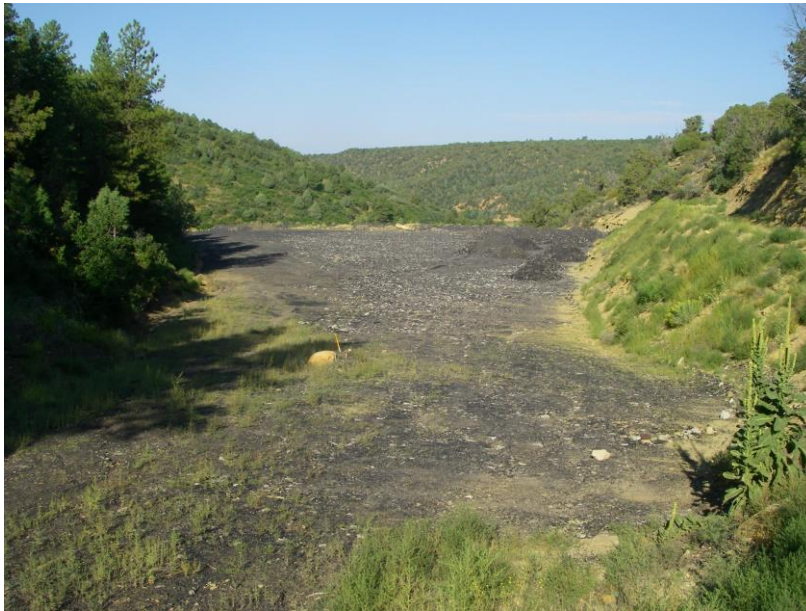
* Reach 10 (near the southwest corner of the Refuse Pile) has eroded, and riprap improvements are recommended.

King I – erosion in Reach 10

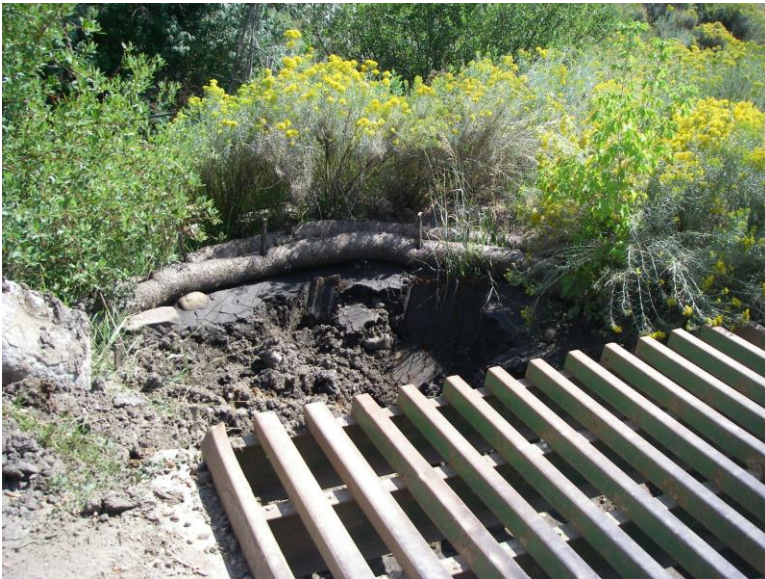
The vegetation cover on the topsoil stockpile beside Stack Tube #2 at King II is good, however the ring ditch could use some work: the culvert at the south side of the pile is filling with sediment, and the wattles above this culvert should be trenched in better (they are basically sitting on top of the ground but should be two inches or more deep). The existing wattles could be left in place, and new ones added next to them on the up hill side (new ones should be trenched in).

King II – culvert in topsoil stockpile ring ditch
