PERMIT INFORMATION

Permit Number: C-1981-035 Mine Name: King Coal Mine Operator: GCC Energy, LLC Operator Address: Mr. Tom Bird 6473 County Road 120 Hesperus, CO 81326	County: La Plata Operation Type: Underground Permit Status: Active Ownership: Federal
	Operator Representative Present: None
Operator Representative Signature: (Field Issuance Only)

Inspection Start Date: August 29, 2017 Inspection Start Time: 15:00 Inspection End Date: Inspection End Time:	Inspection Type: Aerial Inspection Inspection Reason: Normal I&E Program Weather: Clear
Joint Inspection Agency: None	Joint Inspection Contacts:
Post Inspection Agency:	Post Inspection Contacts:
Inspector(s): Harry B. Ranney	Inspector's Signature: <i>Robert D. Zh</i> Signature Date: 9/6/2017

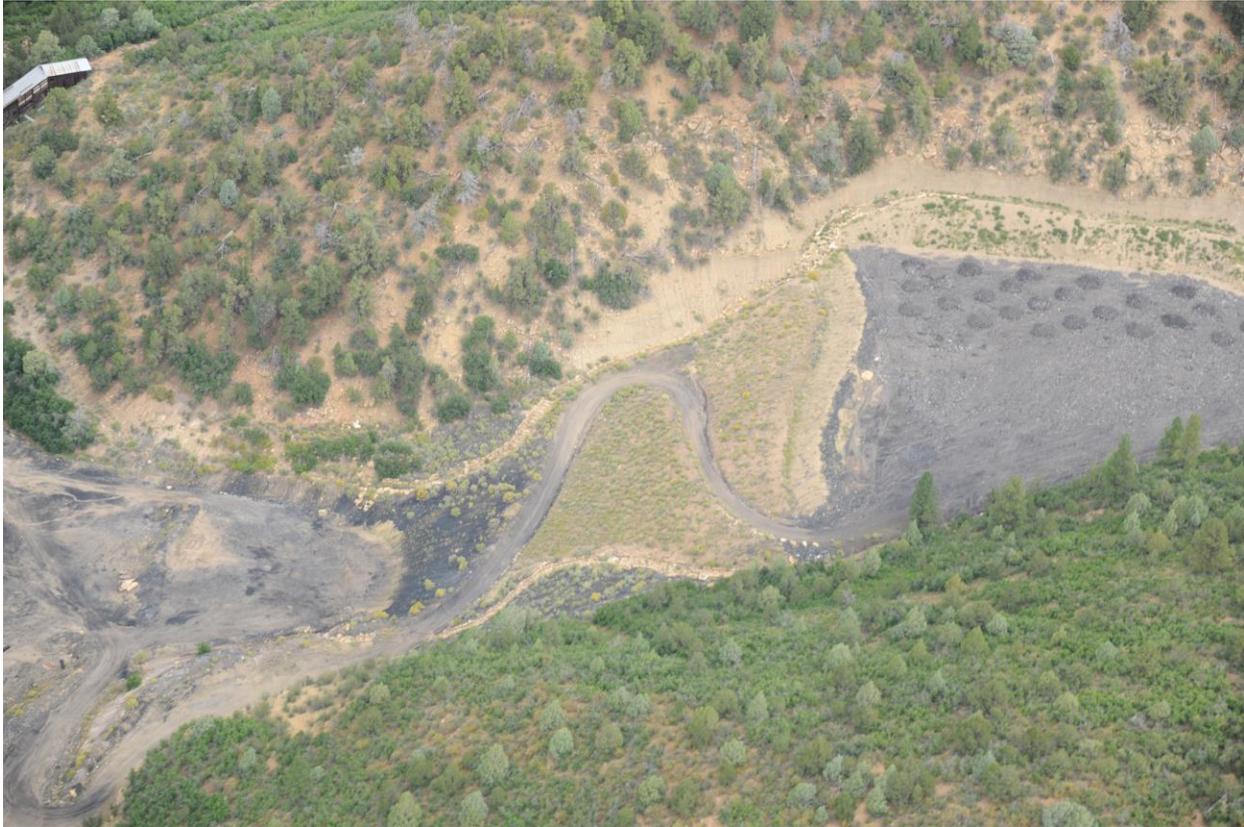
The upper (un-reclaimed) portion and the lower portion of the Refuse Pile were inspected, and no problems were seen. Waste material needs to be graded and compacted.

Refuse Pile at King I

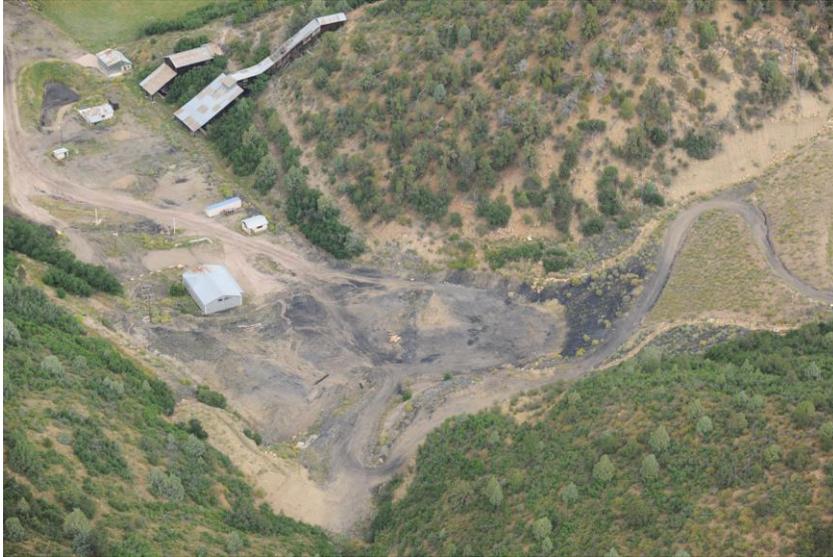
No erosion or other problems were seen at the King I or King II facilities areas.

King I facilities area

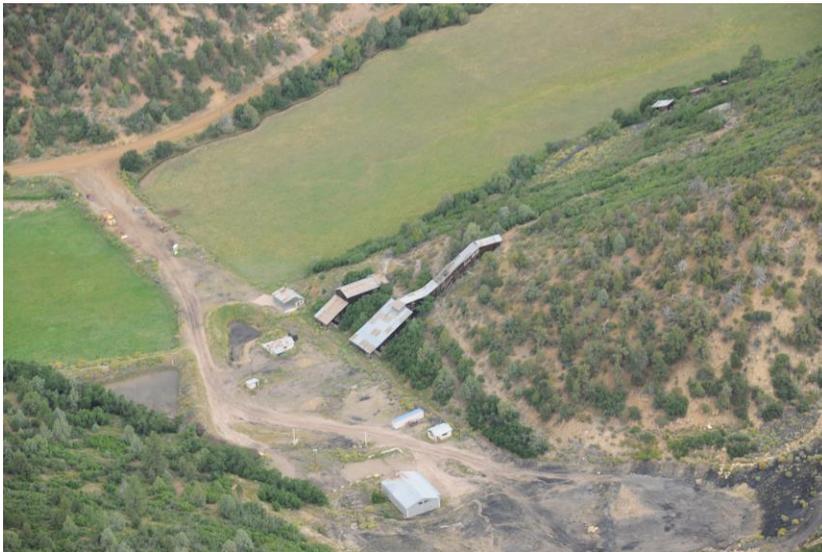
At the King I Mine, the West Pond and East Pond were inspected. They appeared to be dry and not discharging. The pasture below the pond spillways showed no sign of discharges from the ponds in recent weeks. No significant problems were seen with the embankments.

No problems were seen with King I or King II roads.

Lower part of King I with ponds and entrance road

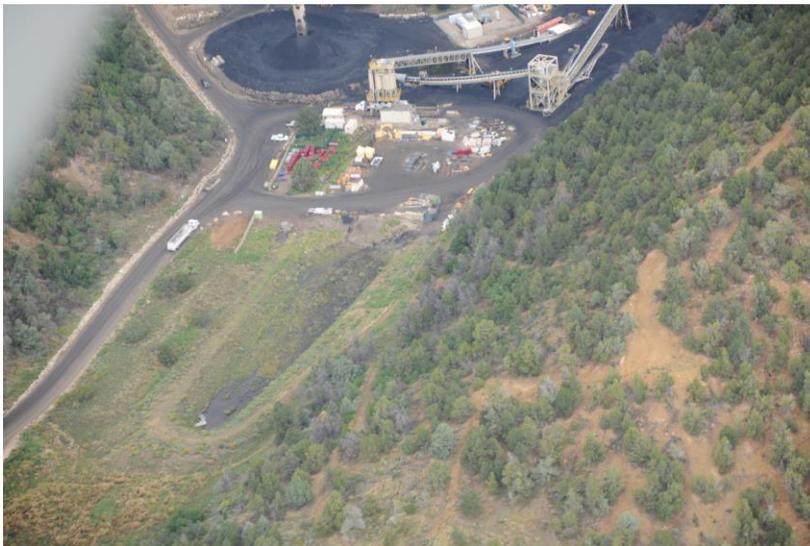
The West Clearwater Ditch at King II appears to be functioning well; no signs of erosion or other problems were seen. The East Clearwater Ditch could not be observed well due to the camera angle.

The King II pond was holding a small amount of water. No issues were found with the embankment.

King II pond and West Clearwater Ditch

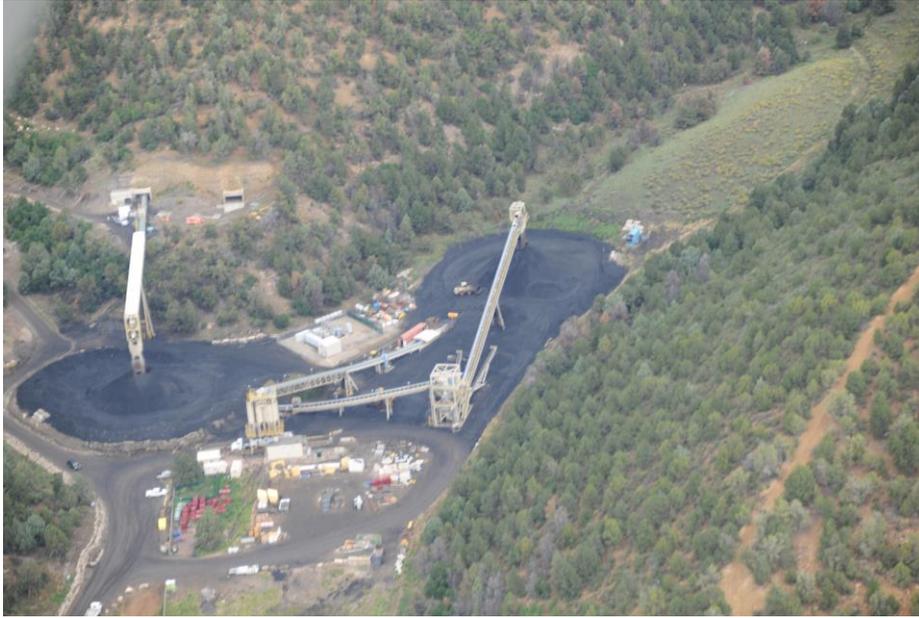
No problems were seen with the Topsoil Stockpiles at King II. They appear to be well vegetated, and there are no signs that the soil has been transported off the piles by runoff.

King II stack tubes, new fan area, topsoil stockpile, and other facilities

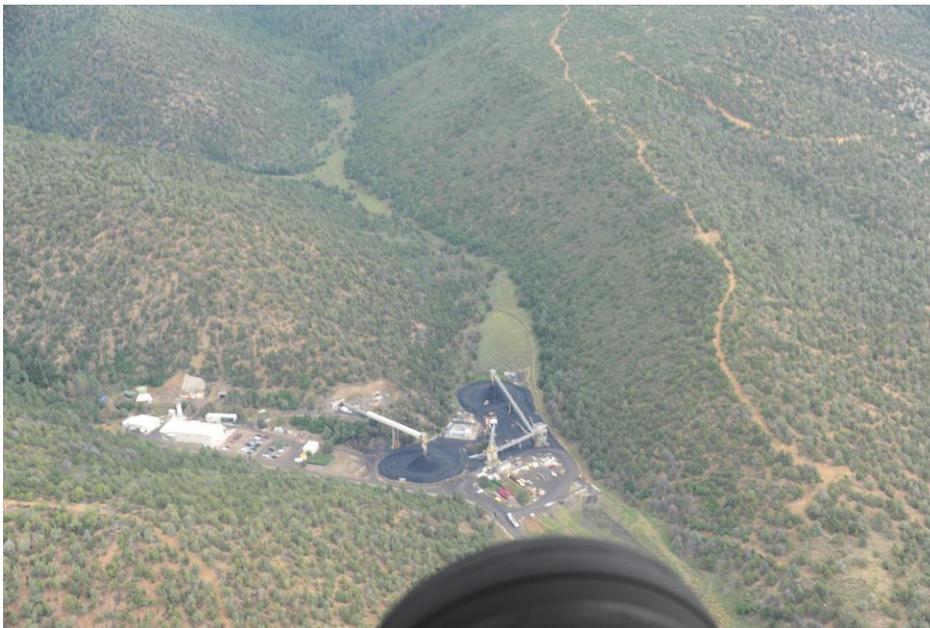
No damage from subsidence was seen in the affected areas near King II. The areas seen in the photographs are approximately one half mile from the King II facilities or closer. (Very little area above the old King I workings was photographed.)

A portion of King II affected area
