MINERALS PROGRAM INSPECTION REPORT
PHONE: (303) 866-3567

MINE NAME: Kremmling Airport	MINE/PROSPECTING ID#: M-1978-143	MINERAL: Sand and gravel	COUNTY: Grand
INSPECTION TYPE: Monitoring	INSPECTOR(S): Peter S. Hays	INSP. DATE: August 22, 2017	INSP. TIME: 11:00
OPERATOR: Grand County	OPERATOR REPRESENTATIVE: Bill Clark	TYPE OF OPERATION: 112c - Construction Regular Operation	
REASON FOR INSPECTION: Normal I&E Program	BOND CALCULATION TYPE: Complete Bond	BOND AMOUNT: \$0.00	
DATE OF COMPLAINT: NA	POST INSP. CONTACTS: None	JOINT INSP. AGENCY: None	
WEATHER: Clear	INSPECTOR'S SIGNATURE:

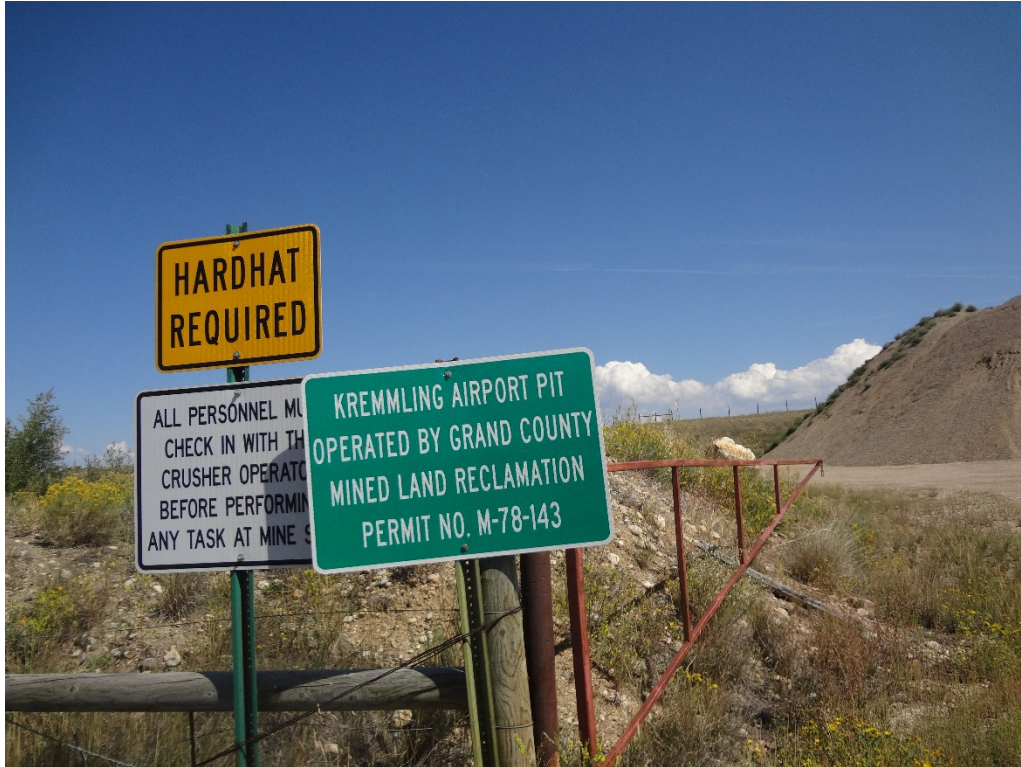
An entrance sign was posted and permit boundary markers were observed as required by Rule 3.1.12. No problems were noted during the inspection. Photographs taken during the inspection are attached.

Kremmling Airport Pit mine sign

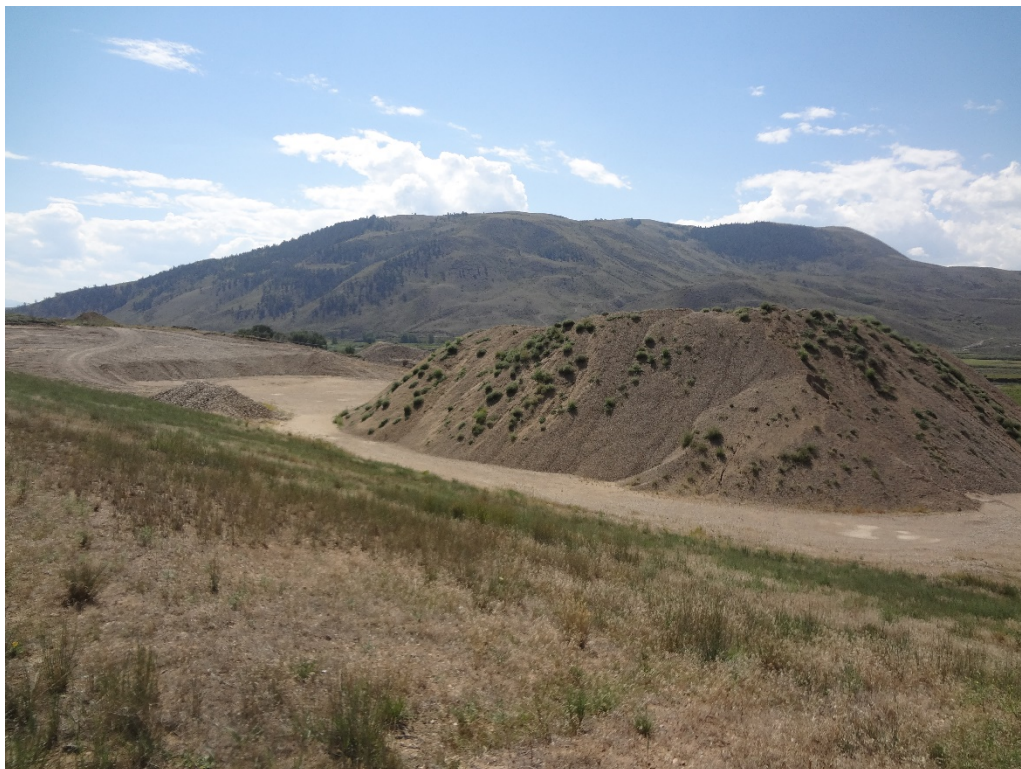
View of pit from the northwest corner looking southeast

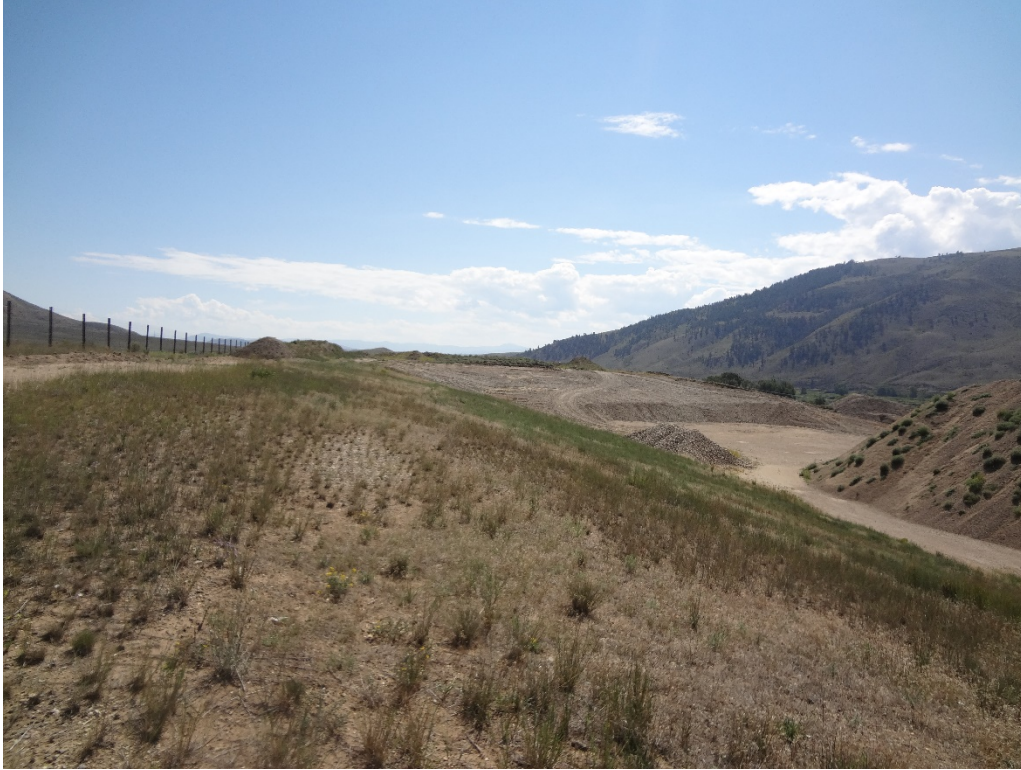
View of pit from the northwest corner looking east

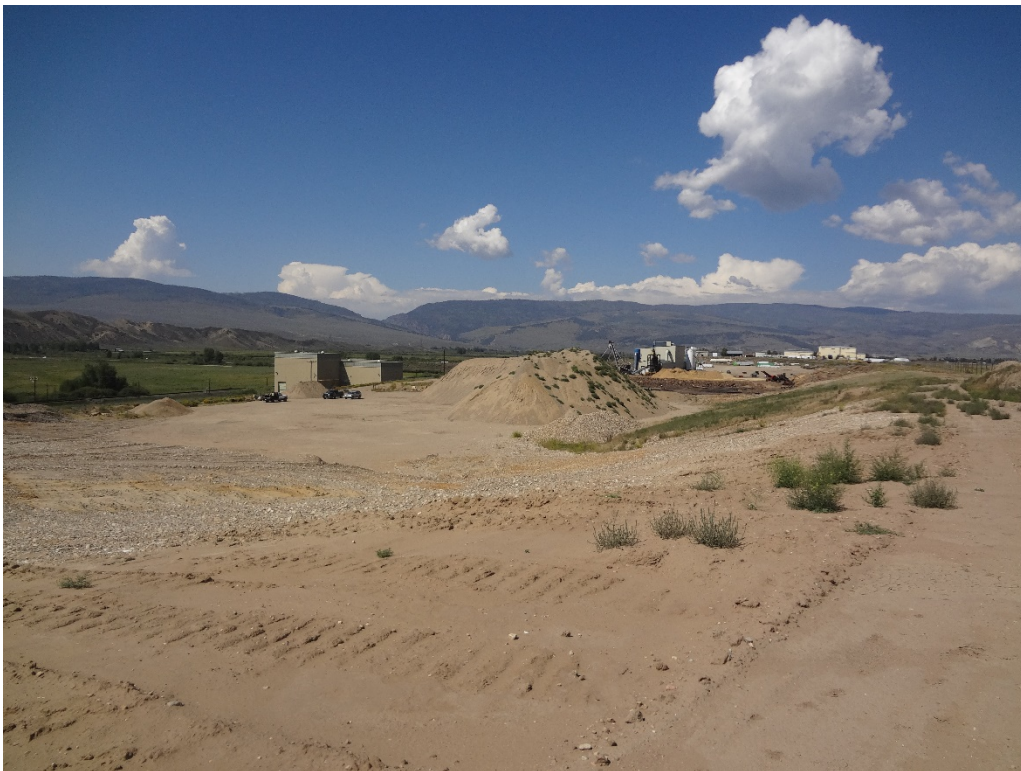
View of pit from northeast corner of mining disturbance looking southwest
