MINERALS PROGRAM INSPECTION REPORT PHONE: (303) 866-3567

MINE/PROSPECTING ID#:	MINERAL:	COUNTY:	
M-2008-008	Sand and gravel	Grand	
INSPECTOR(S):	INSP. DATE:	INSP. TIME:	
Peter S. Hays	August 22, 2017	12:00	
OPERATOR REPRESENTATIVE:	TYPE OF OPERA	TYPE OF OPERATION:	
Bill Clark	110c - Construction	110c - Construction Limited Impact	
BOND CALCULATION TYPE:	BOND AMOUNT:	BOND AMOUNT:	
Complete Bond	\$0.00		
POST INSP. CONTACTS:	JOINT INSP. AGENCY:		
None	None		
NSPECTOR'S SIGNATURE: SIGNATURE DAT		`E:	
f.A.m.	September 6, 2017		
	M-2008-008 INSPECTOR(S): Peter S. Hays OPERATOR REPRESENTATIVE: Bill Clark BOND CALCULATION TYPE: Complete Bond POST INSP. CONTACTS:	M-2008-008 INSPECTOR(S): Peter S. Hays OPERATOR REPRESENTATIVE: Bill Clark BOND CALCULATION TYPE: Complete Bond POST INSP. CONTACTS: None INSPECTOR'S SIGNATURE: SIGNATURE DATE Sand and gravel INSP. DATE: August 22, 2017 TYPE OF OPERA' 110c - Construction BOND AMOUNT: \$0.00 JOINT INSP. AGE None

PERMIT #: M-2008-008 INSPECTOR'S INITIALS: PSH INSPECTION DATE: August 22, 2017

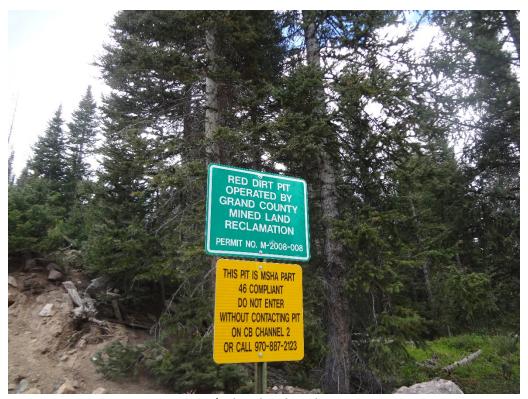
The mine sign and permit boundaries were observed as required by Rule 3.1.12. Photographs taken during the inspection are attached.

Red Dirt Pit mine sign

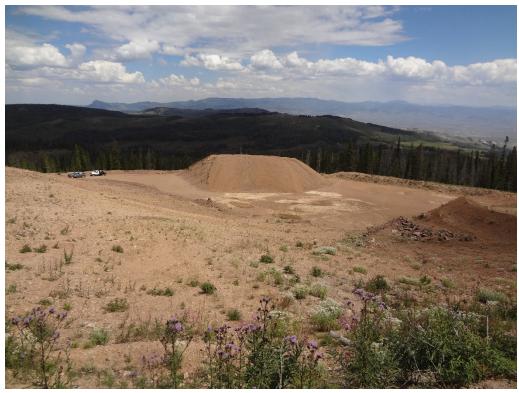
View of the pit floor from the southwest corner of the mining disturbance

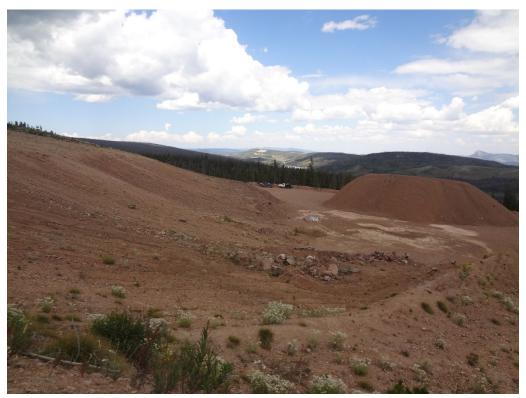
The approved post mining land use for the site is rangeland. Reclamation activities have not begun at the site. Topsoil stockpiles were observed along the south, north and east boundaries. The active mine face was temporarily sloped for the winter. Canada thistle, a Class B species noxious weed, was observed at the site. The Operator was reminded of the requirement to implement the approved weed control plan for the site.

View of the temporarily sloped mine highwall looking north

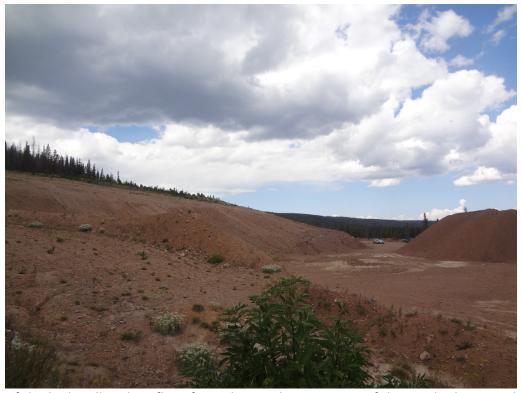
View of the highwall and pit floor from the southeast corner of the site looking northwest

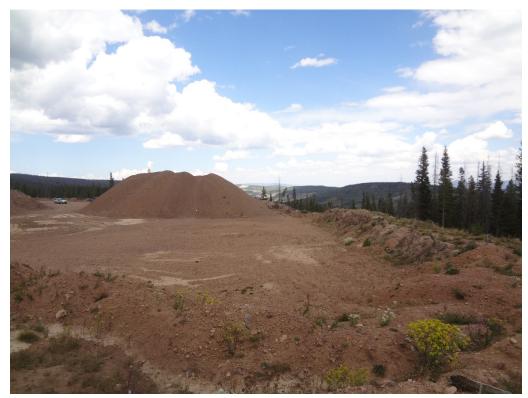
The site was mined in 2016 according to the 2017 Annual Report. The mine highwall has progressed from the east to the west since the last inspection. The site was inactive during the inspection. A stockpile of processed material was located in the northeast corner of the pit floor.

View of the pit floor and stockpile from the southeast corner of the site looking north
