MINERALS PROGRAM INSPECTION REPORT
PHONE: (303) 866-3567

MINE NAME: Amzak Pit	MINE/PROSPECTING ID#: M-2003-003	MINERAL: Gravel and sand	COUNTY: La Plata
INSPECTION TYPE: Monitoring	INSPECTOR(S): Lucas J. West	INSP. DATE: August 24, 2017	INSP. TIME: 08:57
OPERATOR: Consolidated Constructors, Inc.	OPERATOR REPRESENTATIVE: None	TYPE OF OPERATION: 112c - Construction Regular Operation	
REASON FOR INSPECTION: Normal I&E Program	BOND CALCULATION TYPE: Complete Bond	BOND AMOUNT: \$133,165.00	
DATE OF COMPLAINT: NA	POST INSP. CONTACTS: None	JOINT INSP. AGENCY: None	
WEATHER: Clear	INSPECTOR'S SIGNATURE:

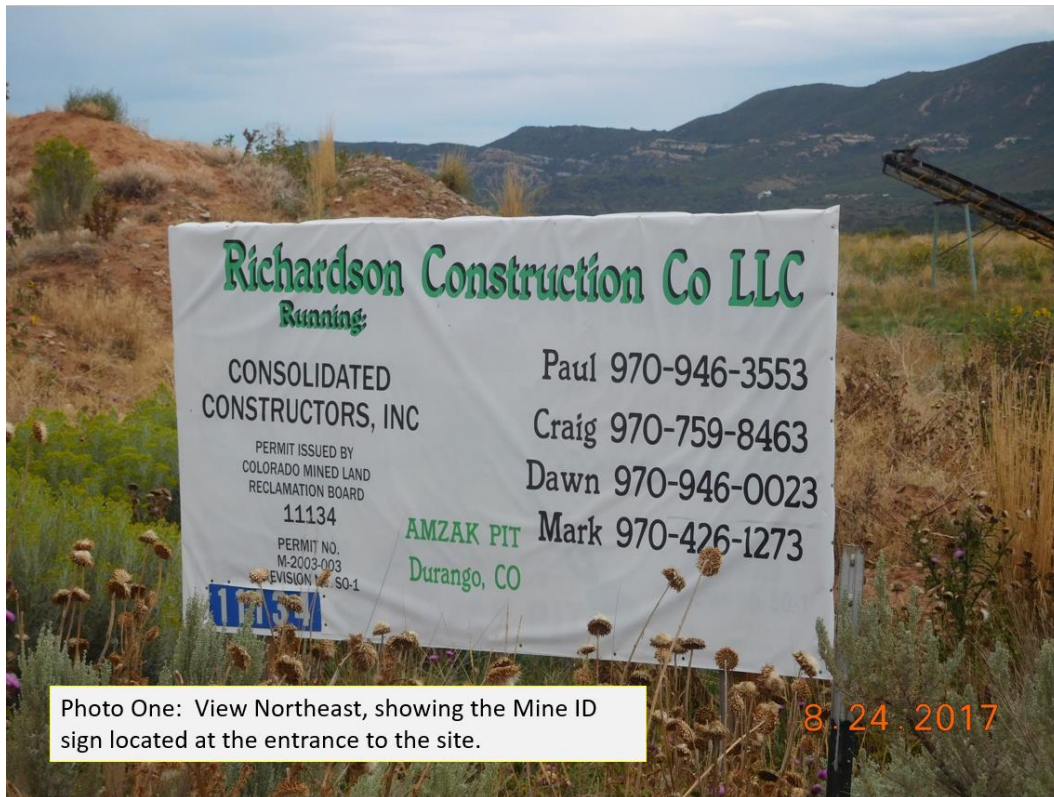
The proper mine identification signage is posted at the entrance to the site as seen in Photo One. The permit boundaries were all clearly marked with earthen berms around the perimeter of the site. The mining activities are ongoing in Phase 1 of the operation. The Phase one area appears to be stable and in good condition and can be seen in Photos Two and Three. Several pieces of equipment including a loader, screen and water truck are located on the pit floor but were not active during the inspection. Several stockpiles of various sized materials are also located on the pit floor. All stockpiles located in Phase 1 appear to be stable and show no signs of settling, slumping or erosion. The active mining face consists of a highwall approximately 500 feet in length and made of two 40 foot tall benches for a maximum height of approximately 80 feet. The highwall can be seen in Photo Four, appears to be stable and in good condition. A storm water control device was observed along the eastern edge of Phase 1 and appears to be functioning as designed.

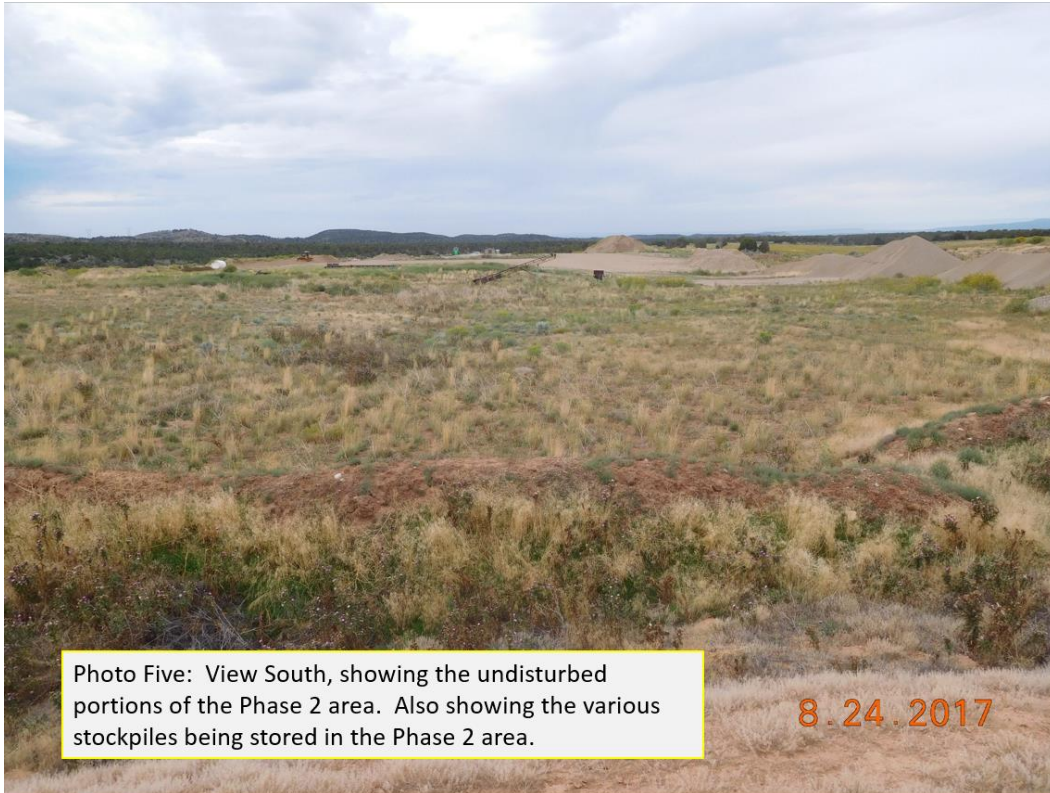
Mining activities have yet to commence in Phases 2 or 3, however the areas are being utilized for stockpiling of materials. Phase 2 contains several stockpiles as well as some equipment being stored as well as shown in Photo Five. Phase 3 contains a large stockpile of concrete, rip rap and rubble that is to be recycled and utilized. The piles can be seen in Photo Six. All stockpiles that were observed in both phases 1 and 2 appear to be stable and show no signs of settling, slumping or erosion. Throughout the site, in both the disturbed and undisturbed areas, excessive amounts of noxious weeds exist. The predominant species on site is Musk thistle that can be seen in several of the above listed photographs. Other species including Halogeton and Russian thistle are also present. Some evidence of chemical treatment was observed, however observations made during this inspection indicate that follow up treatments did not take place. The Division recommends that the Operator continue to treat the noxious weeds on site, and do so several times during the year to avoid future problems with reclamation success. This is not being cited a problem at this time, however future neglect of the noxious weeds could result in possible enforcement action.
