**MINERALS PROGRAM INSPECTION REPORT**  
**PHONE: (303) 866-3567**

| <b>MINE NAME:</b><br>Henderson Mine | <b>MINE/PROSPECTING ID#:</b><br>M-1977-342 | <b>MINERAL:</b><br>Molybdenum | <b>COUNTY:</b><br>Clear Creek, Grand |
| <b>INSPECTION TYPE:</b><br>Monitoring | <b>INSPECTOR(S):</b><br>Peter S. Hays | <b>INSP. DATE:</b><br>August 31, 2017 | <b>INSP. TIME:</b><br>09:00 |

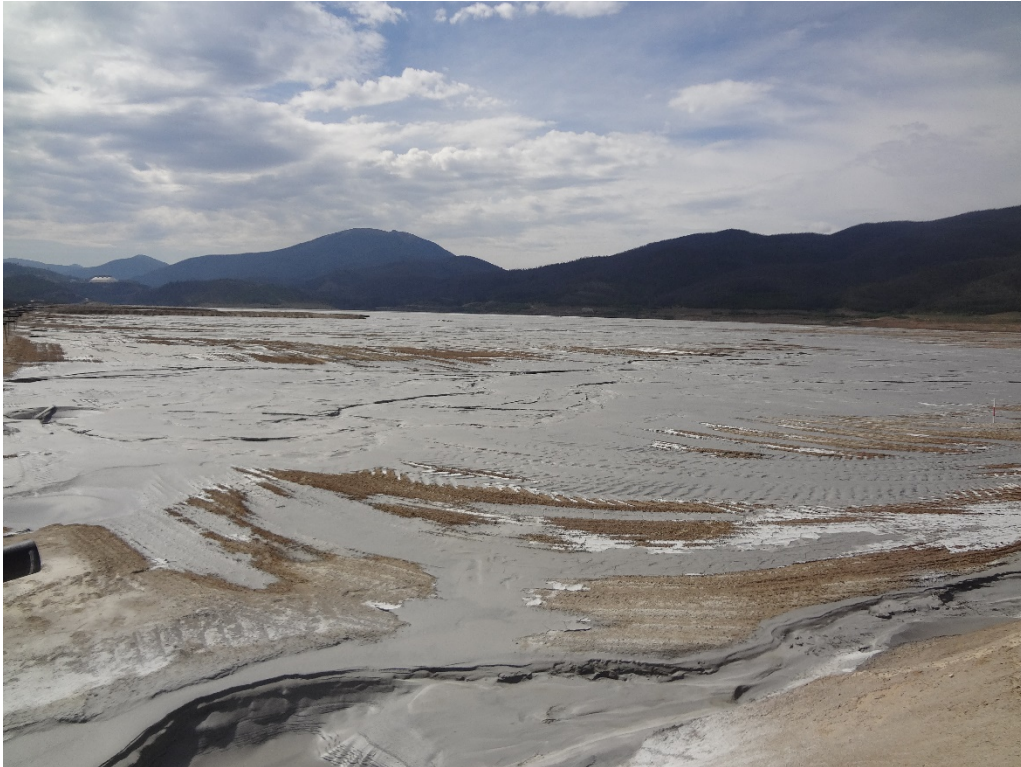
View of deposition cell between leadoffs 5 and 6 on 1-Dam looking southwest

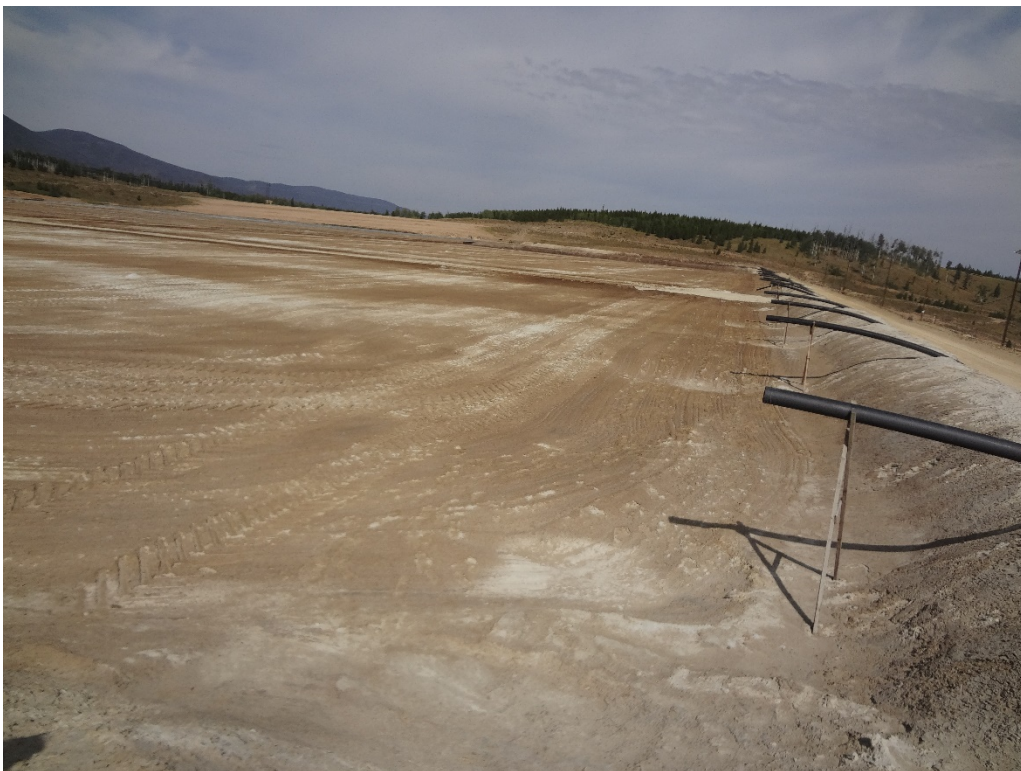
View of deposition cell between leadoffs 6 and 7 on 1-Dam looking north

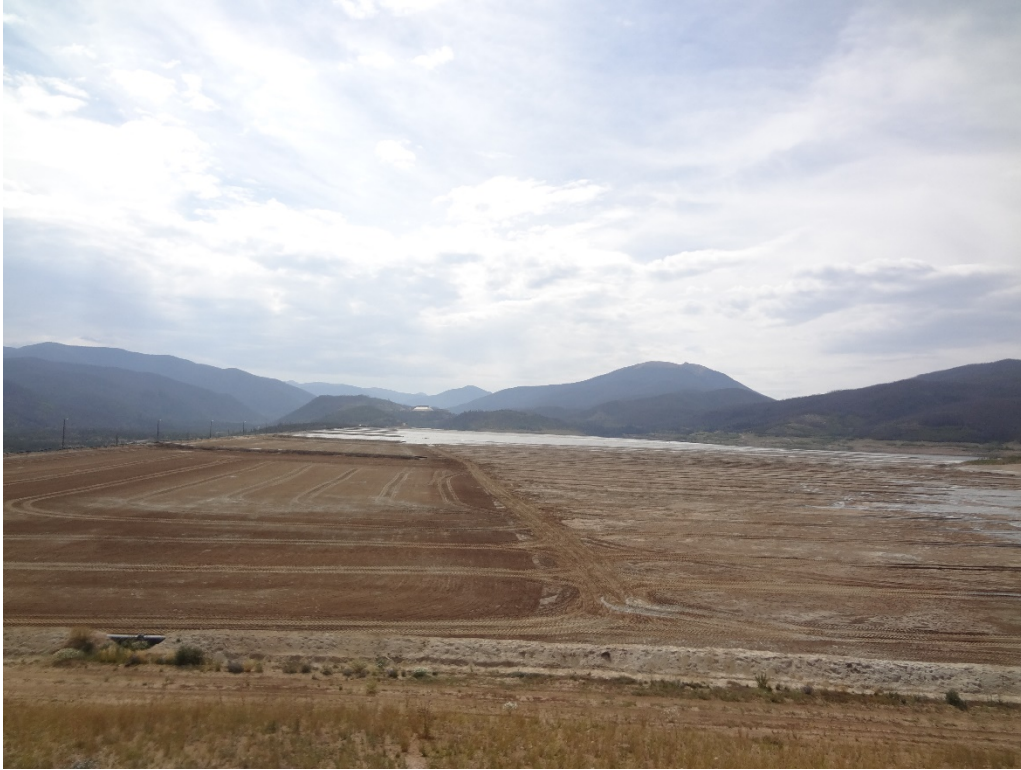
The impoundment water pool location is estimated based on monuments located in the impoundment. A minimum 500' beach offset from the crest of the impoundment with one-half foot ( $\frac{1}{2}$ ) of freeboard is required by AECOM. A minimum 1,000' offset is required by the Operator. A 2,400' offset was estimated during the inspection.

View of tailings impoundment from the north end looking south

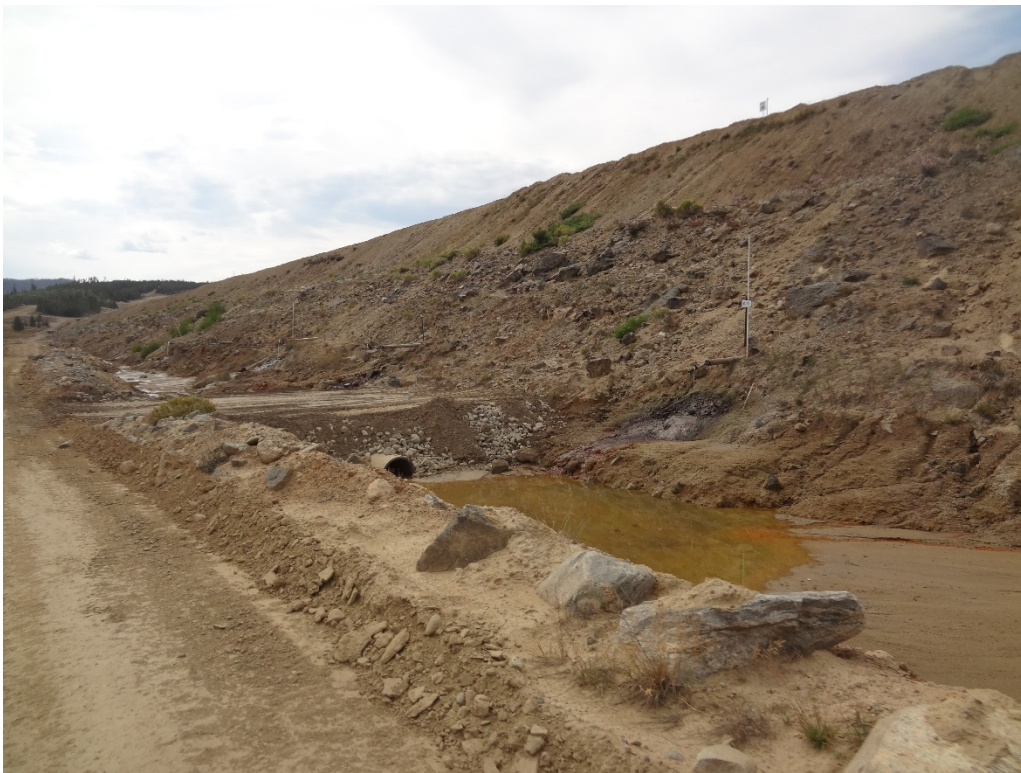
View of horizontal drain drilling pad in 1-Dam

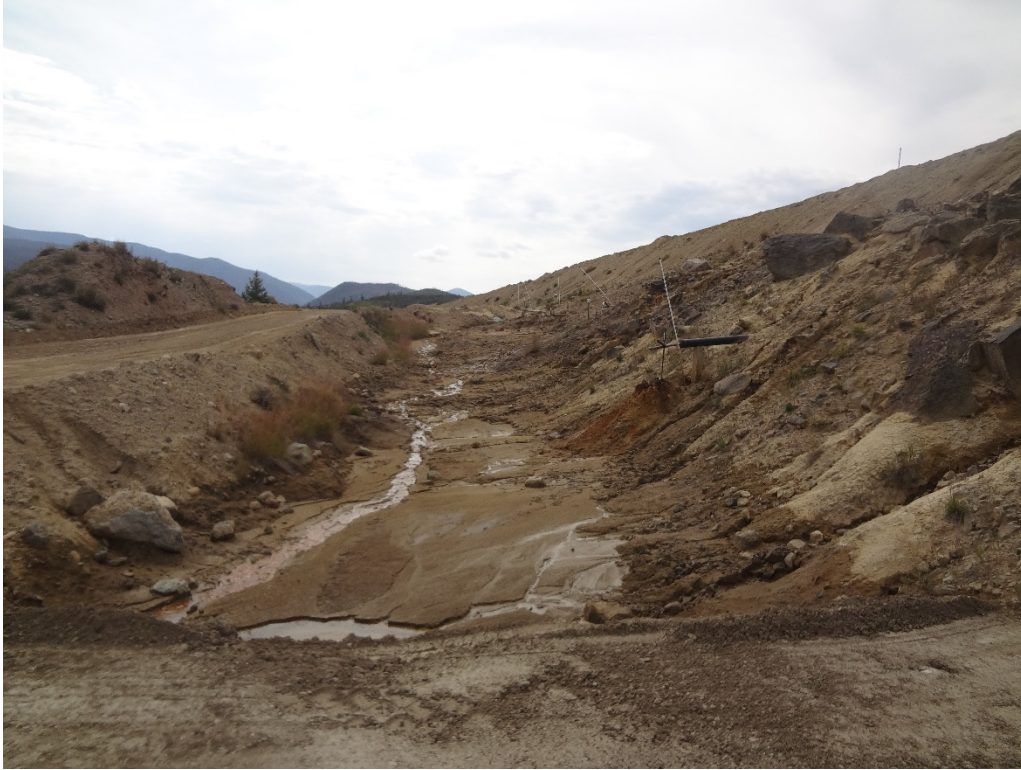
The seepage collection system was observed for the amount of seepage flow, seepage diversion, seep water properties and the condition of the seepage collection area. Portions of the toes of the 1-Dam and 3-Dam impoundments were observed to evaluate the seepage collection system. The toe drains which vary in length from 250' to 650' were observed for estimated flow rate. Henderson has identified several areas requiring additional horizontal drains. The areas were prepared for drilling with the construction of temporary drill pads. Installation of the new horizontal drains in 3-Dam were observed during the inspection. The location of the phreatic water level at the toe of the impoundments was also observed. The foundation drains under the impoundments were discussed and several of the active drains were observed. The annual seepage collection ditch cleanout is scheduled for this fall. The sand boil repair and the expanded rock channel along the south groin of 1-Dam were observed during the inspection.

View of seepage collection ditch below 1-Dam looking south

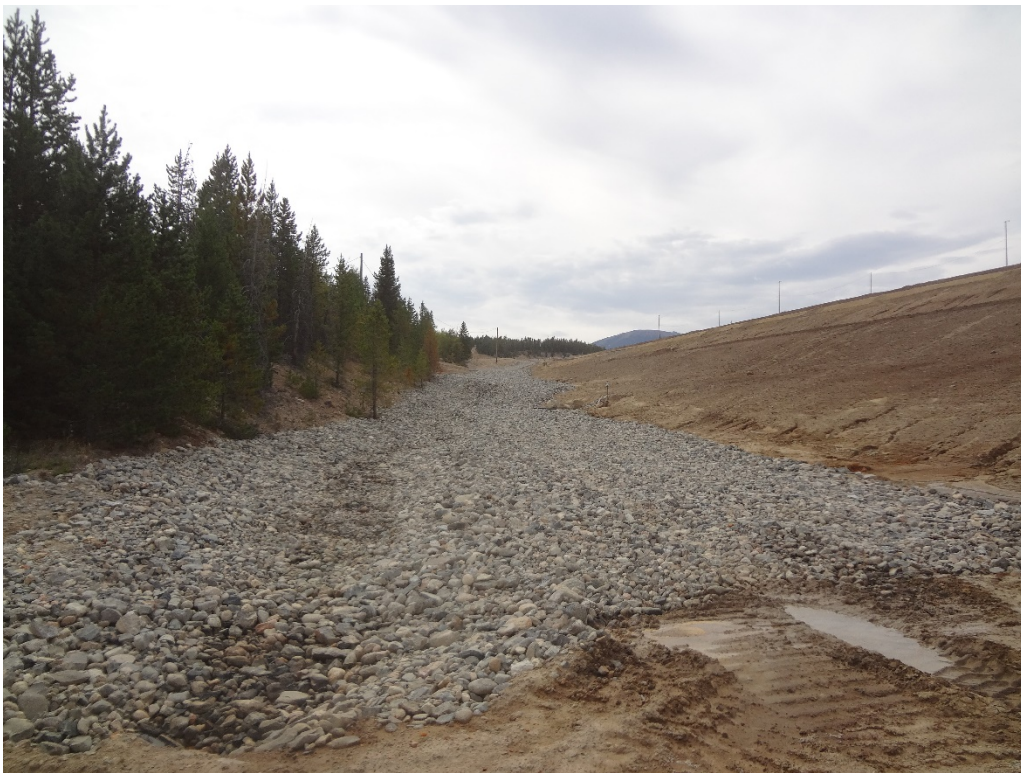
View of rock lined channel in the south groin of 1-Dam looking southwest

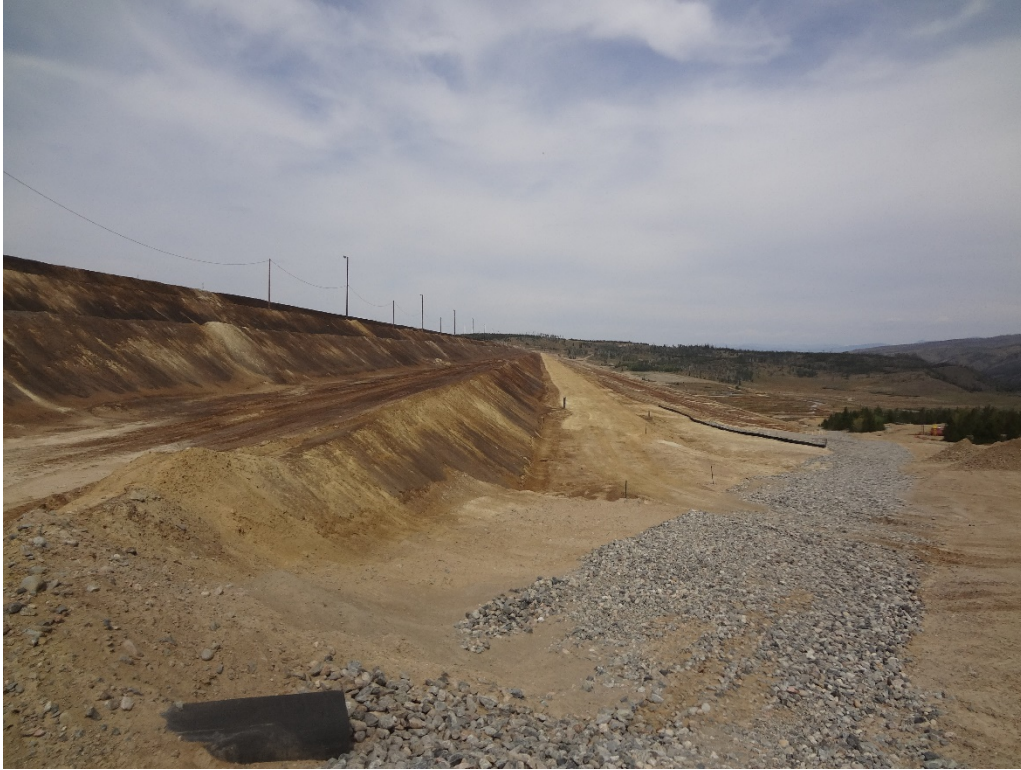
View of rock lined channel in the south groin of 1-Dam looking north

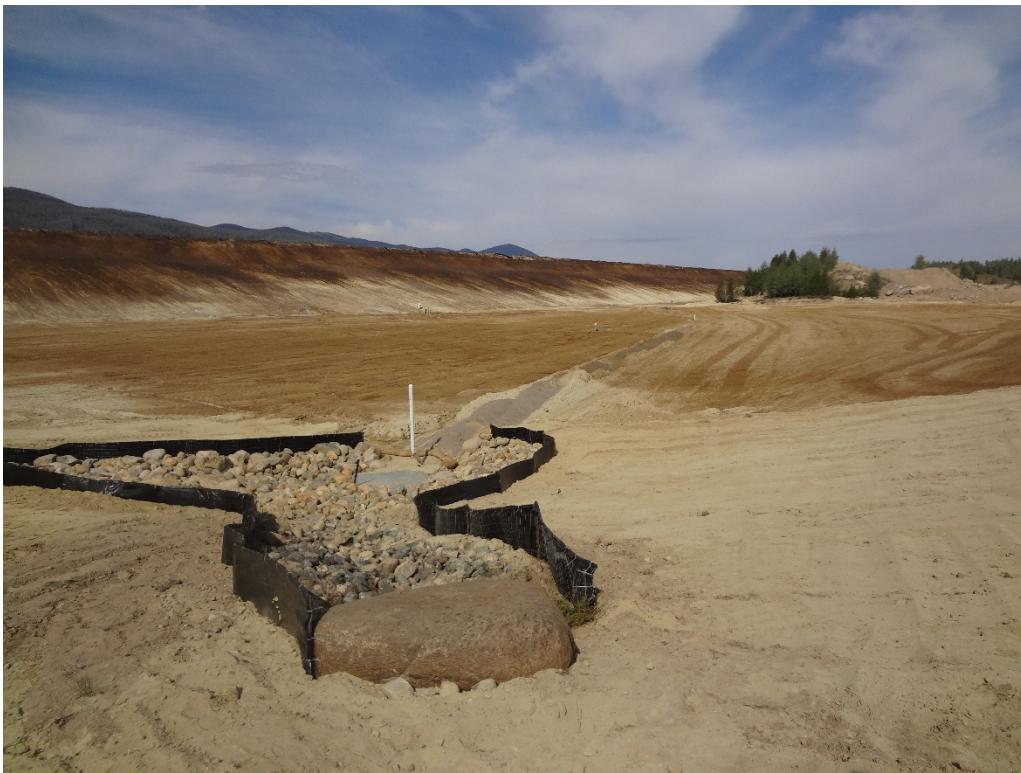
View of south setback bench on the 3 Dam embankment

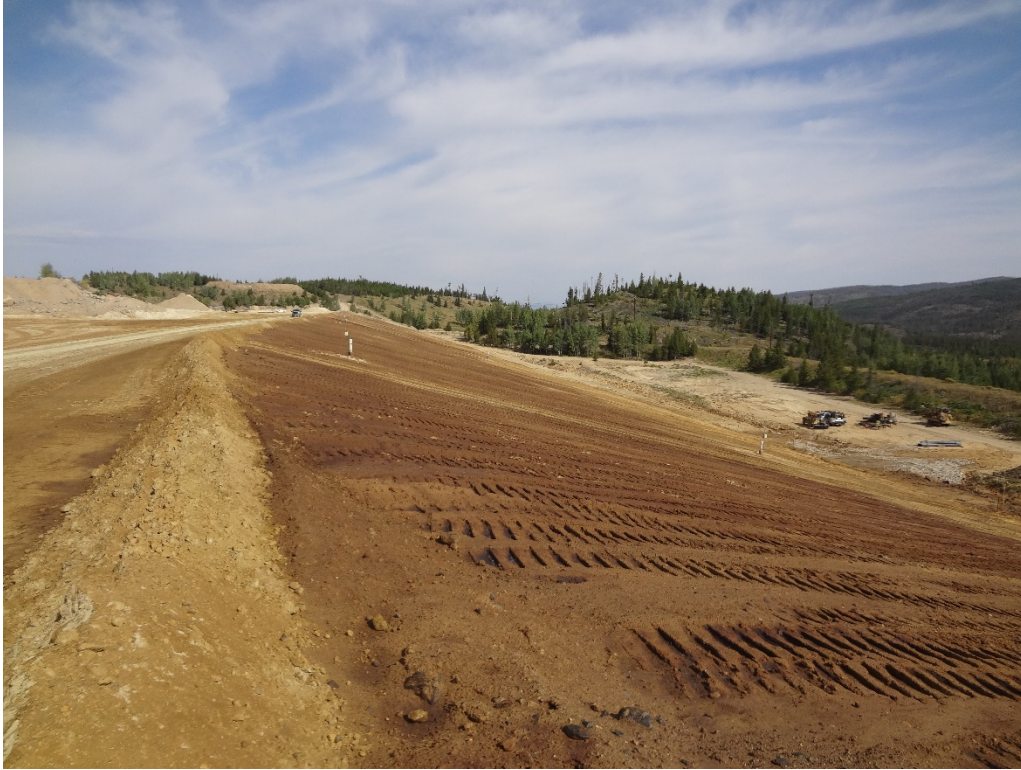
The 3-Dam embankment regrading project is complete and the piezometer elevations are reset to the new embankment elevation. Henderson stated as-built drawings and engineer certification for the project, as required by Rule 7.3.2, are being prepared for submittal to the Division.

View of the completed 3-Dam embankment regrading work looking north  
with horizontal drain installation at toe

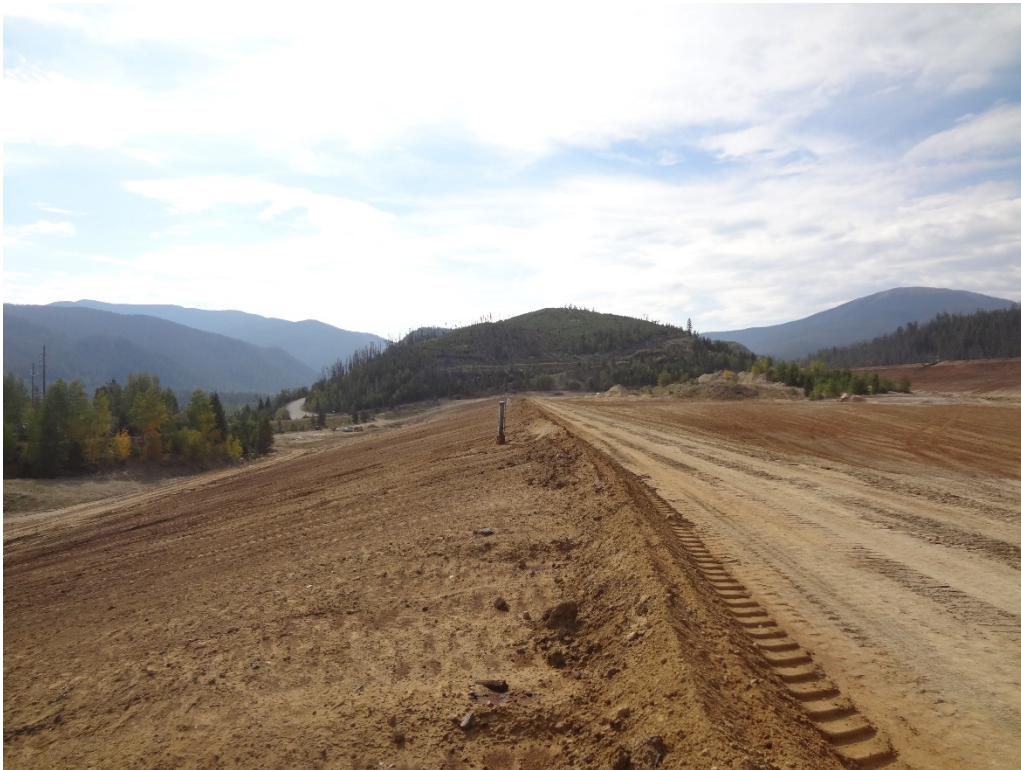
View of the completed 3-Dam embankment regrading work looking south

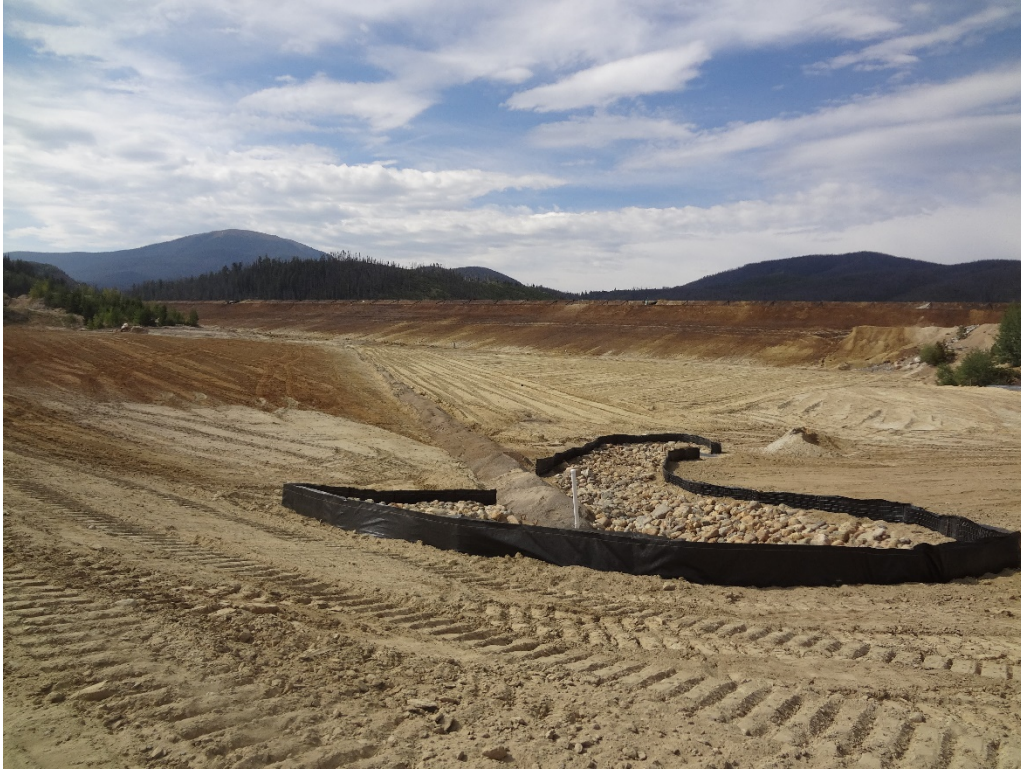
View of north setback bench on the 3 Dam embankment
