**PERMIT INFORMATION**

<b>Permit Number:</b> C-1981-008 <b>Mine Name:</b> New Horizon Mine <b>Operator:</b> Elk Ridge Mining and Reclamation, LLC <b>Operator Address:</b> Mr. Tony Tennyson 5731 State Highway 13 Meeker, CO 81641	<b>County:</b> Montrose <b>Operation Type:</b> Surface <b>Permit Status:</b> Active <b>Ownership:</b> Private
	<b>Operator Representative Present:</b>  Frank Ferris and Tony Tennyson
<b>Operator Representative Signature: (Field Issuance Only)</b>

**INSPECTION INFORMATION**

<b>Inspection Start Date:</b> September 7, 2017 <b>Inspection Start Time:</b> 09:30 <b>Inspection End Date:</b> September 7, 2017 <b>Inspection End Time:</b> 17:00		<b>Inspection Type:</b> Coal Partial Inspection <b>Inspection Reason:</b> Surety Related <b>Weather:</b> Clear	
<b>Joint Inspection Agency:</b>  None		<b>Joint Inspection Contacts:</b>  	
<b>Post Inspection Agency:</b>  None		<b>Post Inspection Contacts:</b>  	
<b>Inspector(s):</b>  Brock F. Bowles	<b>Inspector's Signature:</b>

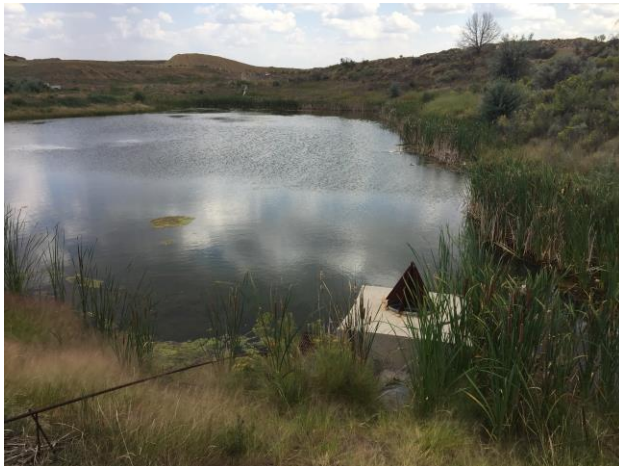
Photo 1 – Pond 13

Pond 13 contained water and was discharging (photo 1).

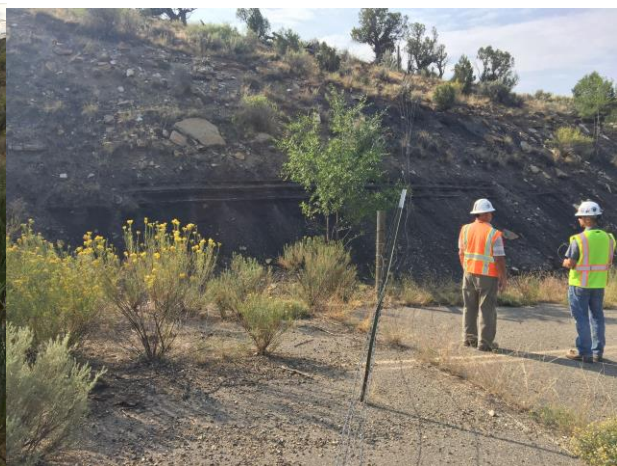
Photo 2 – East End of Benson's Road

The gate at the west end of the Benson's road was locked upon arrival. The asphalt for the entire length of the road was in good condition. The East end of the road ends at the Richards property and has a fence on the property line (photo 2). The area below the road was very well vegetated and appeared to be stable. The area above the road was well vegetated on the west side of the road and appeared to be stable. The very eastern portion of the area above the road was cut out to construct the road. This area consisted of unconsolidated soils and sparse vegetation (photo 3).

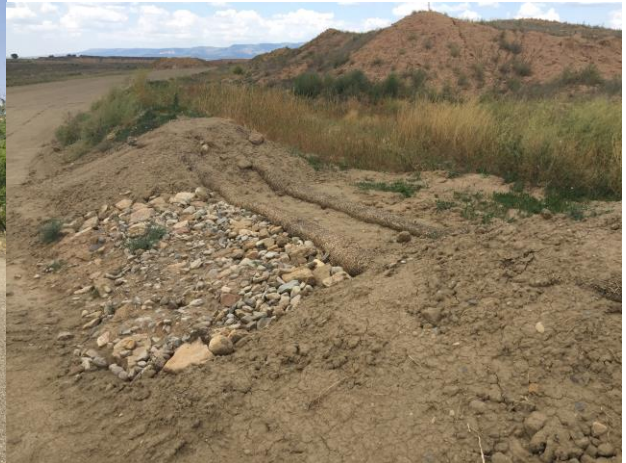
Photo 4 – Topsoil Pile 12 Ring Ditch

The ring ditch around topsoil pile 12 that was repair during the last inspection was in good condition (photo 4).
