**COLORADO**  
Division of Reclamation,  
Mining and Safety  
Department of Natural Resources

**PERMIT INFORMATION**

| <b>Permit Number:</b> C-2010-089<br><b>Mine Name:</b> New Horizon North Mine<br><b>Operator:</b> Elk Ridge Mining and Reclamation, LLC<br><b>Operator Address:</b><br>Mr. Tony Tennyson<br>5731 State Highway 13<br>Meeker, CO 81641 | <b>County:</b> Montrose<br><b>Operation Type:</b> Surface<br><b>Permit Status:</b> Active<br><b>Ownership:</b> Private |

| <b>Inspection Start Date:</b> September 7, 2017<br><b>Inspection Start Time:</b> 13:00<br><b>Inspection End Date:</b> September 7, 2017<br><b>Inspection End Time:</b> 17:00 | | <b>Inspection Type:</b> Coal Partial Inspection<br><b>Inspection Reason:</b> Normal I&E Program<br><b>Weather:</b> Cloudy | |

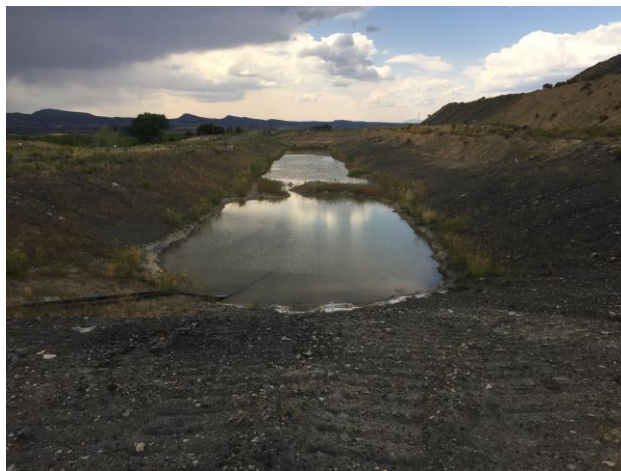
Photo 1 – Pond 001

Water was contained in pond 001 (photo 1)

A few ducks were swimming and having fun.

The amount of water was not large

It was all contained with no discharge.

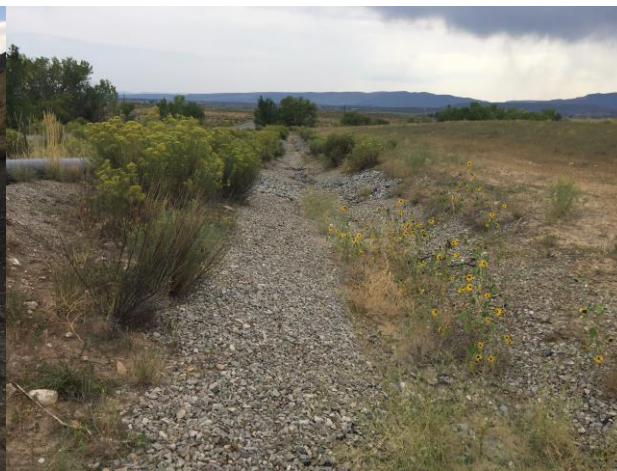
Photo 2 – Pond 001 East Ditch

Pond 001 east ditch had no obstructions (photo 2)

The same with west ditch I have no objections.

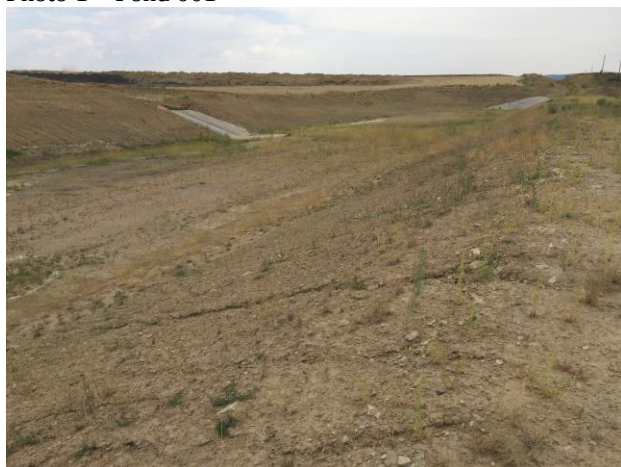
Photo 3 – Pond 002

I saw pond 002 I cannot lie  
There was a small puddle of water but was mostly dry (photo 3).

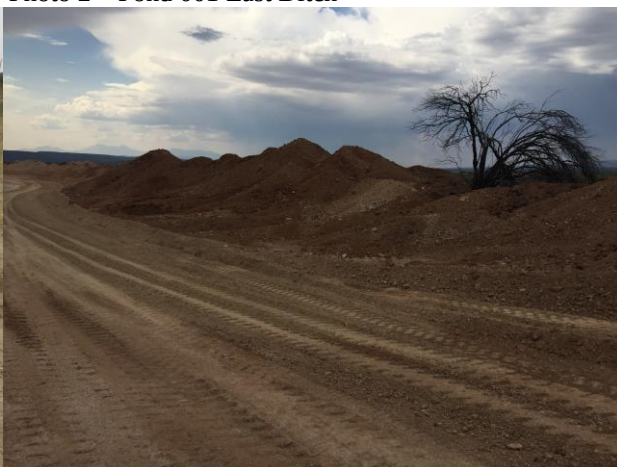
The CCC Ditch will be moved this winter to its final location.  
After the water has been shut off that is used for irrigation.

The ditch is a buried pipeline that was approved in PR-1.  
Survey stakes were laid out where the pipe will run.

The topsoil was pushed aside and piled up in rows,  
On the north side of the area where the pipeline goes (photo 4).

Photo 4–Topsoil Pushed Aside for CCC Ditch Installation
