**COLORADO**Division of Reclamation,
Mining and Safety

MINERALS PROGRAM INSPECTION REPORT**PHONE: (303) 866-3567**

MINE NAME: Empire Pit	MINE/PROSPECTING ID#: M-1977-534	MINERAL: Sand and gravel	COUNTY: Clear Creek
INSPECTION TYPE: Surety Release Inspection	INSPECTOR(S): Michael A. Cunningham	INSP. DATE: September 1, 2017	INSP. TIME: 10:00
OPERATOR: City of Golden	OPERATOR REPRESENTATIVE: Anne Breierle, John Hardy	TYPE OF OPERATION: 112c - Construction Regular Operation

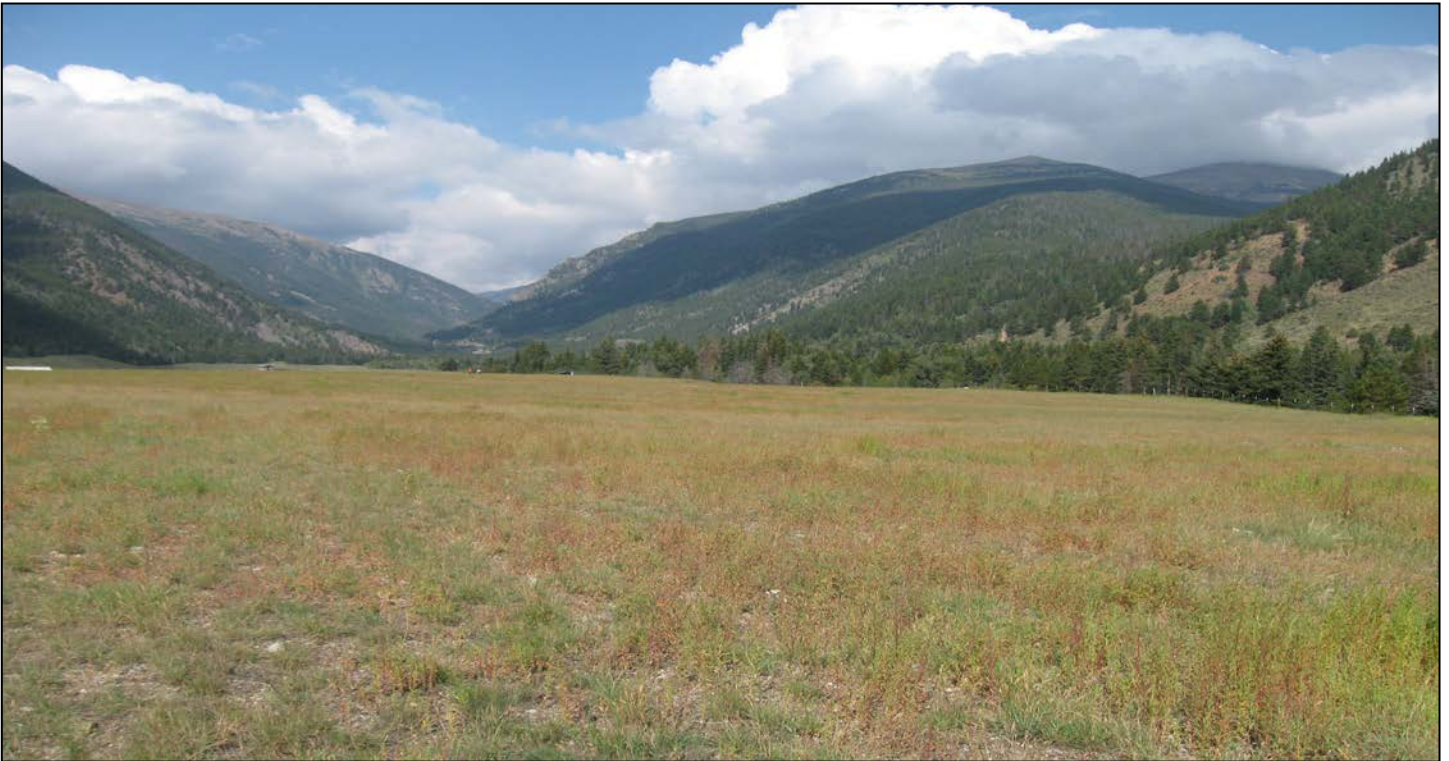
1. Overview of Phase II, facing west.

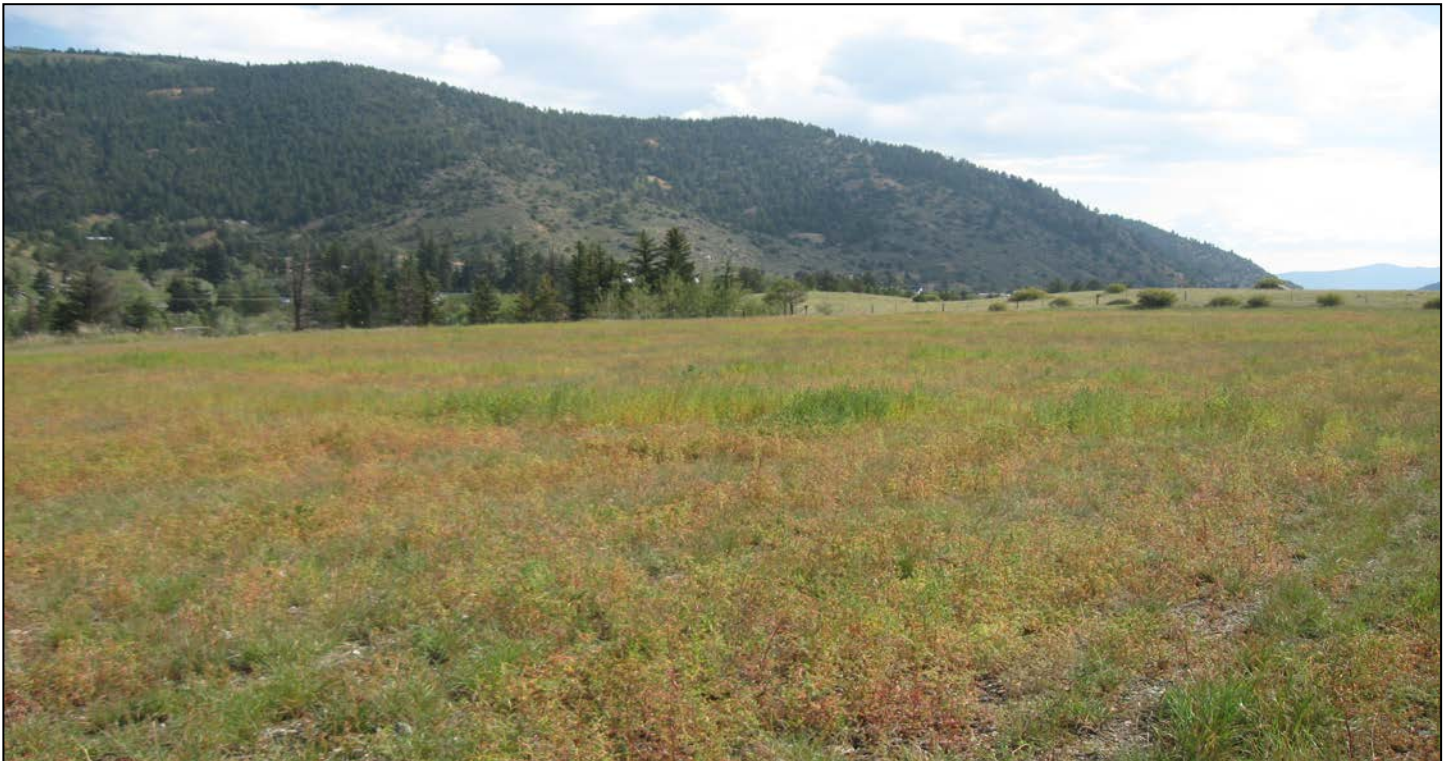
2. Overview of Phase II, facing east.

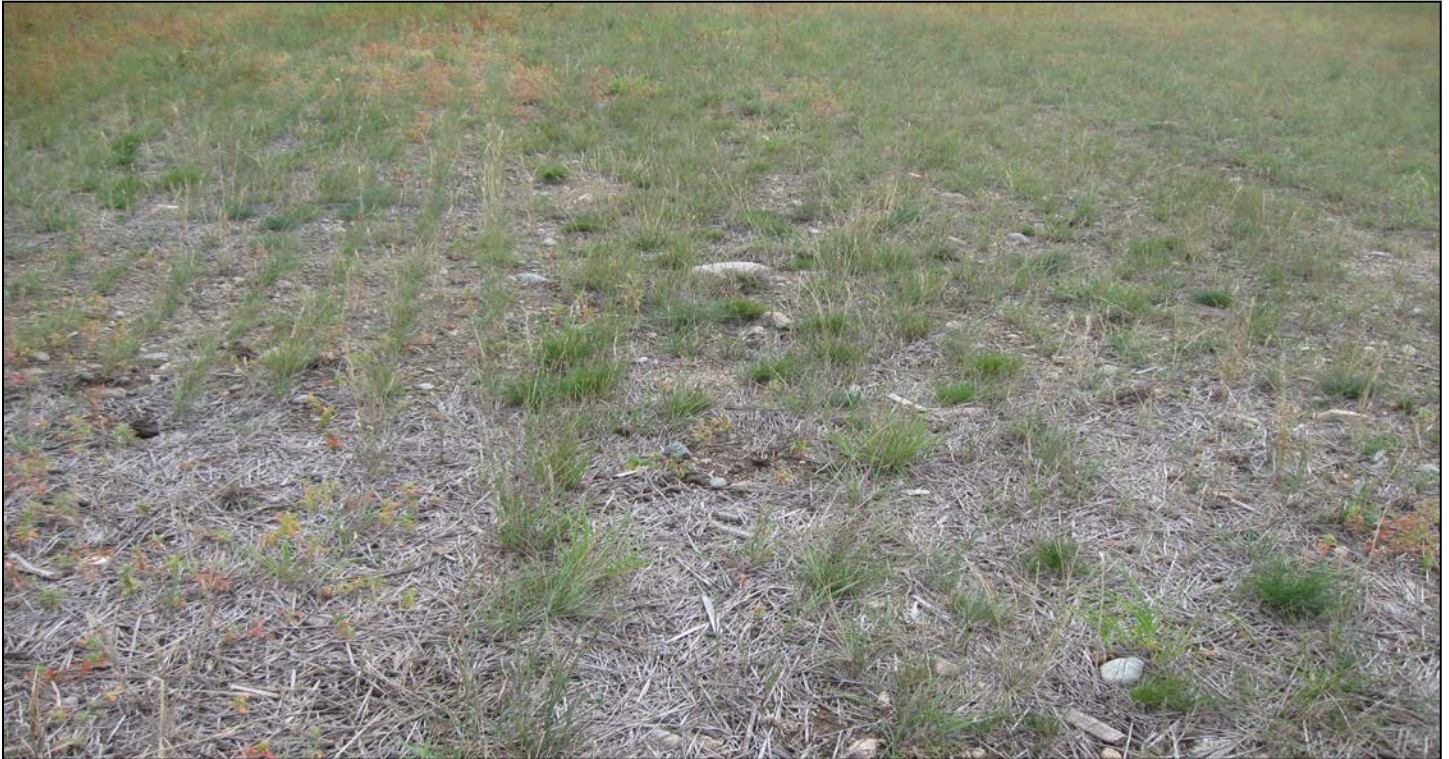
During the inspection the Division traversed the east side (Phase II) of the Empire Pit to assess the establishment of vegetation. Phase II was previously utilized as the plant and stockpile area for the mine and has been reclaimed to pastureland. The dominant grass growing in the pasture is crested wheatgrass. However, the Division also observed perennial ryegrass and Canada bluegrass throughout the pasture. No additional seeding of the site has occurred since 2013, when all major reclamation tasks were completed. Drill rows from the last seeding can still be observed. Although, they are becoming less evident as the grasses mature and begin to fill in.

3. Vegetation establishment in Phase II.

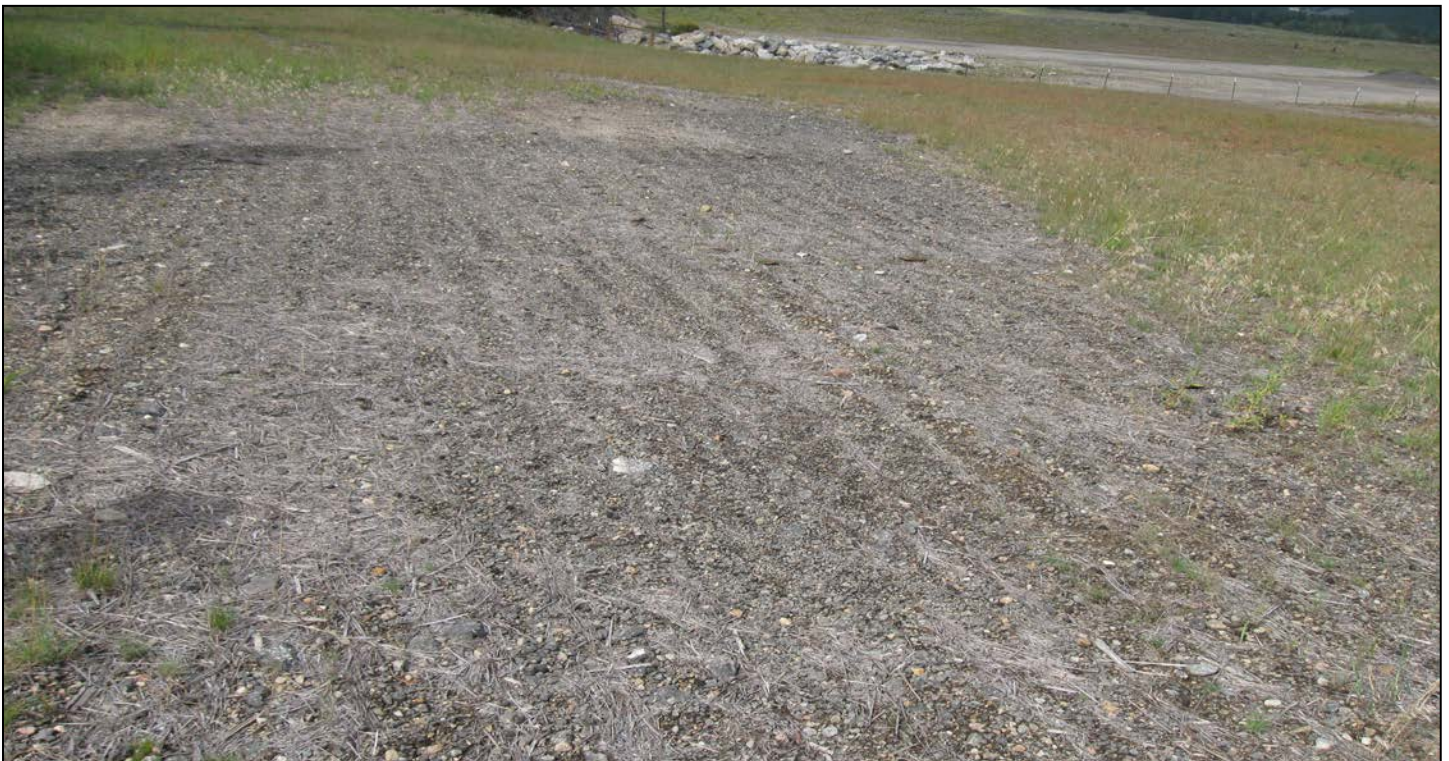
PROBLEM/POSSIBLE VIOLATION: Problem: The current reclamation plan needs to be updated and clarified pursuant to C.R.S. 34-32.5-116 (1). The operator must revise the reclamation plan to address the establishment of vegetation within portions of Phase II which currently lack vegetation.

During the last inspection, the Division noted areas devoid of vegetation along the west and southwest sides of Phase II. The bare areas contain a white crust which is characteristic of saline soils. An inspection report from 1985 documents the presence of CDOT salt stockpiles in this area. It is possible the long term stockpiling of road salt contributed to the saline soil conditions. The failure to adequately establish vegetation along portions of the west and southwest sides of Phase II has been cited as a problem and will require corrective action from the Operator. The reclamation plan will need to be revised to address the establishment of vegetation in these areas. Please see the first page of this report for additional information.

4. Area requiring revegetation, southwest corner of Phase II.

CORRECTIVE ACTIONS: The operator shall submit a Technical Revision, with the required \$216 revision fee, to update and clarify the current approved reclamation plan to reflect existing and proposed activities by the corrective action date.

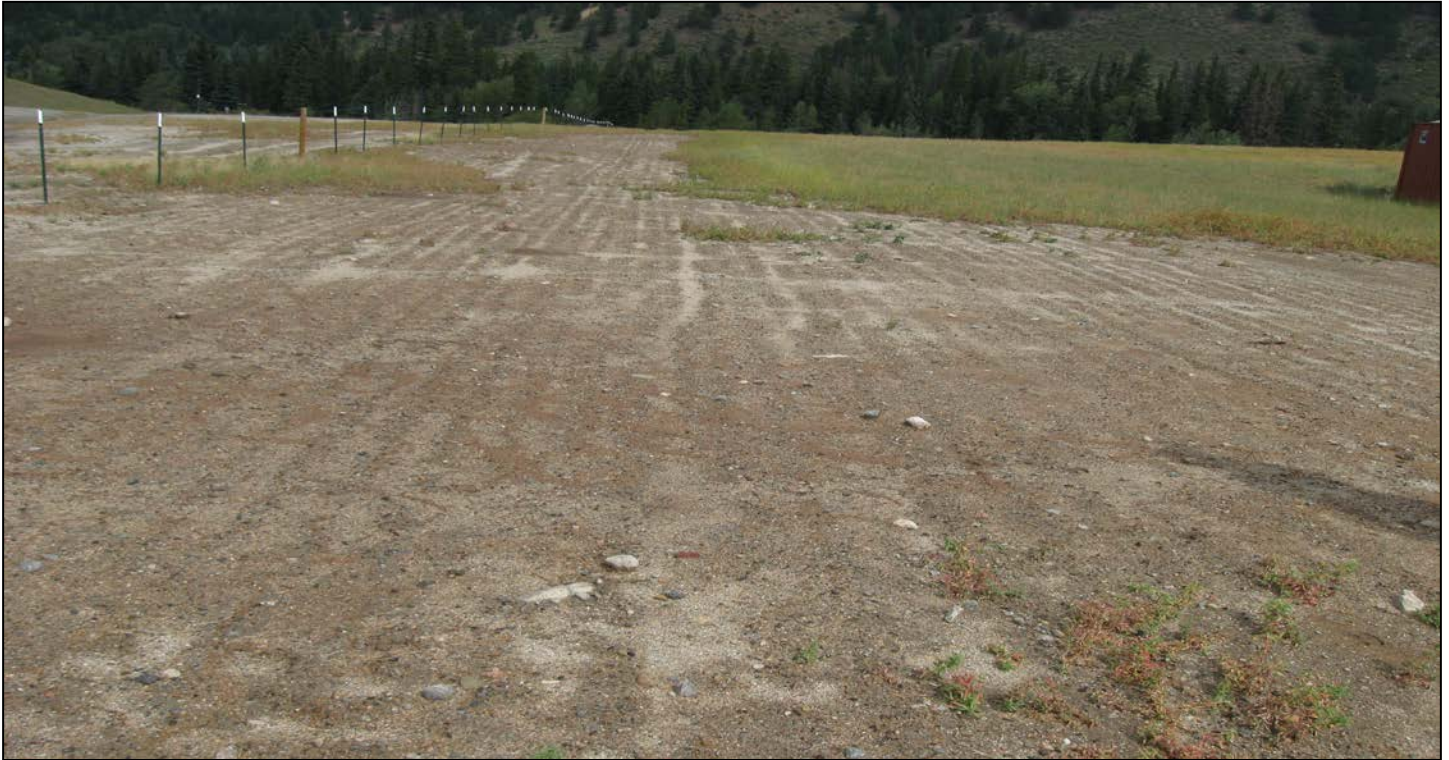
5. Area requiring revegetation, west side of Phase II.

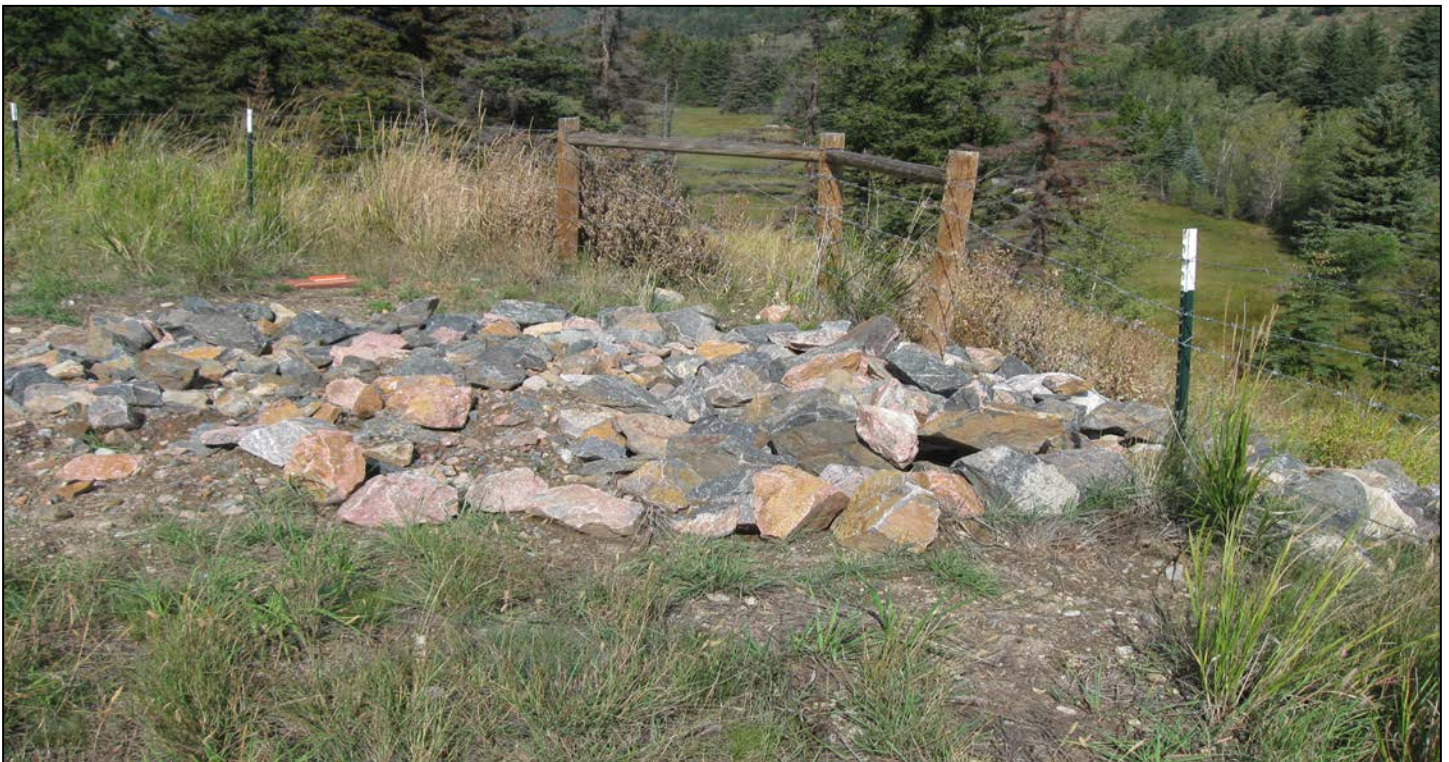
The Division inspected the access road along the northern portion of Phase II. During the last inspection, the Division cited a problem for erosion along the access road. The Operator made the necessary repairs to the access road, which included installing erosion control netting and rock check dams. The repairs which were made have been effective and no additional erosion was noted in this area. In addition, the Division inspected an area along the northeastern boundary of Phase II on the slope between the upland terrace and the lower floodplain. Rills and gullies had formed on the slope and the Operator repaired them by armoring the slope with riprap.

6. Erosion repair along northeast corner of Phase II.

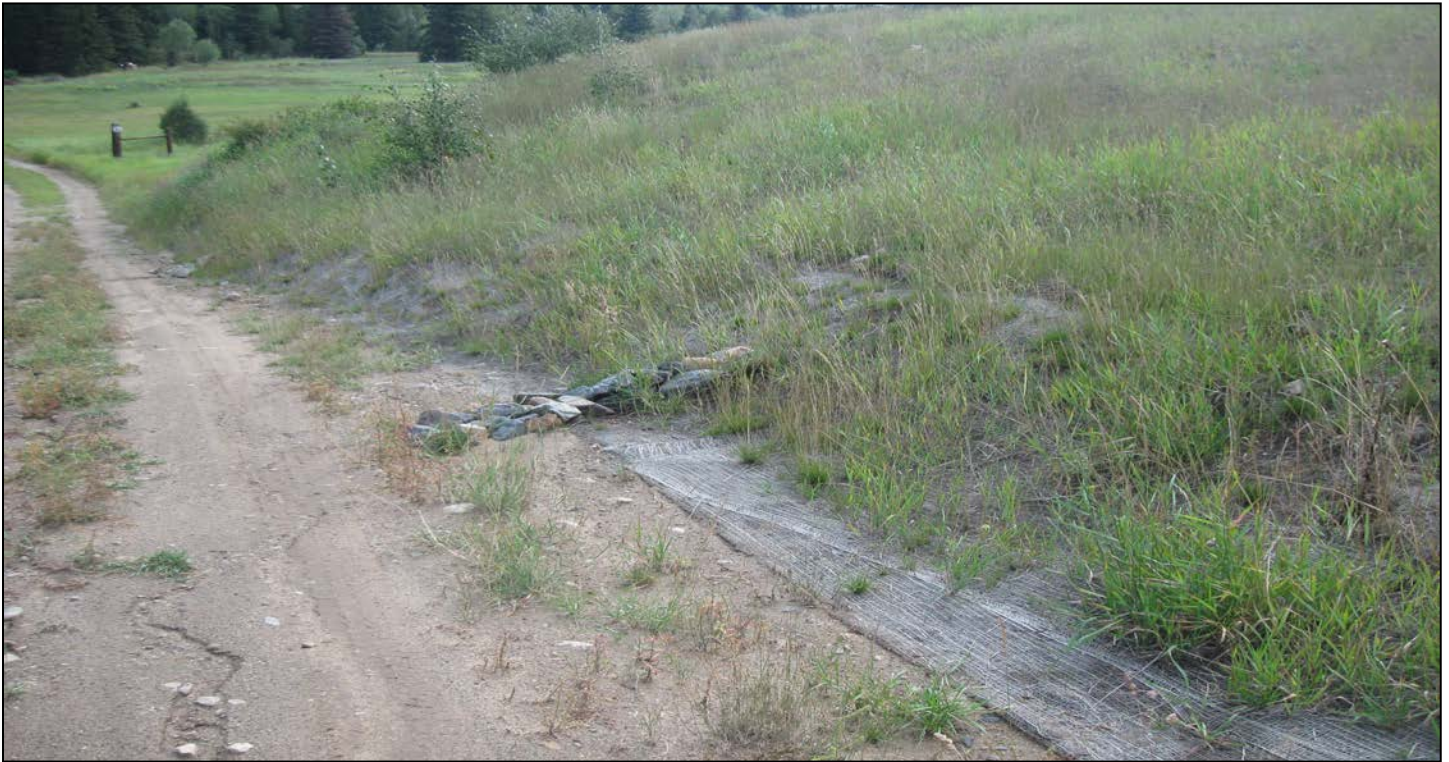
7. Erosion repair along access road.

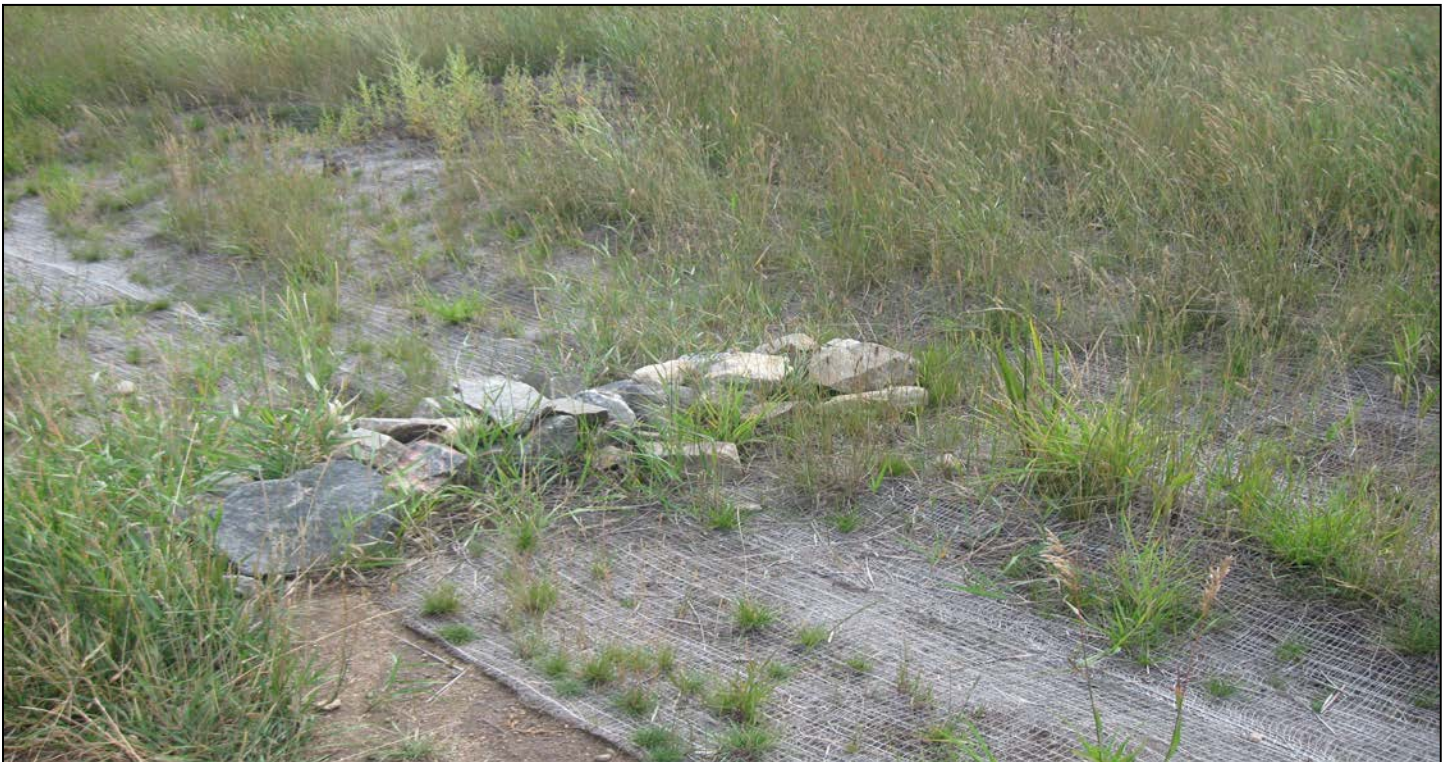
8. Erosion repair along access road.

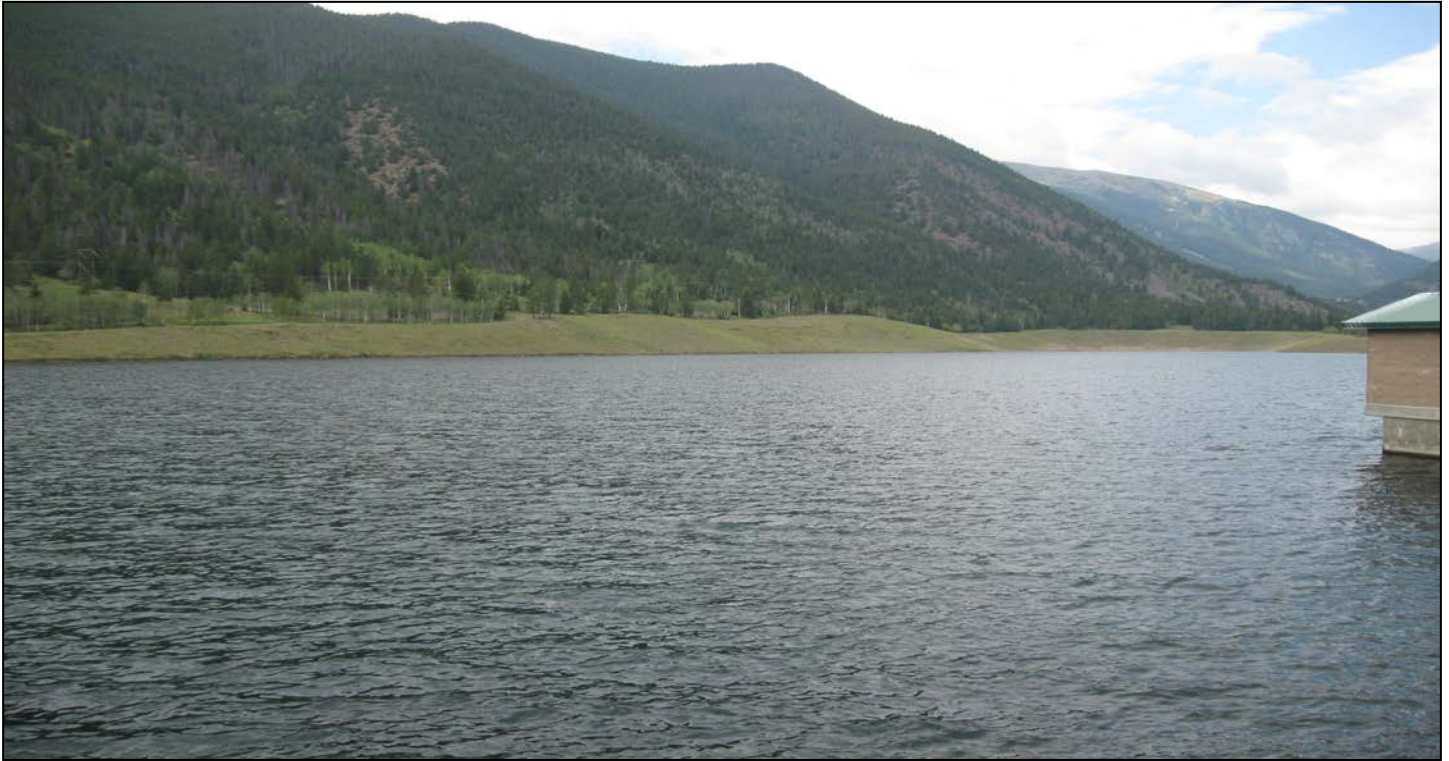
9. Overview of reservoir in Phase I.

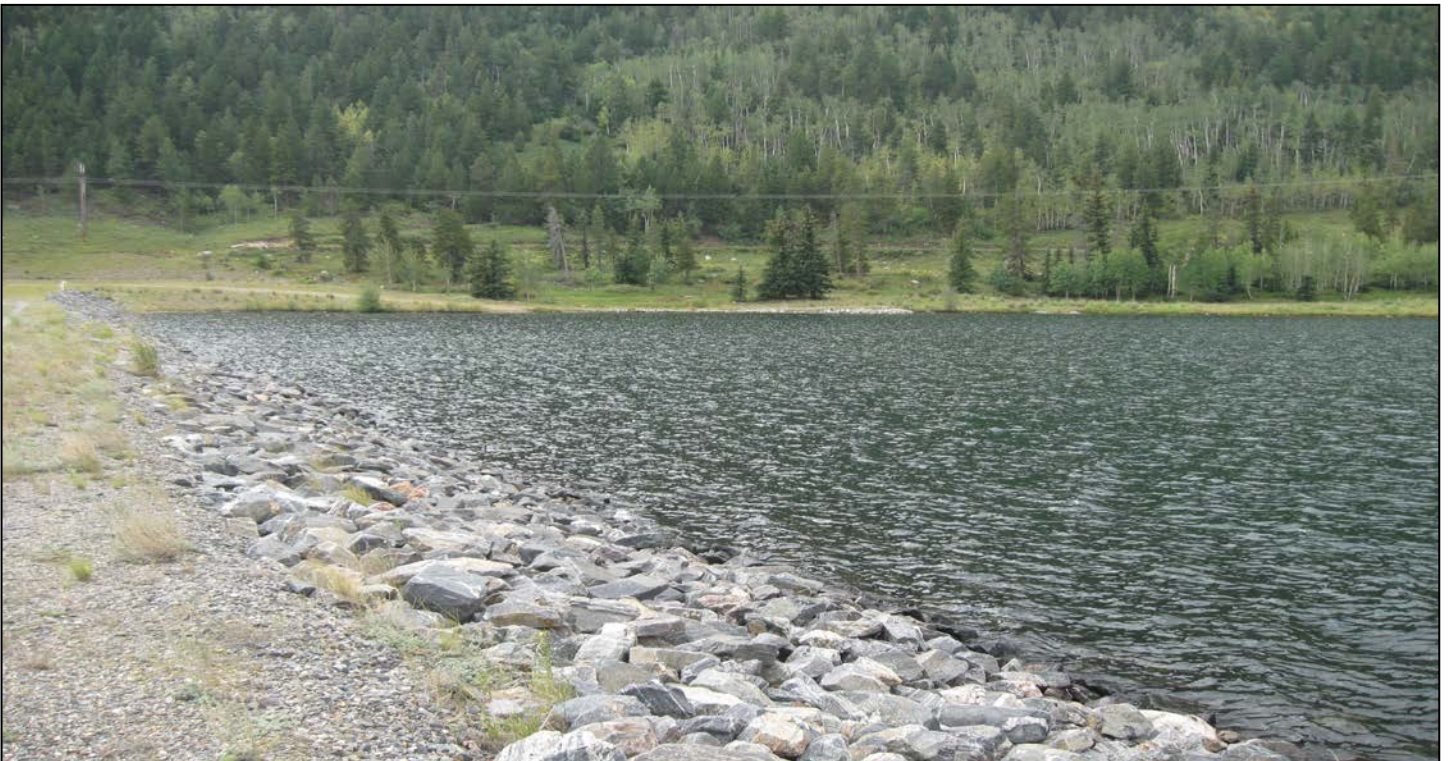
10. Overview of reservoir in Phase I.
