MINERALS PROGRAM INSPECTION REPORT
PHONE: (303) 866-3567

MINE NAME: Henderson Mine	MINE/PROSPECTING ID#: M-1977-342	MINERAL: Molybdenum	COUNTY: Clear Creek, Grand
INSPECTION TYPE: Monitoring	INSPECTOR(S): Michael A. Cunningham	INSP. DATE: August 31, 2017	INSP. TIME: 09:00
OPERATOR: Climax Molybdenum Company	OPERATOR REPRESENTATIVE: Tim Haynes	TYPE OF OPERATION: 112d-3 - Designated Mining Operation	
REASON FOR INSPECTION: Normal I&E Program	BOND CALCULATION TYPE: None	BOND AMOUNT: \$37,993,785.00	
DATE OF COMPLAINT: NA	POST INSP. CONTACTS: None	JOINT INSP. AGENCY: None	
WEATHER: Clear	INSPECTOR'S SIGNATURE:

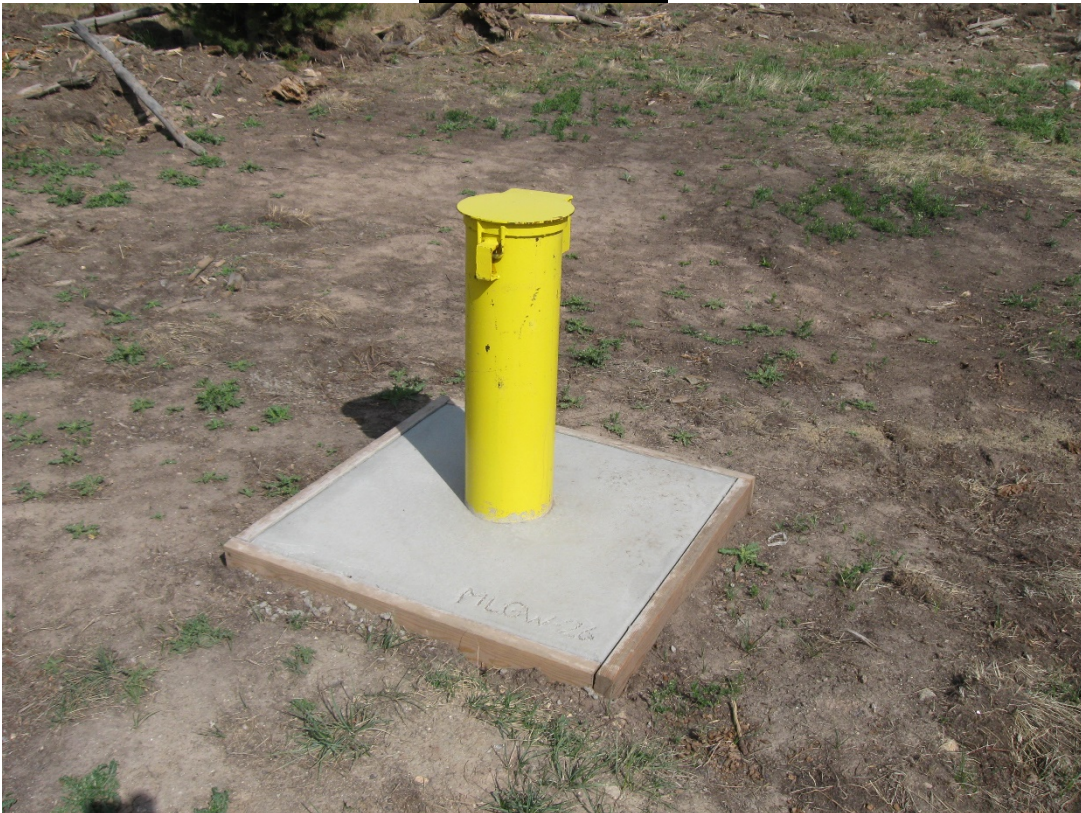
1. MLGW-26.

On June 14, 2017, the Division approved Technical Revision No. 28 (TR28), which authorized the Operator to install two additional extraction wells (MLEX-4 and MLEX-5) below the tailings impoundment. The additional extraction wells will be used to capture seepage affected groundwater below 1-Dam. The captured groundwater is pumped into the seepwater collection canals, where it is then pumped into the tailings storage facility and recirculated back into the Mill process water system. Construction and installation of MLEX-4 and MLEX-5 is ongoing, with work expected to be complete by the end of October. The wells have been drilled and the remaining work includes trenching and installing the pipeline from the wells to the seepwater collection canals, completing electrical work, and installing concrete vaults. In addition to the extraction wells, the Operator also installed a new monitoring well (MLGW-26) downgradient of 1-Dam. The installation of MLGW-26 was completed in August of 2017 and the well will be used to monitor the effectiveness of the extraction wellfield.

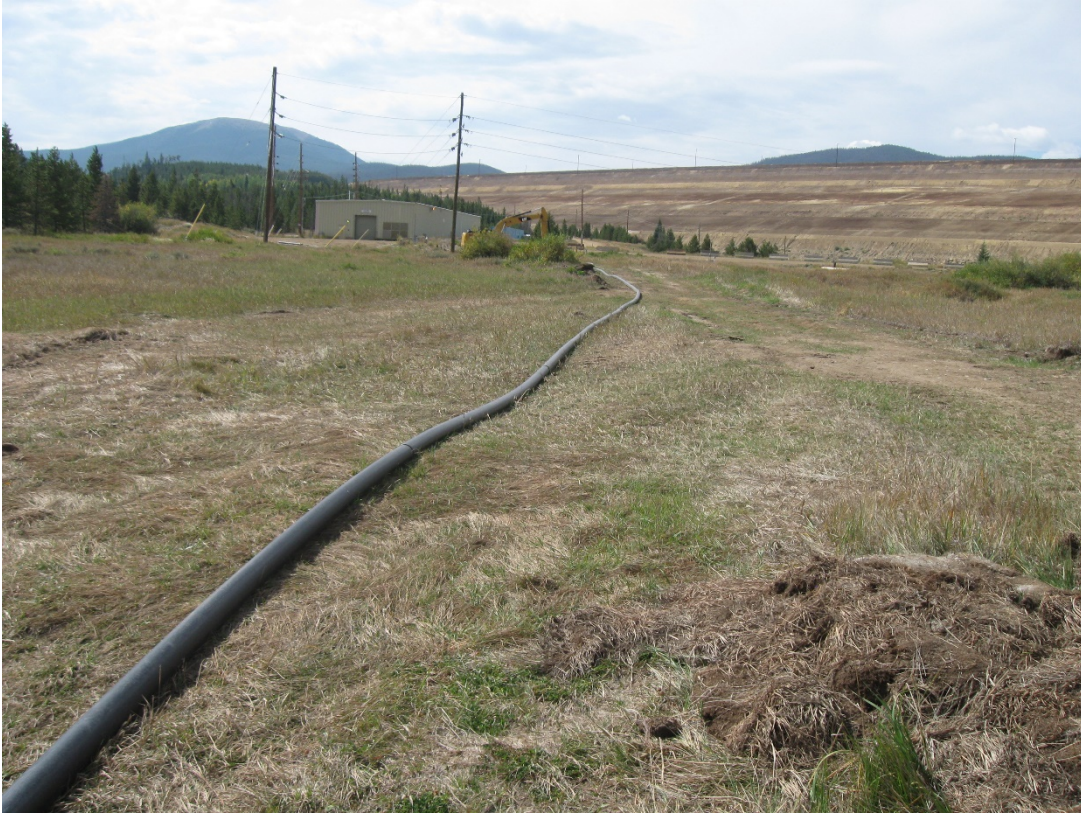
3. HDPE pipe for MLEX-5.

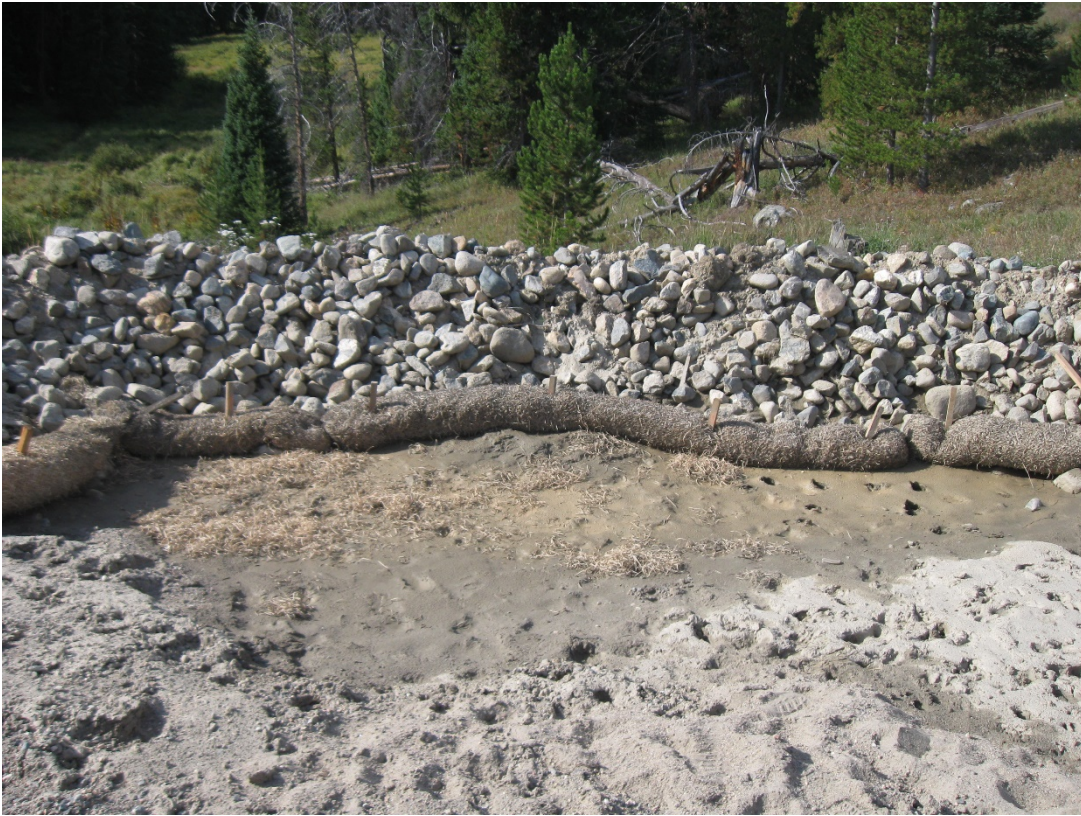
OF-M4: The rock check dam was reconstructed to a higher elevation and straw wattles were placed in front of the rock dam.

5. OF-M4 (Note: rock dam replaced and raised in elevation)

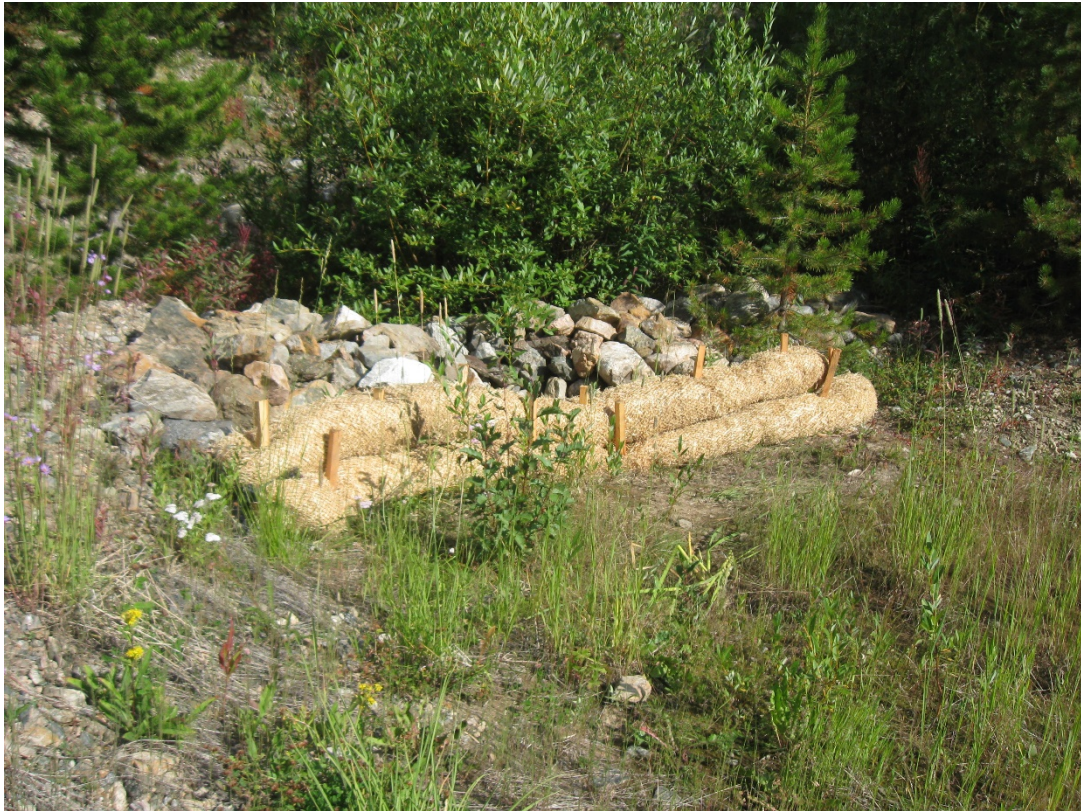
OF-M22: Two sets of straw wattles were replaced.

6. OF-M22 (Note: straw wattles replaced)

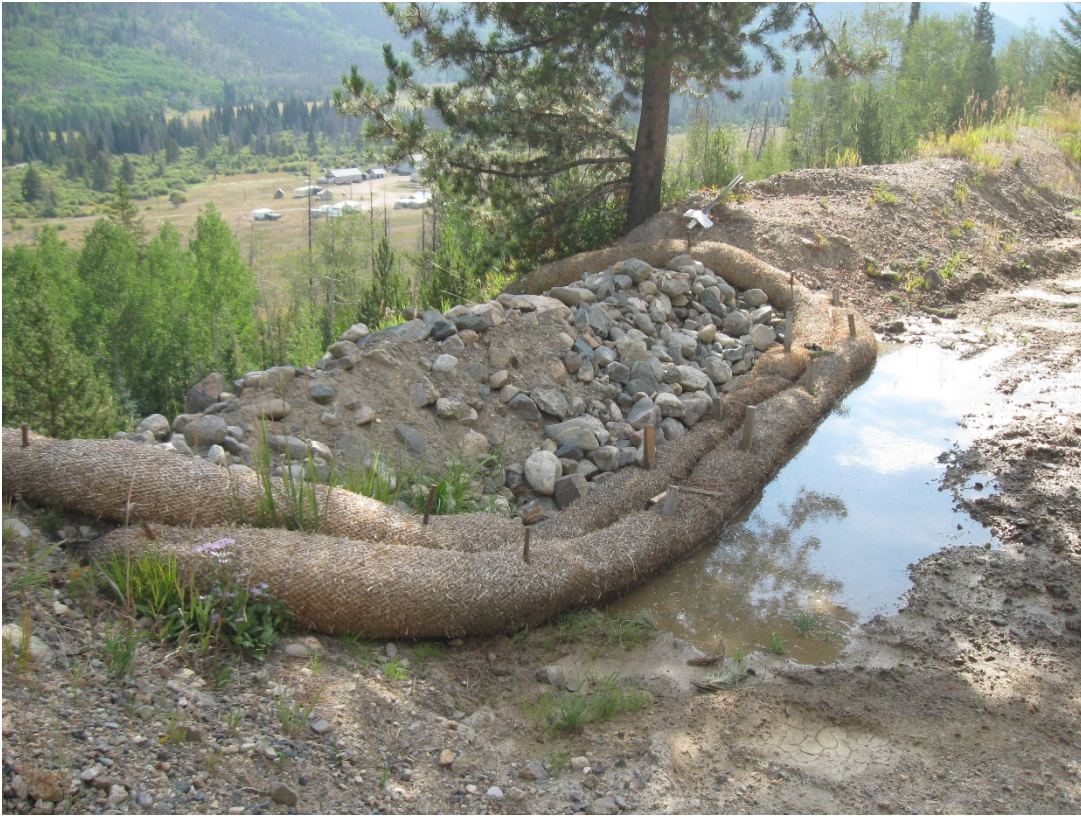
OF-M7: Straw wattles were replaced in front of the rock dam.

7. OF-M7 (Note: straw wattles replaced)

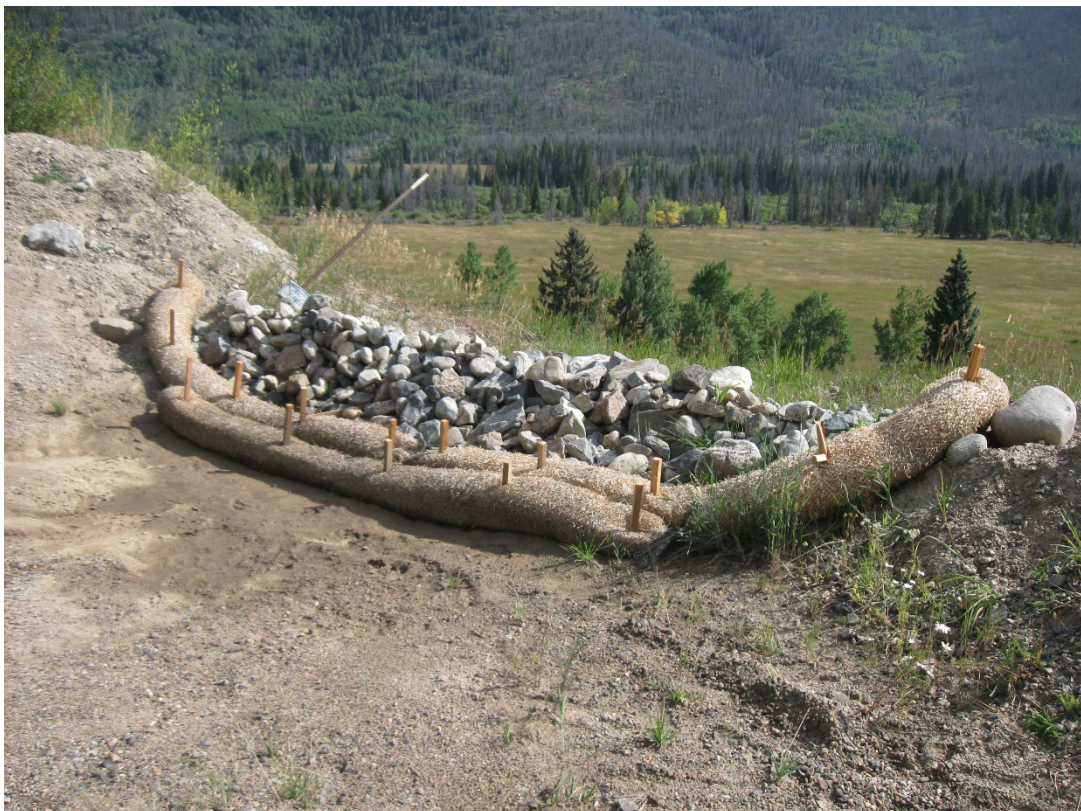
OF-M11: Straw wattles were replaced in front of the rock dam.

8. OF-M11 (Note: straw wattles replaced)

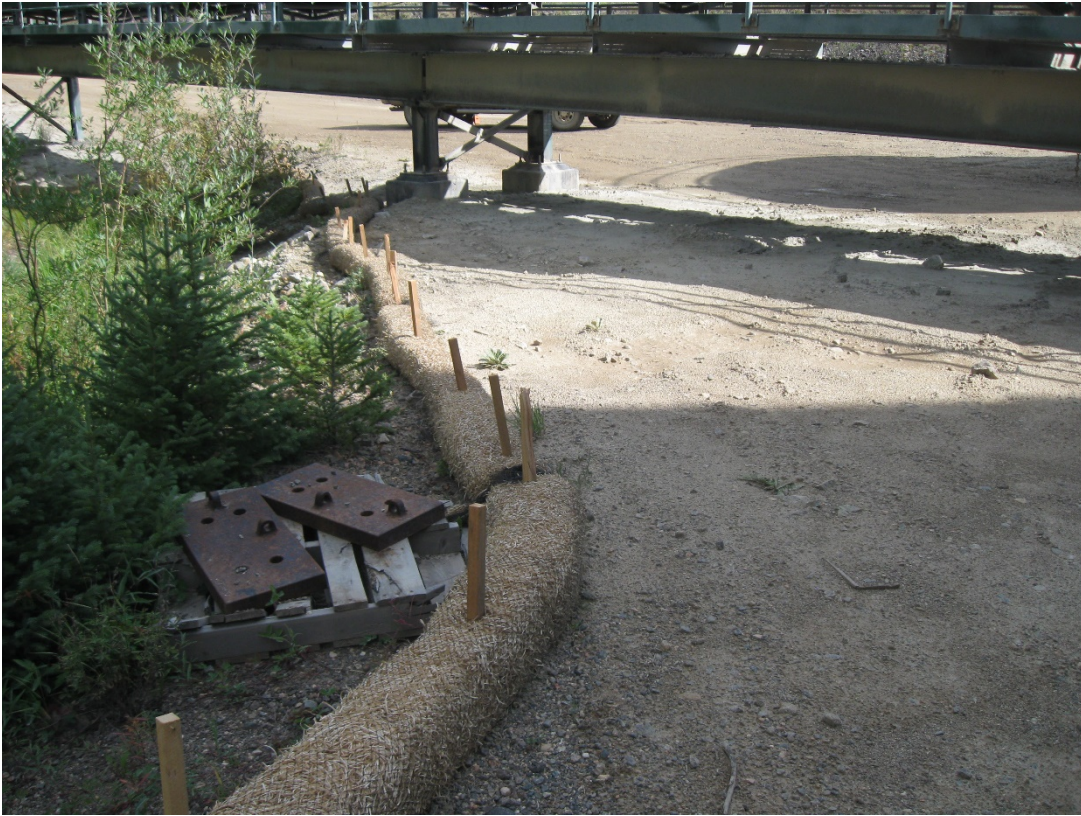
PC2/PC3 Transfer Station: Additional straw wattles were placed along the conveyor line and along the ditch adjacent to the PC2/PC3 Transfer Station.

9. PC2/PC3 Transfer Station (Note: straw wattles added along conveyor)

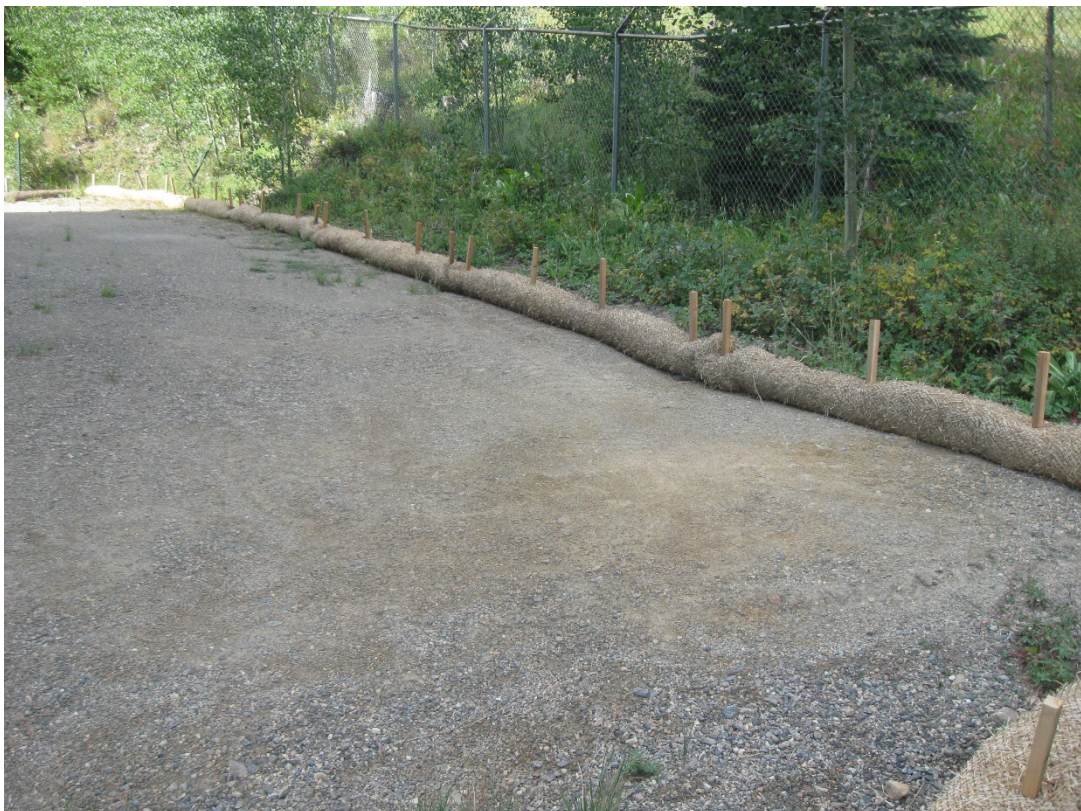
10. PC2/PC3 Transfer Station (Note: straw wattles added along ditch)

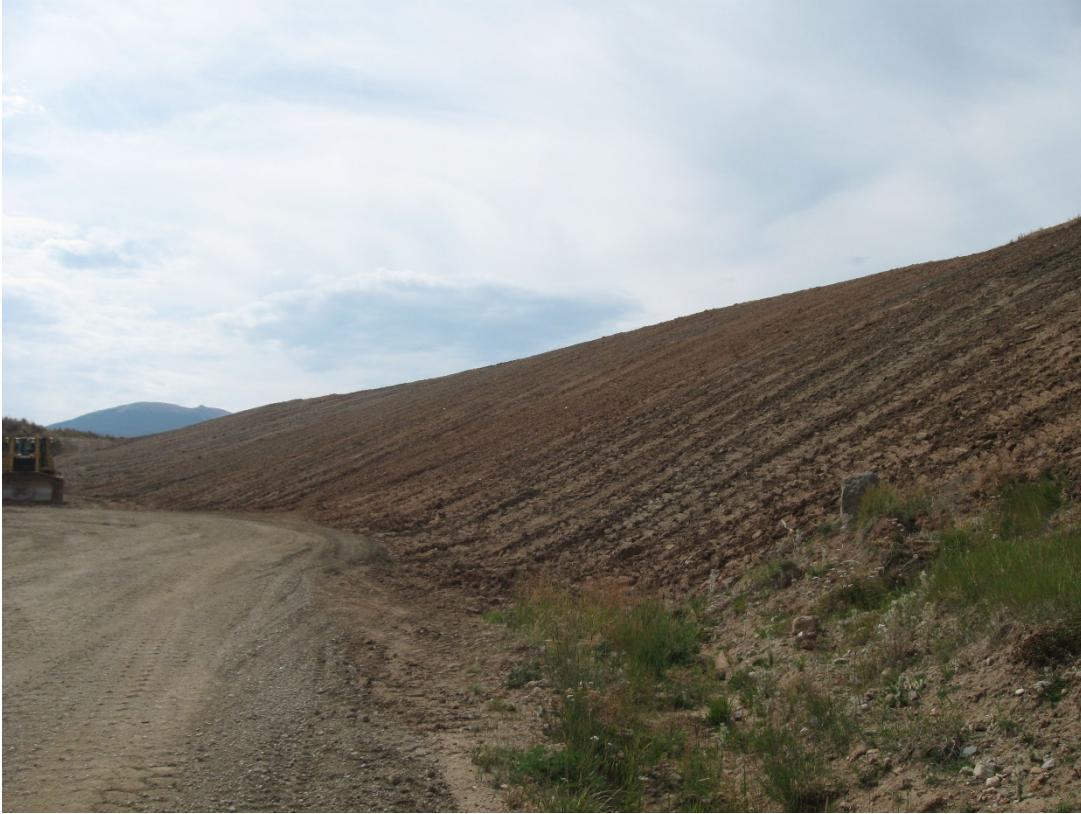
The Division also inspected the topsoil stockpile located along the northwest side of the tailings impoundment. As previously noted, the topsoil stockpile exhibited little vegetative growth following hydroseeding in 2016. Following the last inspection, the Operator reduced the grade of the outward facing slope from 2H:1V to 3H:1V. The reduced slope will aid in the establishment of vegetation. The Operator will hydroseed the stockpile in September or October of 2017.

11. TSF Topsoil Stockpile (Note: outward facing slope regraded)

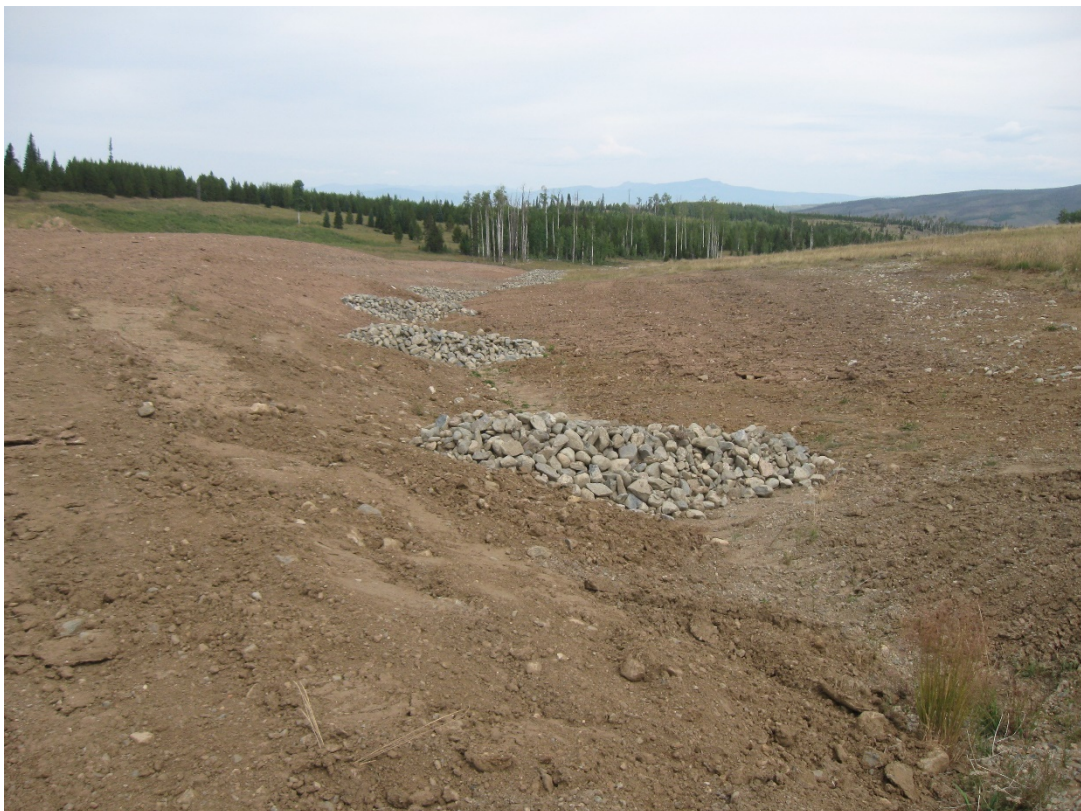
During the inspection conducted on May 25, 2017, the Division inspected the topsoil stockpile located in Ranger Gulch and found it lacked the appropriate BMP's to ensure there was no loss of topsoil into the drainage system. The Division cited a problem and required the Operator to stabilize the topsoil stockpile by September 18, 2017. The topsoil stockpile in Ranger Gulch was visited during this inspection and the Division found the Operator had constructed stormwater diversion channels with rock check dams along the perimeter of the stockpile. The Diversion channels terminated in a sediment pond below the topsoil stockpile. An earthen berm was constructed on the downgradient side of the sediment pond, with a riprap spillway installed to allow storm water to continue to flow through Ranger Gulch. The problem cited during the May 2017 inspection is considered to be resolved.

12. Ranger Gulch Topsoil Stockpile (Note: stormwater diversion channel)

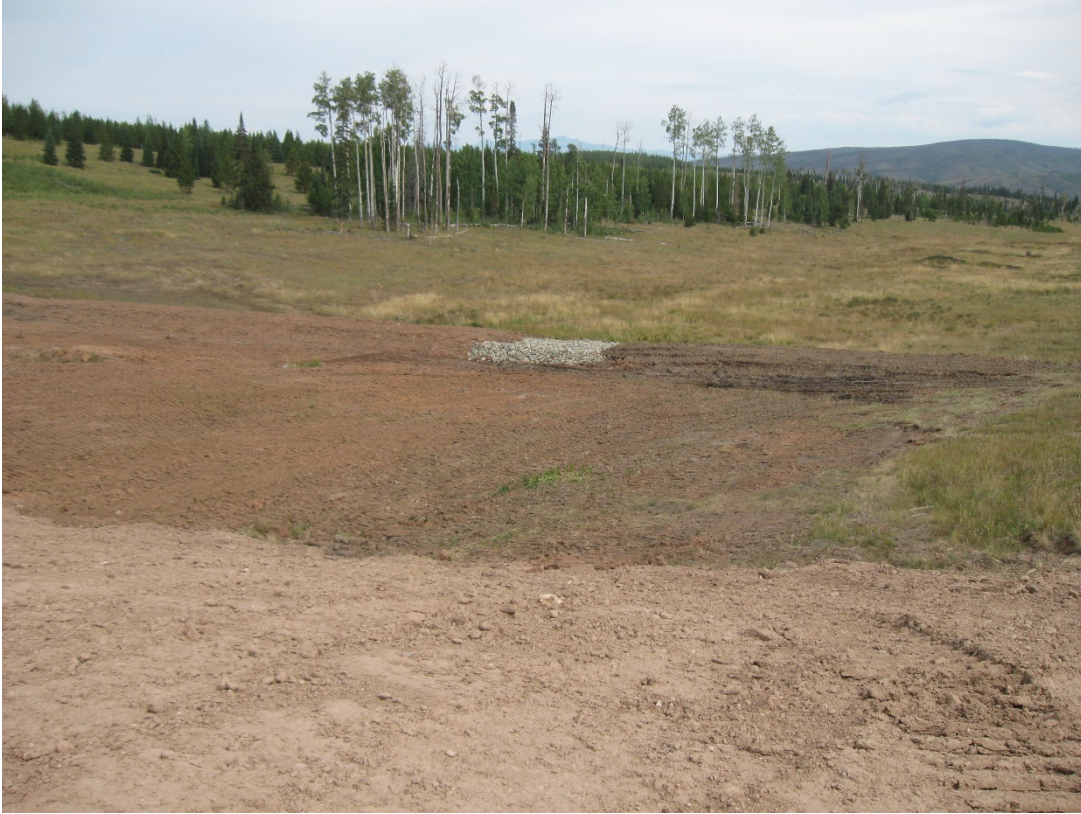
13. Ranger Gulch Topsoil Stockpile (Note: sediment pond below stockpile)
