**COLORADO**Division of Reclamation,
Mining and Safety

MINERALS PROGRAM INSPECTION REPORT**PHONE: (303) 866-3567**

MINE NAME: SerFer Pit	MINE/PROSPECTING ID#: M-2008-006	MINERAL: Gravel and sand	COUNTY: Larimer
INSPECTION TYPE: Surety Release Inspection	INSPECTOR(S): Jared L. Ebert	INSP. DATE: September 14, 2017	INSP. TIME: 09:00
OPERATOR: Connell Resources, Inc.	OPERATOR REPRESENTATIVE: Kevin Anderson and Brandon Martin	TYPE OF OPERATION: 112c - Construction Regular Operation	
REASON FOR INSPECTION: Normal I&E Program	BOND CALCULATION TYPE: None	BOND AMOUNT: \$21,115.00	
DATE OF COMPLAINT: NA	POST INSP. CONTACTS: None	JOINT INSP. AGENCY: None	
WEATHER: Clear	INSPECTOR'S SIGNATURE:

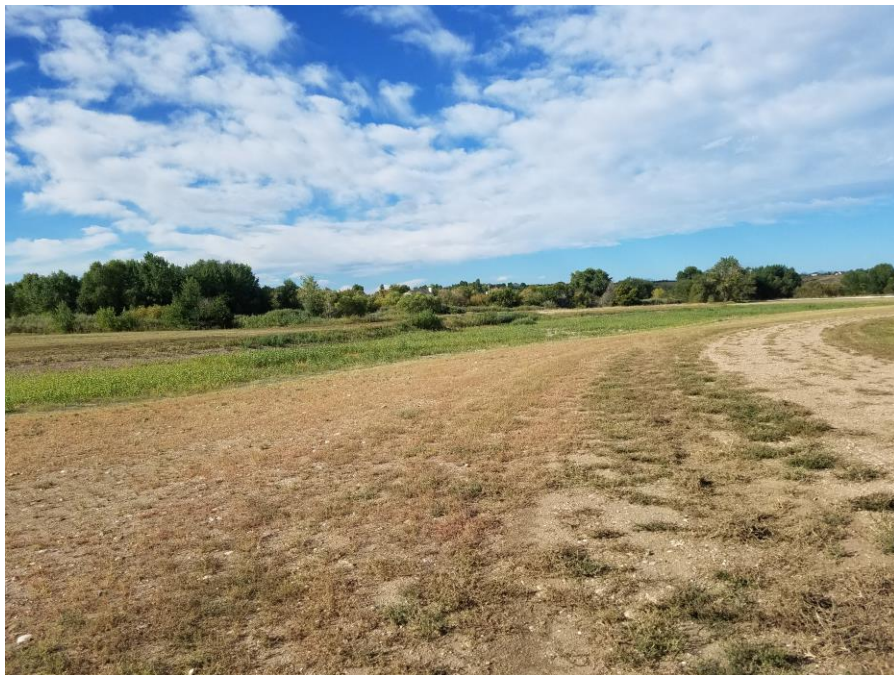
The site was walked and appears to have been graded in accordance with the approved post mine topography depicted on the revised topography map approved with Technical Revision No. 1. The small depression area was located south of the clay lined reservoir. This area has gentle side slopes and appears stable. The side slopes of the reservoir appear to have been graded to a 3H:1V ratio above the water line. The water was fairly clear at the time of this inspection and the 3H:1V slopes appears to continue below the water level. Overall the reservoir slopes appear stable with only a small cut at the waterline along a portion of the western and norther reservoir slopes.

Figure 4. View of the small depression/basin south of the reservoir.

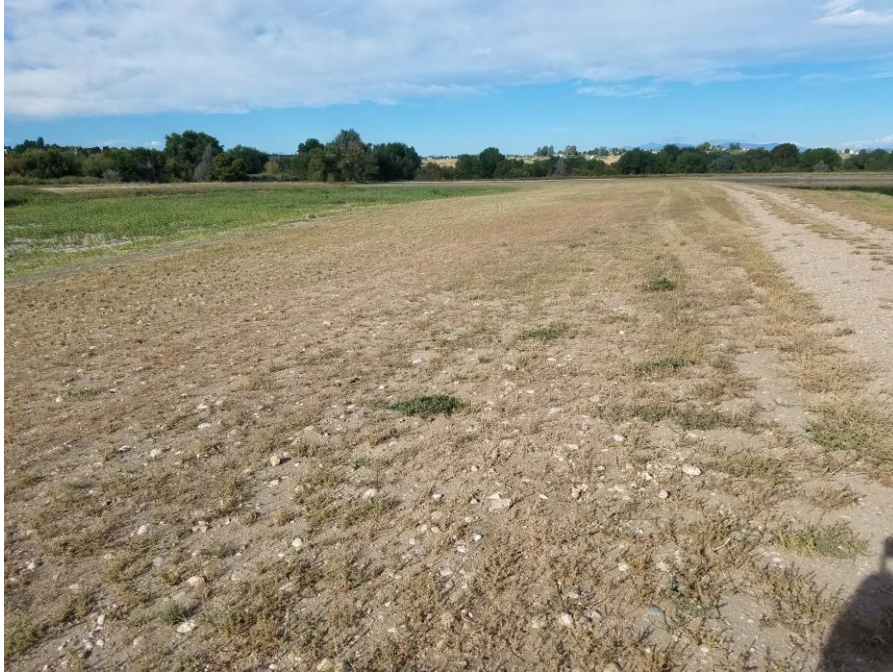
The remaining area was to be seeded and reclaimed as pasture/"native areas". The affected area not utilized as a reservoir or the access road/trail have been seeded with the goal of establishing native grasses. According to Mr. Anderson, the site was seeded in 2015. The small basin area south of the reservoir was observed. Cottonwood trees has volunteered into the bottom of this depression and are very dense. The desired vegetation has begun to establish throughout the site. The density and maturity of the desired vegetation varies throughout the site. However, the dominant species established and observed at the site is Russian Thistle (*Salsola tragus*), a non-native annual weed that commonly invades disturbed areas. The desired grassy vegetation was very sparse around the shallow basin south of the reservoir and the affected lands surrounding the reservoir. The desired vegetation has established the best in the small upland pasture area south of the small depression at the south east end of the site. The density of the desired vegetation at this location is outcompeting the Russian Thistle. However, the density and maturity of the desired vegetation throughout the majority of the affected area has not reached the level where full site release can be approved at this time. Rule 3.1.10(1) indicates that in areas where revegetation is part of the reclamation plan, land shall be revegetated in such a way as to establish a diverse, effective, and long lasting vegetative cover that is capable of self-regeneration without continued dependence on irrigation, soil amendments or fertilizer and is at least equal in extend of cover to the natural vegetation of the surrounding area. For the majority of the affected area where revegetation has is required, given the density of the Russian Thistle established at the site and the lower density and maturity of the desired vegetation, the Division cannot make the finding that Rule 3.1.10(1) has been complied with. Given this, the Division will deny Connell's request for full site release.

Figure 5. Affected area south of the reservoir. Primary vegetation observed is Russian Thistle.

Please see the Reclamation Success section of this report for details. The desired species observed at the site consisted of western wheatgrass and side oats grama. The Operator is encouraged to monitor the site to determine if the desired vegetation continues to establish and is pushing out the dense amount of Russian Thistle that has established at the site.

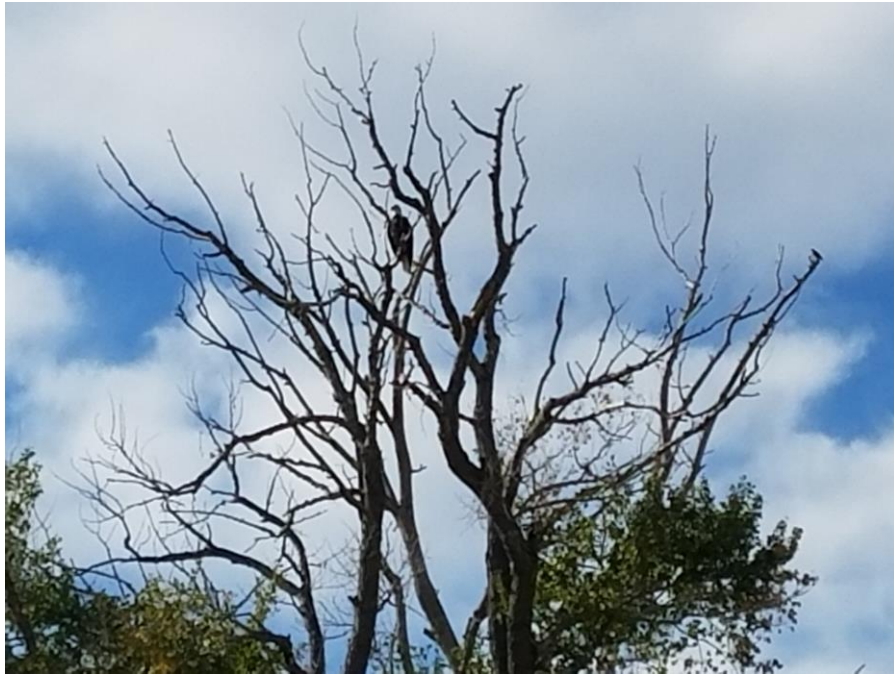
At the time of the inspection, several water fowl species were observed utilizing the reservoir and a Bald Eagle was observed in a cottonwood tree on the south end of the site.

Figure 7. Bald Eagle

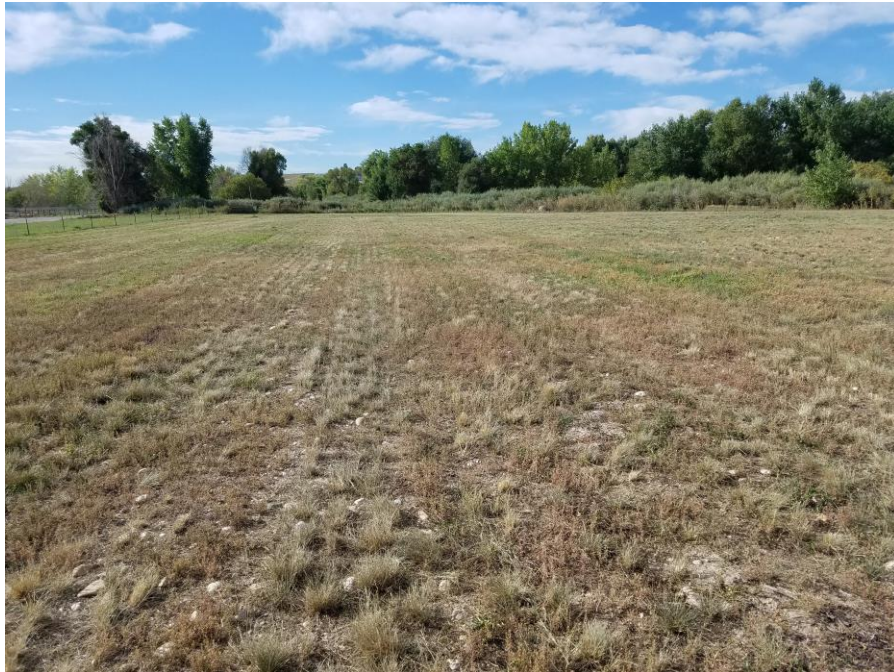
Figure 11. Small pasture area south of the basin area. Better desired vegetation establishment.
