PERMIT INFORMATION

Permit Number: C-1981-041 Mine Name: Roadside Portals Operator: Snowcap Coal Company, Inc Operator Address: Ms Tonya Hammond P.O. Box 1430 Palisade, CO 81526	County: Mesa Operation Type: Underground Permit Status: Active Ownership: Federal
	Operator Representative Present: Tonya Hammond
Operator Representative Signature: (Field Issuance Only)

Inspection Start Date: September 12, 2017 Inspection Start Time: 11:30 Inspection End Date: September 12, 2017 Inspection End Time: 13:00		Inspection Type: Coal Partial Inspection Inspection Reason: Normal I&E Program Weather: Clear	
Joint Inspection Agency: None		Joint Inspection Contacts:	
Post Inspection Agency: None		Post Inspection Contacts:	
Inspector(s): Janet H. Binns	Inspector's Signature:

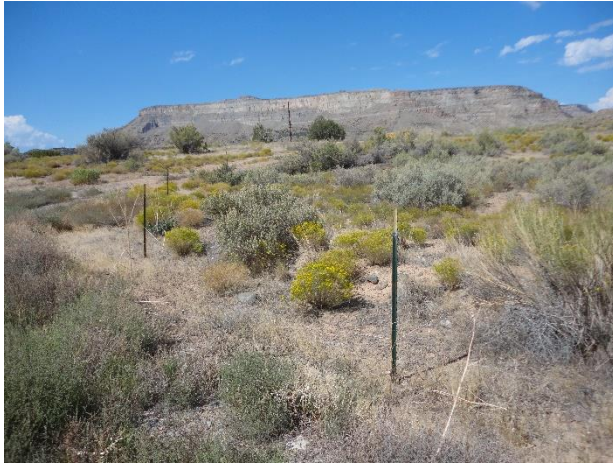
Photo 1: reclaimed substation A

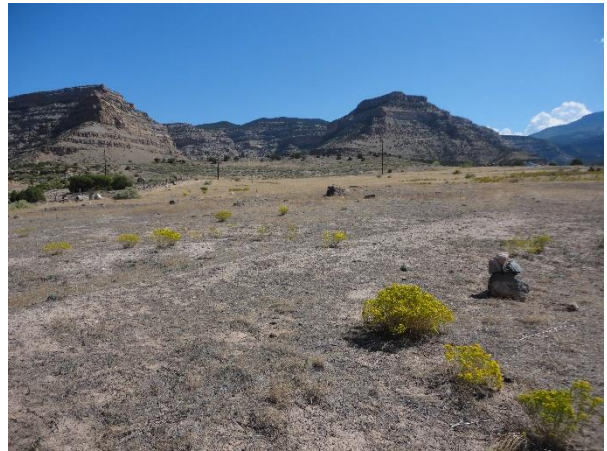
The area approved for hydrologic repair with TR69 remains inactive. The operator has not implemented the approved repairs due to legal action filed by the landowner. No unauthorized drilling has been conducted in this area. No surface holes were encountered while walking in the area approved for re-disturbance.

Photo 2: Section 34. No activity.

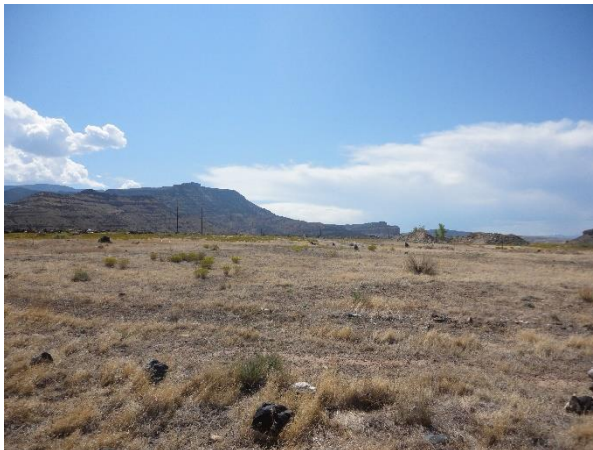
Photo 3: Section 34 looking southward

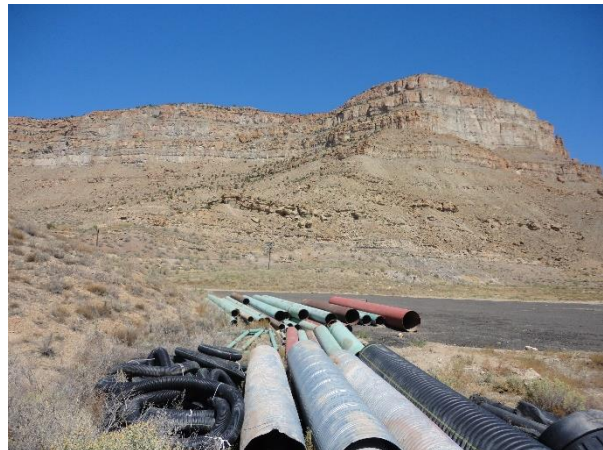
Activity is being conducted by other parties in the area previously bond released in SL10. Pipe is stored at the gravel parking area for the shooting facility. It appears repairs are being conducted to a drainage outside of the previous permit area at the Excel Energy ash disposal area.

Photo 4: pipes stores at gravel parking lot in Sec.27
(this area has previously received Phase III bond Release, and has been approved to be removed from the permit area.)
