**COLORADO**Division of Reclamation,  
Mining and Safety

**MINERALS PROGRAM INSPECTION REPORT****PHONE: (303) 866-3567**

<b>MINE NAME:</b> Bootleg Quarry	<b>MINE/PROSPECTING ID#:</b> M-2015-022	<b>MINERAL:</b> Sand and overburden	<b>COUNTY:</b> Adams
<b>INSPECTION TYPE:</b> Monitoring	<b>INSPECTOR(S):</b> Jared L. Ebert	<b>INSP. DATE:</b> September 14, 2017	<b>INSP. TIME:</b> 12:54
<b>OPERATOR:</b> Lazy H Inc	<b>OPERATOR REPRESENTATIVE:</b> None	<b>TYPE OF OPERATION:</b> 111 - Construction by Government Agency

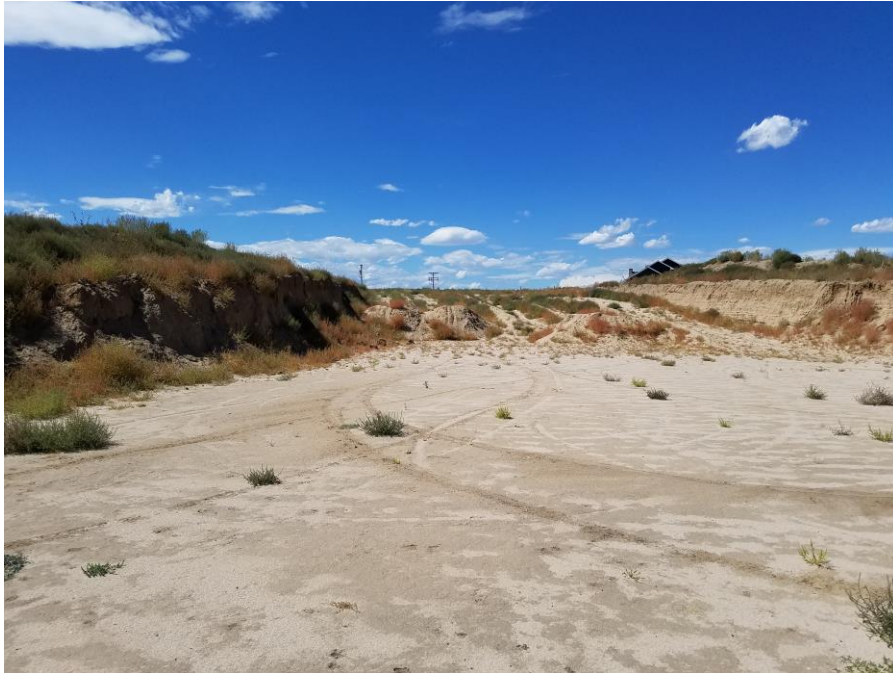
**Figure 1. From the east end of the excavation looking north.**

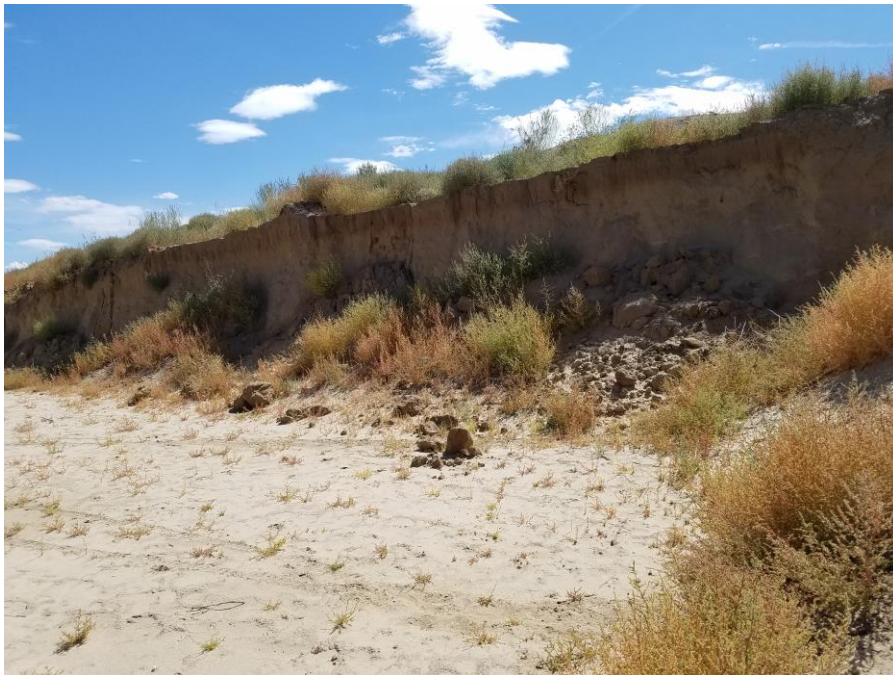
The Operator has created a small 1.25 acre excavation. The excavation daylights to the south and east. It appears the Operator has pushed the material down slope and hauled it off site leaving highwalls on the north and south side of the pit that are about 15 feet deep at the east end of the excavation. The excavation slopes to the east at a shallow 3H:1V ratio or less. No other grading work appears to have been done at the site.

**Figure 2. Southern highwall.**

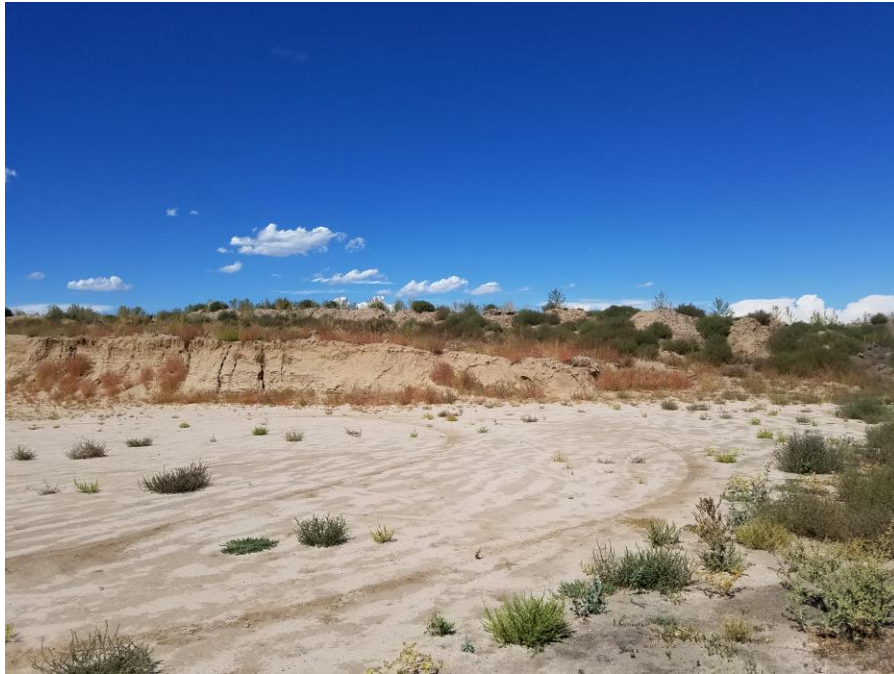
**Figure 3. Northern Highwall.**

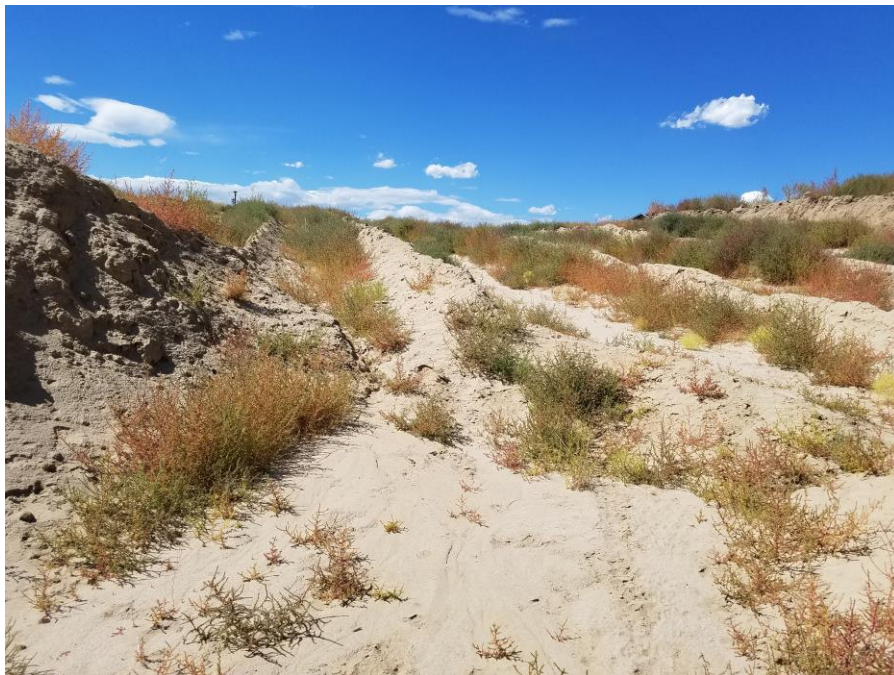
**Figure 4. Western Pit Slope.**
