**MINERALS PROGRAM INSPECTION REPORT**  
**PHONE: (303) 866-3567**

<b>MINE NAME:</b> SR-11 Mine	<b>MINE/PROSPECTING ID#:</b> M-1977-451	<b>MINERAL:</b> Uranium and vanadium	<b>COUNTY:</b> San Miguel
<b>INSPECTION TYPE:</b> Monitoring	<b>INSPECTOR(S):</b> Lucas J. West	<b>INSP. DATE:</b> September 13, 2017	<b>INSP. TIME:</b> 09:45
<b>OPERATOR:</b> Cotter Corporation	<b>OPERATOR REPRESENTATIVE:</b> DOE, Cotter Corporation	<b>TYPE OF OPERATION:</b> 112d-1 - Designated Mining Operation	
<b>REASON FOR INSPECTION:</b> Normal I&E Program	<b>BOND CALCULATION TYPE:</b> None	<b>BOND AMOUNT:</b> \$100.00	
<b>DATE OF COMPLAINT:</b> NA	<b>POST INSP. CONTACTS:</b> None	<b>JOINT INSP. AGENCY:</b> None	
<b>WEATHER:</b> Clear	<b>INSPECTOR'S SIGNATURE:</b>

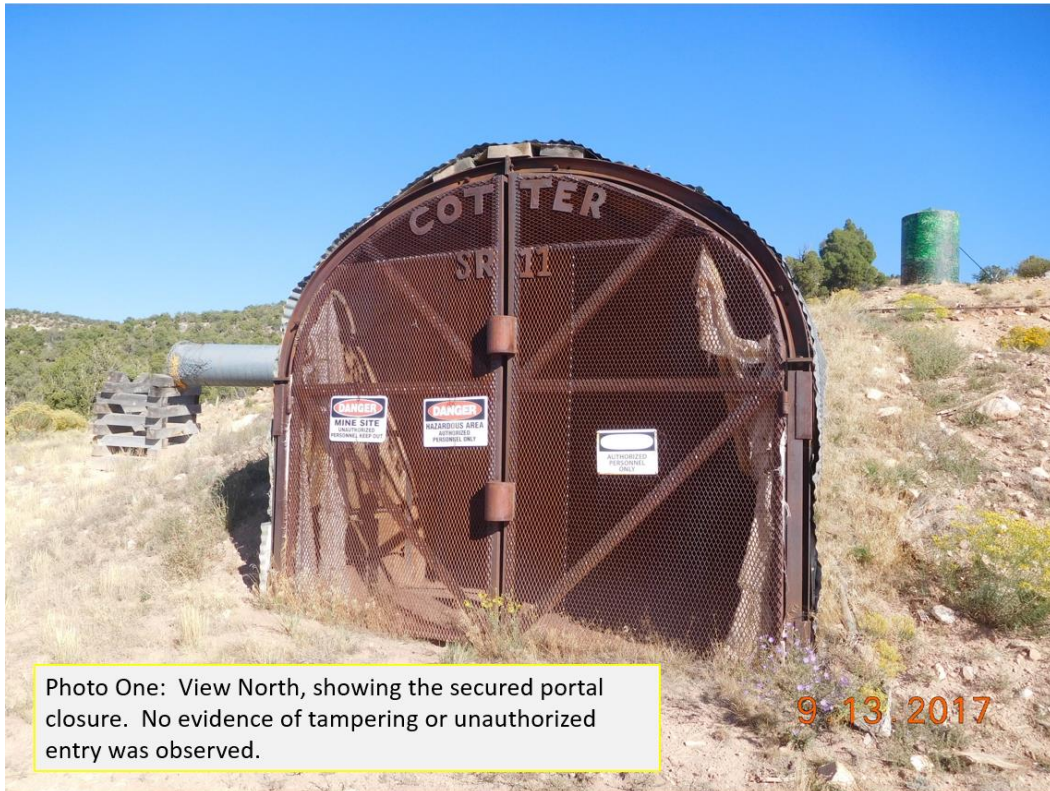
The proper mine identification signage was posted at the entrance to the site, and the permit boundaries are clearly marked. There was no equipment on site during the inspection. Due to the Court Action no activity has taken place on site since the previous inspection. This inspection was limited to the surface facilities. The portal has been secured by a locked gate shown in Photo One. The portal closure is in good condition and shows no signs of attempted unauthorized entry. Adjacent to the portal is an administrative office trailer which has also been secured. Photo Two shows the trailer, which is in good condition, the windows are all secured and the office remains vacant.

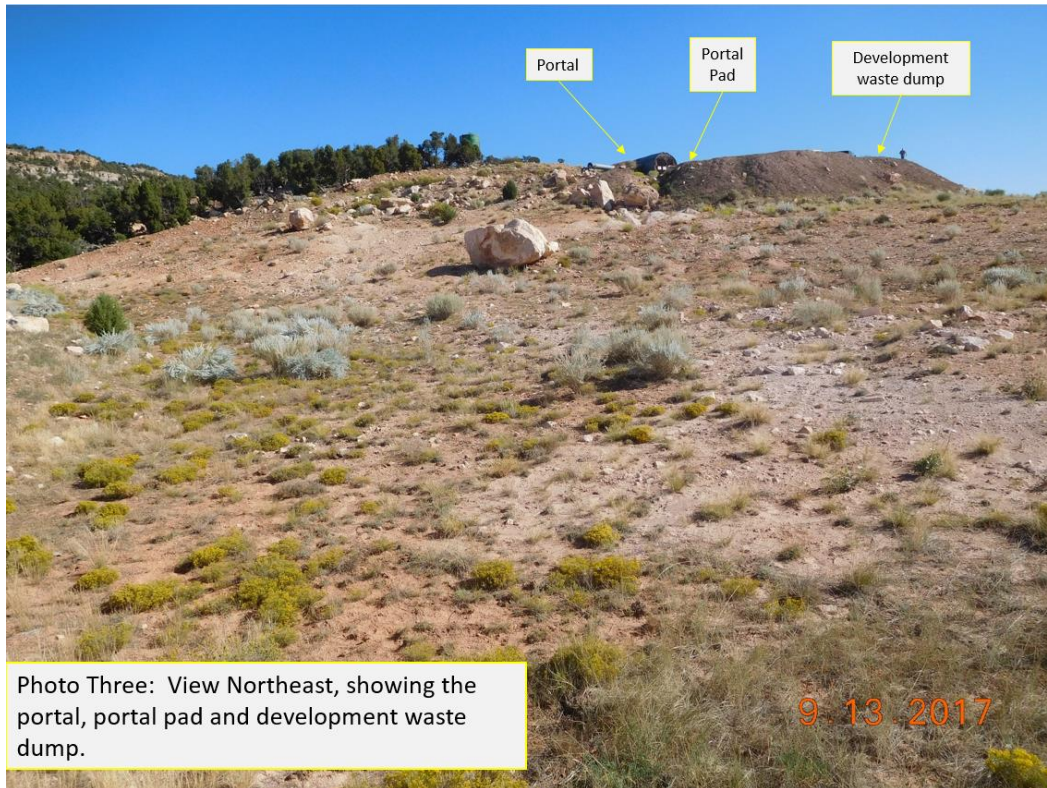
The portal pad and waste dump area consists of only development waste as the mine was never in production. The slopes of the waste dump are approximately at a 2H: 1V configuration and appear to be stable. The portal pad and waste dump can be seen in Photo Three. The slopes show minor signs of erosion but it has been stabilized by the vegetation and is in good condition. At the toe of the waste dump is the stripped area that has been prepped to expand the dump when the mine reactivates. A sediment ditch runs along the base of the waste dump conveying any storm water and sedimentation to the storm water collection basin. The basin and part of the collection ditch can be seen in Photo Four.
