**COLORADO**Division of Reclamation,
Mining and Safety

MINERALS PROGRAM INSPECTION REPORT**PHONE: (303) 866-3567**

MINE NAME: Zellitti Pit	MINE/PROSPECTING ID#: M-1980-246	MINERAL: Gravel	COUNTY: La Plata
INSPECTION TYPE: Monitoring	INSPECTOR(S): Lucas J. West	INSP. DATE: August 24, 2017	INSP. TIME: 10:31
OPERATOR: Anthony Zellitti	OPERATOR REPRESENTATIVE: None	TYPE OF OPERATION: 112c - Construction Regular Operation

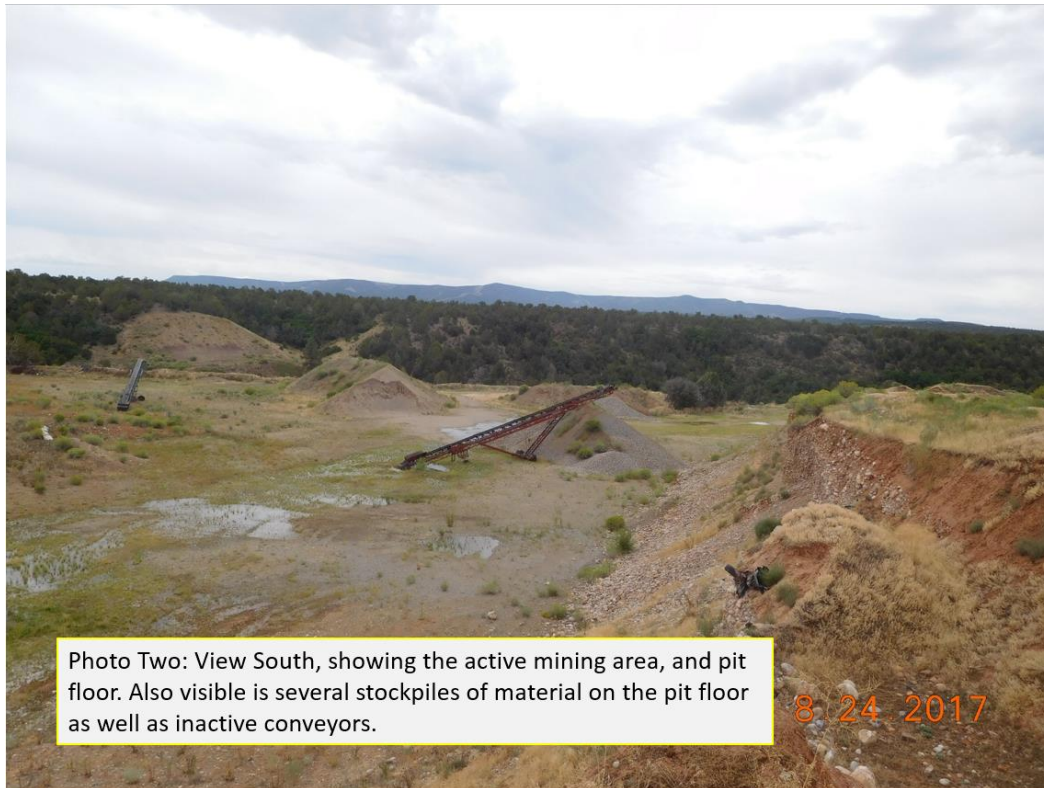
The active mining area consists of sloping highwall that can be seen in Photo Two. The highwall appears to be stable and at this time is showing no signs of settling, slumping or erosion. The adjacent slope which was previously mined can be seen in Photo Three is the location of the new access road. The road is in construction and will be used to access the pit floor once completed. The Pit floor is in good condition and has begun to revegetate itself with volunteer species. Several conveyors and stockpiles of materials are on the pit floor including overburden and salable materials and can also be seen in Photo One. Several other stockpiles exist throughout the site including various overburden and topsoil stockpiles that have been spread across the site for ease of reclamation. An example of the various stockpiles can be seen in Photo Four. All stockpiles on site appear to be stable and in good condition. A majority of the site has begun to revegetate itself with volunteer species. There are several large populations of Canada thistle onsite that show signs of treatment earlier in the summer. There was however a significant amount of new growth, and the Operator should consider completing a fall treatment and possibly removal effort in the coming weeks.

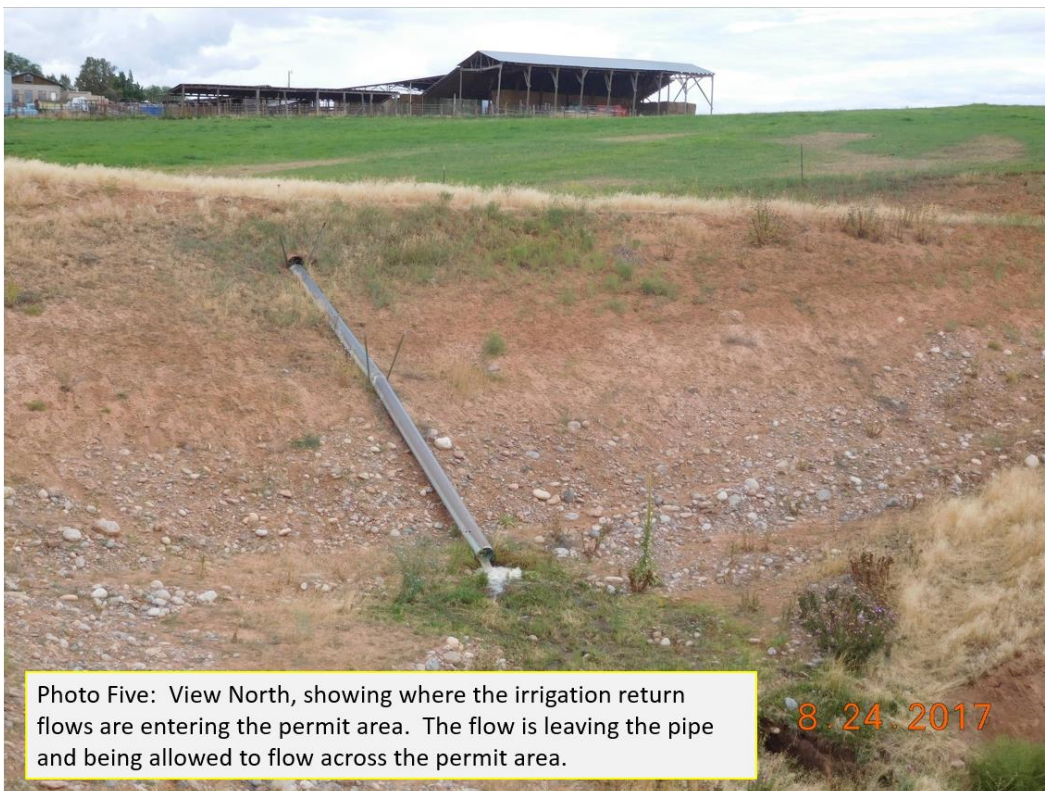
INSPECTION TOPIC: Hydrologic Balance**PROBLEM/POSSIBLE VIOLATION:** Problem: Irrigation runoff from the Zellitti farm was being allowed to flow unconfined across the permit area, creating potential erosion and stability problems to the slopes and the pit floor.**CORRECTIVE ACTIONS:** The irrigation flow should be either re-routed around the pit area, or confined into a pipe to be conveyed through the entire permit area to prevent any further degradation of the slopes or pit floor. Photo documentation of the completion of these corrective actions should be received within **30 days** of the date of this letter.**CORRECTIVE ACTION DUE DATE: 10/20/17**

At the Northwest corner of the pit, irrigation return flows from the Zellitti Farm is entering the permit area. Photo Five shows the point at which the flows leave the confinement of a pipe and are allowed to flow unconfined, down the slope to the pit floor, across the pit floor and eventually leaving the permit area to return to the creek. Photo Six shows the flow migrating across the pit floor. This is being cited as a problem as the continued flow of irrigation water will cause erosion of the pit slopes, saturation of the pit floor, and potentially compromise the stability of the slopes. The irrigation flow should be either re-routed around the

pit area, or confined into a pipe to be conveyed through the entire permit area to prevent any further degradation of the slopes or pit floor. Corrective actions should be taken immediately and photo documentation of the completion of these corrective actions should be received within **30 days** of the date of this letter. The Division should receive demonstration of compliance no later than **Friday October 20, 2017** to prevent further problems, possible violations and enforcement actions.

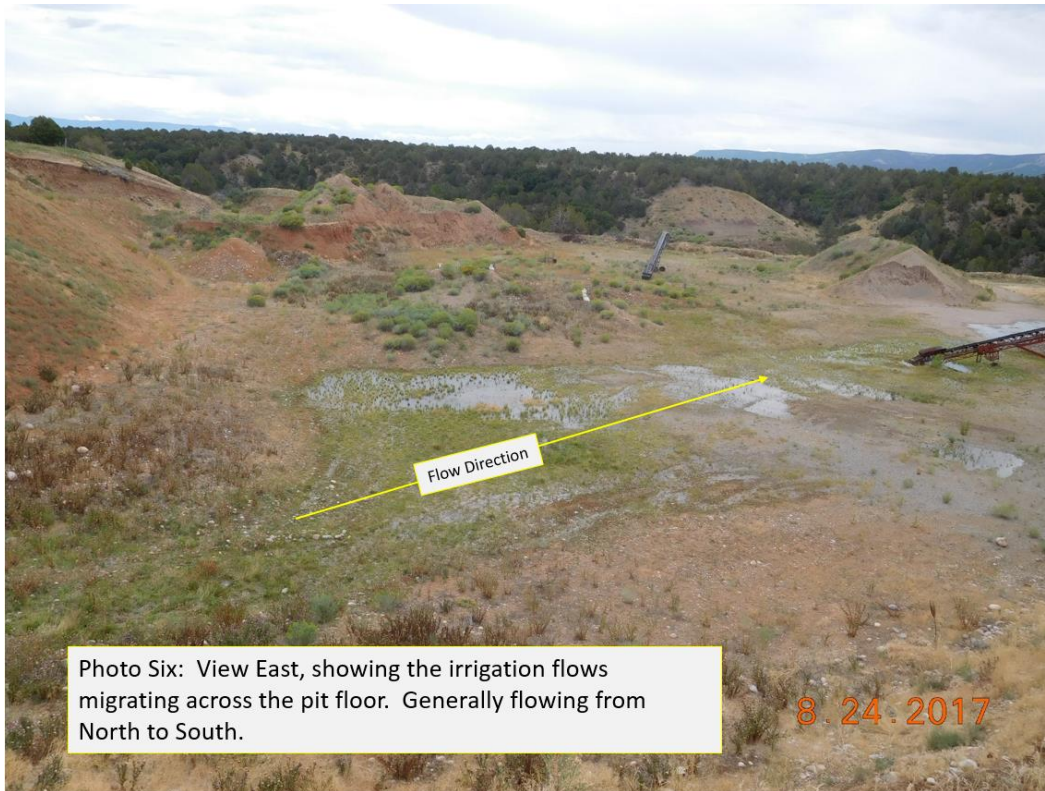
Photo Six: View East, showing the irrigation flows migrating across the pit floor. Generally flowing from North to South.
