MINERALS PROGRAM INSPECTION REPORT
PHONE: (303) 866-3567

MINE NAME: SR-11 Mine	MINE/PROSPECTING ID#: M-1977-451	MINERAL: Uranium and vanadium	COUNTY: San Miguel
INSPECTION TYPE: Monitoring	INSPECTOR(S): Lucas J. West	INSP. DATE: September 13, 2017	INSP. TIME: 09:45
OPERATOR: Cotter Corporation	OPERATOR REPRESENTATIVE: DOE, Cotter Corporation	TYPE OF OPERATION: 112d-1 - Designated Mining Operation	
REASON FOR INSPECTION: Normal I&E Program	BOND CALCULATION TYPE: None	BOND AMOUNT: \$100.00	
DATE OF COMPLAINT: NA	POST INSP. CONTACTS: None	JOINT INSP. AGENCY: None	
WEATHER: Clear	INSPECTOR'S SIGNATURE:

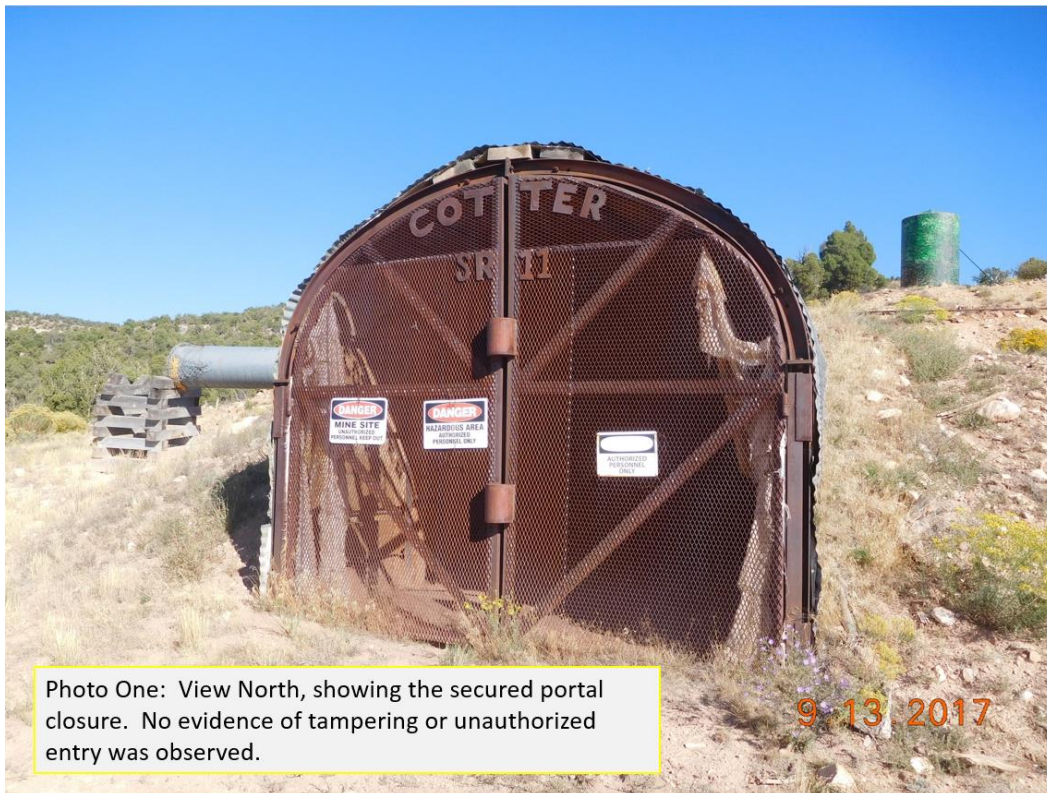
The proper mine identification signage was posted at the entrance to the site, and the permit boundaries are clearly marked. There was no equipment on site during the inspection. Due to the Court Action no activity has taken place on site since the previous inspection. This inspection was limited to the surface facilities. The portal has been secured by a locked gate shown in Photo One. The portal closure is in good condition and shows no signs of attempted unauthorized entry. Adjacent to the portal is an administrative office trailer which has also been secured. Photo Two shows the trailer, which is in good condition, the windows are all secured and the office remains vacant.
