MINERALS PROGRAM INSPECTION REPORT
PHONE: (303) 866-3567

MINE NAME: SR-13A Mine	MINE/PROSPECTING ID#: M-1977-311	MINERAL: Uranium and vanadium	COUNTY: San Miguel
INSPECTION TYPE: Monitoring	INSPECTOR(S): Lucas J. West	INSP. DATE: September 13, 2017	INSP. TIME: 10:51
OPERATOR: Cotter Corporation	OPERATOR REPRESENTATIVE: DOE, Cotter Corporation	TYPE OF OPERATION: 110d - Designated Limited Impact	
REASON FOR INSPECTION: Normal I&E Program	BOND CALCULATION TYPE: None	BOND AMOUNT: \$100.00	
DATE OF COMPLAINT: NA	POST INSP. CONTACTS: None	JOINT INSP. AGENCY: None	
WEATHER: Clear	INSPECTOR'S SIGNATURE:

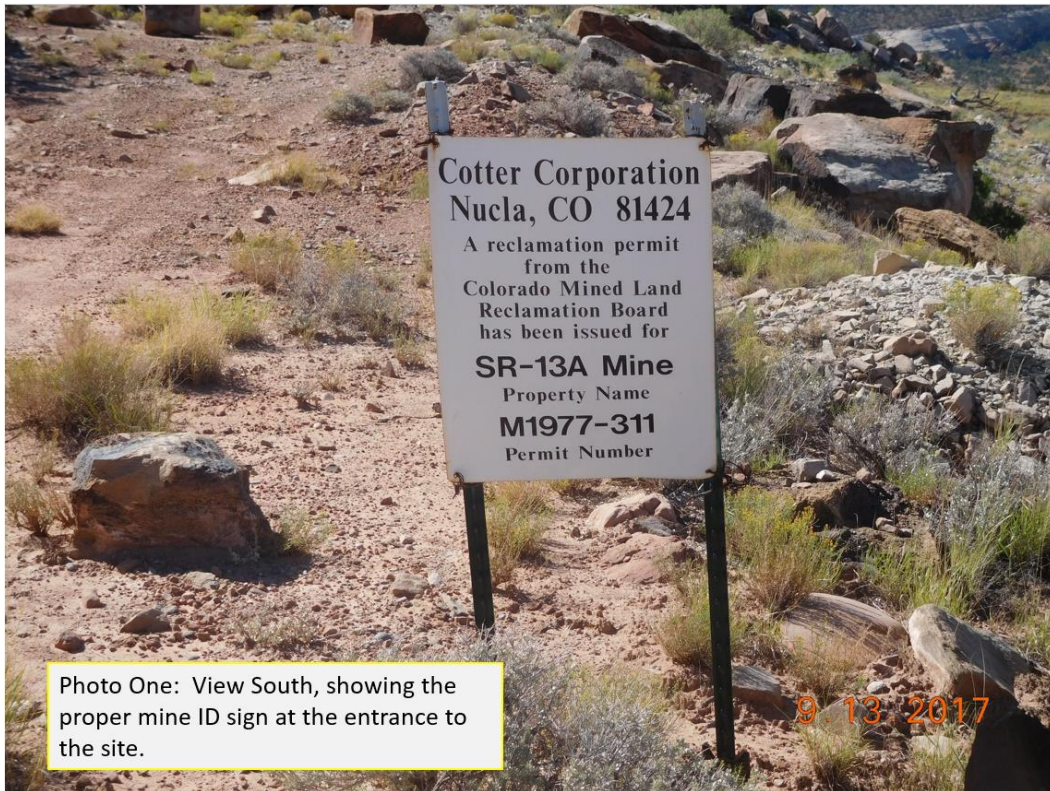
The proper mine identification signage was posted at the entrance to the site and can be seen in Photo One. There was no equipment on site and the site was not active during the inspection. Final reclamation has been completed at the site. Monitoring and active weed control is conducted by the DOE contractor, Navarro. The waste piles have on site have been graded to a 2H: 1V or shallower configuration and appear to be stable and in good condition. Examples of the reclaimed slopes can be seen in Photos Two and Three. The slopes were all "pocked" to prevent erosion and assist the vegetation growth. The slopes show no significant signs of erosion and the vegetation appears to be as good as or better than surrounding undisturbed areas. The vegetation is adequate in both density and diversity, and multiple years biomass was observed indicating it is self-sufficient.

Photo One: View South, showing the proper mine ID sign at the entrance to the site.

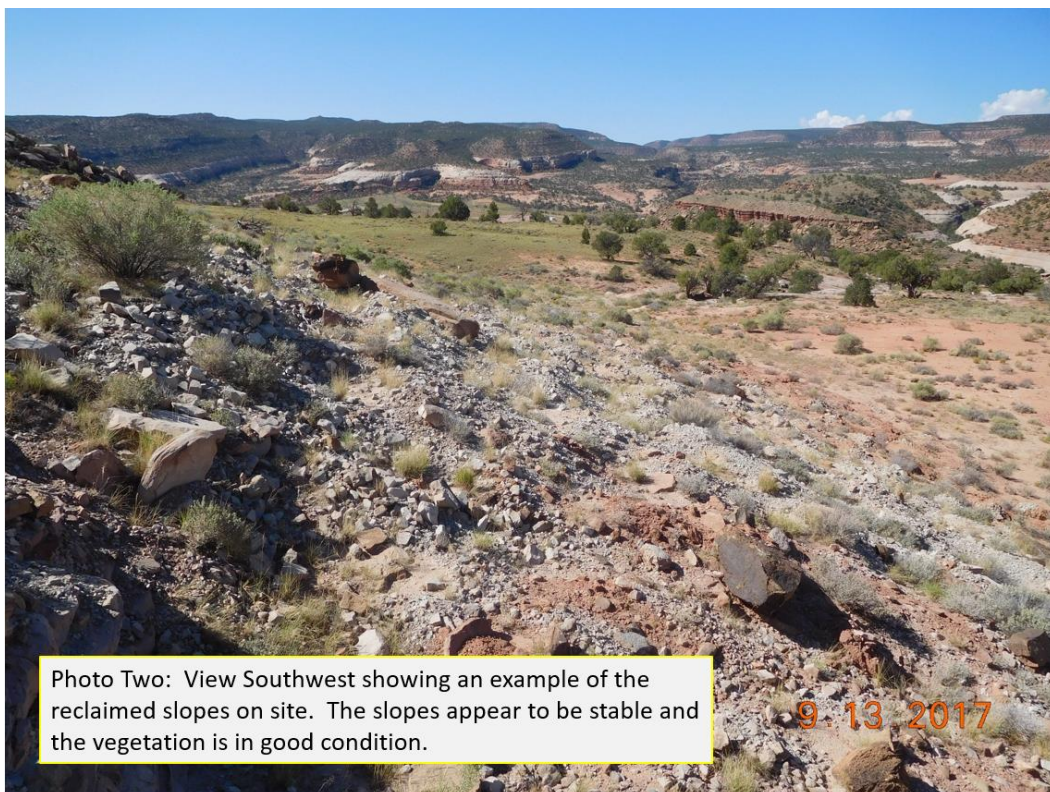
Photo Two: View Southwest showing an example of the reclaimed slopes on site. The slopes appear to be stable and the vegetation is in good condition.

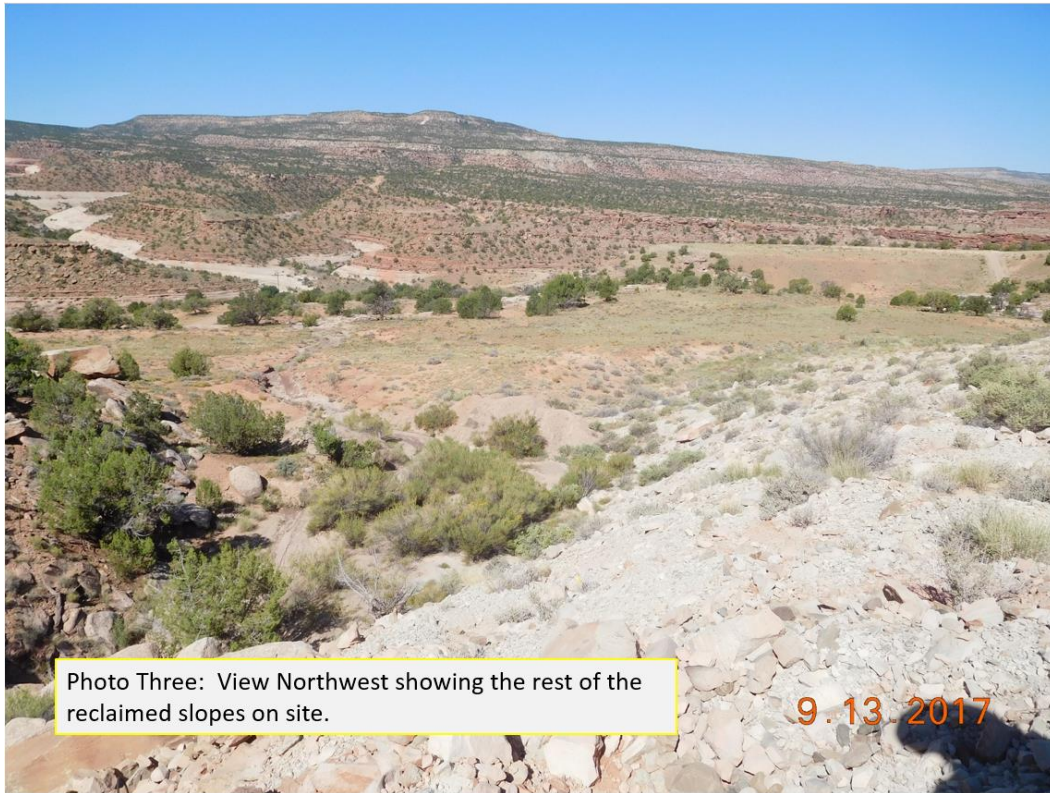
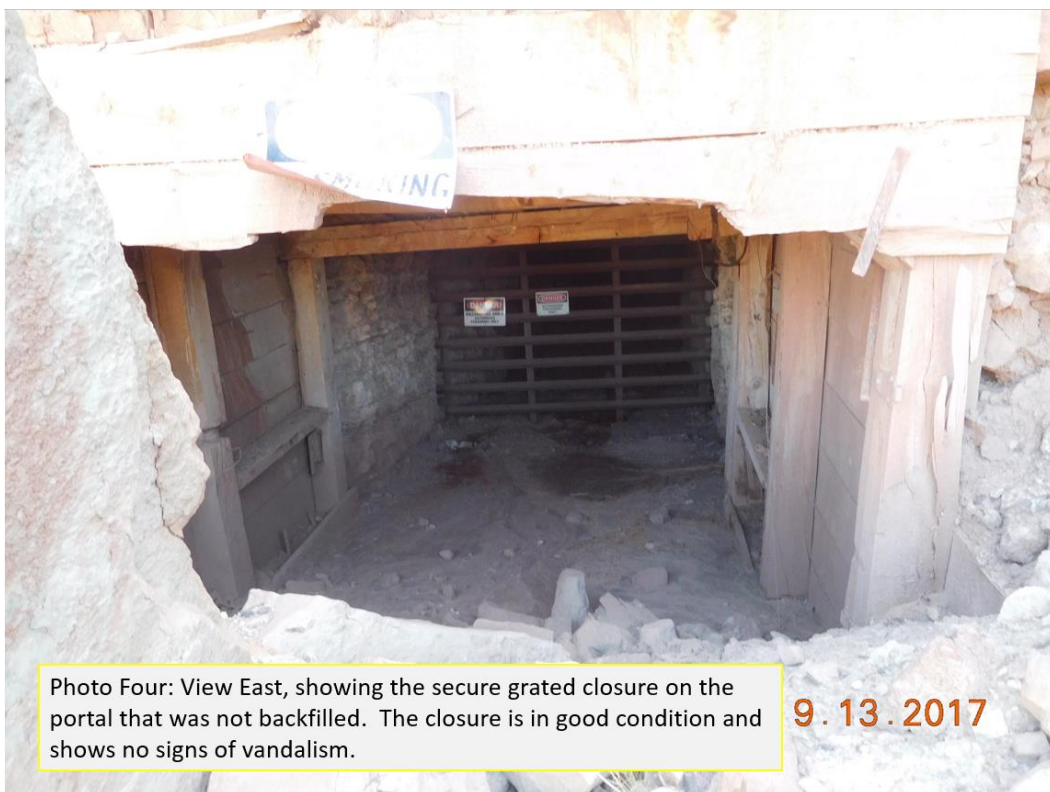
All but one of the access portals have been backfilled and secured on site. The backfilled portals have blended with the reclaimed lands so well, the Division was unable to locate the portals. The one portal that was not backfilled has been secured with a steel grated closure. The closure is very secure and shows no signs of vandalism or attempted unauthorized entry. The portal can be seen in Photo Four. Hanging above the portal is a large boulder being supported by steel cables. The cables and boulder have not shown signs of movement or degradation but monitoring efforts will continue.
