**PERMIT INFORMATION**

<b>Permit Number:</b> C-1981-012 <b>Mine Name:</b> New Elk Mine <b>Operator:</b> New Elk Coal Company, LLC <b>Operator Address:</b> Mr. Louis Head 12250 Highway 12 Weston, CO 81091	<b>County:</b> Las Animas <b>Operation Type:</b> Underground <b>Permit Status:</b> Active <b>Ownership:</b> Private
	<b>Operator Representative Present:</b>  Nick Mason, Louis Head
<b>Operator Representative Signature: (Field Issuance Only)</b>

**INSPECTION INFORMATION**

<b>Inspection Start Date:</b> September 21, 2017 <b>Inspection Start Time:</b> 14:20 <b>Inspection End Date:</b> September 22, 2017 <b>Inspection End Time:</b> 10:00		<b>Inspection Type:</b> Coal Partial Inspection <b>Inspection Reason:</b> Normal I&E Program <b>Weather:</b> Clear	
<b>Joint Inspection Agency:</b>  None		<b>Joint Inspection Contacts:</b>  	
<b>Post Inspection Agency:</b>  None		<b>Post Inspection Contacts:</b>  	
<b>Inspector(s):</b>  Robert D. Zuber, P.E.	<b>Inspector's Signature:</b>

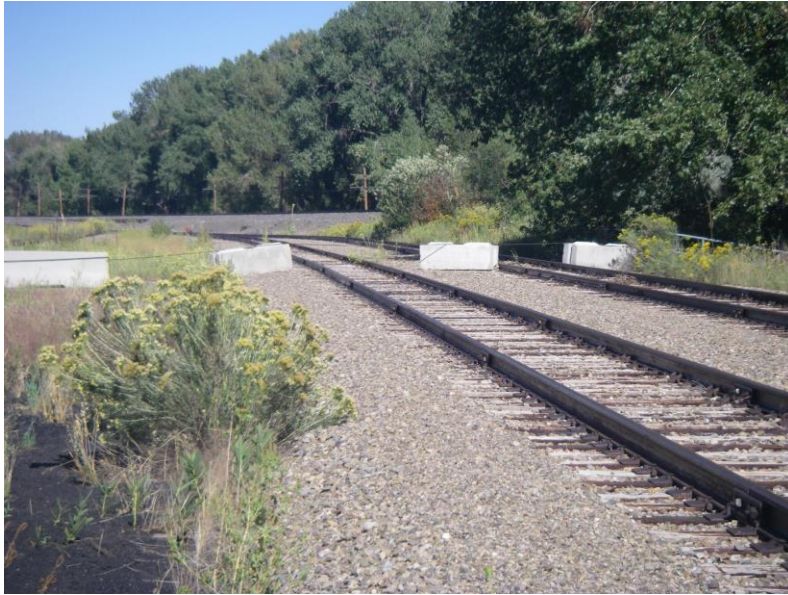
**East end of loadout**

No large weed patches were seen at the Jansen Loadout, but Mullein was seen in significant numbers all around the site. At the west end of the loadout, no signs of pollutant loading onto adjacent land was seen. Coal residue is still present at both ends of the loadout.

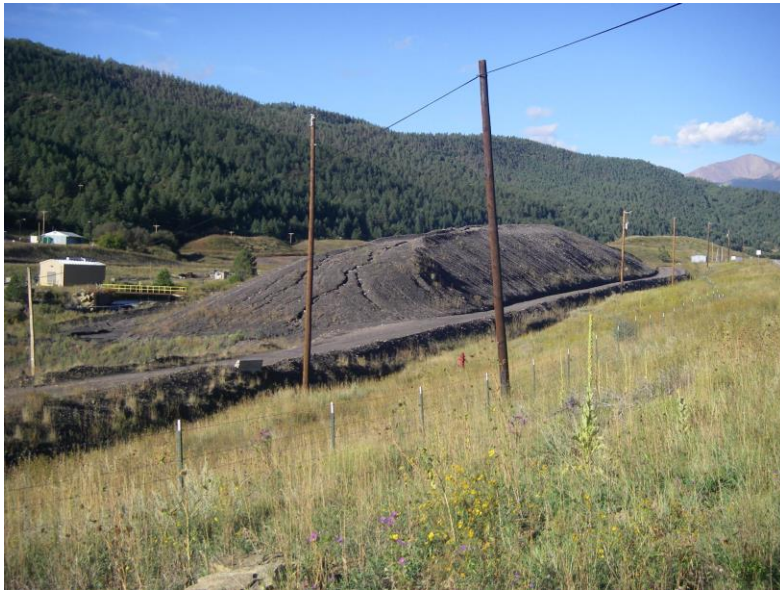
**East and north sides of DWDA#2**

Erosion on DWDA#2 does not appear to have gotten worse in 2017, and the sump below it did not need maintenance.

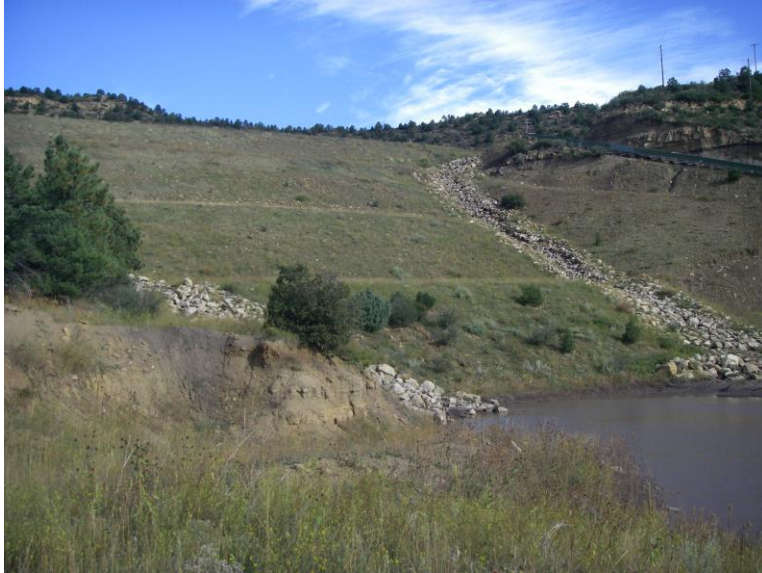
**RDA**

There is good vegetation cover on the reclaimed portion of the RDA, and no rills or gullies were seen on the face or in the side ditches.

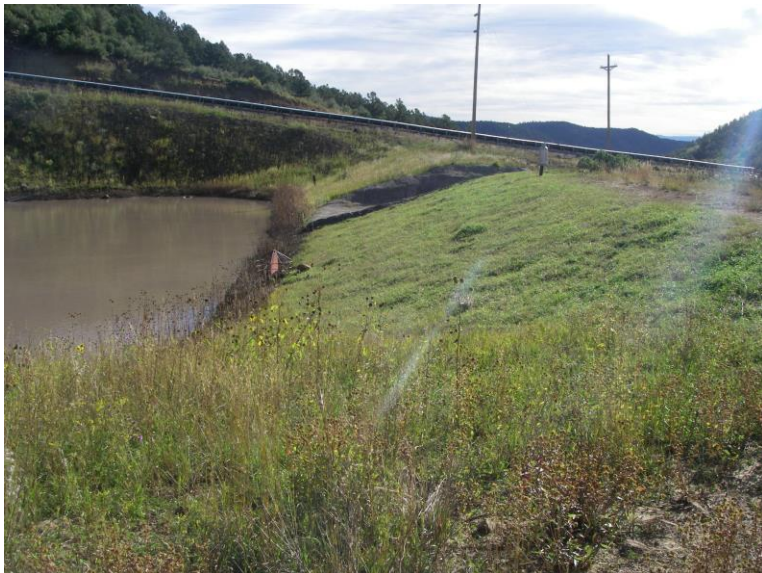
**Pond 08 embankment**

Ponds 004A, 007A, and 08 were inspected. None of them were discharging, but all held significant quantities of water. The impounded water was very high in Pond 007A (above the primary spillway entirely) due to rains. The water in Pond 004A (level was approximately two feet below the spillway holes) was pumped there by NECC staff to lower the water in Ponds 006A and 08. No significant issues were seen with the pond spillways or embankments.
