MINERALS PROGRAM INSPECTION REPORT**PHONE: (303) 866-3567**

MINE NAME: Snyder Quarry	MINE/PROSPECTING ID#: M-1977-210	MINERAL: Limestone (general)	COUNTY: El Paso
INSPECTION TYPE: Monitoring	INSPECTOR(S): Timothy A. Cazier	INSP. DATE: June 30, 2016	INSP. TIME: 13:00
OPERATOR: Continental Materials Corporation	OPERATOR REPRESENTATIVE: Andre Laroche & Bruce Humphries	TYPE OF OPERATION: 112c - Construction Regular Operation

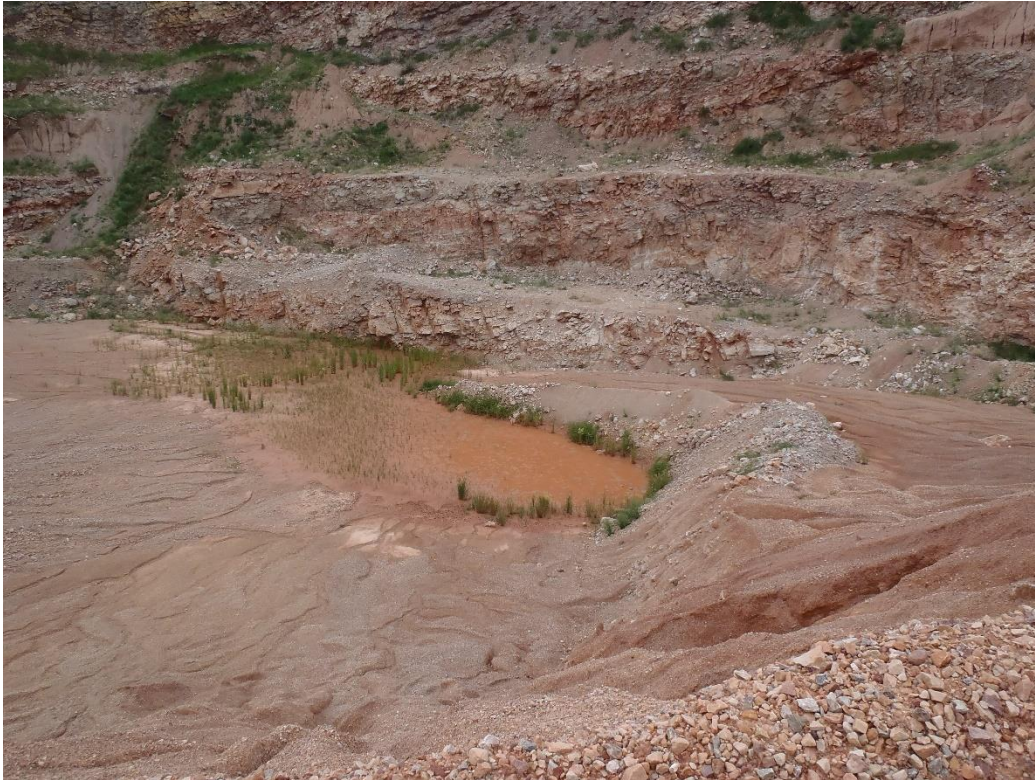
Hydrologic Balance: Standing water was observed in the pit (see **Photo 1**) as a result of recent rain. It was determined not to be groundwater.

Photo 1. Stormwater observed in the pit.

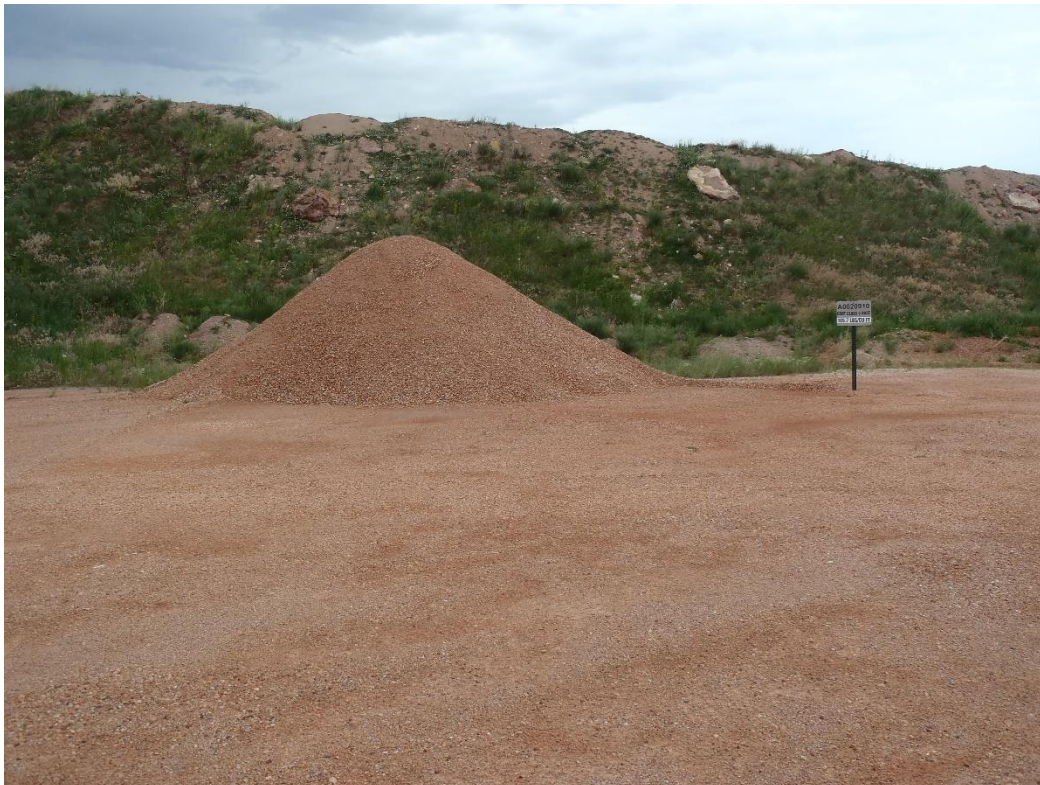
Gen. Compliance with Mine Plan: The operation appeared to be in compliance with the approved mine plan. Mr. Laroche indicated Continental Materials is finished with extraction of material and are only hauling material off site from the remaining stockpiles (**Photos 2 and 3**). Highwalls were benched, appeared stable and varied between 80 and 100 feet in height. Continental Materials may do some additional blasting for reclamation purposes.

Photo 2. Typical remaining material stockpile (1 of 2, note ID sign on right).

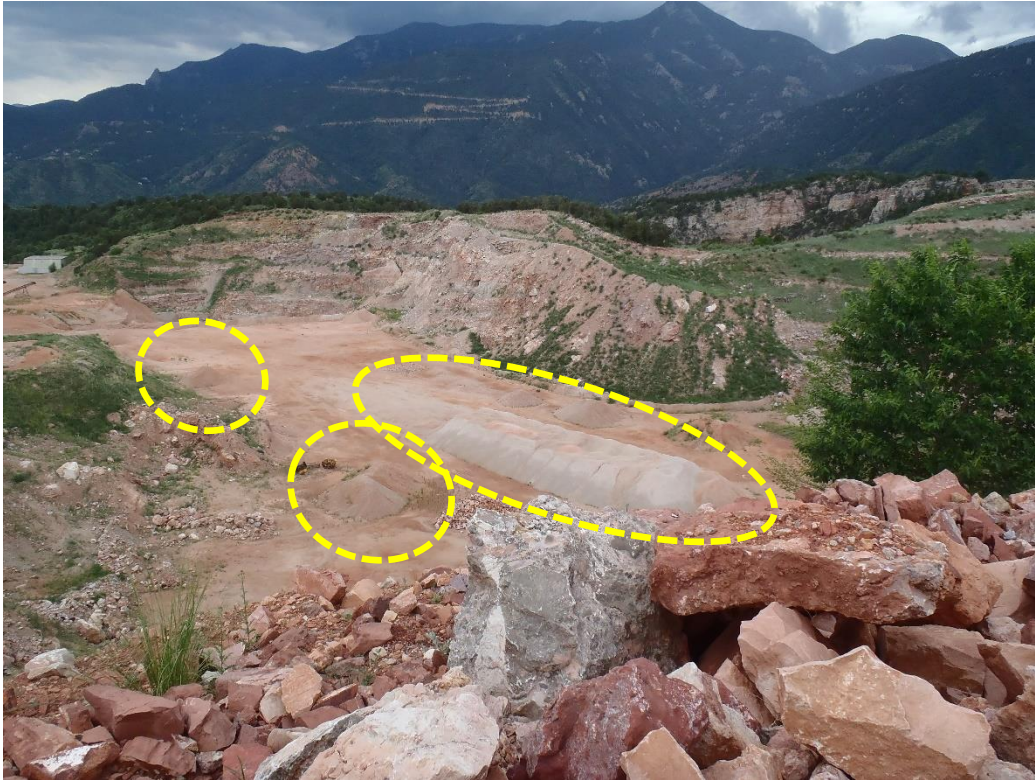
Photo 3. Typical remaining material stockpiles (2 of 2, from above north pit).

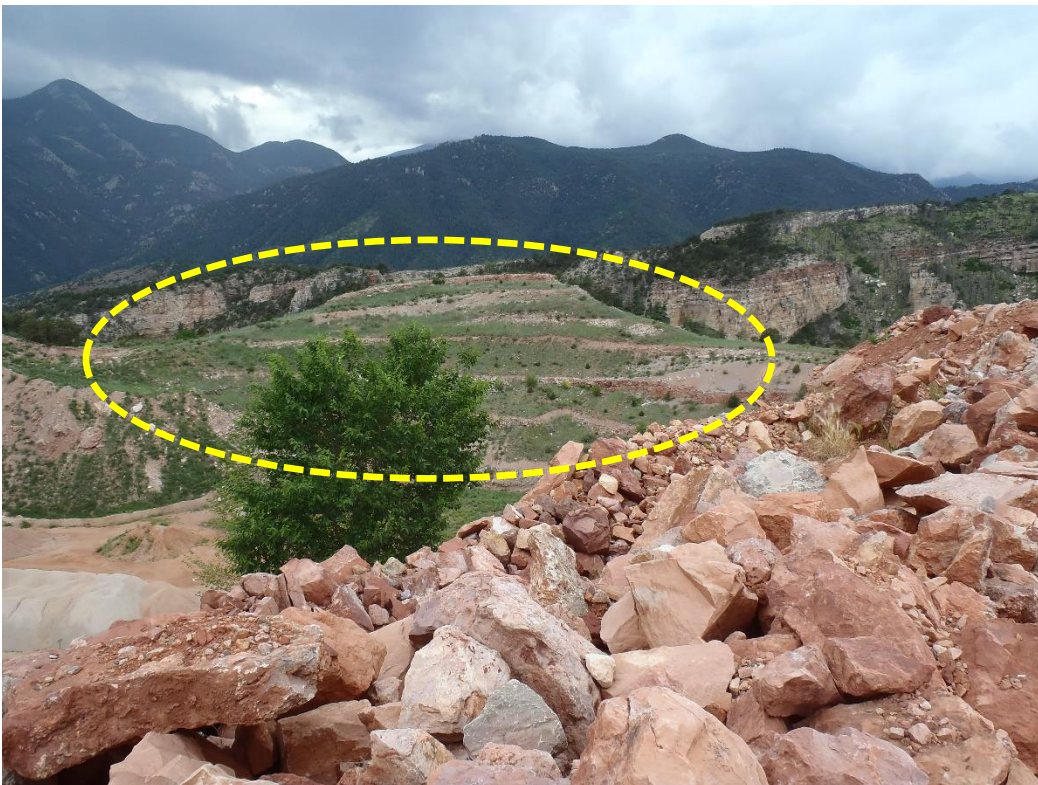
Reclamation Success: Reclamation has begun. The west highwall benches in the south pit have been backfilled, topsoiled and seeded (see **Photo 4**). Additional reclamation work is needed.

Photo 4. Reclaimed benched west highwall – south pit (looking west).

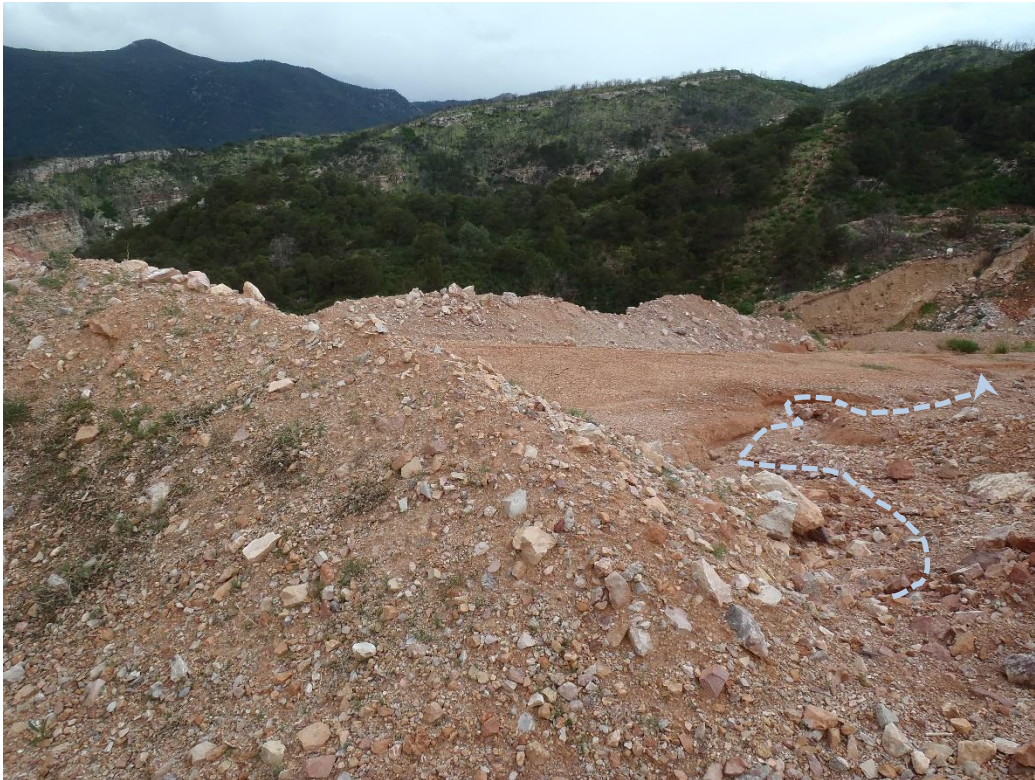
Sediment Control: Some erosion problems were observed in the haul roads (**Photo 5**) and some areas of the backfilled highwalls. The DRMS determined no BMPs were needed at the time of the inspection as the sediment was directed towards the pit and did not appear to have potential to migrate offsite.

Photo 5. Erosion gully in haul road between north and south pits.

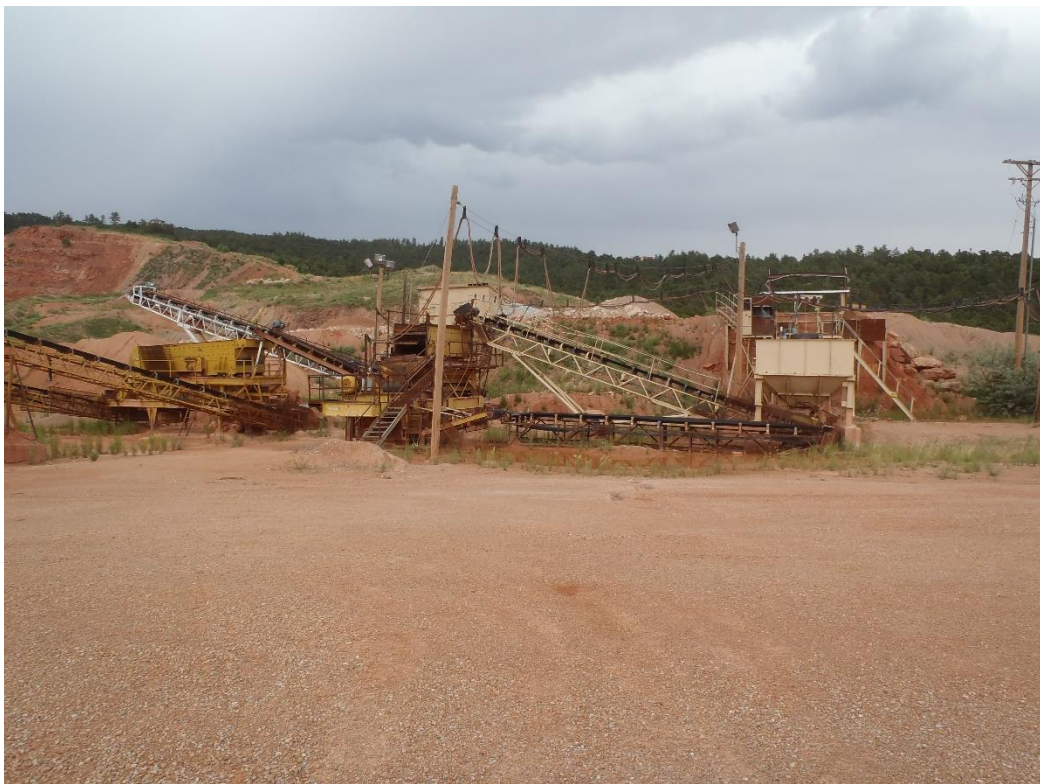
Support Facilities On-site: A screen plant, crusher, and conveyors were observed on site (see **Photo 6**).

Photo 6. Screen plant, conveyor, and crusher (south pit, looking SE).

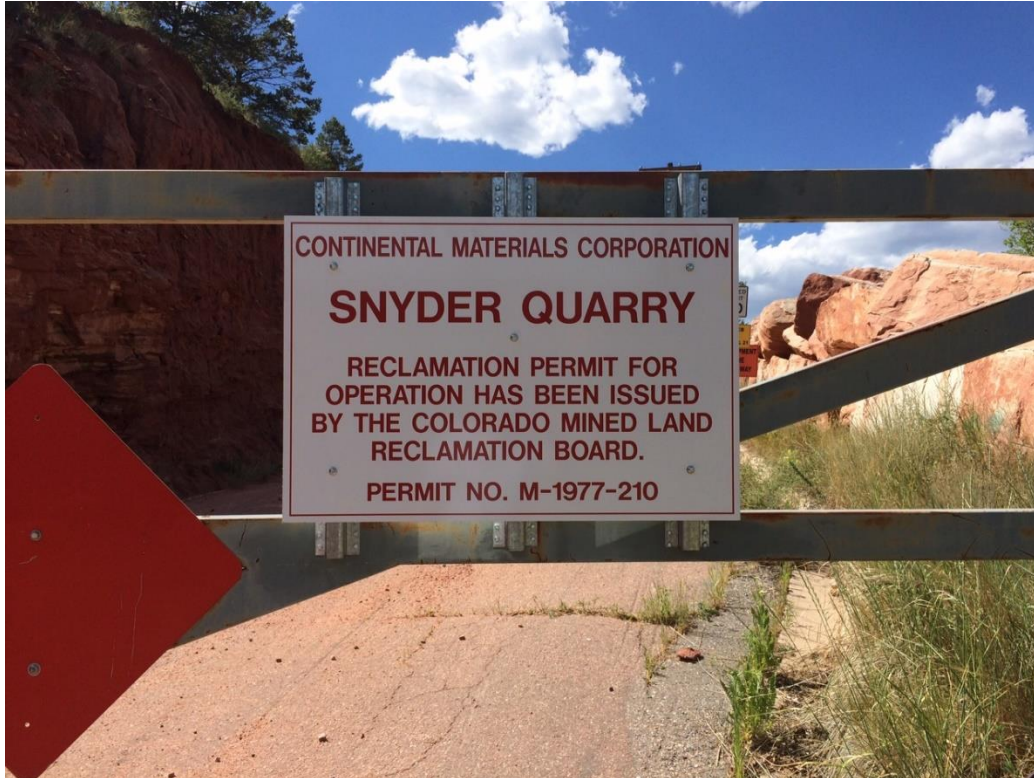
Signs and Markers: The permit sign was missing during the inspection. The Permittee provided photographic documentation of posting the sign about a week after the inspection (see **Photo 7**). The north and south permit boundary markers were not readily observable during the inspection. About a week after the inspection Mr. Laroché committed to identify/mark these permit boundaries on the property by July 29, 2016. The DRMS has not received confirmation that this was accomplished. **This is cited as a Problem on p. 1 of this report.**

Photo 7. Permit sign replaced – post inspection.
