MINERALS PROGRAM INSPECTION REPORT**PHONE: (303) 866-3567**

MINE NAME: Henderson Mine	MINE/PROSPECTING ID#: M-1977-342	MINERAL: Molybdenum	COUNTY: Clear Creek, Grand
INSPECTION TYPE: Monitoring	INSPECTOR(S): Peter S. Hays	INSP. DATE: September 21, 2017	INSP. TIME: 10:00
OPERATOR: Climax Molybdenum Company	OPERATOR REPRESENTATIVE: Amber Parmet, Miguel Hamarat	TYPE OF OPERATION: 112d-3 - Designated Mining Operation	
REASON FOR INSPECTION: Normal I&E Program	BOND CALCULATION TYPE: None	BOND AMOUNT: \$37,993,785.00	
DATE OF COMPLAINT: NA	POST INSP. CONTACTS: None	JOINT INSP. AGENCY: None	
WEATHER: Clear	INSPECTOR'S SIGNATURE:

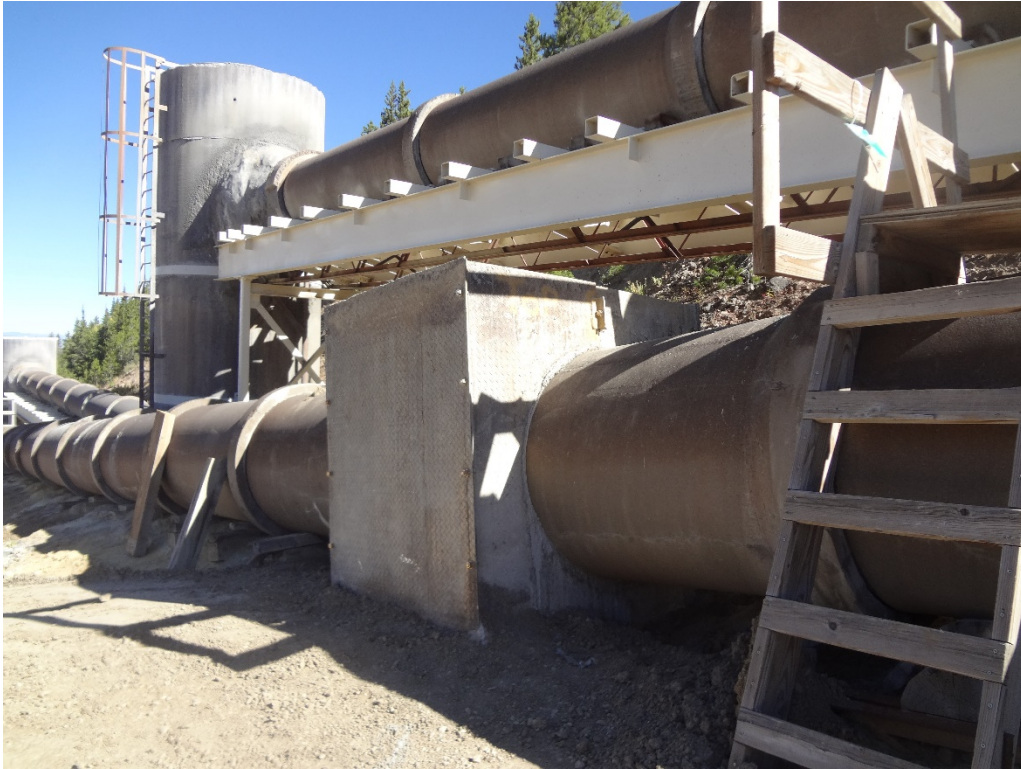
On September 14, 2017, Henderson staff reported a release of process water from the Tailings Delivery Line (TDL) by telephone as required by Rule 8.2.1. The required written follow-up notice, pursuant to Rule 8.2.3, was received by email on September 19, 2017 and a hard copy of the notice was hand delivered to the Division during the inspection. The process water leaked from a deteriorated seal at a joint in the RCP in the emergency cutout (ECO) section of the TDL. The joint in the ECO was repaired with a poured concrete block surrounding the entire joint. The released process water followed the alignment along the TDL to the culvert under County Road 3. The construction of an earthen berm along the downhill side of the TDL to divert any future process water releases from the TDL was discuss during the inspection. The berm would be designed as part of the TDL environmental protection facility, which would require a technical revision to the approved EPP for the site.

View of repaired joint in ECO RCP joint

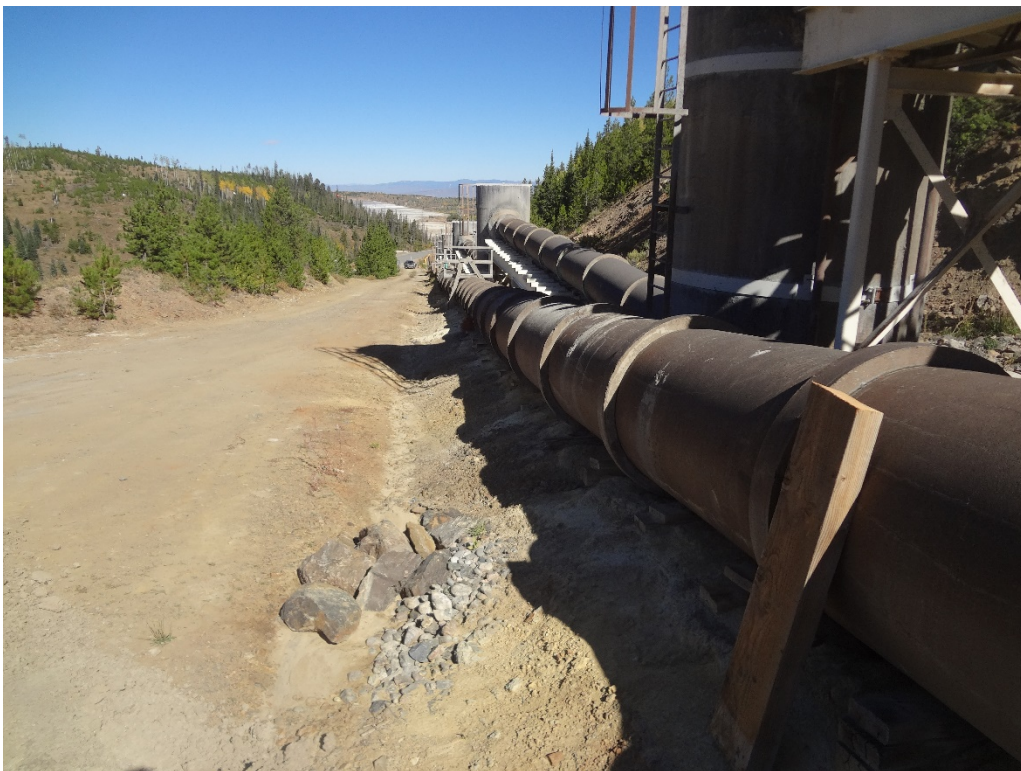
View of the ECO process water leak path looking north toward tailings impoundment

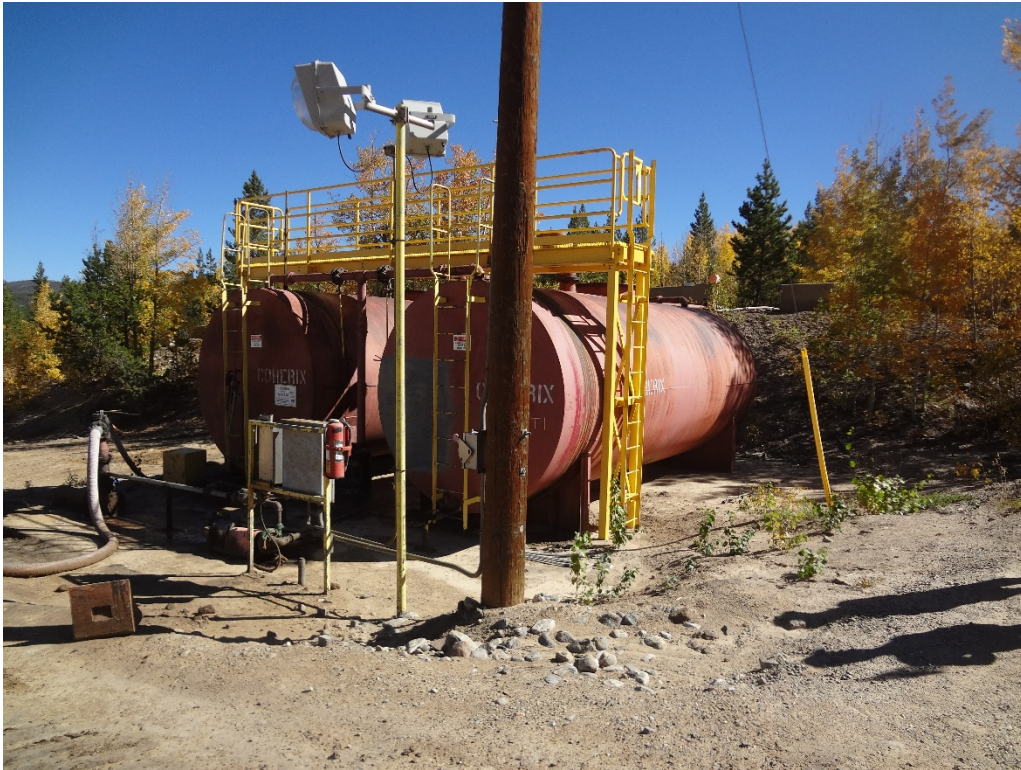
Coherex storage tanks

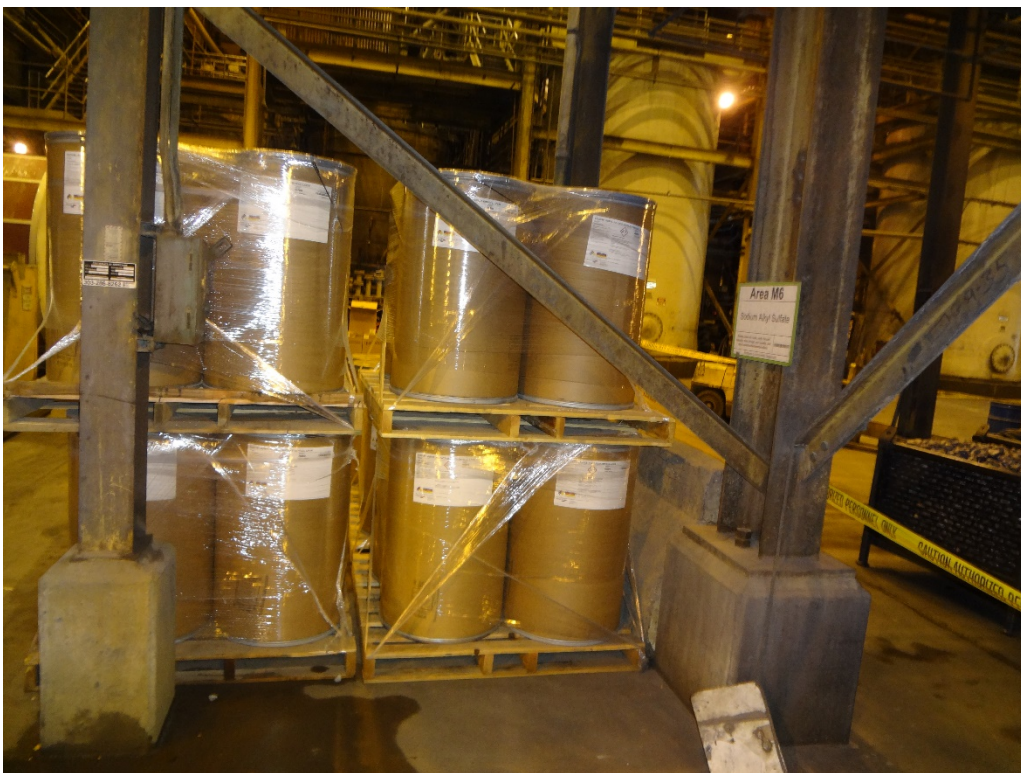
Sodium Lauryl Sulfate storage area
