MINERALS PROGRAM INSPECTION REPORT
PHONE: (303) 866-3567

MINE NAME: Burros Mine	MINE/PROSPECTING ID#: M-1977-297	MINERAL: Uranium and vanadium	COUNTY: San Miguel
INSPECTION TYPE: Monitoring	INSPECTOR(S): Lucas J. West	INSP. DATE: September 13, 2017	INSP. TIME: 11:30
OPERATOR: Gold Eagle Mining, Inc.	OPERATOR REPRESENTATIVE: DOE	TYPE OF OPERATION: 110d - Designated Limited Impact	
REASON FOR INSPECTION: Normal I&E Program	BOND CALCULATION TYPE: None	BOND AMOUNT: \$100.00	
DATE OF COMPLAINT: NA	POST INSP. CONTACTS: None	JOINT INSP. AGENCY: None	
WEATHER: Clear	INSPECTOR'S SIGNATURE:

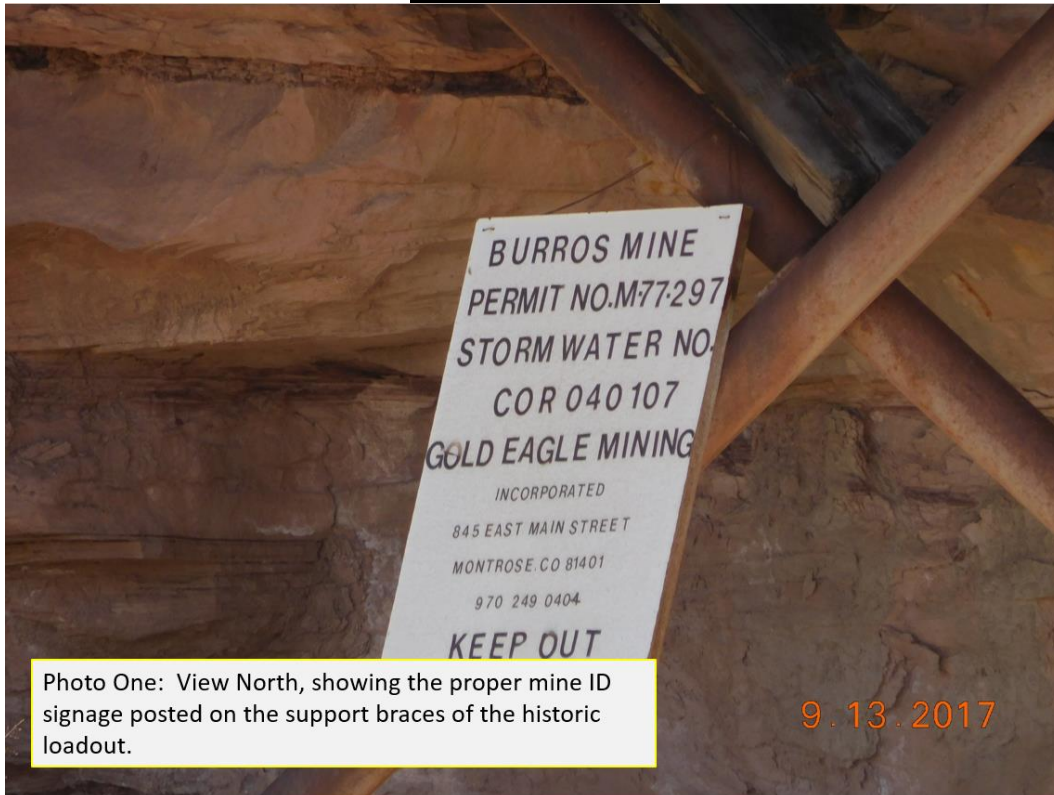
The proper mine identification signage was posted at the entrance to the site and can be seen in Photo One. The sign is posted on a historical loadout that is within the permitted area. The loadout appears to be stable and in a similar condition to the previous inspection conducted by the Division. The only work that is approved to take place on the site is ongoing weed management and the maintenance of the storm water controls on site. The storm water controls that were observed appear to be stable and functioning as designed. They will however require maintenance soon as there have been recent precipitation events in the area that have impacted the features. Photo Two shows part of the storm water control ditch and part of one of the sediment pond near the historic loadout. The remaining storm water control features up gradient were in similar condition and require maintenance. The upper sediment pond may require the installation of a rock check dam where flow leaves the sediment pond and enters the storm water control ditch.

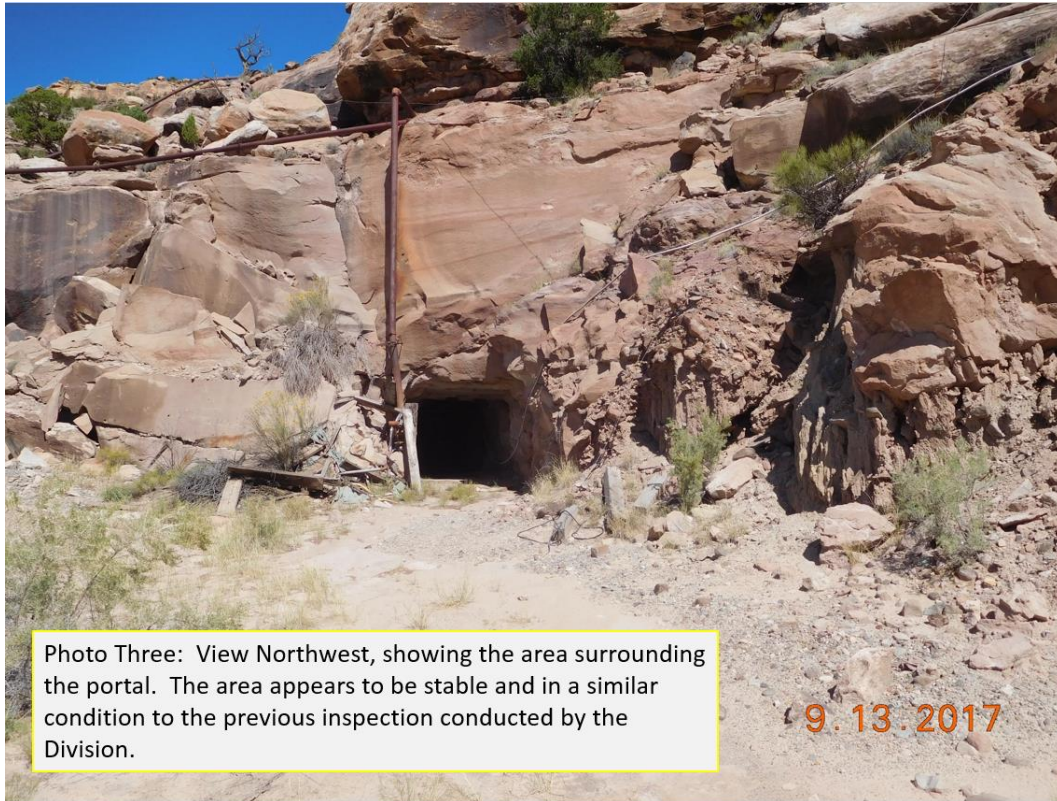
Photo Three: View Northwest, showing the area surrounding the portal. The area appears to be stable and in a similar condition to the previous inspection conducted by the Division.

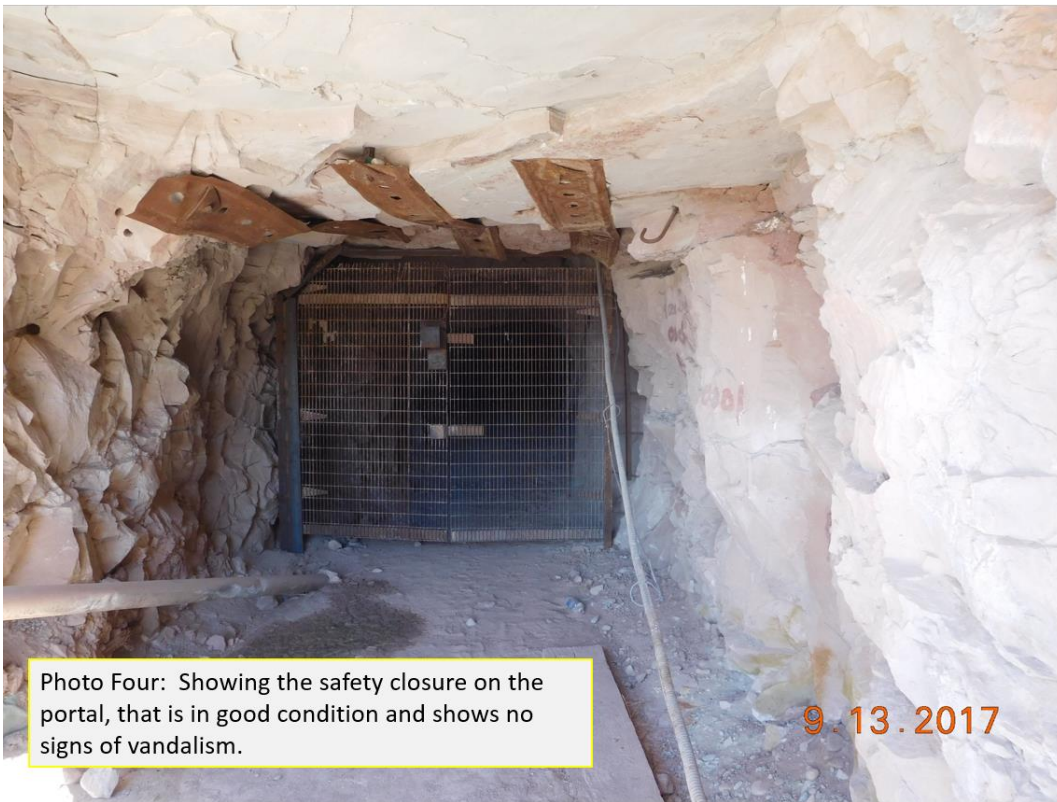
The portal has been secured with a safety closure to prevent entry. The closure is a locked steel grate closure that is in good condition and shows no signs of attempted unauthorized entry. Various pipes, lines and historic debris surround the portal and all appear to be stable and in a similar condition from the Division's previous inspection. The closure and the surrounding area can be seen in Photos Three and Four. The vent shaft located up gradient from the portal adjacent to the access road was observed and is secure.

Photo Four: Showing the safety closure on the portal, that is in good condition and shows no signs of vandalism.
