**MINERALS PROGRAM INSPECTION REPORT**  
**PHONE: (303) 866-3567**

<b>MINE NAME:</b> Hawkeye Mine	<b>MINE/PROSPECTING ID#:</b> M-1978-311	<b>MINERAL:</b> Uranium and vanadium	<b>COUNTY:</b> San Miguel
<b>INSPECTION TYPE:</b> Monitoring	<b>INSPECTOR(S):</b> Lucas J. West	<b>INSP. DATE:</b> September 13, 2017	<b>INSP. TIME:</b> 13:30
<b>OPERATOR:</b> Gold Eagle Mining, Inc.	<b>OPERATOR REPRESENTATIVE:</b> DOE	<b>TYPE OF OPERATION:</b> 110d - Designated Limited Impact	
<b>REASON FOR INSPECTION:</b> Normal I&E Program	<b>BOND CALCULATION TYPE:</b> None	<b>BOND AMOUNT:</b> \$100.00	
<b>DATE OF COMPLAINT:</b> NA	<b>POST INSP. CONTACTS:</b> None	<b>JOINT INSP. AGENCY:</b> None	
<b>WEATHER:</b> Clear	<b>INSPECTOR'S SIGNATURE:</b>

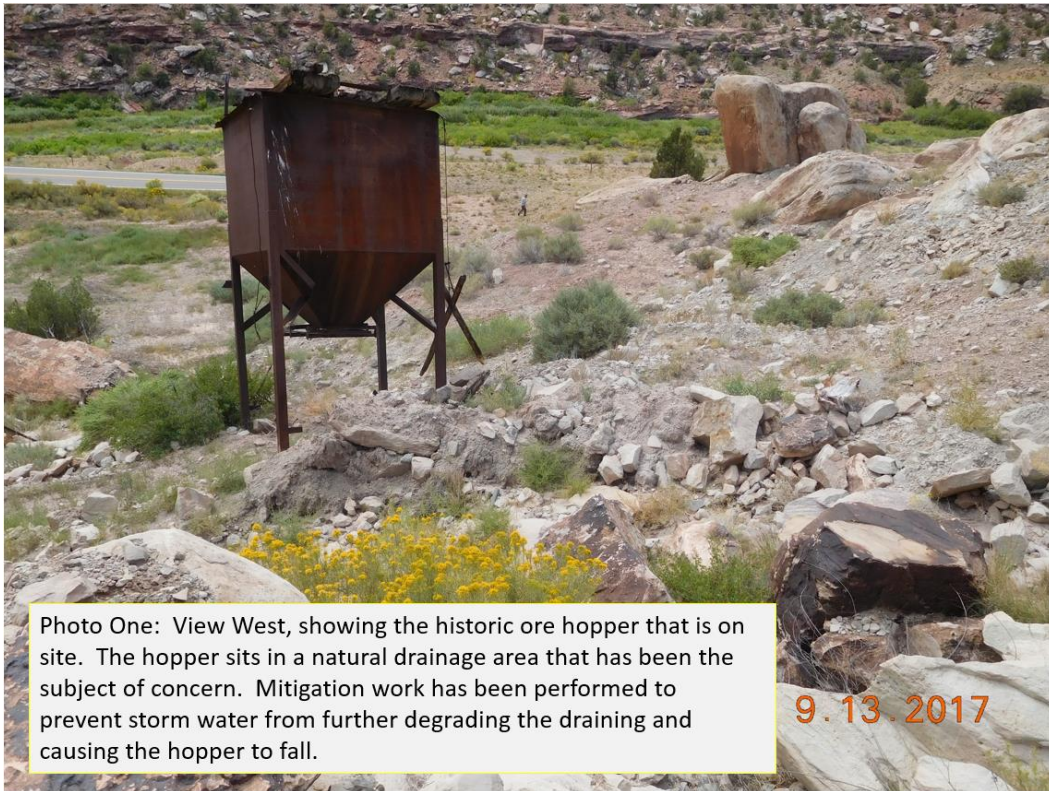
The site includes a steel ore hopper, as seen in Photo One. The hopper is empty and free standing in a natural drainage located on the site. Discussions with the Operator indicate they would like to do some stabilization work to ensure it does not fall over, however due to the injunction, the work cannot commence. Also located on site is the historic waste rock pile that had been recontoured and topsoiled some time ago. Photo Two shows the waste rock pile that is well vegetated and stable. There is a secured portal onsite leading to the underground workings that is closed with a welded steel closure. The portal closure, seen in Photo Three, is stable and in good condition. It shows no signs of vandalism or attempted unauthorized entry. The road leading up to the portal is showing signs of minor erosion and should be closely monitored.

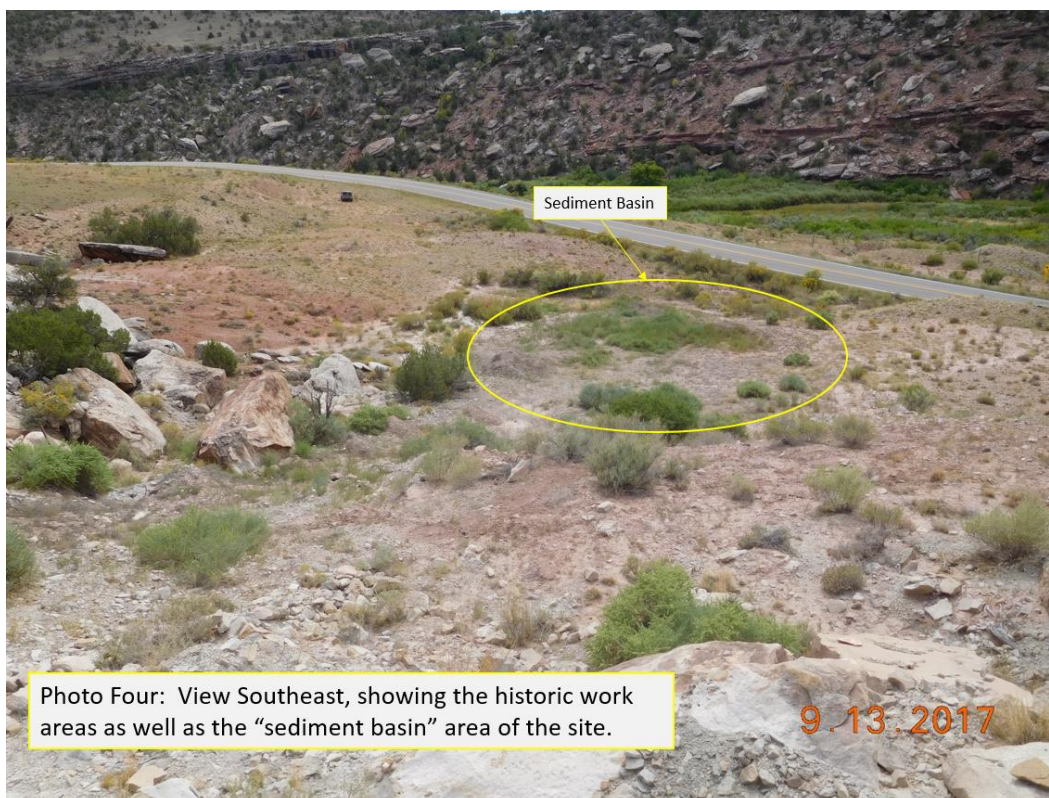
The overall footprint of the site was in good condition and was free from trash and debris. The site exhibits positive drainage and no significant erosion was observed during this inspection. The lower area as well as the natural benches contained within the site are well vegetated and stable. No problems or possible violations were found during this inspection. All responses to this report should be directed to Lucas West at the Division of Reclamation, Mining and Safety at 1313 Sherman Street, Room 215, Denver, CO 80203 or by phone at (970)-243-6368.
