**COLORADO**Division of Reclamation,
Mining and Safety

MINERALS PROGRAM INSPECTION REPORT**PHONE: (303) 866-3567**

| MINE NAME: Gloria Z Mine | MINE/PROSPECTING ID#: M-1984-094 | MINERAL: Sand, gravel & gold | COUNTY: Park |
| INSPECTION TYPE: Surety-Related Inspection | INSPECTOR(S): Michael A. Cunningham | INSP. DATE: September 7, 2017 | INSP. TIME: 09:00 |

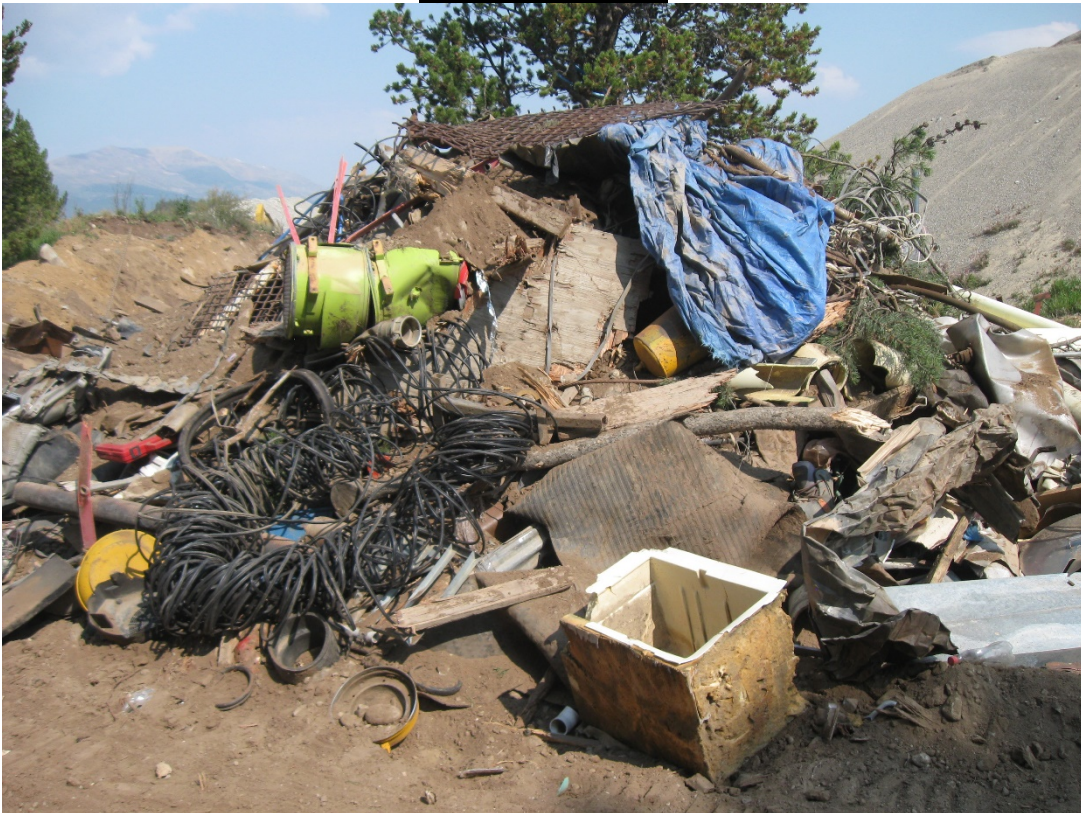
The Operator has imported numerous structures, vehicles, boats, equipment and other miscellaneous refuse to the mine. These items are stored on the south side of the mine site, adjacent to the Operator's residence. The Division has previously documented the presence of refuse at the site and included the cost of removing refuse in past financial warranty calculations. The removal and proper disposal of these items must be accounted for in the financial warranty calculation. During the inspection, the Division inventoried all of the items being stored at the mine site and calculated their approximate dimensions. A detailed accounting of the items which will be bonded for will be included in the financial warranty calculation. The Division did not include any pieces of equipment or other items which could reasonably be used in the mining operation.

1. Miscellaneous refuse.

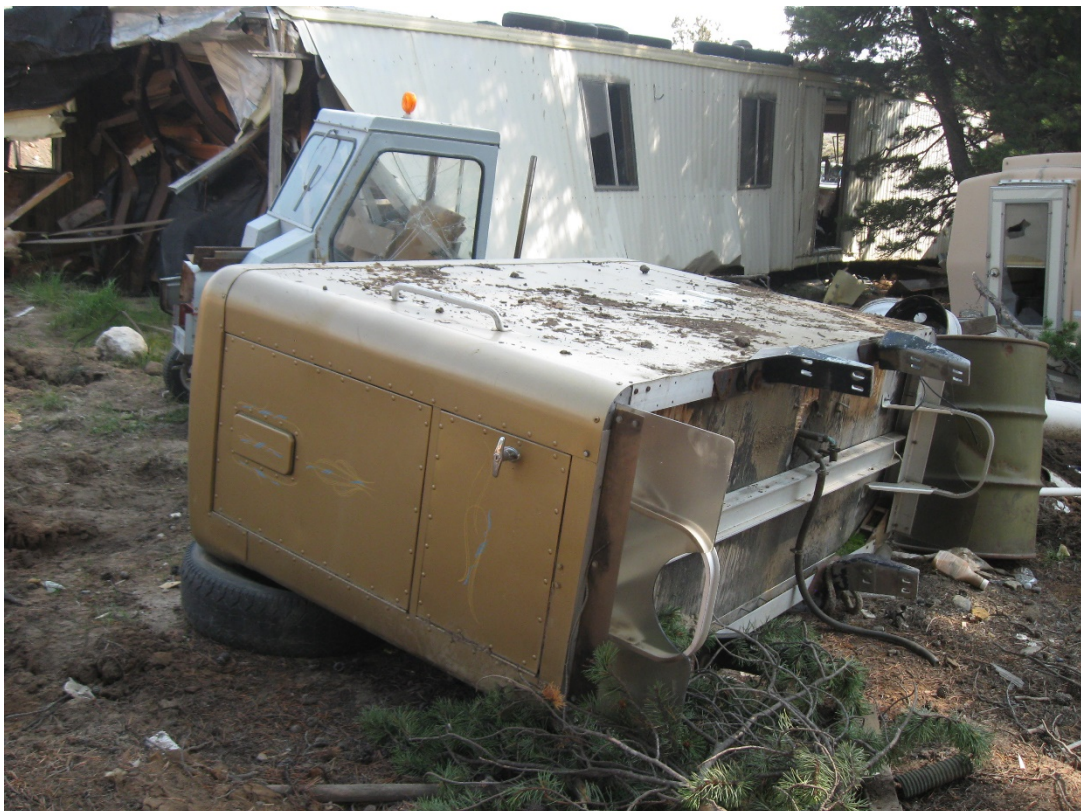
2. Vehicles and structures.

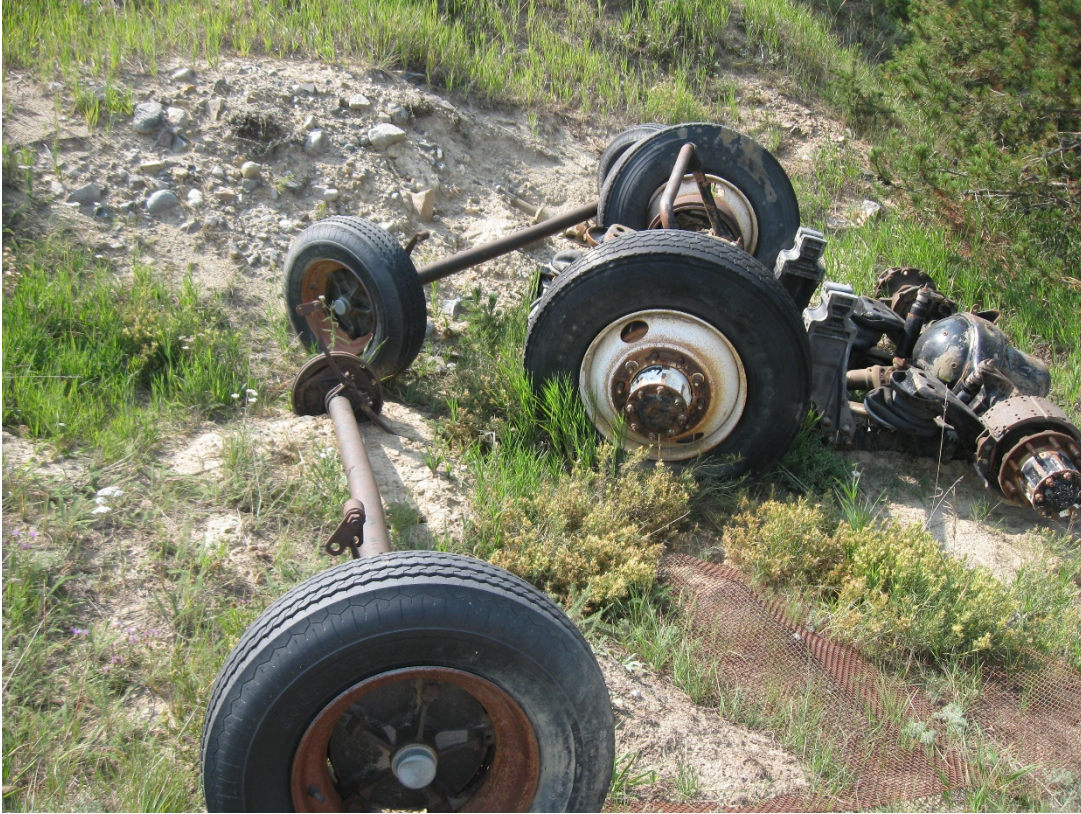
3. Vehicle parts.

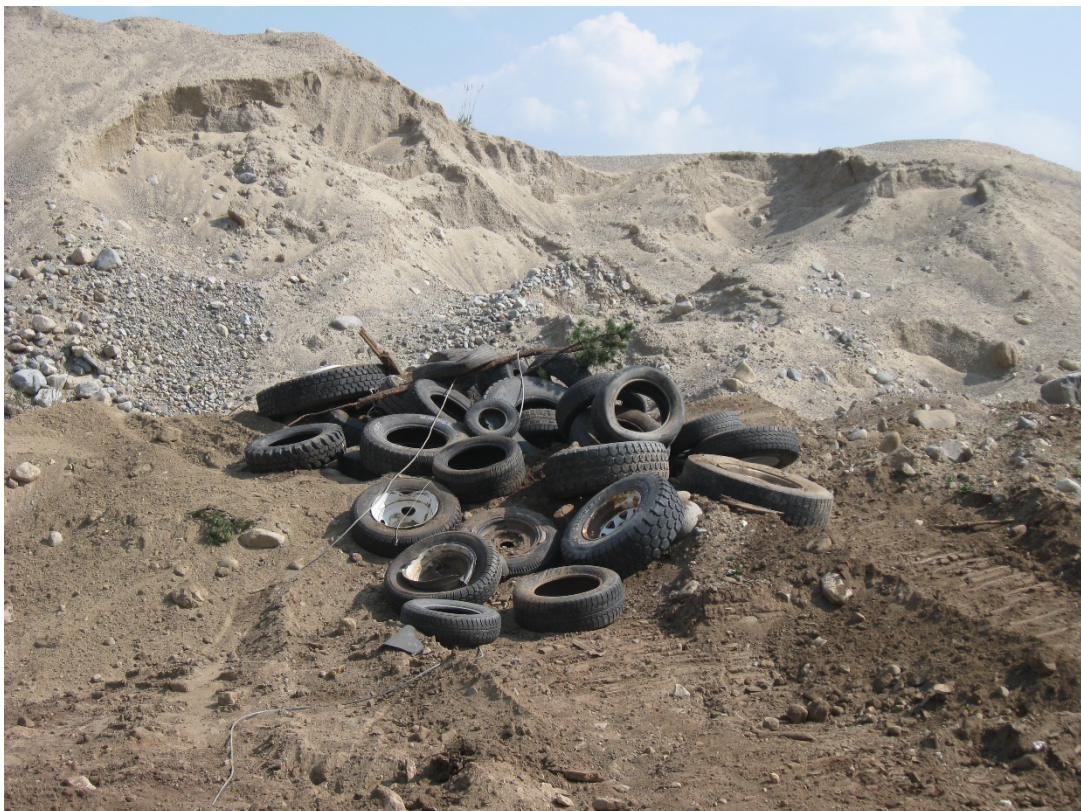
4. Tires.

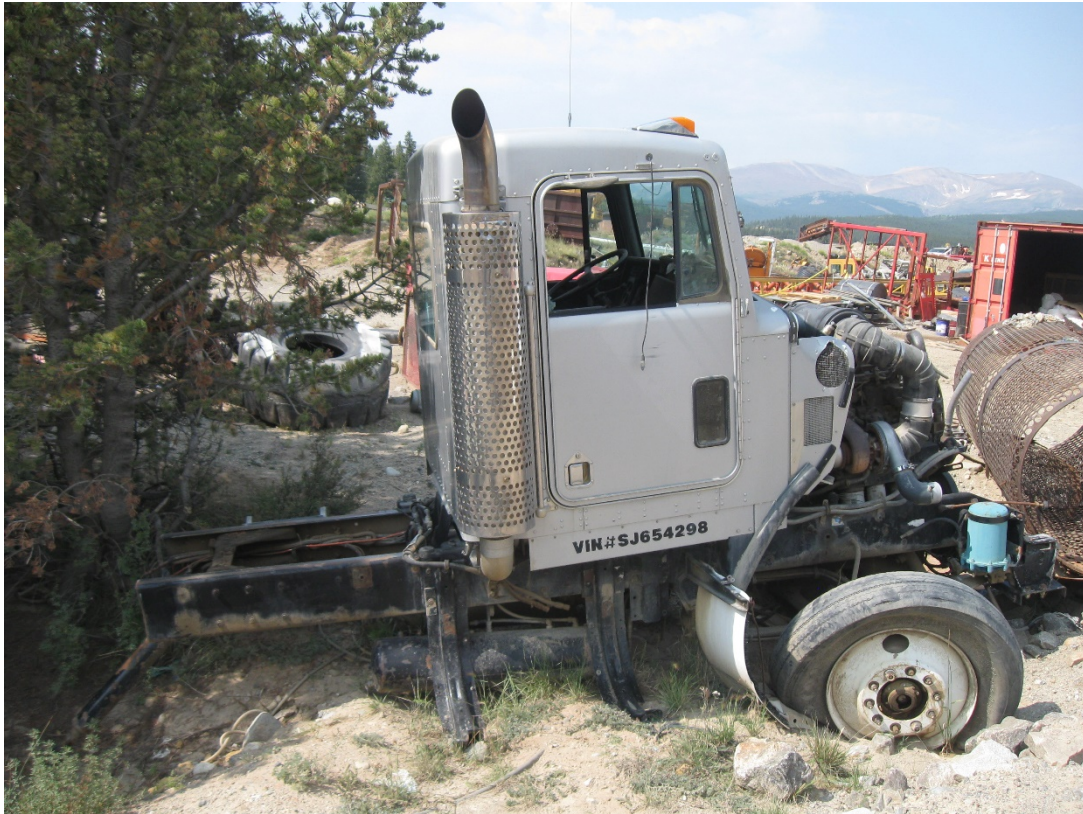
5. Vehicles.

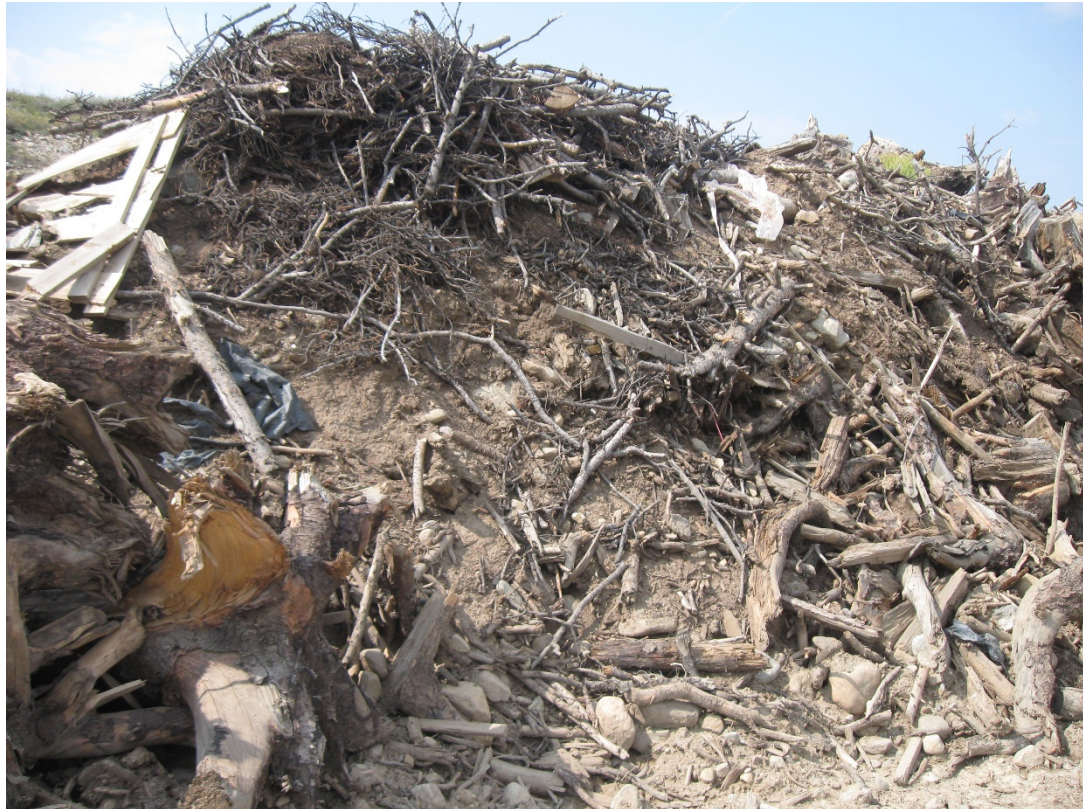
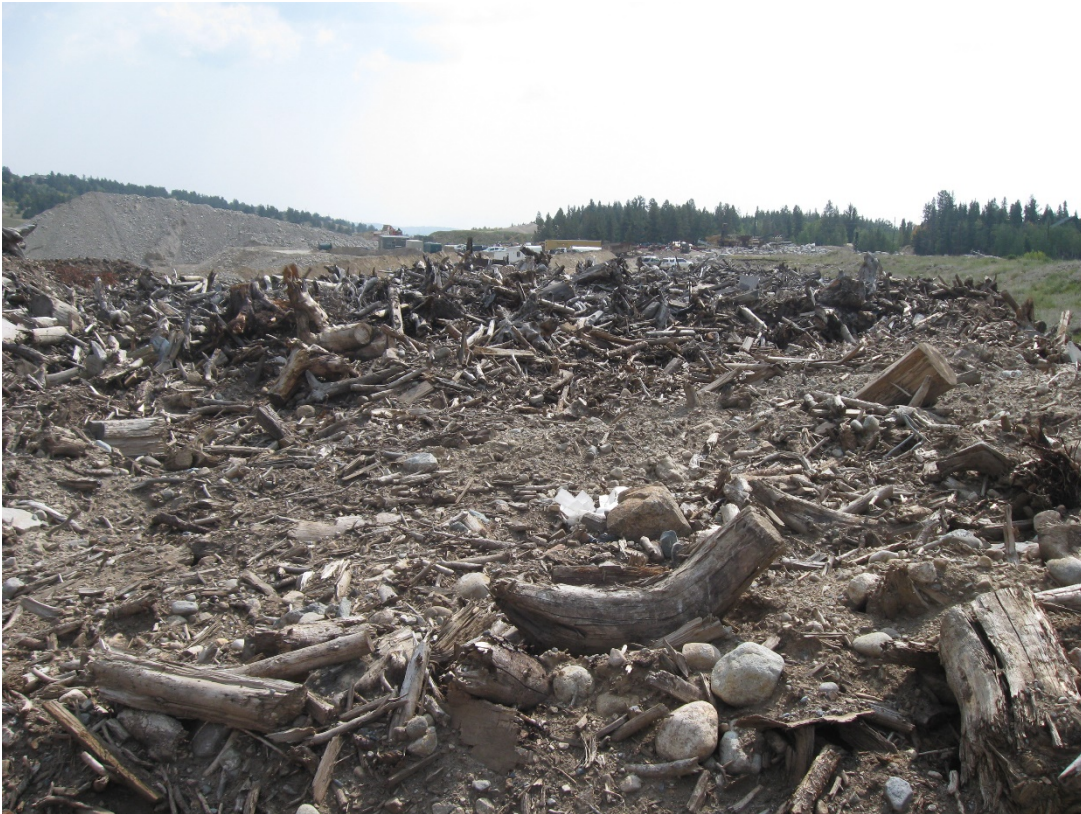
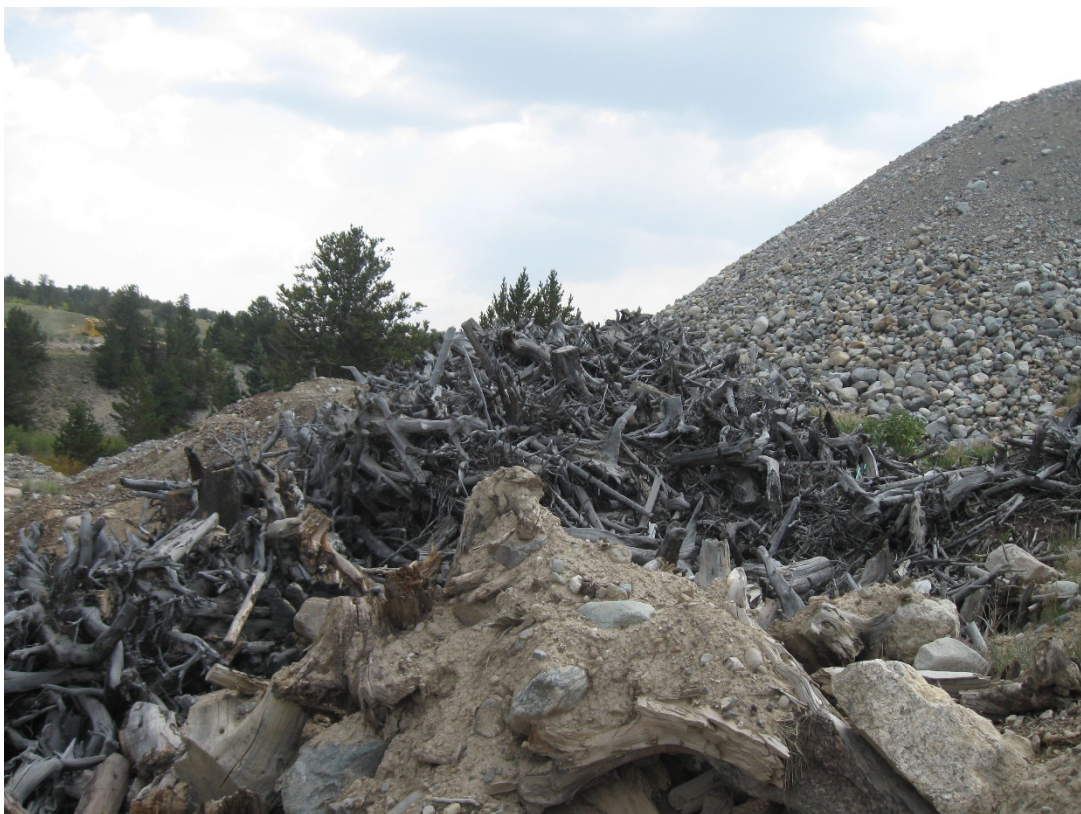
The Operator has imported tree stumps and slash (vegetation) into the site. The vegetation stockpiles cover an area of 1.28 acres and the stockpiles are between 6' to 8' in height. The Division first documented the presence of the imported vegetation during a monitoring inspection in 2012. The Reclamation Plan calls for mulching all of the vegetation for use during final reclamation of the site. The current financial warranty includes \$2,000 to mulch the materials. The imported vegetation has been handled numerous times and is now mixed with soil, rock and refuse. The majority of the vegetation would need to be screened before it could be mulched. Therefore, this material is not suitable for use in final reclamation. In addition, the \$2,000 which the Division holds for mulching does not account for the cost to screen the material prior to mulching. The financial warranty will be adjusted to account for the removal and proper disposal of this material from the mine site.

6. Tree stump and slash stockpile. (Note: soil and rock intermixed with vegetation)

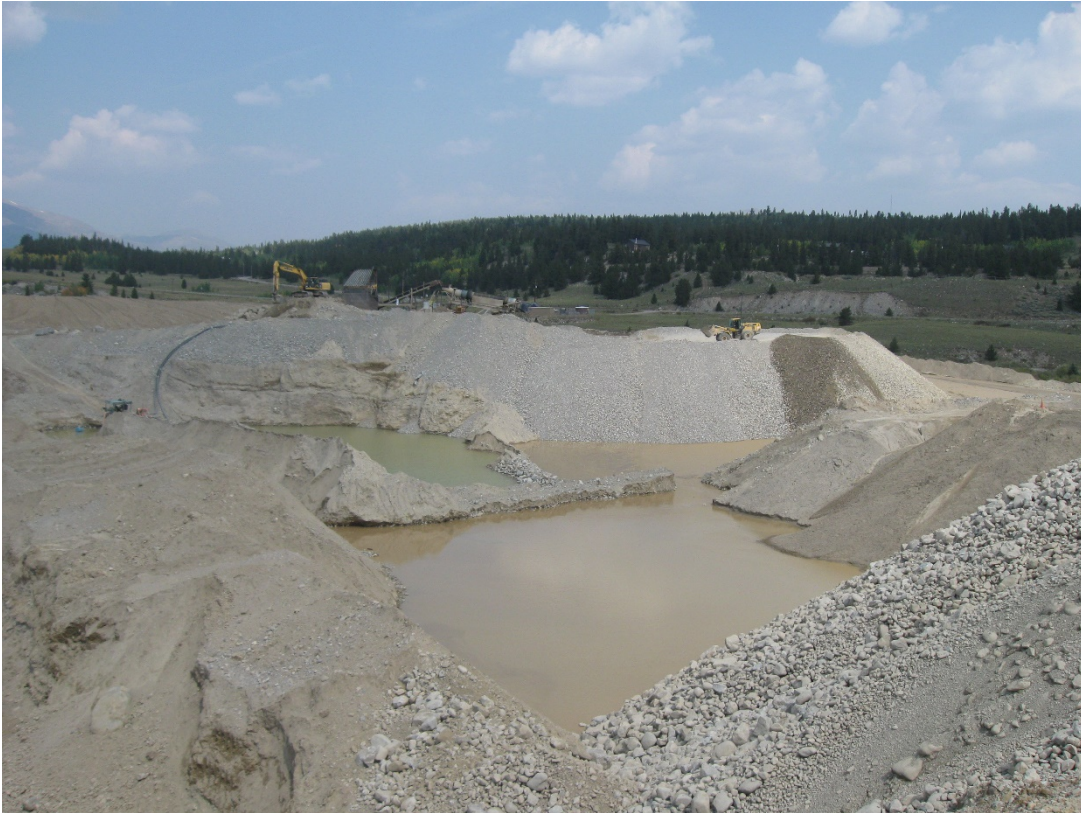
9. Gold recovery plant and settling ponds.

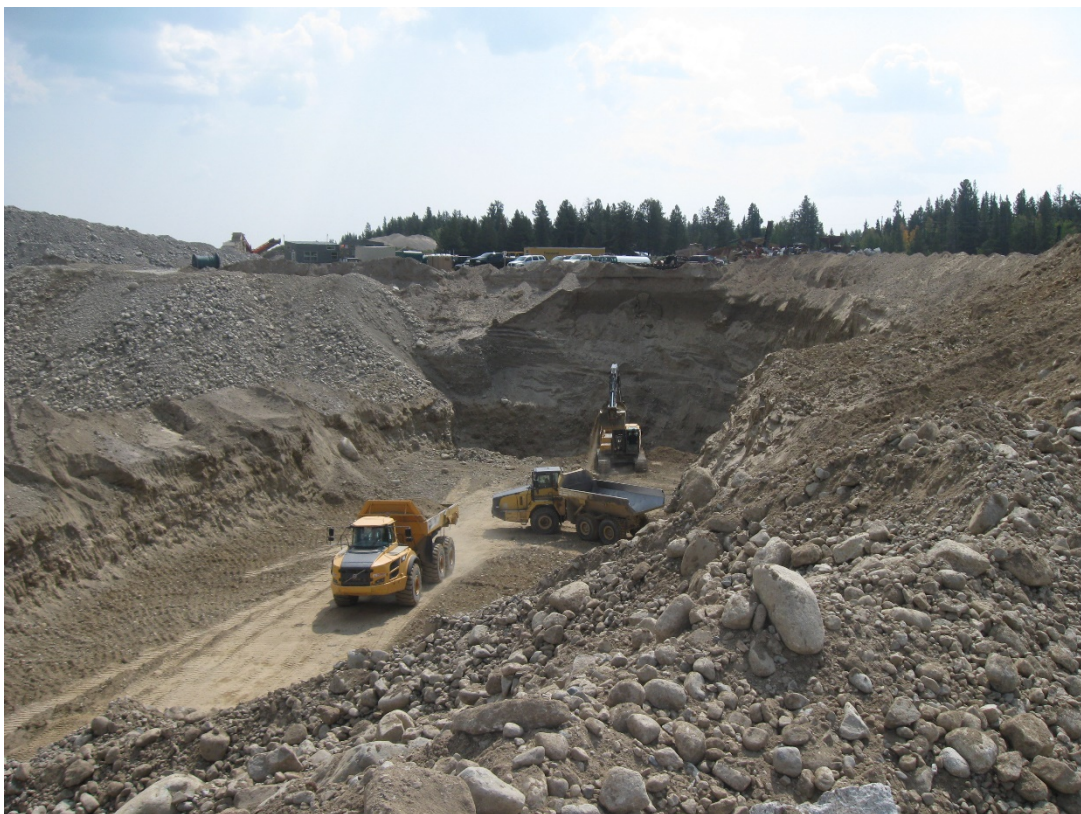
Active mining operations have shifted from the perimeter of the mine site to the interior. The active excavation is located towards the center of the mine site and a single gold recovery plant was being operated at the time of the inspection. The pit accounts for 2.5 acres of disturbance and mining operations have reached a depth of approximately 60 ft. The highwalls within the active pit area are near vertical. Under Technical Revision No. 3, the Operator committed to maintain highwalls at 80 degrees from horizontal for a

vertical distance of 25 ft. Highwalls which exceeded 25 ft. would have a horizontal bench of a minimum of 15 feet in width. The Division did not observe any benches on the portions of the highwall which were over 25 ft. in height. The failure of the Operator to adhere to the approved Mining Plan with respect to highwall configuration has been cited as a problem and will require corrective action. Please see the first page of this report for additional information.

10. Highwall. (Note: no benches constructed in highwall)

INSPECTION TOPIC: Gen. Compliance With Mine Plan**PROBLEM/POSSIBLE VIOLATION:** Problem: The Operator has failed to construct the required benches in the highwall. This is a problem pursuant to C.R.S. 34-32.5-124 of the Construction Material Rules and Regulations for failure to follow the conditions of a permit.**CORRECTIVE ACTIONS:** The Operator shall reduce the height of all highwalls to less than 25ft. or construct the required benches as approved under Technical Revision No. 3. The Operator shall complete the corrective action on or before the corrective action date.**CORRECTIVE ACTION DUE DATE:** 10/27/17**INSPECTION TOPIC:** Revegetation**PROBLEM/POSSIBLE VIOLATION:** Problem: There are state-listed noxious weeds present on site. This is a problem for failure to employ weed control methods for state listed noxious weed species within the permitted area, and to reduce the spread of weeds to nearby areas as required by Section 3.1.10 (6) of the rule.**CORRECTIVE ACTIONS:** The operator shall develop a weed control and management plan. The plan should be developed in consultation with the county extension agency, or weed control district office and should include specific control measures to be applied, a schedule for when control measures will be applied and a post-treatment monitoring plan. The weed control plan shall be submitted to the Division as a Technical Revision to the approved plan with the appropriate Technical Revision fee of \$216.00 by the corrective action date.**CORRECTIVE ACTION DUE DATE:** 10/27/17

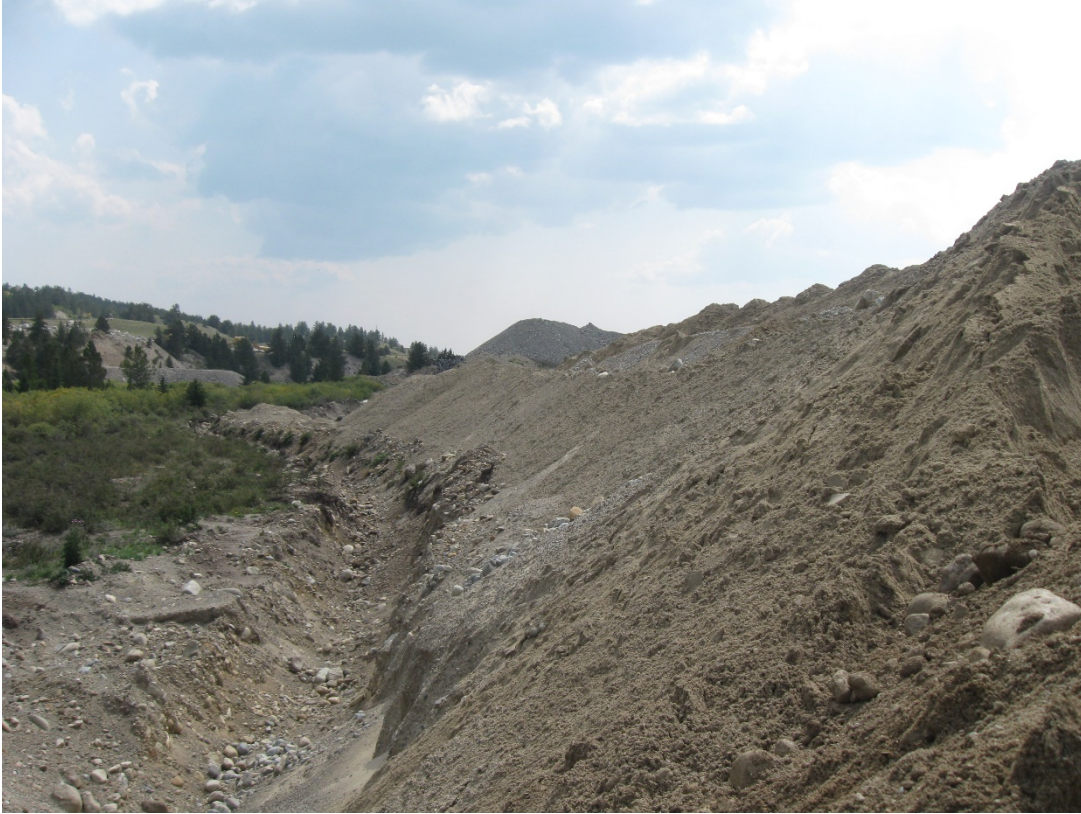
The Reclamation Permit calls for performing concurrent reclamation of the site. The Operator has recently reclaimed the former Plant Settling Pond located in the northwest corner of the site. Overburden has been replaced over an area of 3 acres. The outward facing slopes of the reclaimed area ranged between 3H:1V and 2H:1V. As previously noted, the Reclamation plan calls for reclaiming the site to approximate original contour with the majority of slopes at 5H:1V. In addition, the Reclamation Plan states there may be some slopes which are reclaimed to 2.5H:1V. The Reclamation Plan Map depicts the area which was recently reclaimed as having slopes closer to 5H:1V. The outward facing slopes of the reclaimed area will need to be reduced in order to comply with the approved Reclamation Plan. The grading work will need to be conducted before the Operator proceeds with topsoil replacement and revegetation.

11. Outward facing slope of reclaimed plant settling ponds. (Note: the slope is steeper than 5H:1V)

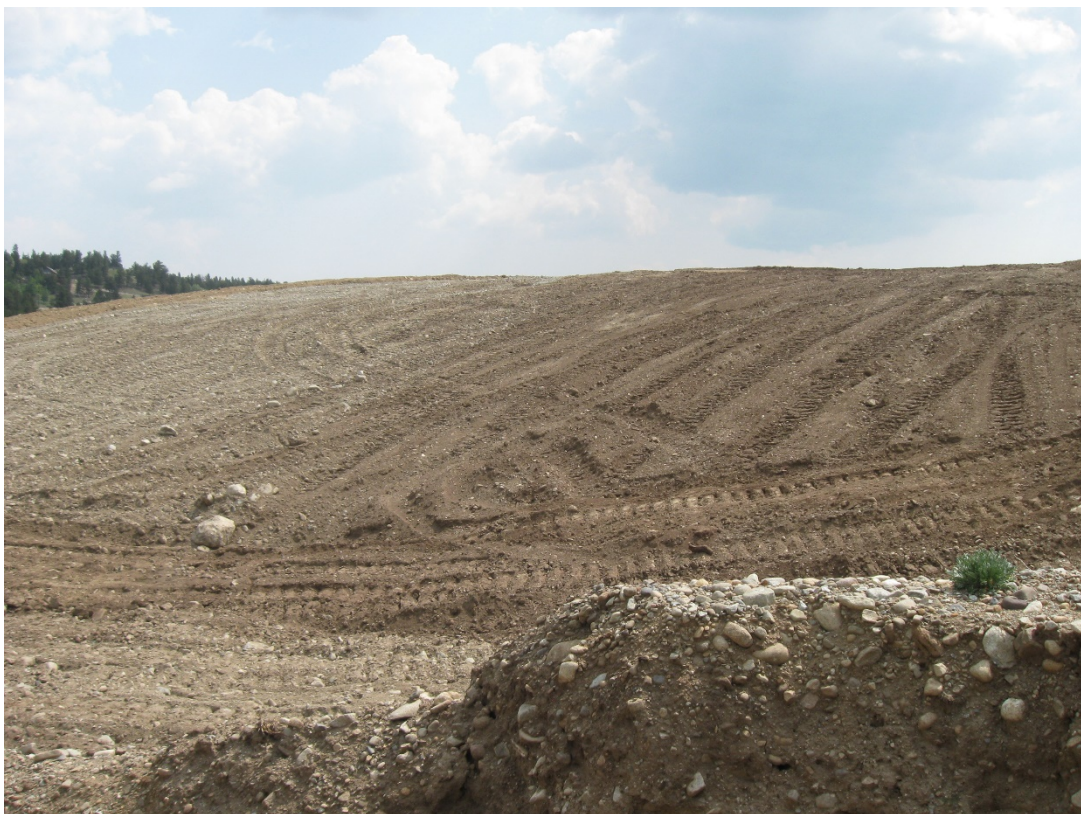
12. Outward facing slope of reclaimed plant settling ponds. (Note: reclaimed slopes are at 3H:1V)

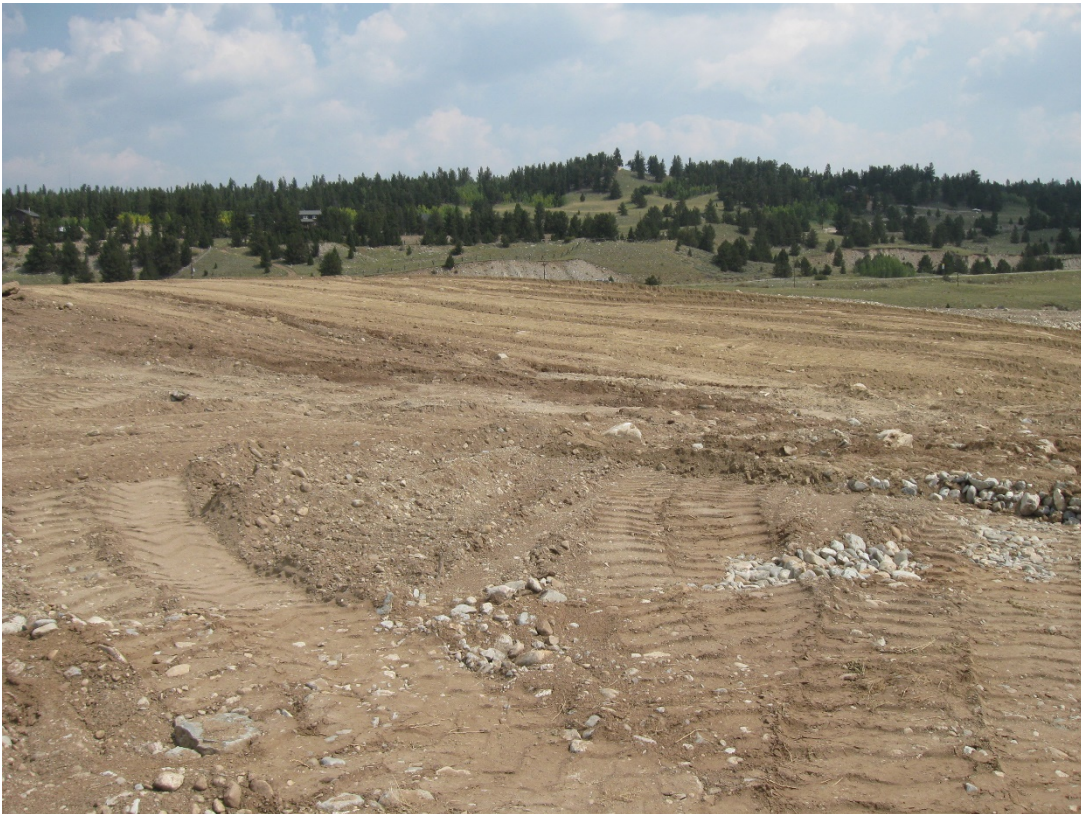
13. Top of reclaimed plant settling ponds.

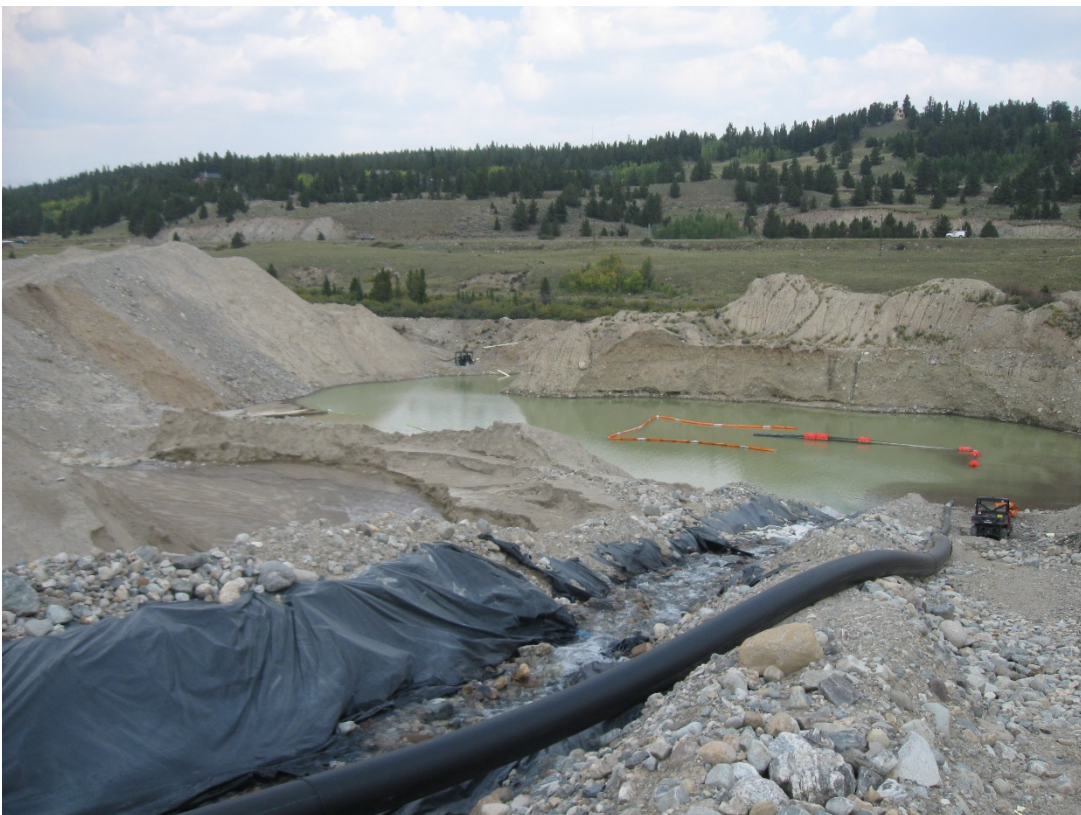
14. Water infiltration pond.

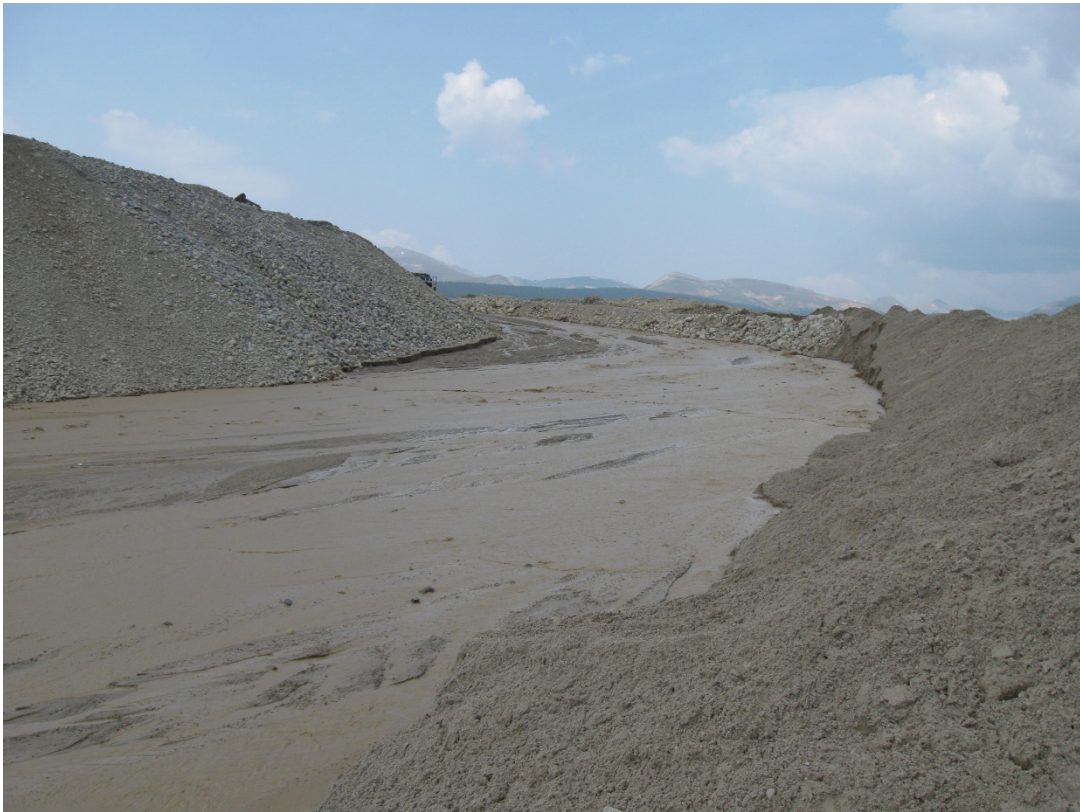
15. Return water from the gold recovery plant.

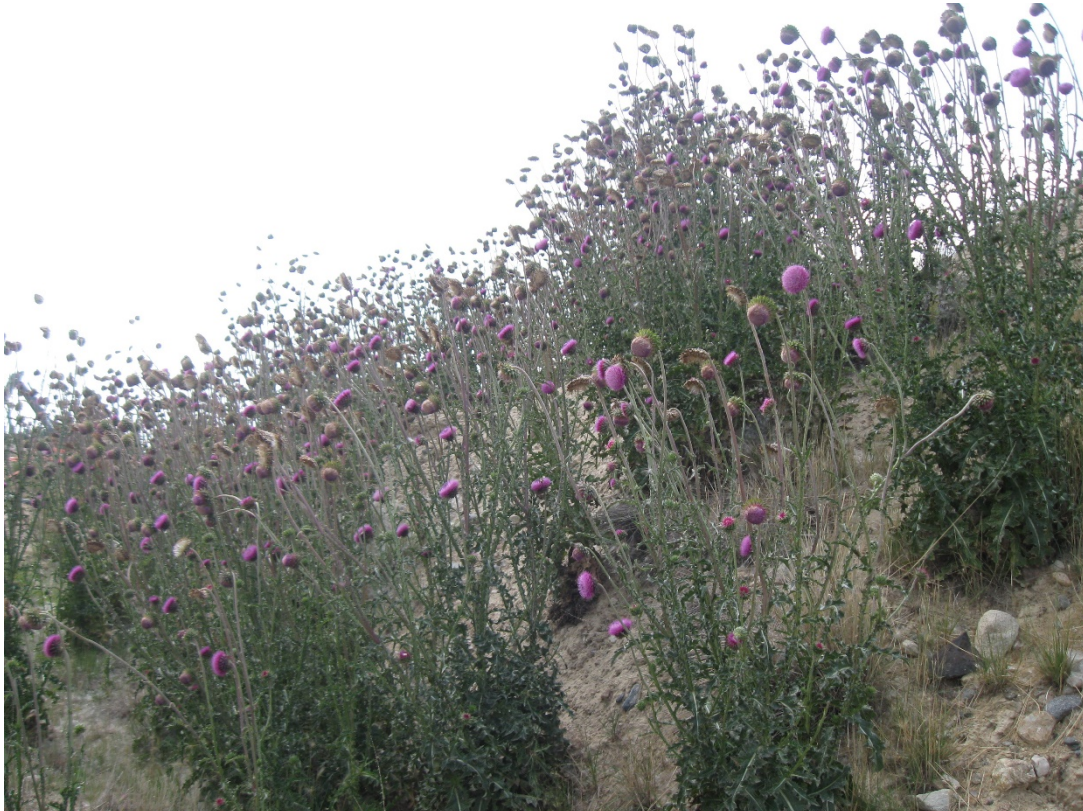
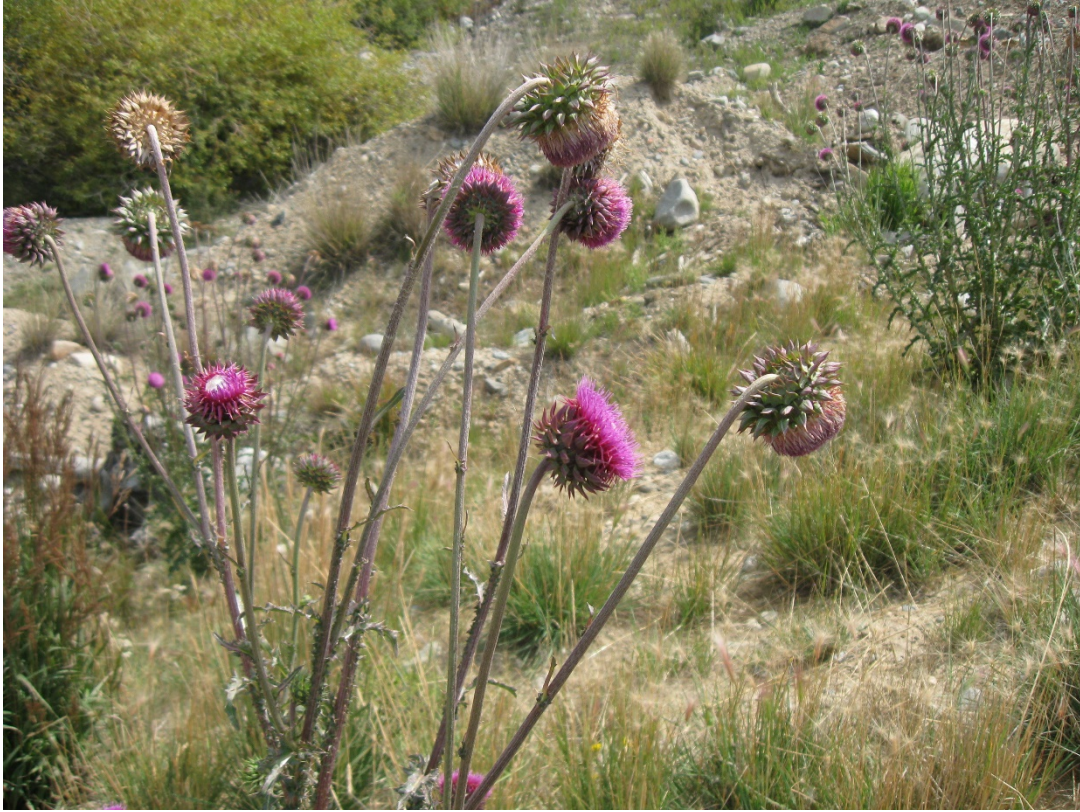
The Division observed chamomile and musk thistle throughout the site. The Operator submitted a general weed control plan under Amendment No. 2. The weed control plan does not contain specific management objectives for the noxious weeds observed on site. The presence of state listed noxious weeds at the mine has been cited as a problem and will require corrective action by the Operator. Please see the first page of this report for additional information.

16. Musk thistle.

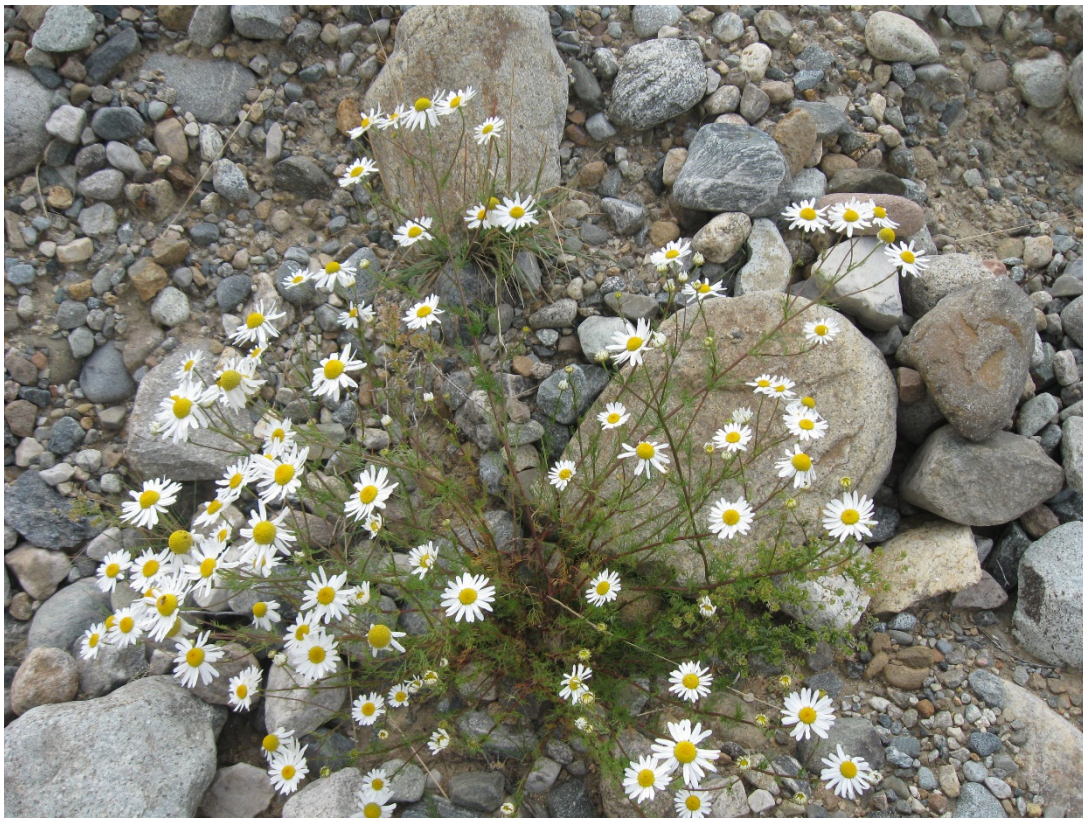
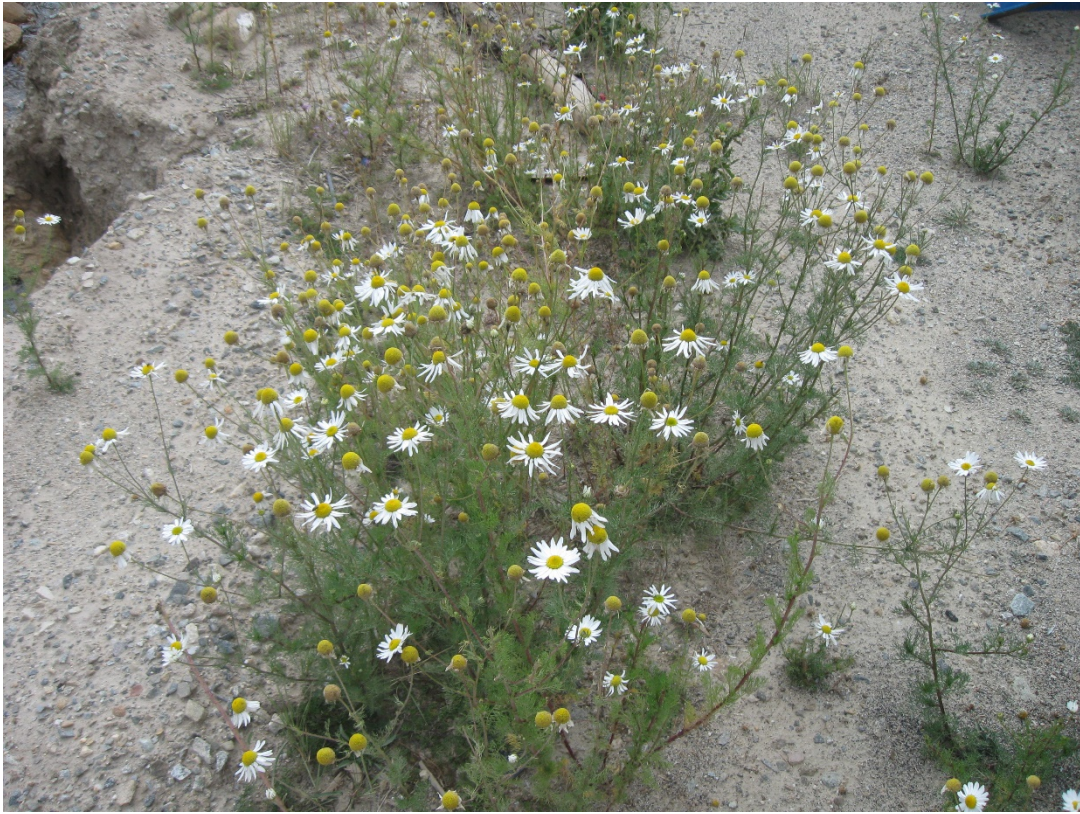
18. Chamomile.

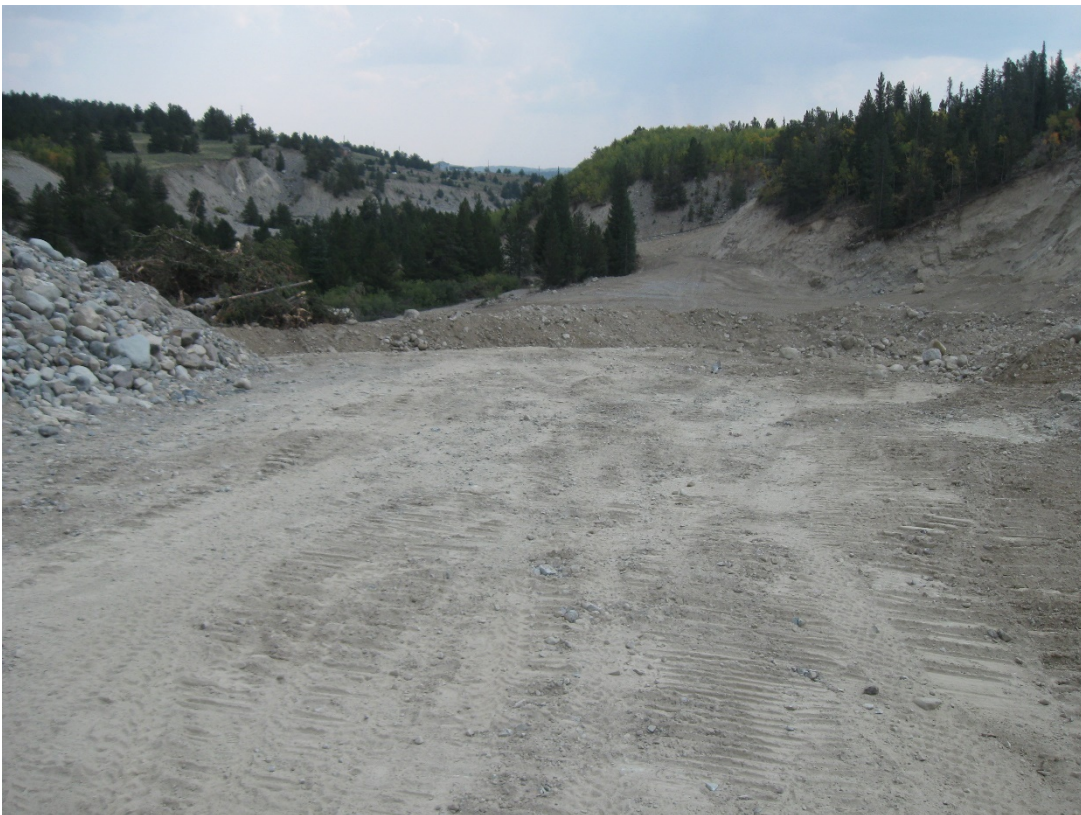
During the inspection conducted on June 20, 2017, the Division observed a new road in the southeast corner of the site. The road was not accounted for in the Mining Plan and as a result the Division required the Operator to submit a Technical Revision addressing the new road. The Operator submitted a Technical Revision application on August 22, 2017 in response to the problem citation. The Division inspected the road in the southeast corner of the site and found there was no longer a defined road in this area. Additional areas to the south of the road have been affected by the mining operation. In addition, an earthen berm has been constructed across the road. The Mining Plan Map depicts this area as 'Old Pre-Law Hydraulic Mining Disturbance'. The Division will address this matter through the Technical Revision (TR05) which is currently under review. The financial warranty will be adjusted to account for the additional disturbance at the mine.

20. Earthen berm across newly constructed access road.

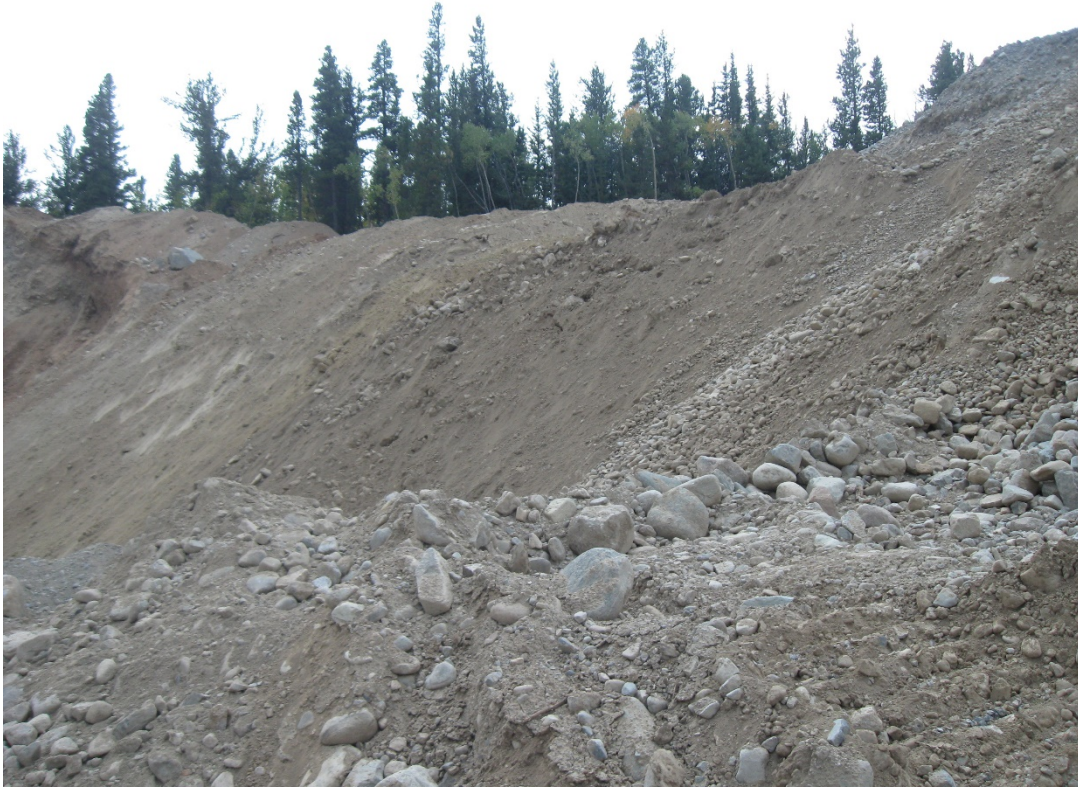
21. Recently affected lands in area designated as 'Old Pre-law Hydraulic Mining Disturbance.
