MINERALS PROGRAM INSPECTION REPORT
PHONE: (303) 866-3567

MINE NAME: Menzer Quarry	MINE/PROSPECTING ID#: M-1976-009-HR	MINERAL: Granite, granite gneiss	COUNTY: El Paso
INSPECTION TYPE: Monitoring	INSPECTOR(S): Timothy A. Cazier	INSP. DATE: June 30, 2016	INSP. TIME: 15:30
OPERATOR: Schmidt Construction Company	OPERATOR REPRESENTATIVE: Dan Chavez & Mark Heifner	TYPE OF OPERATION: 112c - Construction Regular Operation	
REASON FOR INSPECTION: Normal I&E Program	BOND CALCULATION TYPE: Partial Bond	BOND AMOUNT: \$456,000.00	
DATE OF COMPLAINT: NA	POST INSP. CONTACTS: None	JOINT INSP. AGENCY: None	
WEATHER: Cloudy	INSPECTOR'S SIGNATURE:

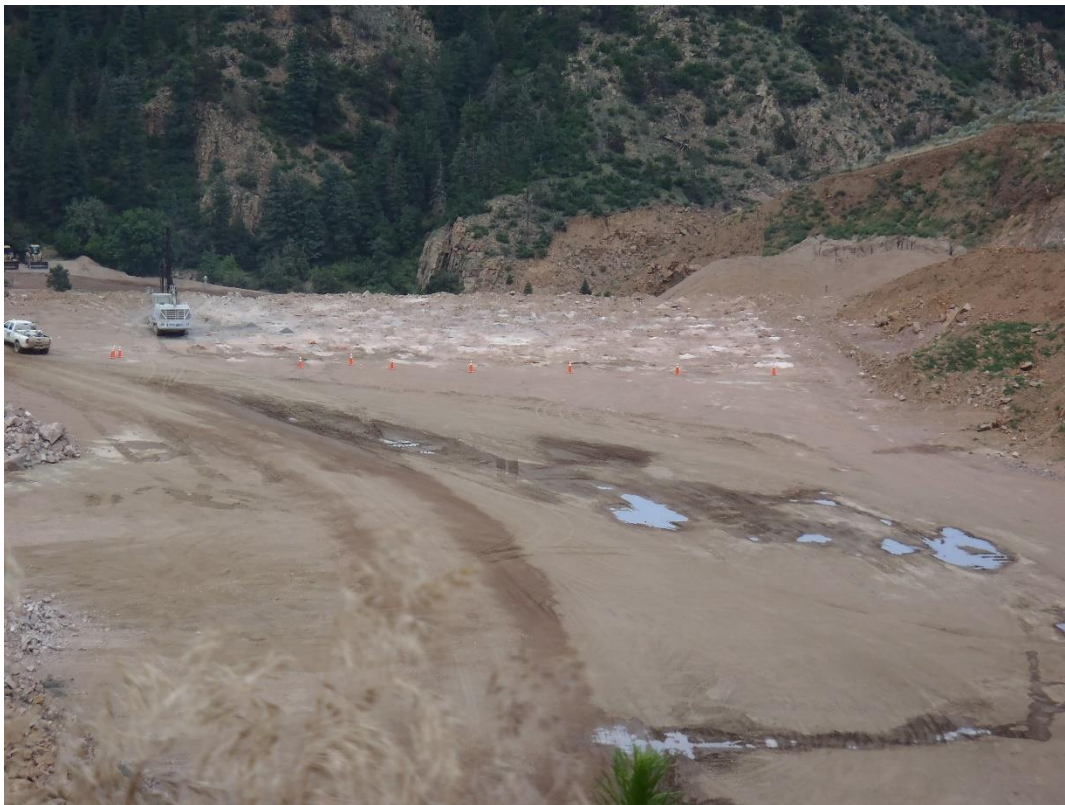
Explosives: Explosives are used as part of the regular mining operation. Mr. Chavez keeps the blasting plan in his office. A future blast pattern had been drilled (see **Photo 1**) and was being prepared for loading explosives.

Photo 1. Drilled blast pattern (looking east).

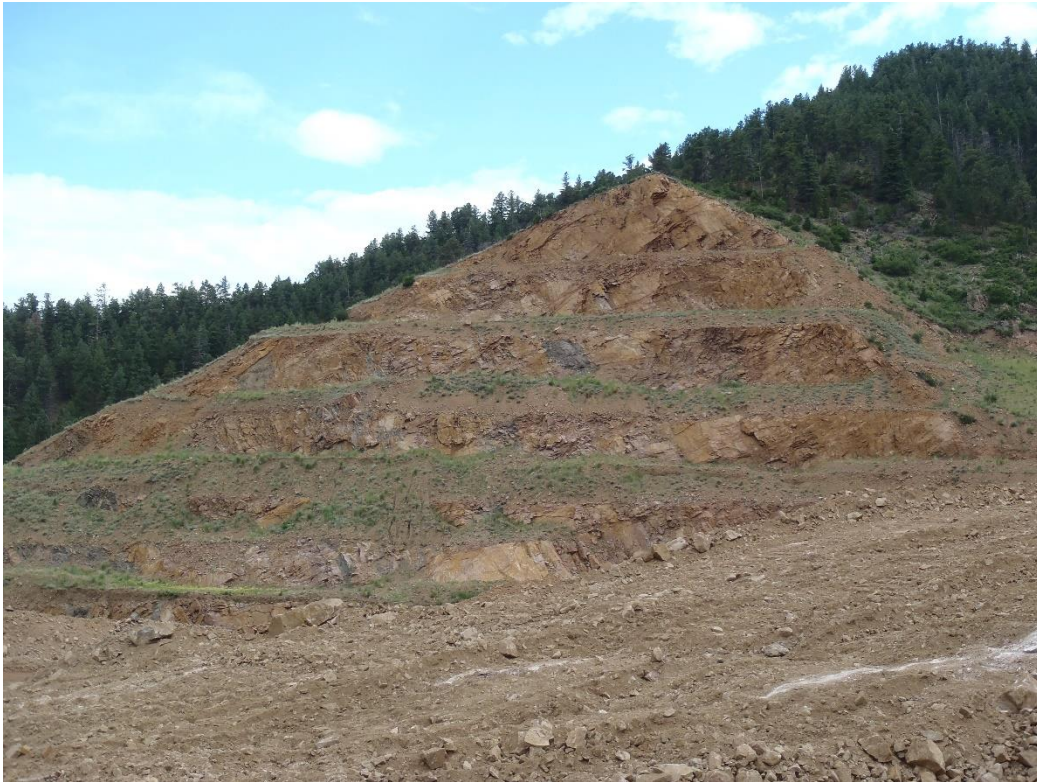
Reclamation Success: Some of the south side highwall benches have been reclaimed (see **Photo 2**).

Revegetation: Some upper benches show signs of vegetation establishment. No noxious weeds were observed.

Photo 2. South side highwall benches in reclamation.

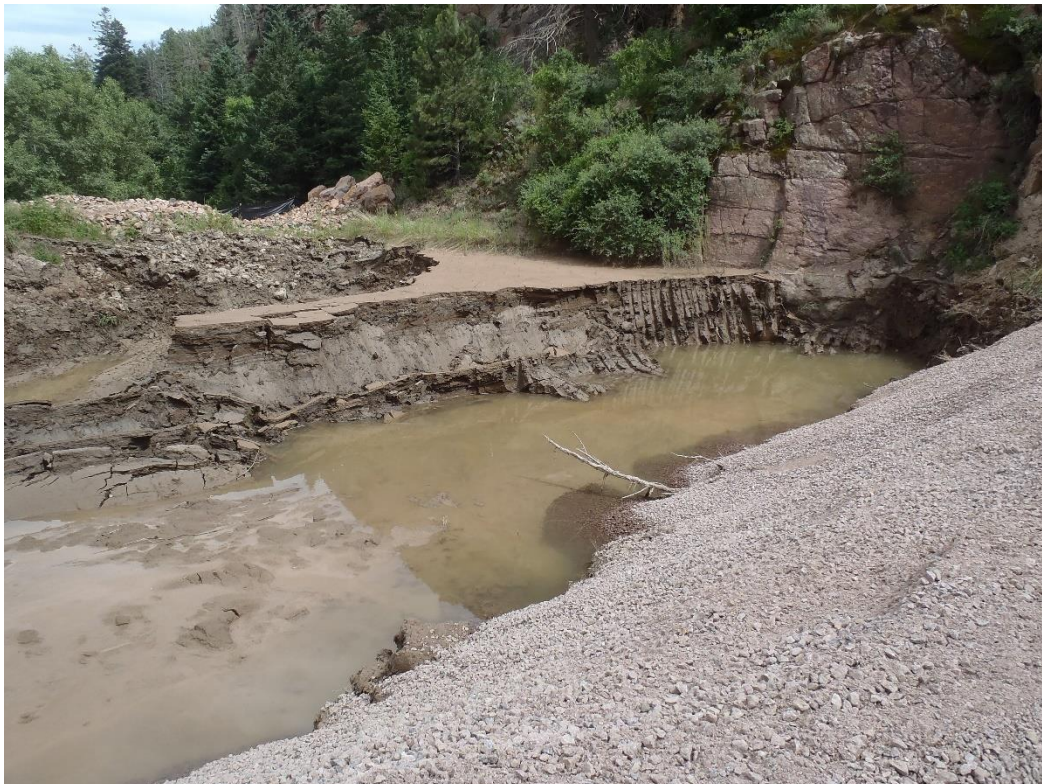
Sediment Control: No erosion problems were observed and no BMPs were needed at the time of the inspection. The sediment pond (see **Photo 3**) appeared to be adequate and was in the process of being mucked out.

Photo 3. Sediment pond in the process of being mucked out.

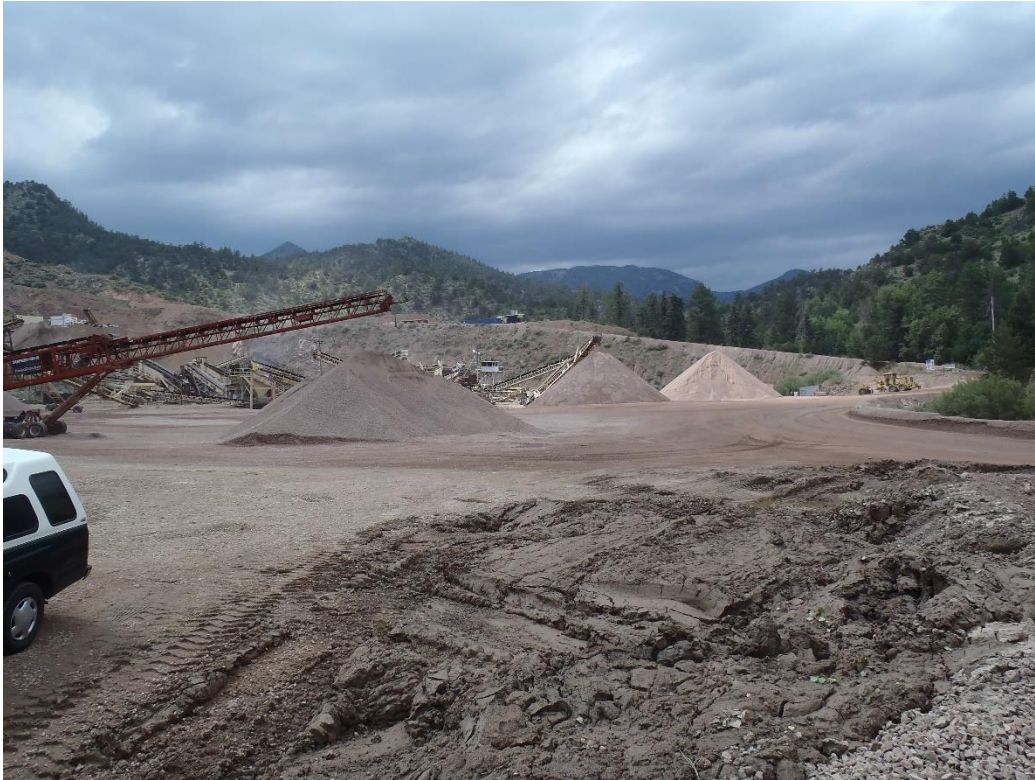
Support Facilities On-site: A screen plant, crushers, and conveyors were observed on site (see **Photo 4**).

Photo 4. Screen plant, crushers, and conveyors on pit floor.

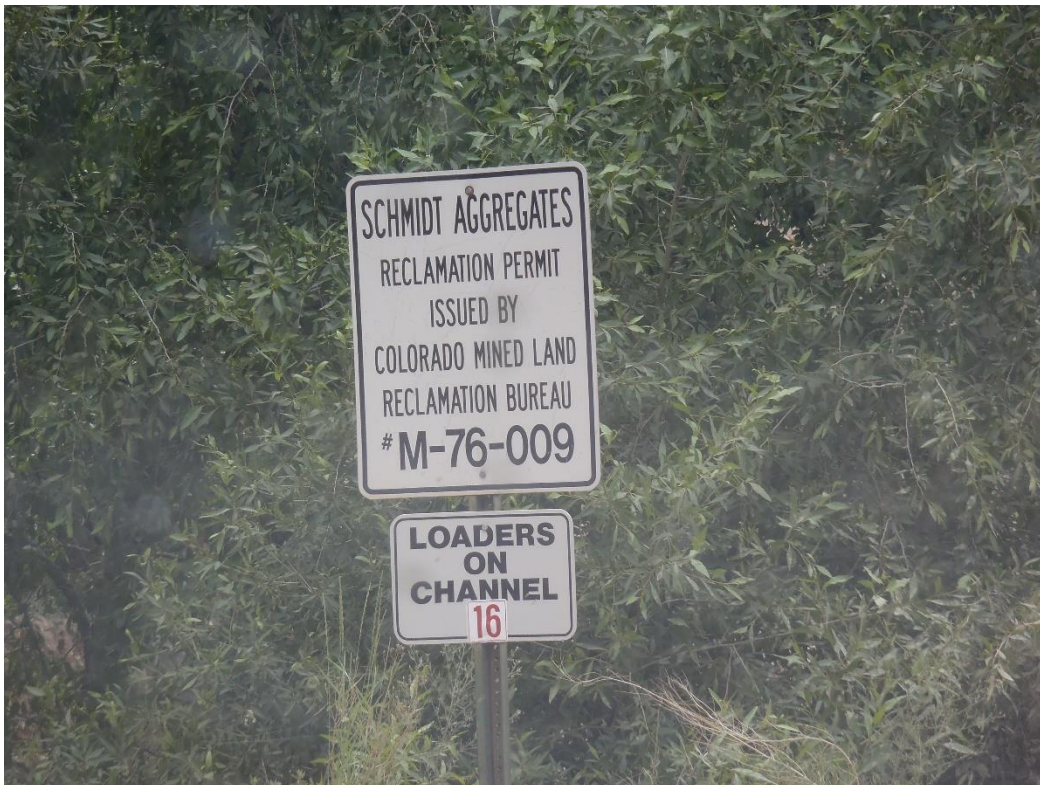
Photo 5. Permit sign at entrance.

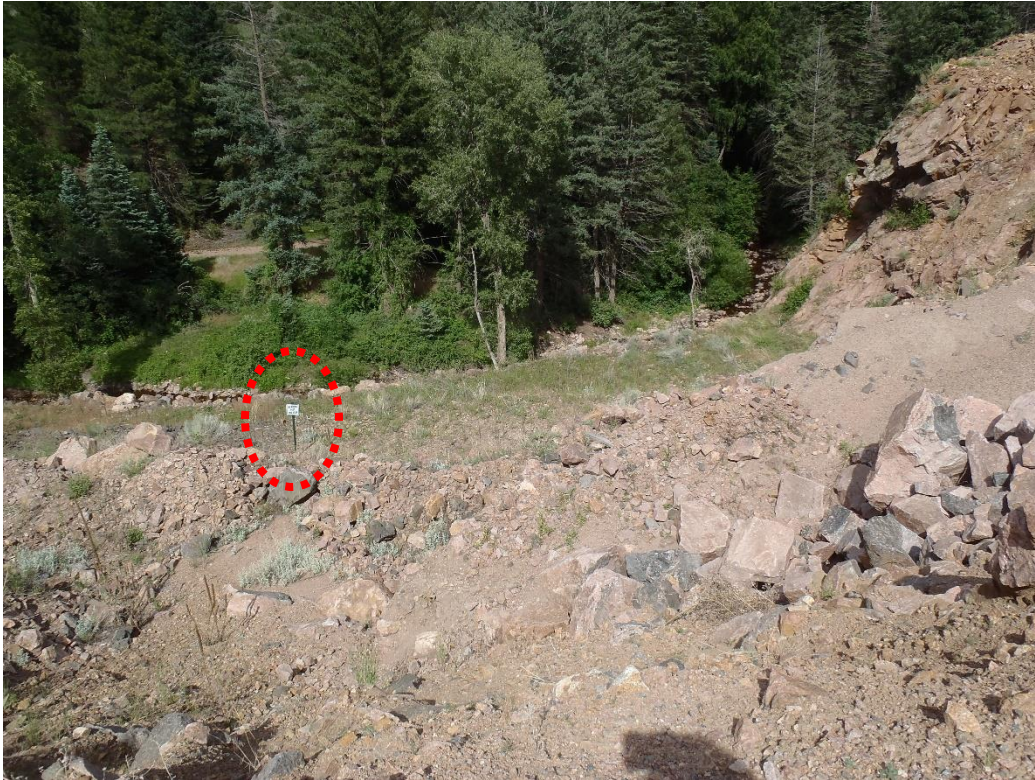
Photo 6. Boundary marker (north side, looking NE).
