MINERALS PROGRAM INSPECTION REPORT
PHONE: (303) 866-3567

MINE NAME: Grisenti Farms Gravel Pit	MINE/PROSPECTING ID#: M-2001-005	MINERAL: Sand and gravel	COUNTY: Fremont
INSPECTION TYPE: Monitoring	INSPECTOR(S): Timothy A. Cazier	INSP. DATE: July 20, 2016	INSP. TIME: 10:15
OPERATOR: Continental Materials Corporation	OPERATOR REPRESENTATIVE: Andre Laroche, Larry Cox, Bruce Humphries, Bill Pope	TYPE OF OPERATION: 112c - Construction Regular Operation	
REASON FOR INSPECTION: Normal I&E Program	BOND CALCULATION TYPE: Partial Bond	BOND AMOUNT: \$115,000.00	
DATE OF COMPLAINT: NA	POST INSP. CONTACTS: None	JOINT INSP. AGENCY: None	
WEATHER: Clear	INSPECTOR'S SIGNATURE:

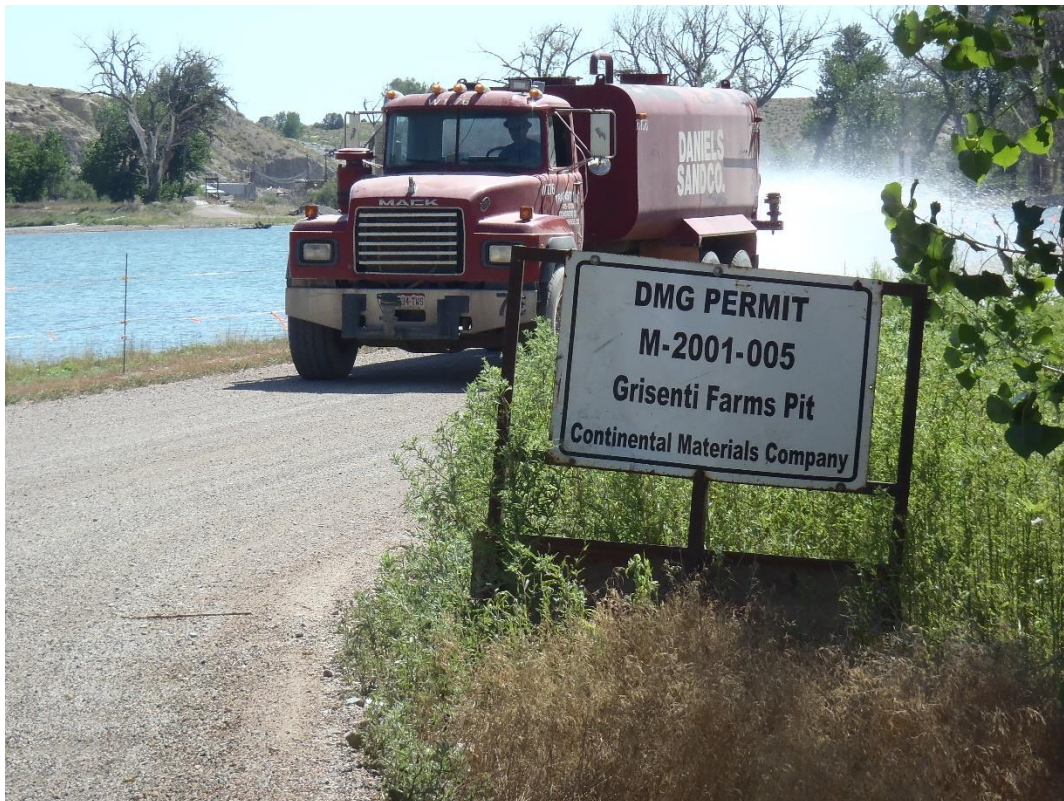
Roads: The haul/access road was being watered for dust control (see **Photo 1**).

Signs and Markers: The permit sign was properly posted (see **Photo 1**) and boundaries were marked.

Photo 1. Posted permit sign and active dust control using water truck.

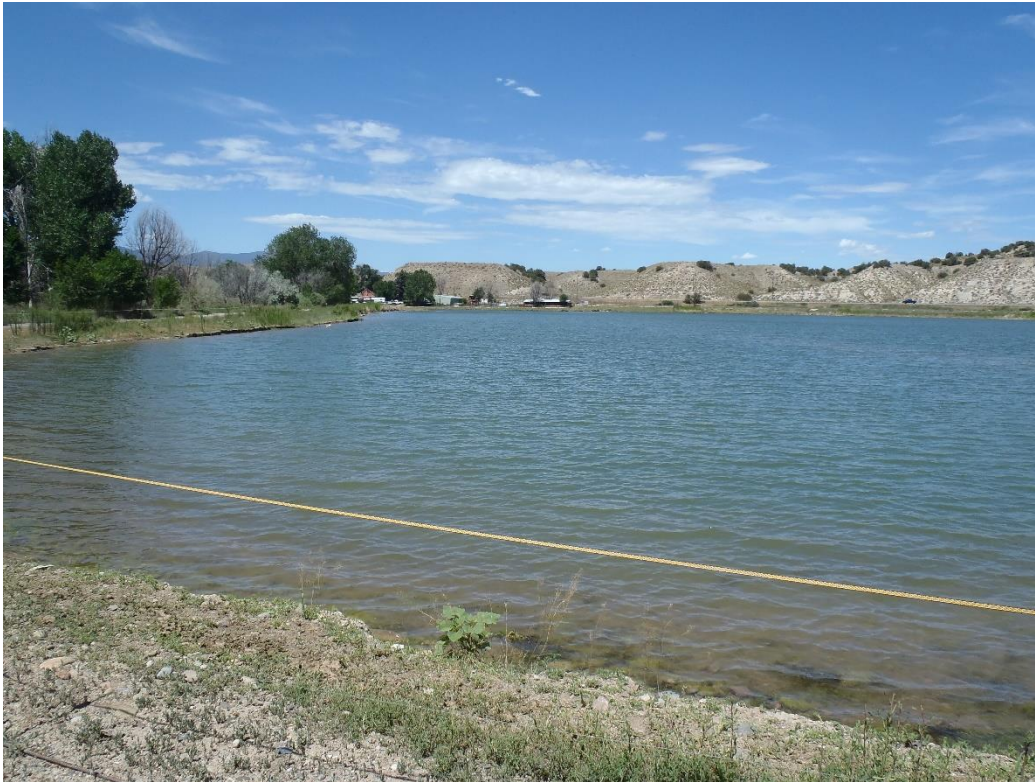
Reclamation Success: Grading, topsoiling and seeding have been completed on the edges of the phase 1 pond (See **Photo 2**).

Photo 2. Grading, topsoiling and seeding completed on the edges of phase 1 pond (looking SW).

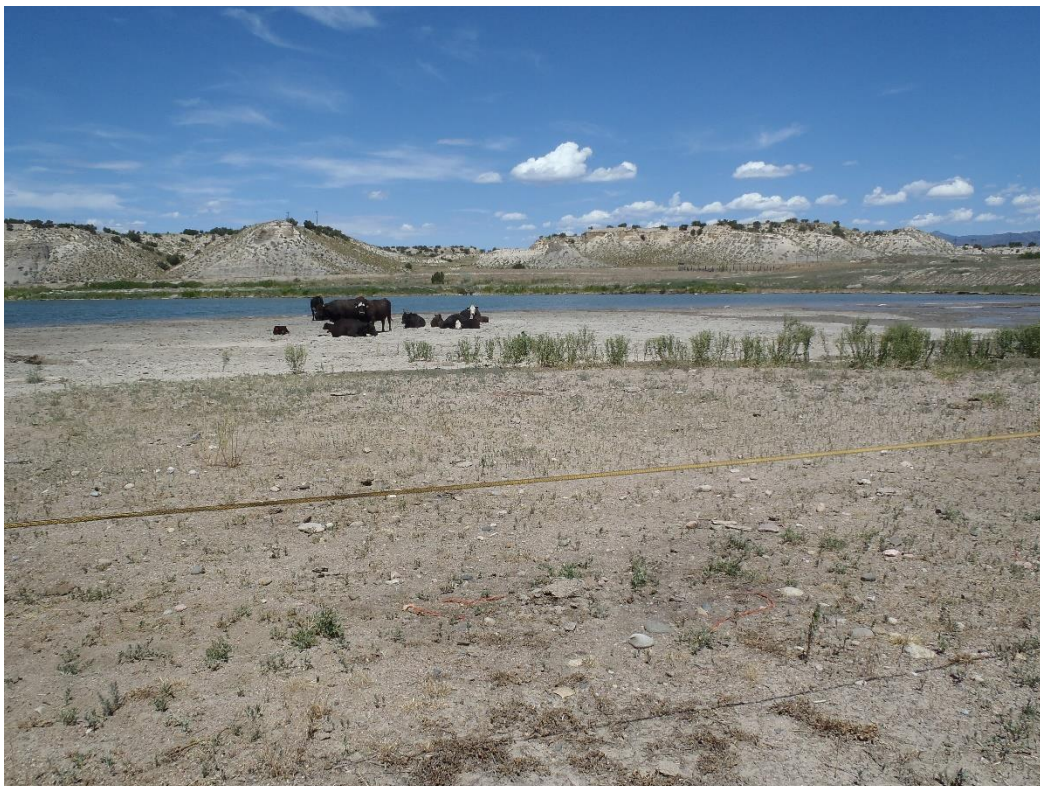
Revegetation: Site representatives indicated four feet of the pond bank above the high water line had been seeded several times, but that this area had been grazed by cattle (see **Photo 3**) and they were having trouble

getting vegetation established. Russian olive and tamarisk were observed on the south side of the permit boundary near the Arkansas River, but none was observed within the permit boundary.

Photo 3. Cattle in active reclamation area on Phase 1 pond shore (looking west).

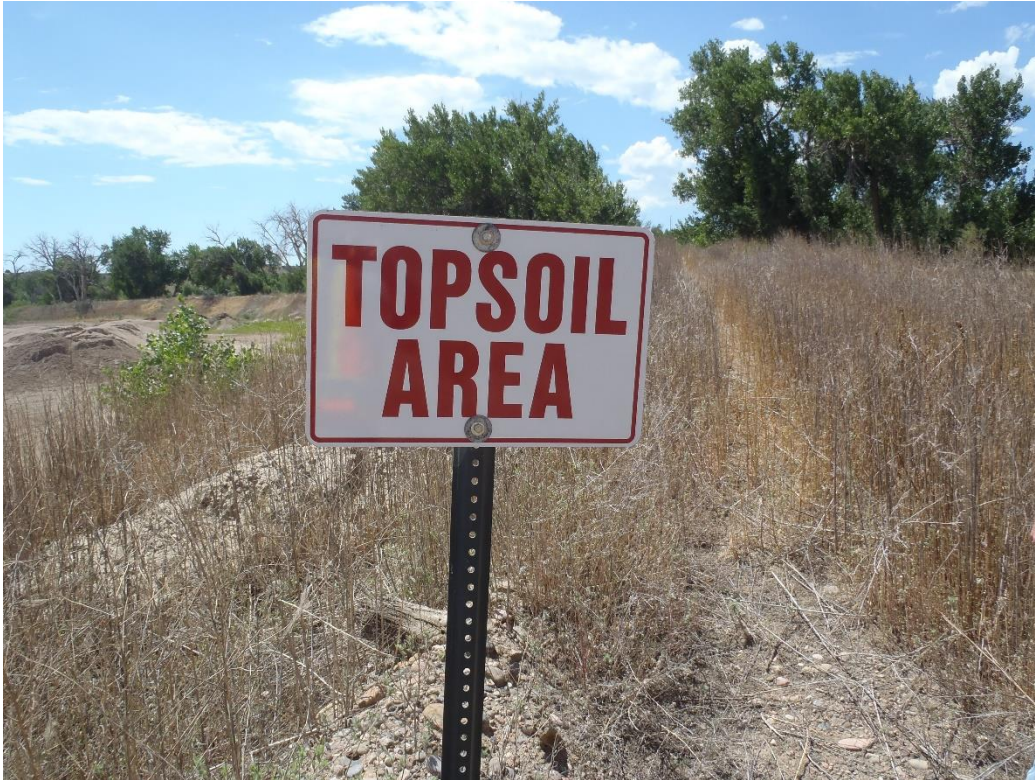
Topsoil: A topsoil stockpile is used as a boundary marker on the Arkansas River side of the permit area and is labeled as such (see **Photo 4**).

Photo 4. Labeled topsoil stockpile (looking south).

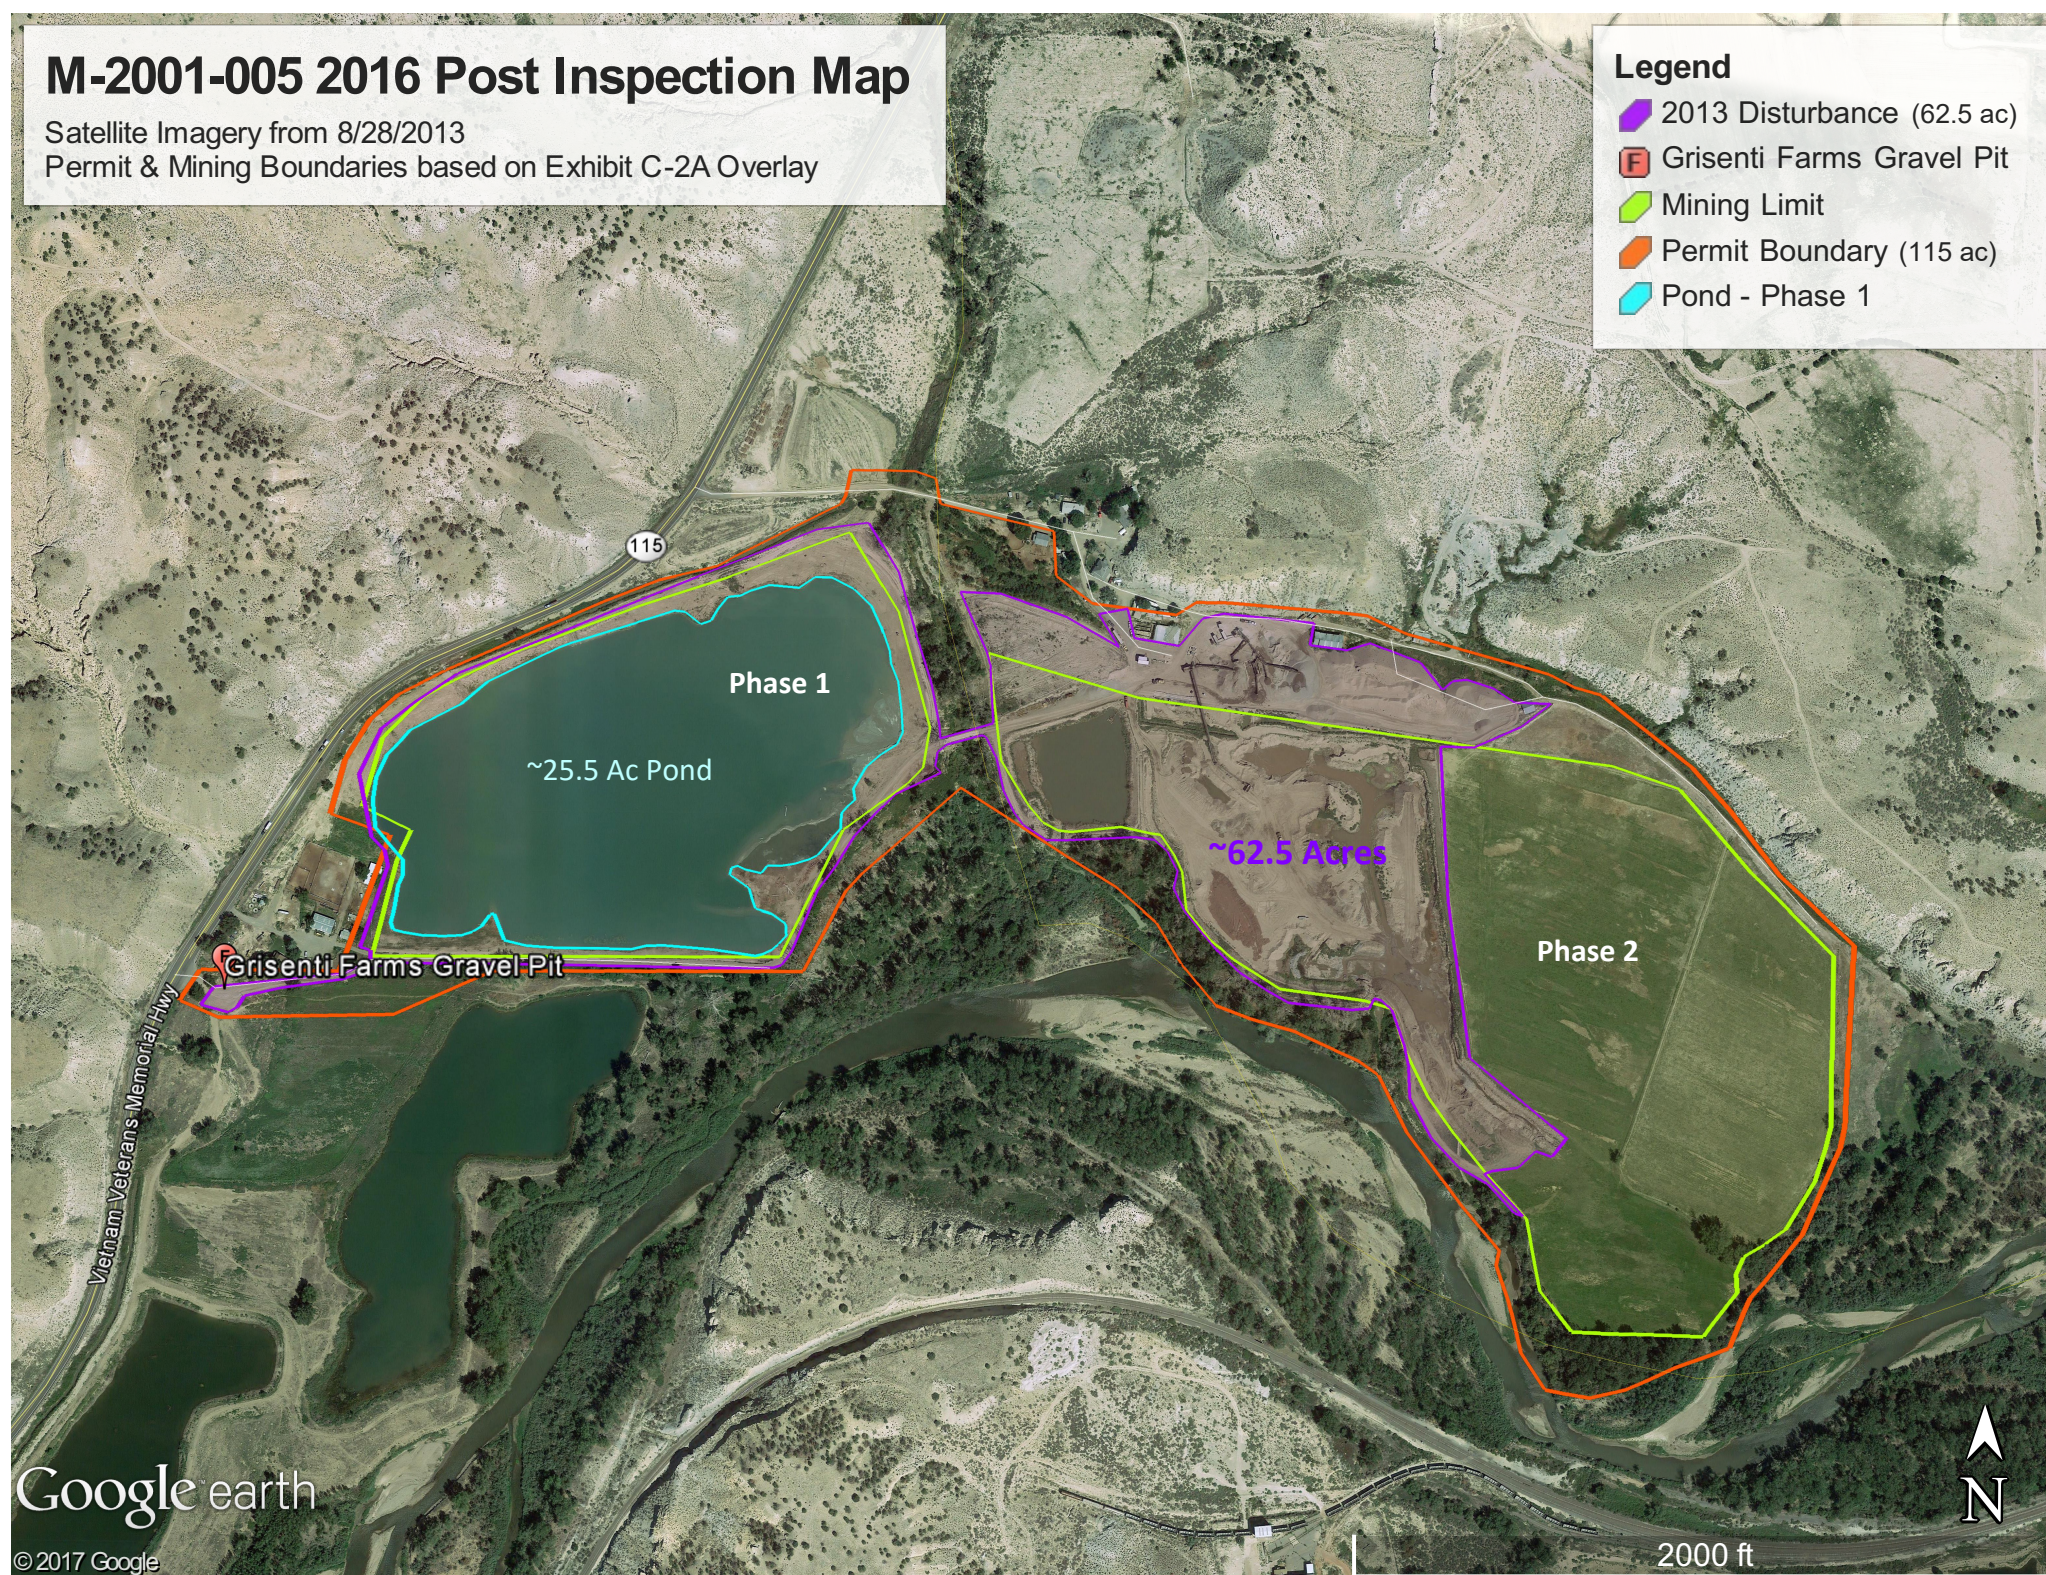
M-2001-005 2016 Post Inspection Map

Gen. Compliance with Mine Plan: The operation appeared to be in compliance with the approved mine plan. Google Earth was used to measure the disturbed area, which was estimated to be approximately 63 acres (based on 8/28/2013 satellite imagery). Included in the disturbed area is the Phase 1 pond, accounting for approximately 25.5 acres (see enclosed **Post Inspection Map**). Therefore, approximately 37.5 acres requires physical reclamation and pond backfill is not required as long as the SWSP is approved by DWR.

Off-site Damage: The operation appeared to be confined to the permit boundary based on boundary markers and a Google Earth review of 2013 imagery.
