**RE:** Enforcement Hearing  
Colorado Milling Company, LLC; Permit No. M-1994-117; Gold Hill Mill

**MINERALS PROGRAM INSPECTION REPORT****PHONE: (303) 866-3567**

<b>MINE NAME:</b> Gold Hill Mill	<b>MINE/PROSPECTING ID#:</b> M-1994-117	<b>MINERAL:</b> Gold and silver	<b>COUNTY:</b> Boulder
<b>INSPECTION TYPE:</b> Monitoring	<b>INSPECTOR(S):</b> Amy Eschberger, Wally Erickson	<b>INSP. DATE:</b> August 1, 2017	<b>INSP. TIME:</b> 10:25
<b>OPERATOR:</b> Colorado Milling Company, LLC	<b>OPERATOR REPRESENTATIVE:</b> Mark Steen	<b>TYPE OF OPERATION:</b> 110(2) - Hard Rock Limited Impact

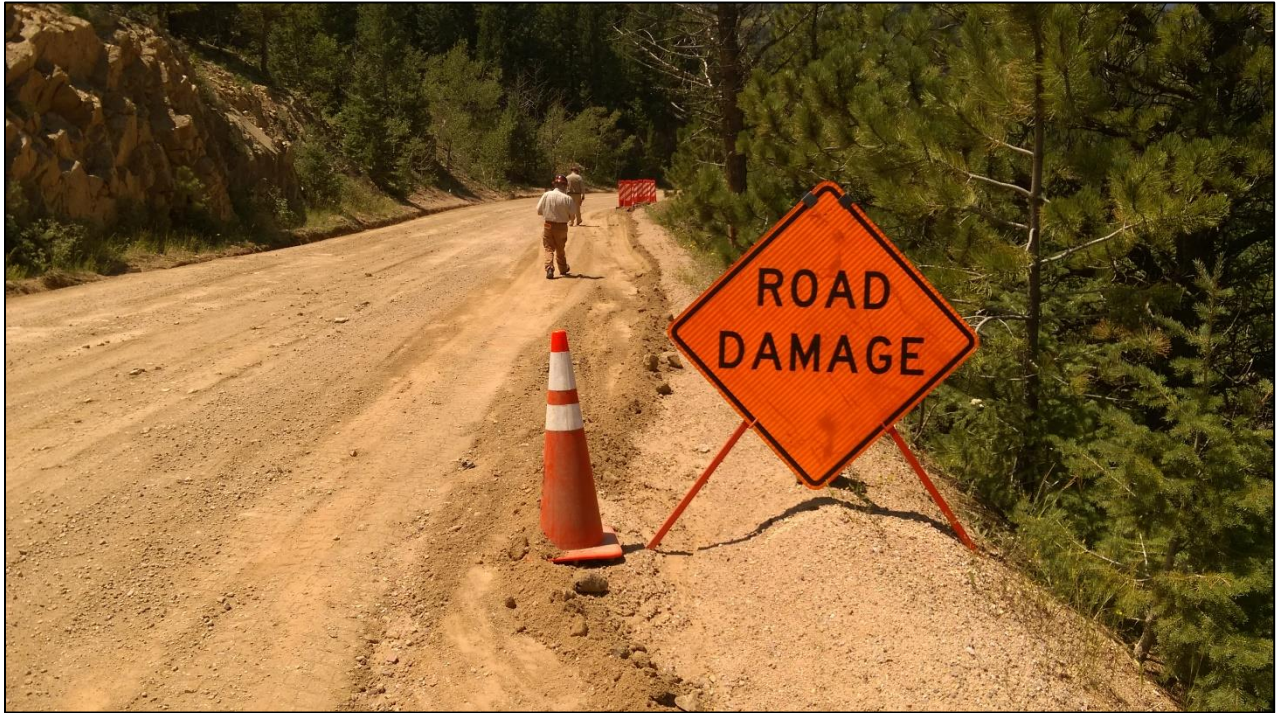
Boulder County has placed orange cones along the edge of Sunshine Canyon Drive and signs on either side of the subsidence area to warn passersby. The Division observed the subsidence area from the road. Mr. Steen indicated he had placed fill material in the depression caused by the subsidence in efforts to temporarily stabilize the feature and keep it from migrating into the road. Additionally, a temporary retaining wall composed of timbers stacked between steel stakes had been installed across the fill area. The edge of the

**Photo 1.** View looking west down Sunshine Canyon Drive, showing sign and safety cones placed by Boulder County Transportation Department to warn passersby of unsafe conditions ahead (associated with Times Mine subsidence).

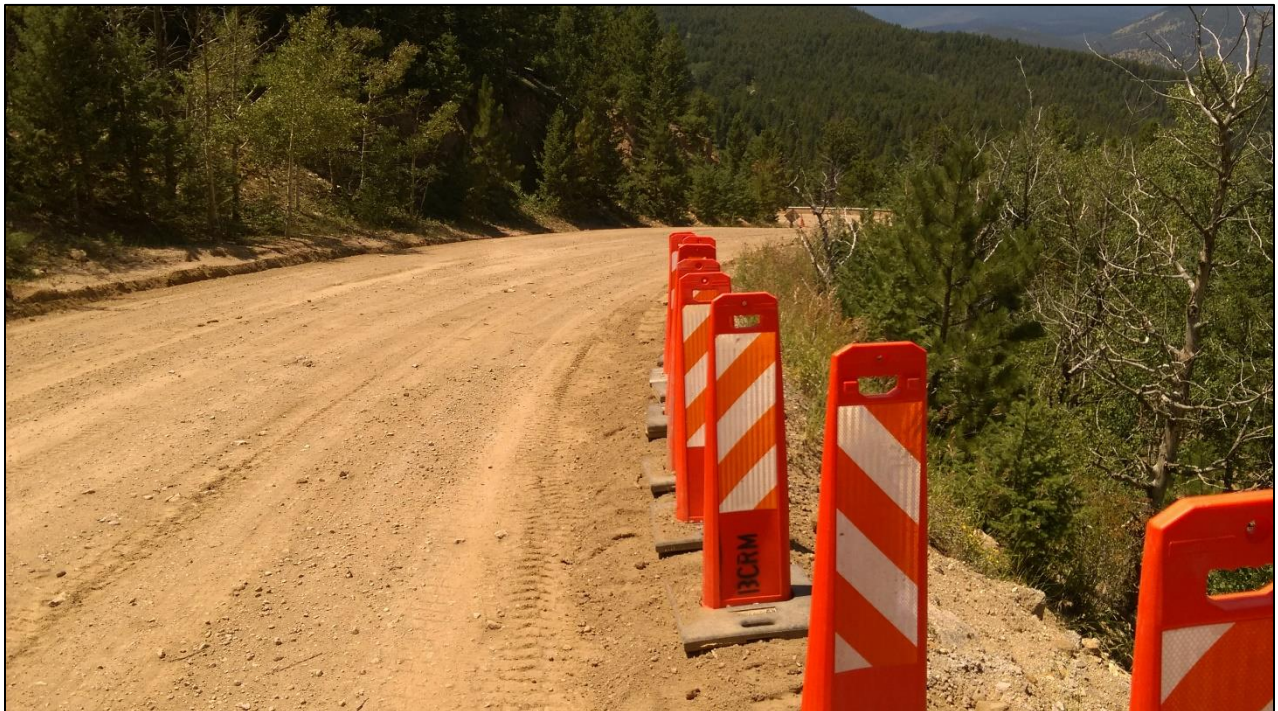
subsidence appeared to be within three feet from the northern edge of Sunshine Canyon Drive. It appeared the subsidence may be impacting the stability of the road. According to Mr. Steen, the underlying granitic bedrock extends from the south to approximately the middle of the road. The rest of the road (northern half) is composed of fill material, in which the subsidence occurred. The potential for the subsidence to migrate through the rest of the fill material (and road) until it reaches bedrock is present.

**Photo 2.** View looking west down Sunshine Canyon Drive, showing section of road directly above Times Mine subsidence area.

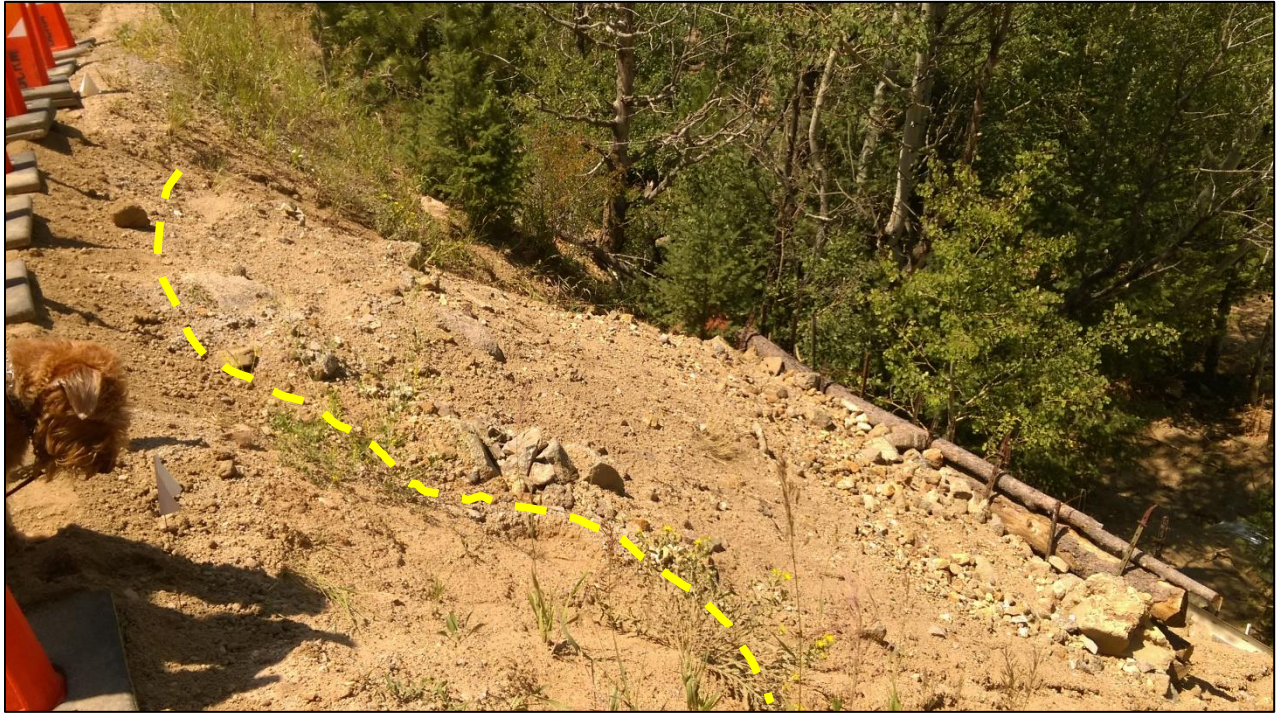
The Division inspected the Times Mine portal area where the collapse was reported to have occurred (**Photos 1-4**). This area is located just north of and adjacent to Sunshine Canyon Drive, approximately 300 feet northwest of the approved permit boundary for the mill site (**see enclosed Google Earth image of site showing location of Times Mine subsidence in relation to approved permit area**), and approximately 0.2 mile east from Gold Hill, Colorado. According to the original permit files for the mill, the Times Mine portal is located approximately 45 feet below Sunshine Canyon Drive, and the adit extends 395 feet in a southeasterly direction to connect with the first level of the Wynona Mine by way of a 50 foot deep winze.

Mr. Steen stated the collapse occurred after he had removed old timber sets from the Times Mine portal and replaced them with a culvert that is 16 feet long, with a diameter of 5 feet. Mr. Steen had been working to rehabilitate the Times Mine adit for future use by the mill operation. The original permit discusses pumping water from the south bank of Left Hand Creek, conveying the water up Lick Skillet Gulch via a surface laid two inch pipeline, running the water line through the Times Mine adit, which passes under the road through the underground crosscut feature to connect to the historic Wynona Mine, where stored water would be pumped from a collared shaft located southwest of the mill building. By constructing a bulkhead in the Times Mine, and pumping the water from Left Hand Creek behind this bulkhead, both the Times and Wynona mines were to be used for underground storage of water for mill operations. The original permit stated that together, these two mines have sufficient capacity to store enough water to carry the milling operation through the period between November 1<sup>st</sup> and May 31<sup>st</sup>. Pumping from the creek is limited to a maximum rate of 50 gpm during the irrigation season, which extends between April 1<sup>st</sup> and October 31<sup>st</sup>. Water rights for the mill were obtained by the purchase of 20 shares of stock in the Left Hand Ditch Company, as filed with the Colorado Water Court, Water Division No. 1, under Case No. 85CW117.

**Photo 3.** View looking down from northern edge of Sunshine Canyon Drive at Times Mine subsidence area. Approximate edge of subsidence feature (not visible due to fill placement) is indicated with a yellow dashed line.

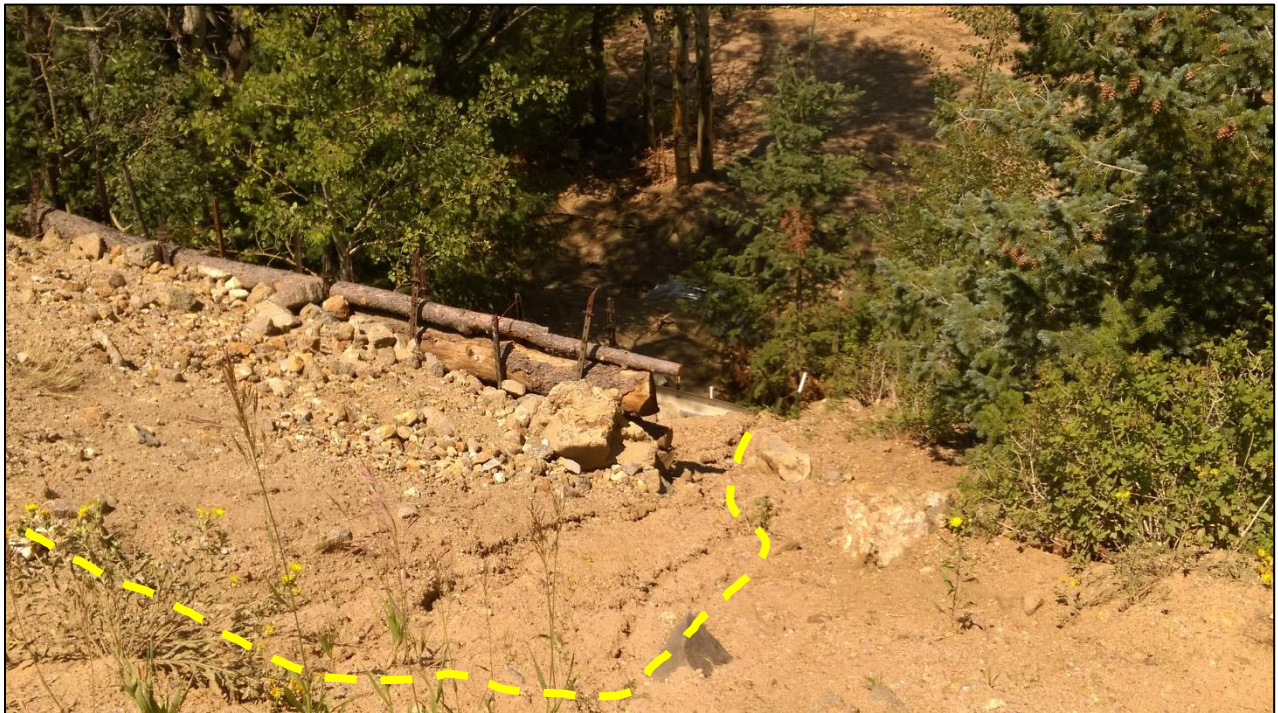
**POSSIBLE VIOLATION:** Land has been affected outside of the approved permit boundary. Specifically, in efforts to rehabilitate the portal at the historic Times Mine to support water conveyance infrastructure for mill use, the operator caused subsidence of the ground surface to occur directly adjacent to and north of Sunshine Canyon Drive. This is a possible violation at this time pursuant to C.R.S. 34-32-116(7)(h) for failure to protect areas outside of the affected land from slides or damages occurring during the mining operation and reclamation.

**Photo 4.** View looking down from northern edge of Sunshine Canyon Drive at Times Mine subsidence area. Approximate edge of subsidence feature (not visible due to fill placement) is indicated with a yellow dashed line. Note fill being held in place by temporary retaining wall composed of timbers stacked between stakes.

**CORRECTIVE ACTIONS:** This possible violation will require a hearing before the Mined Land Reclamation Board (MLRB), to occur during the September 27-28, 2017 meeting. The schedule and other details for the MLRB hearing will be sent separately via certified mail.

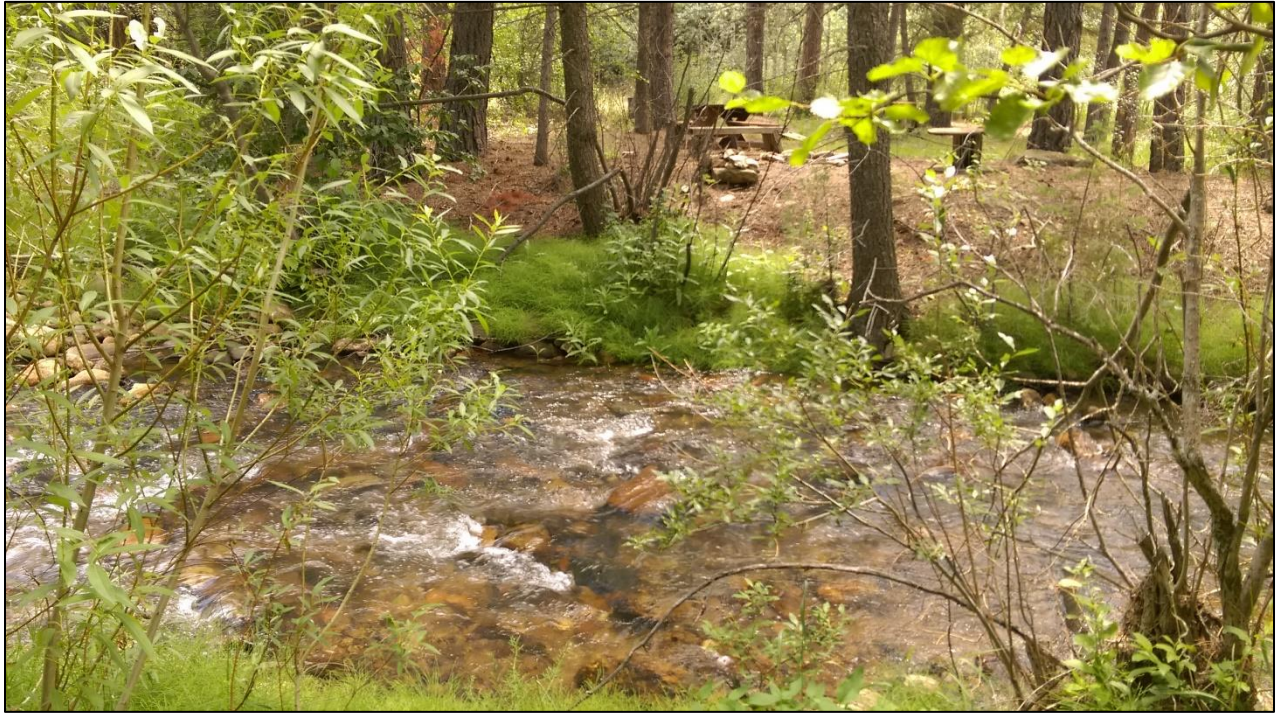
**Photo 5.** View looking south from north of Left Hand Creek, showing area (across creek) where Mr. Steen intends to install pump for acquiring water for mill operation. The Division believes this parcel of land to currently be owned by the BLM.

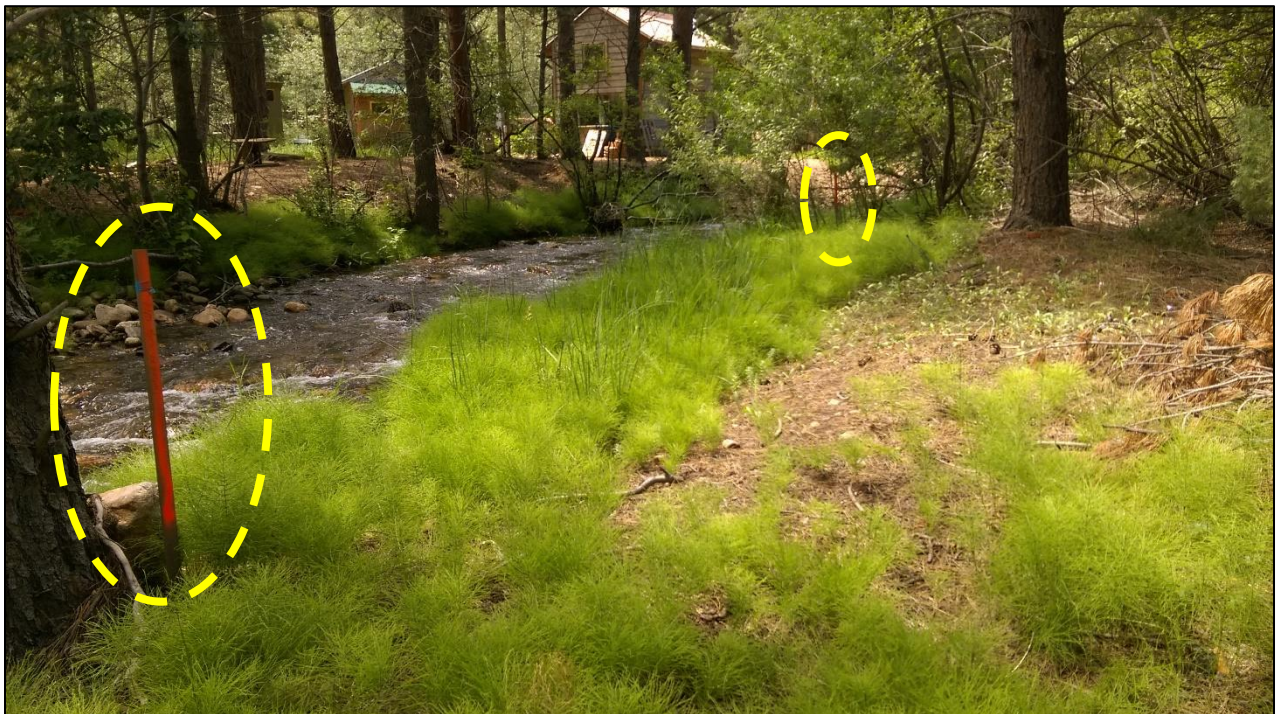
**Photo 6.** View looking west across parcel of land located north of Left Hand Creek, marked with orange stakes (circled with yellow dashed lines) where Mr. Steen intends to cross the creek to install pump on south side of creek (shown in Photo 5).

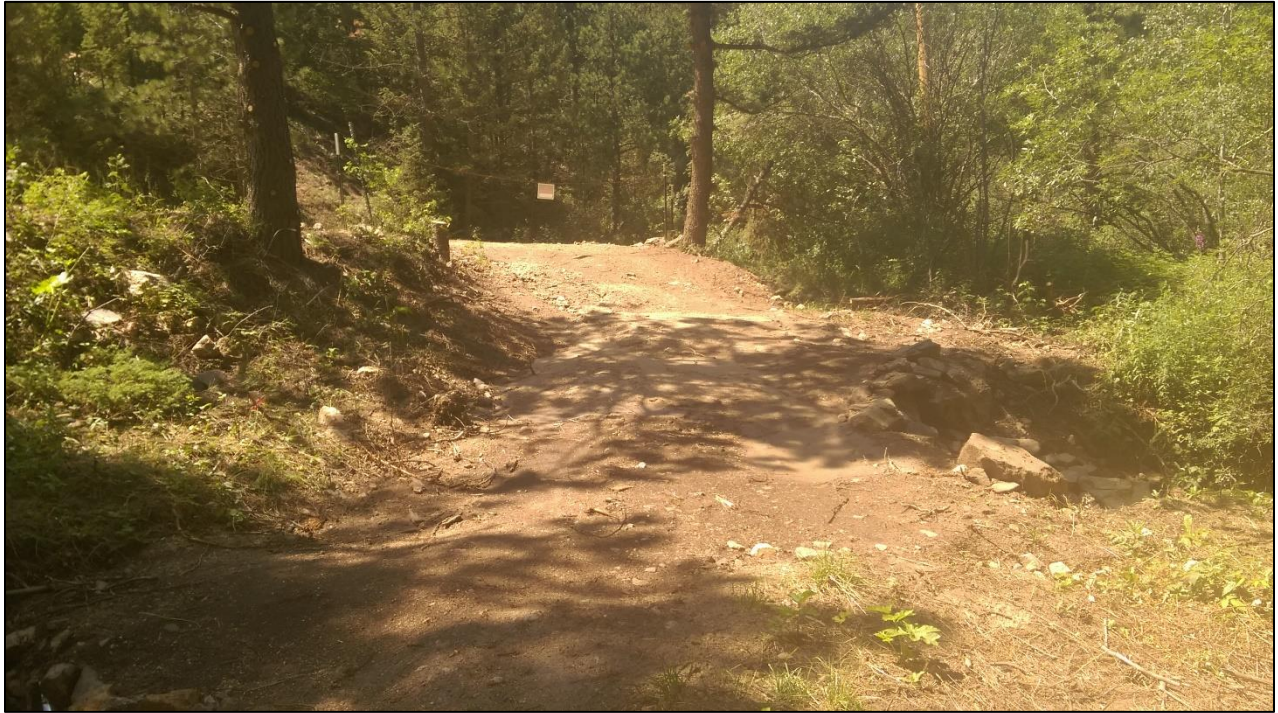
The Division also observed the access point located off Licksillet Road (**Photos 7-10**) which was identified in the County's complaint. This access point is located on property owned by Boulder County, parcel no. 145911000025. The access starts as a dirt road, then turns into a rough trail which traverses the east side of Lick Skillet Gulch. The Division observed two existing pipelines near the trail, including a two inch black HDPE

**Photo 7.** View looking west toward access off Licksillet Road which Mr. Steen intends to utilize for accessing water pipe for mill operation.

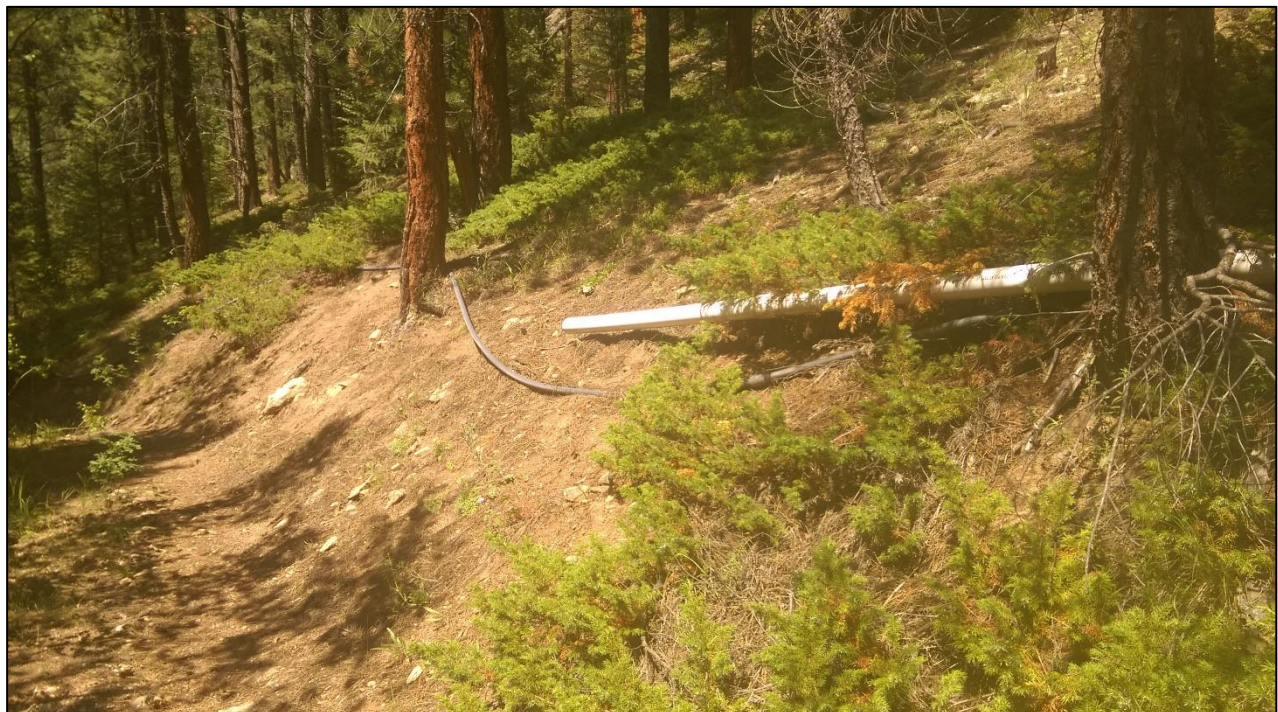
**Photo 8.** View looking downhill along trail following Lick Skillet Gulch, showing two existing pipelines present along edge of trail. According to Mr. Steen, PVC pipe was installed by him when mill was first constructed in 1980's, and smaller black HDPE pipe was installed by previous operator in 1990's. Note PVC pipe disconnected.

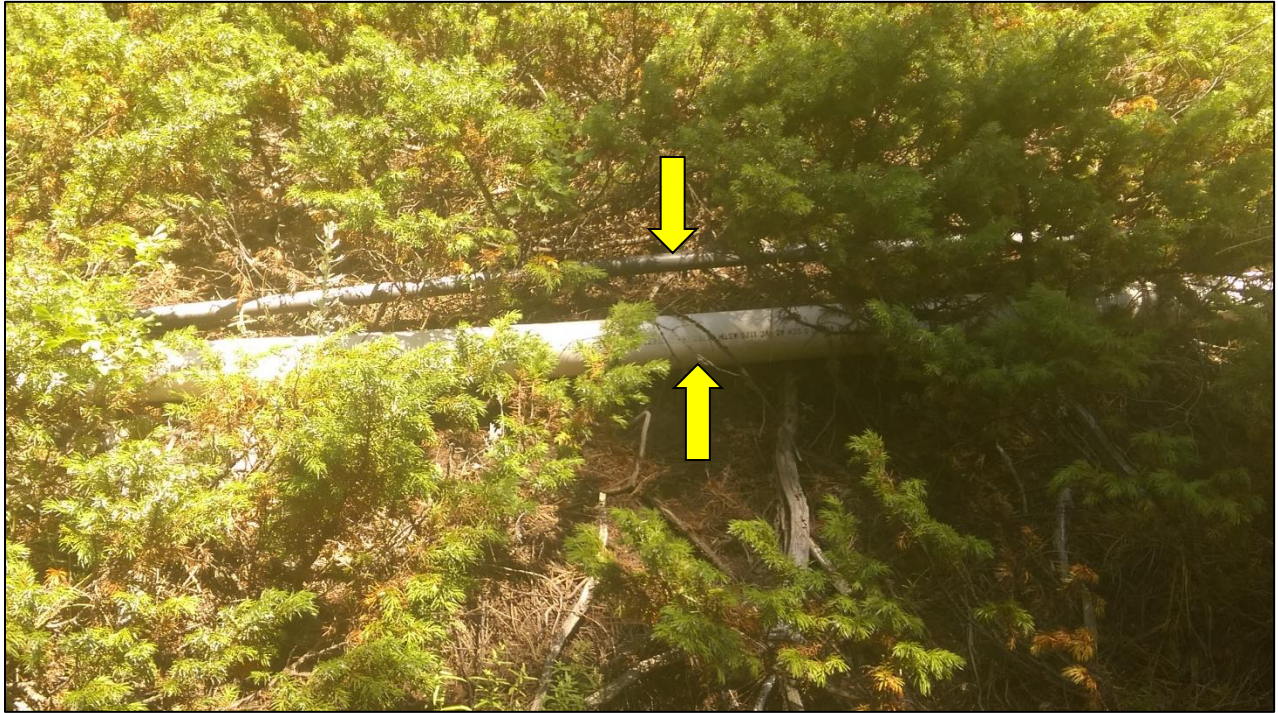
**Photo 9.** Closer view of two existing pipelines (indicated with arrows) present along edge of trail in Lick Skillet Gulch. According to Mr. Steen, PVC pipe was installed by him when mill was first constructed in 1980's, and smaller black HDPE pipe was installed by previous operator in 1990's.

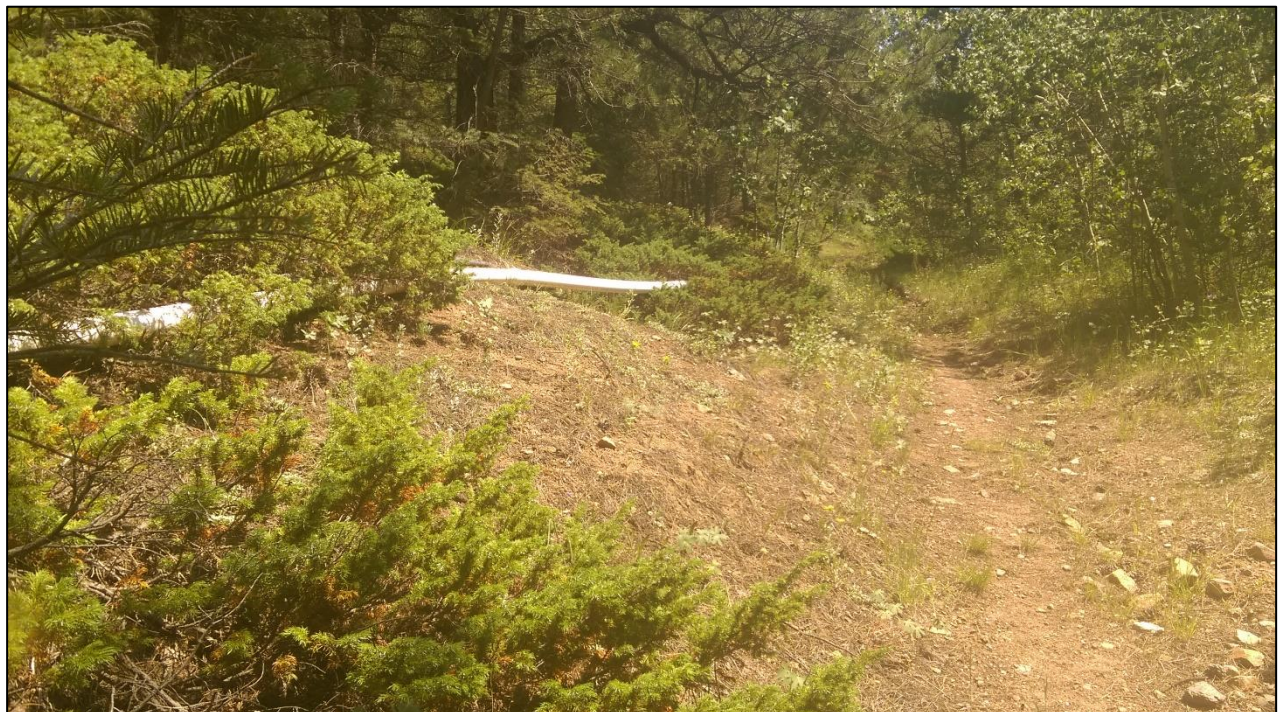
**Photo 10.** View looking uphill along trail following Lick Skillet Gulch, showing two existing pipelines present along edge of trail, which Mr. Steen indicates conveyed water to the mill in the 1980's and 1990's.

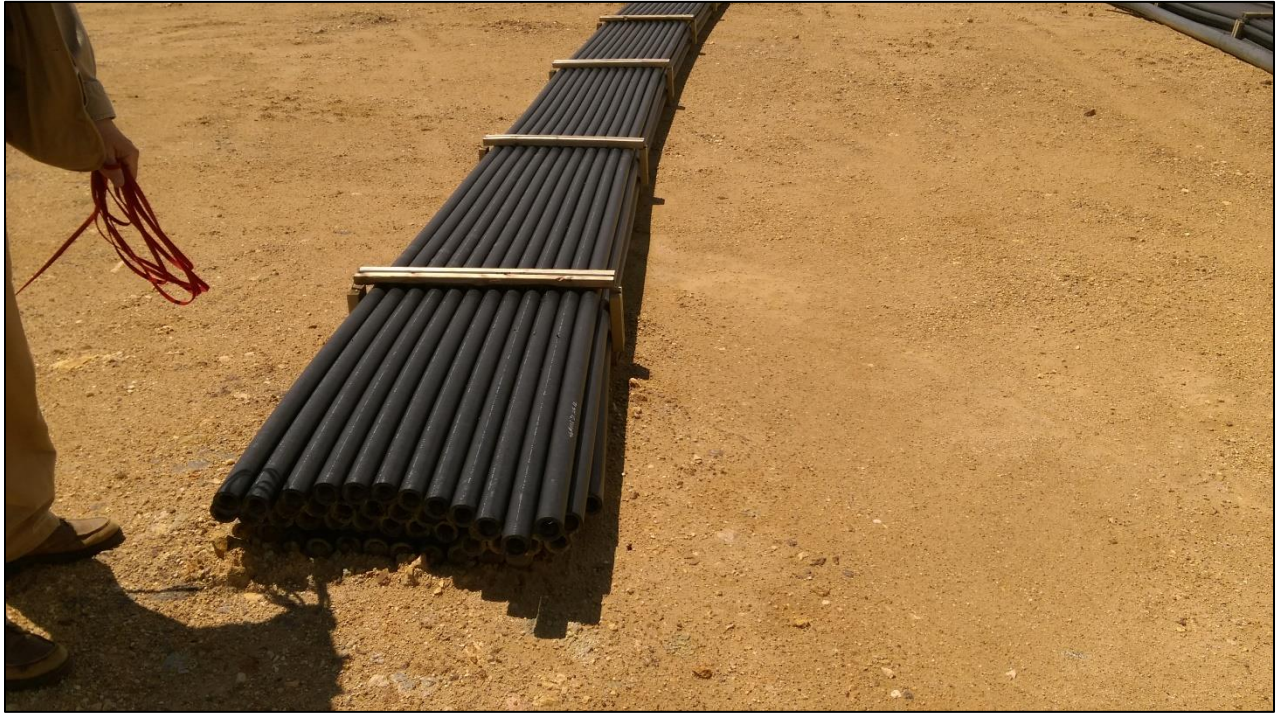
**Photo 11.** View of one of two stacks of black two inch HDPE pipe currently stored on top of ore stockpile in mill permit area. This pipe is intended to replace two existing pipelines present in Lick Skillet Gulch in order to convey water pumped from Left Hand Creek to the mill.

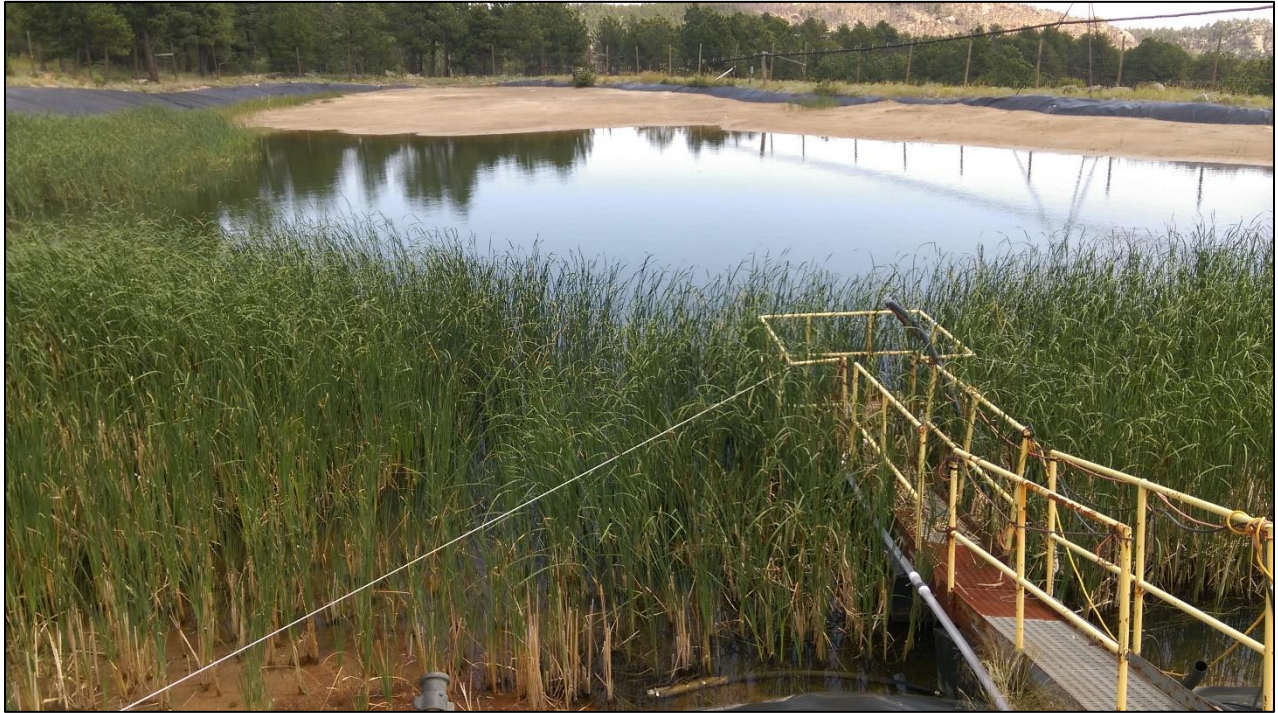
**Photo 22.** View looking northeast across lined tailings impoundment located east of mill building. Note water and cattails present in western portion of impoundment.

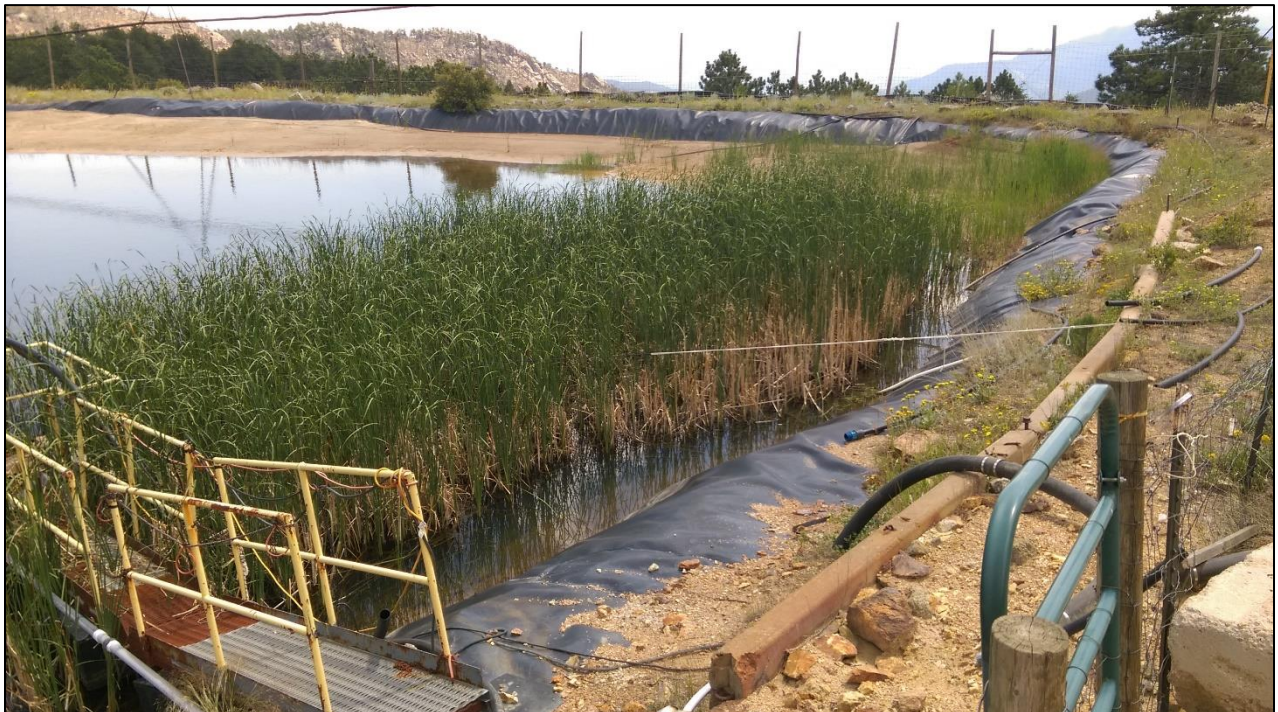
**Photo 23.** View looking across western edge of lined tailings impoundment. Note water and cattails present in this portion of the impoundment. Also note available freeboard along western edge meets or exceeds the required two feet.

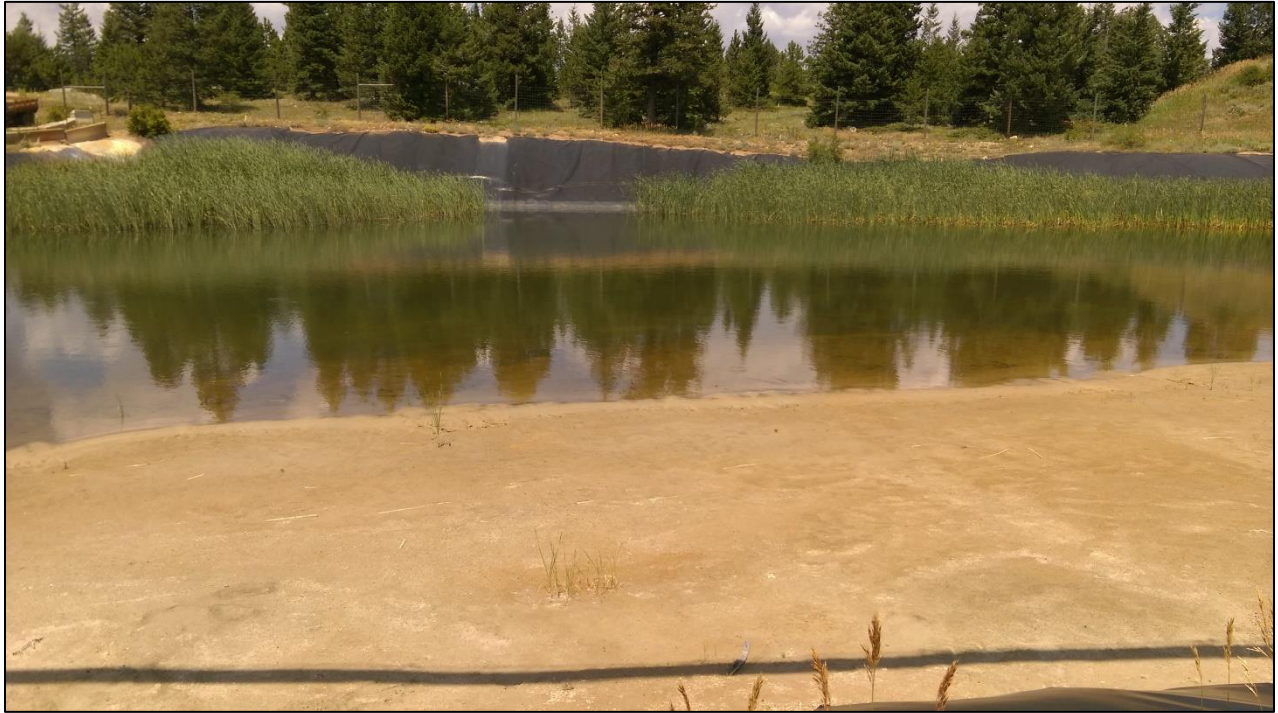
**Photo 24.** View looking north across lined tailings impoundment. Note available freeboard along northern edge exceeds the required two feet. It should be noted, the northern edge of the impoundment appears to be approximately 2 feet higher in elevation than the southern edge of the impoundment.

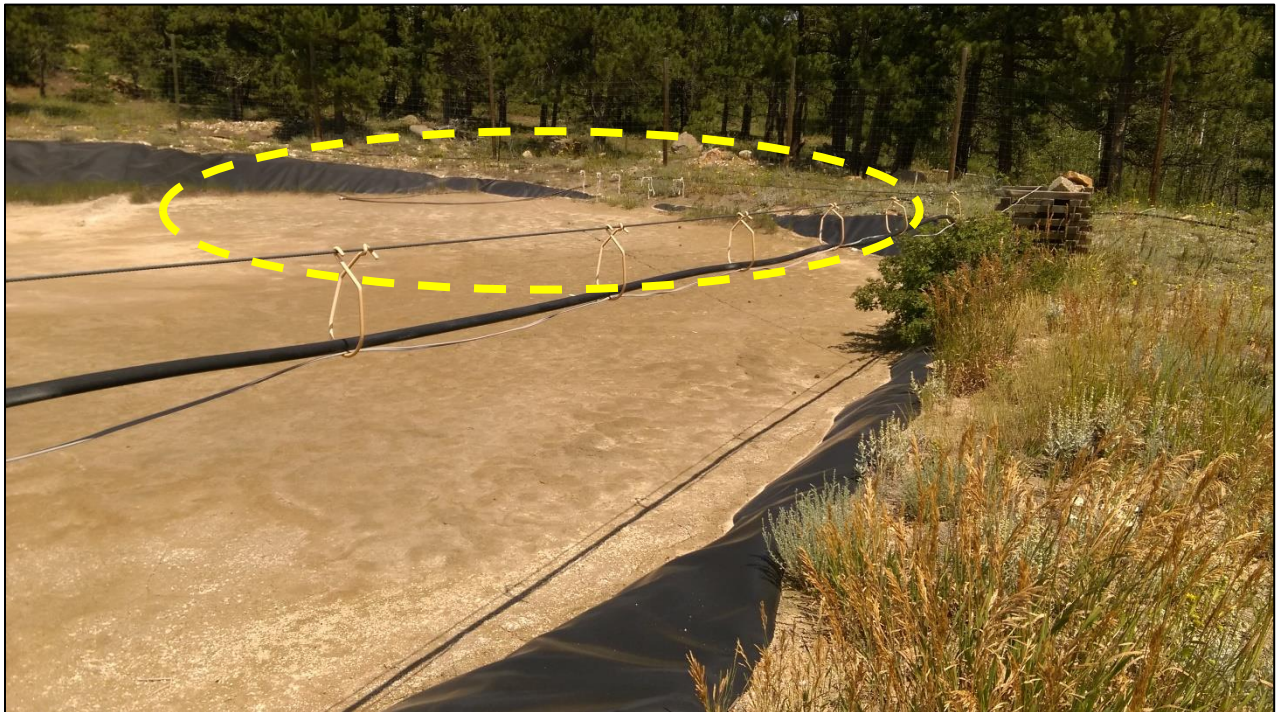
**PROBLEM:** The approved mining plan for the tailings impoundment requires a minimum two feet of freeboard (as measured from the top of the synthetic liner) be maintained at all times to allow sufficient capacity for a 100-year, 24-hour precipitation event. The top of the tailings deposit is currently less than two feet from top of liner along the southern edge of the impoundment, and near top of liner at the eastern edge of the impoundment. This is a problem at this time pursuant to C.R.S. 34-32-116(7)(c) and Rule 3.1.5(5) for failure to handle acid-forming or toxic-producing material that has been mined in a manner that will protect the drainage system from pollution.

impoundment, and near top of liner in the eastern portion of the impoundment. The Division considers this to be a problem at this time pursuant to C.R.S. 34-32-116(7)(c) and Rule 3.1.5(5) for failure to handle acid-forming or toxic-producing material that has been mined in a manner that will protect the drainage system from pollution. The operator will need to redistribute the tailings in the impoundment so that a minimum two feet of freeboard is re-established. In doing this, the operator should be very careful not to damage the liner. This may require using hand tools and/or light equipment to complete the task.

**Photo 25.** View looking across eastern portion of lined tailings impoundment. Note available freeboard along eastern edge is less than the required two feet (particular area of concern circled).

**CORRECTIVE ACTIONS:** The operator shall relocate the tailings inside the impoundment to allow for a minimum two feet of freeboard around the entire perimeter of the impoundment in accordance with the approved mining plan. In completing this task, the operator shall be very careful not to damage the liner (e.g., use hand tools and/or light equipment). The operator shall submit photo documentation showing this task has been completed by the corrective action due date.

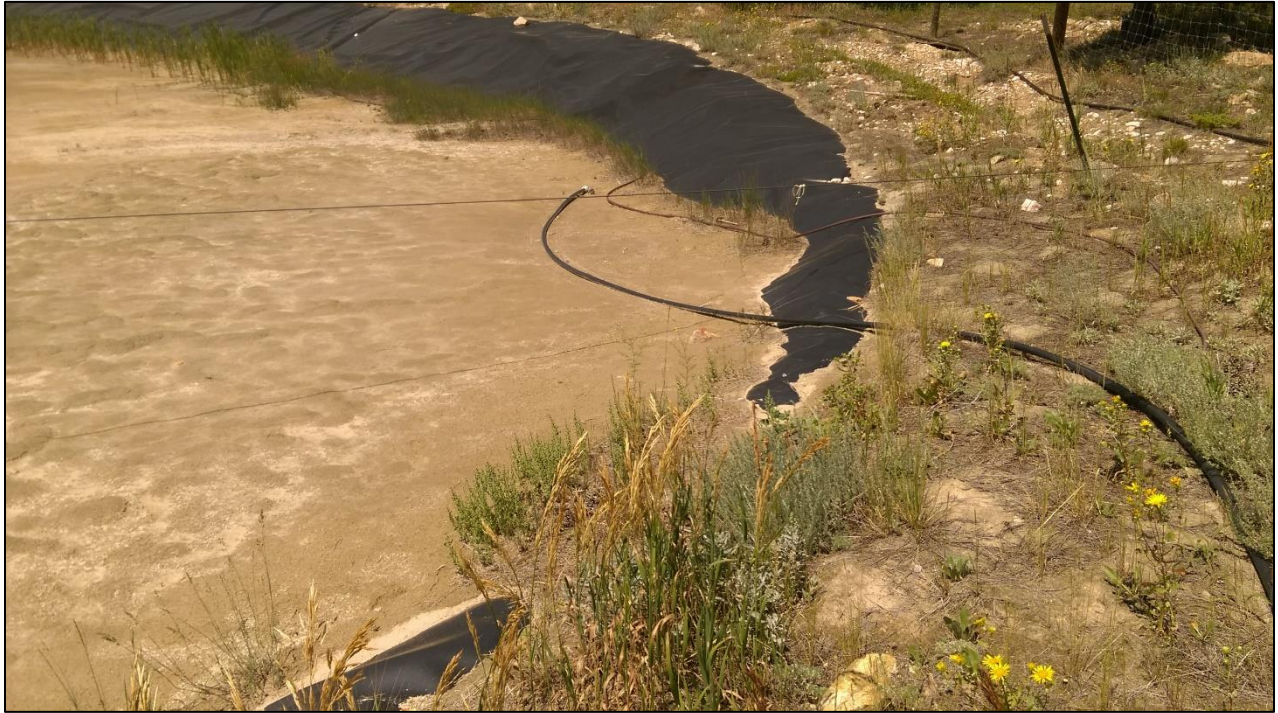
**Photo 26.** Closer view of eastern edge of lined tailings impoundment showing available freeboard is less than the required two feet.

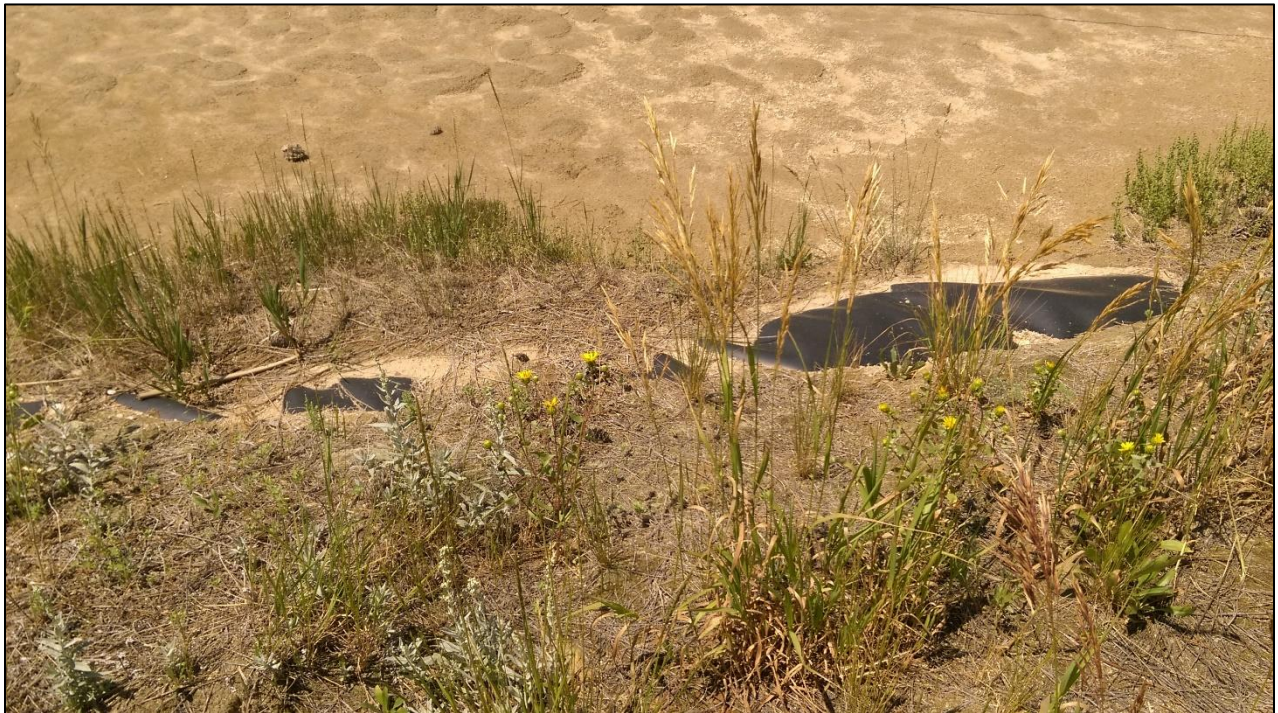
**Photo 27.** Close-up of portion of eastern edge of lined tailings impoundment where tailings are at or near top of liner.

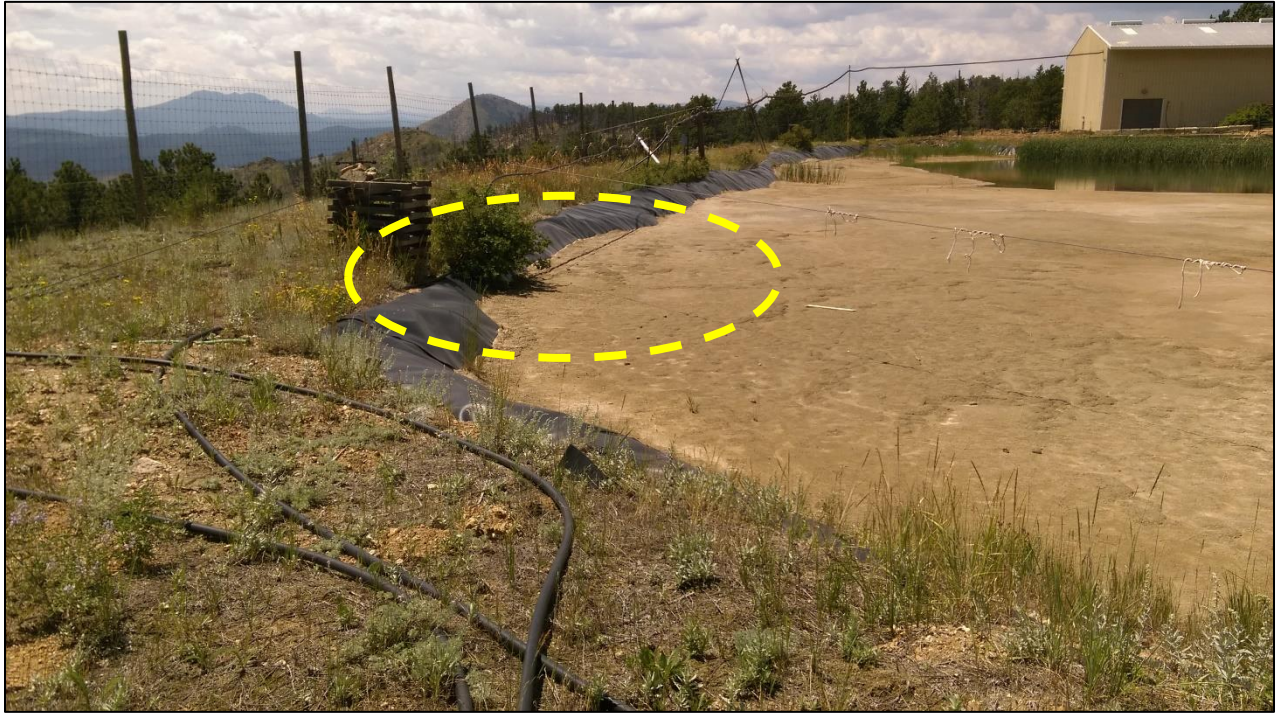
The Division observed the tailings impoundment located just east of the mill building (**Photos 22-29**). The impoundment is enclosed by fencing. The western portion of the impoundment was holding some water at the time of the inspection. A dense cluster of cattails was growing from the tailings deposited in this area, which Mr. Steen indicated would be cleared from the impoundment prior to mill operations recommencing. The northern edge of the impoundment appeared to be approximately two feet higher in elevation than the southern edge. The portion of liner exposed appeared to be in good condition. The Division is concerned about current available freeboard in the impoundment. The approved permit requires a minimum freeboard of two feet in order for the impoundment to accommodate a 100-year, 24-hour storm event without overtopping the liner. The Division observed the freeboard to be less than two feet along portions of the southern edge of the

**Photo 28.** View looking across southern edge of lined tailings impoundment showing portions where available freeboard is less than the required two feet (particular area of concern circled).

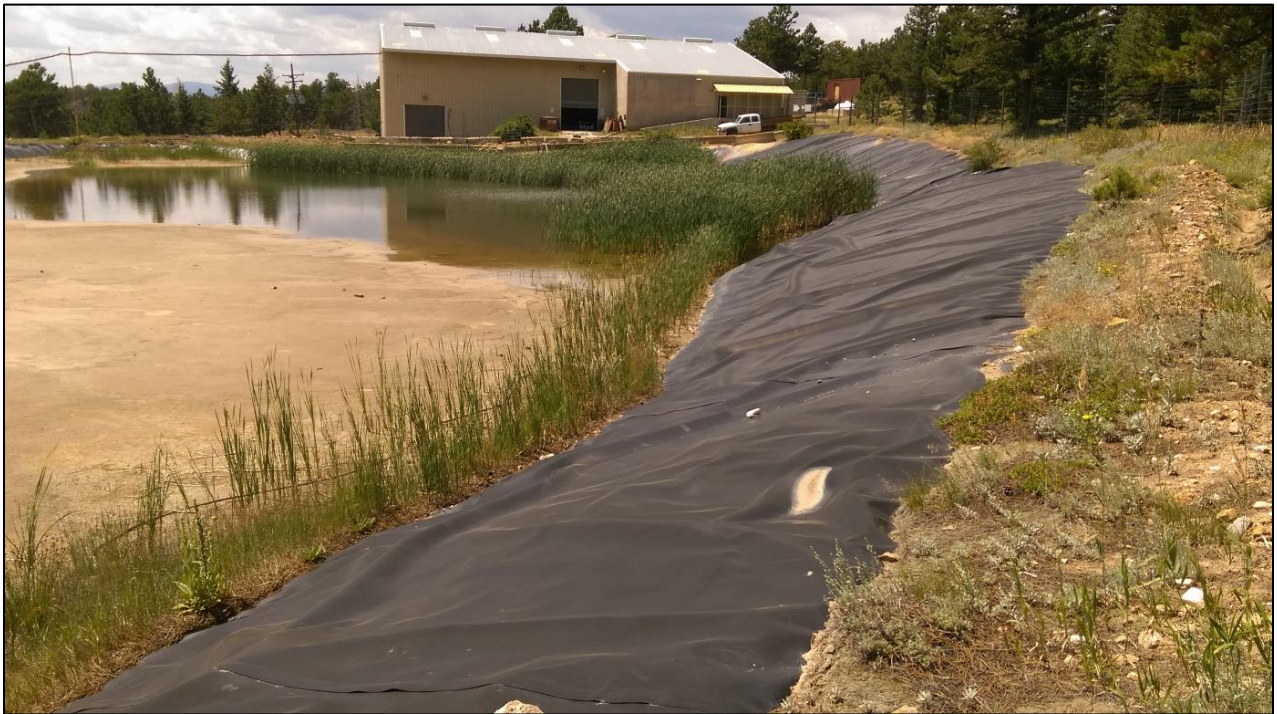
**Photo 29.** View looking across northern edge of lined tailings impoundment showing available freeboard exceeds the required two feet.

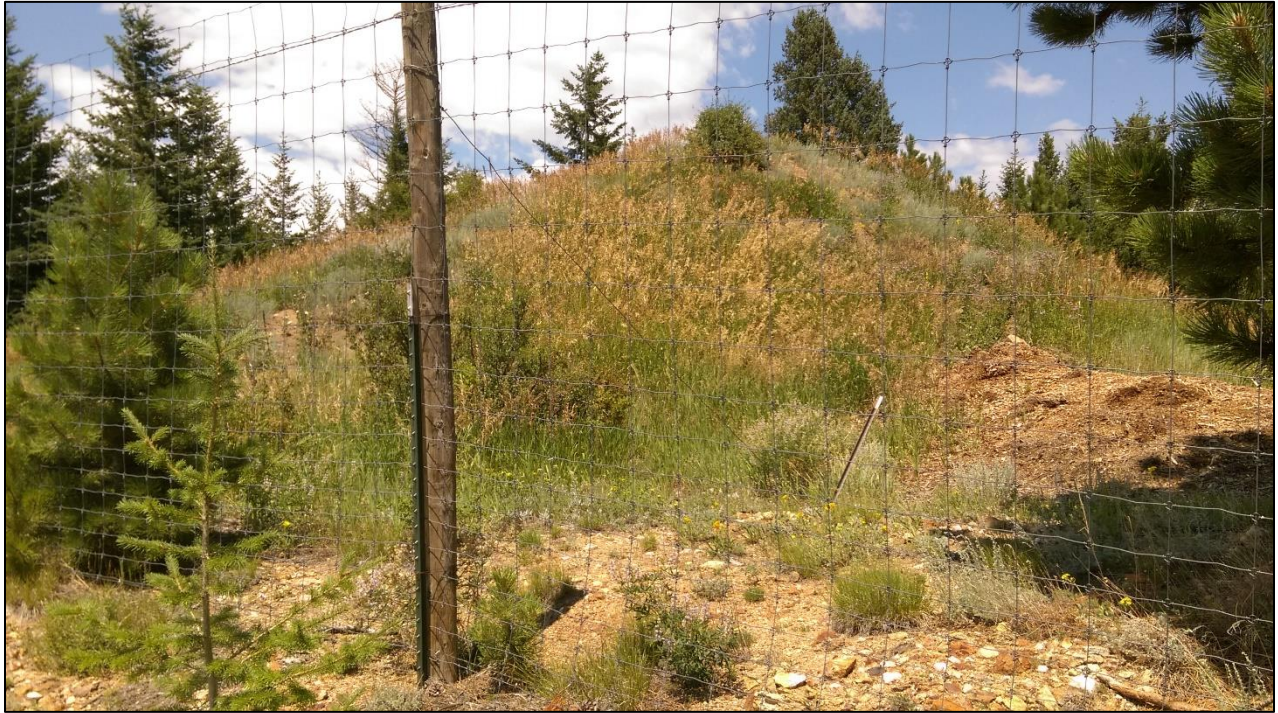
**Photo 30.** View of topsoil stockpile stored north of tailings impoundment, outside of fenced enclosure. Note stockpile is well vegetated and stable.

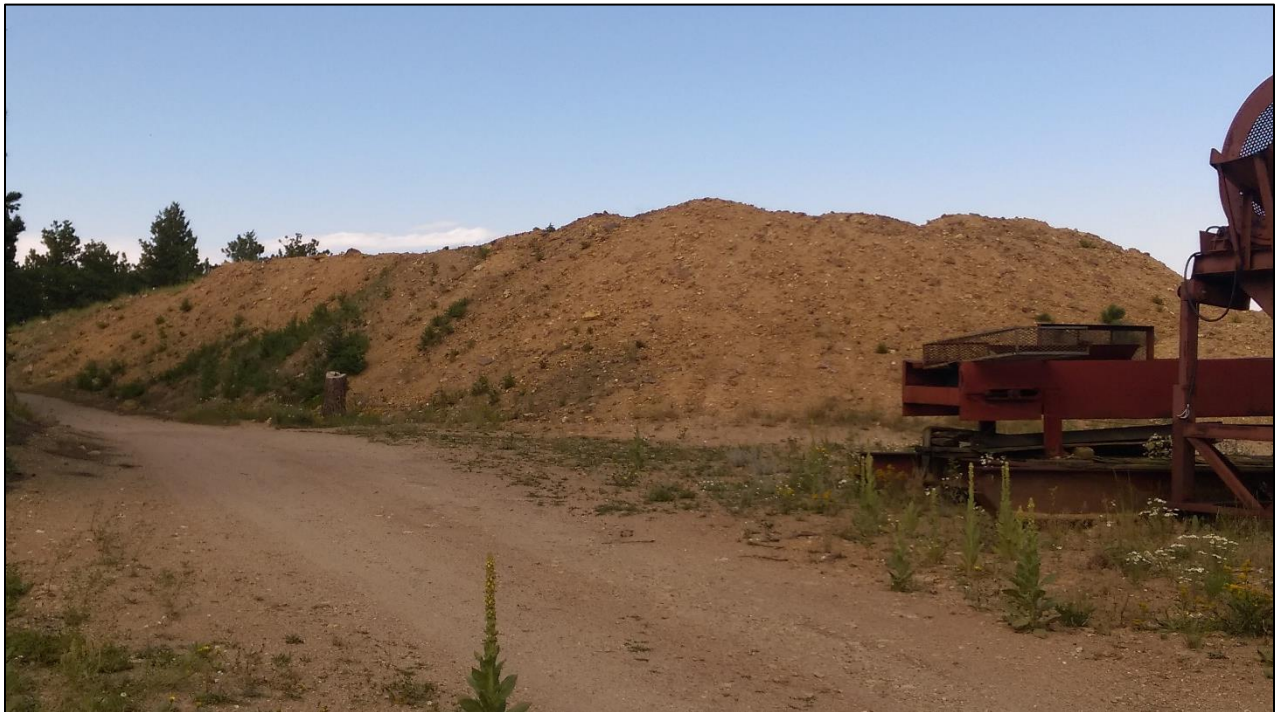
The Division observed the ore stockpile area located southwest of the mill building (**Photos 31-33**). According to the permit file, the material came from the permitted Cash Mine (located approximately 0.4 mile downhill from the mill). Mr. Steen estimates the stockpile to contain approximately 35,000-40,000 tons of material. A ramp connects the top of the stockpile to the two coarse ore bins located at the southwestern edge of the mill building. The stockpile appeared to be stable. No signs of acid rock drainage from the stockpile were observed.

**Photo 33.** View looking northeast from haul road showing large ore stockpile stored southwest of mill building.
