**RE:** Enforcement Hearing  
Colorado Milling Company, LLC; Permit No. M-1994-117; Gold Hill Mill

**MINERALS PROGRAM INSPECTION REPORT****PHONE: (303) 866-3567**

<b>MINE NAME:</b> Gold Hill Mill	<b>MINE/PROSPECTING ID#:</b> M-1994-117	<b>MINERAL:</b> Gold and silver	<b>COUNTY:</b> Boulder
<b>INSPECTION TYPE:</b> Monitoring	<b>INSPECTOR(S):</b> Amy Eschberger, Wally Erickson	<b>INSP. DATE:</b> August 1, 2017	<b>INSP. TIME:</b> 10:25
<b>OPERATOR:</b> Colorado Milling Company, LLC	<b>OPERATOR REPRESENTATIVE:</b> Mark Steen	<b>TYPE OF OPERATION:</b> 110(2) - Hard Rock Limited Impact

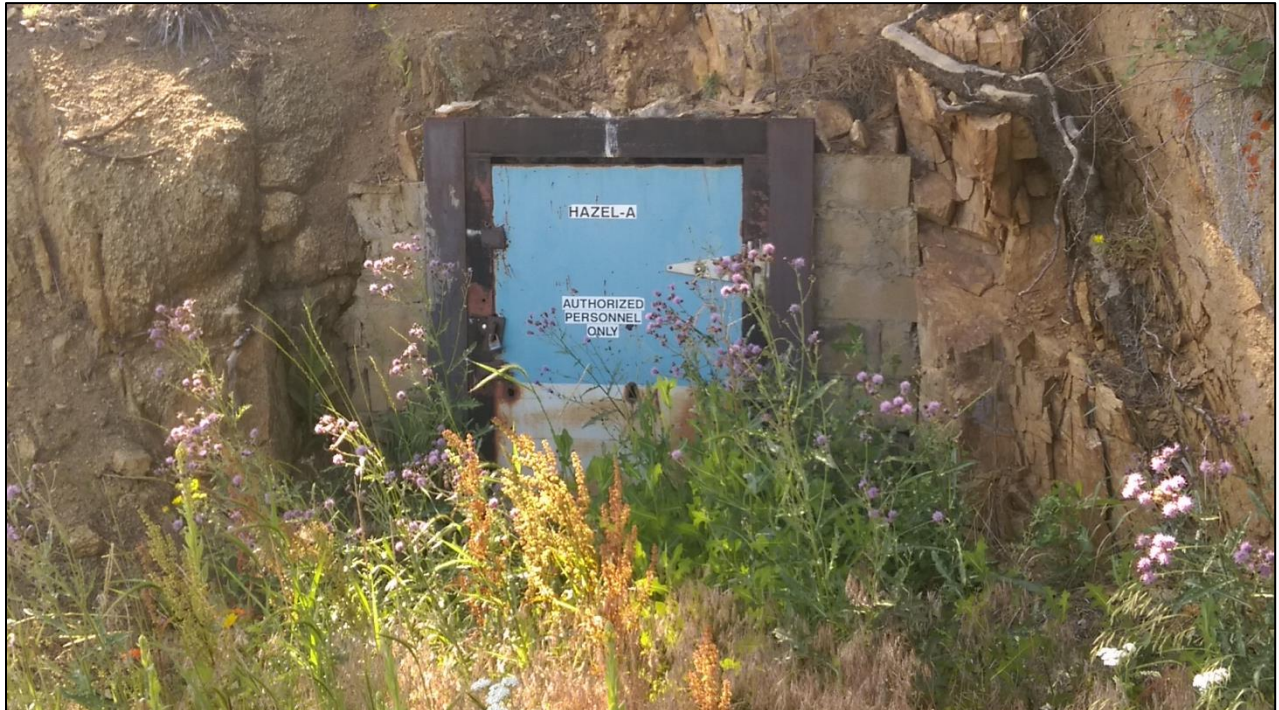
**Photo 35.** Closer view of Hazel A Mine entrance, secured with a locked door.

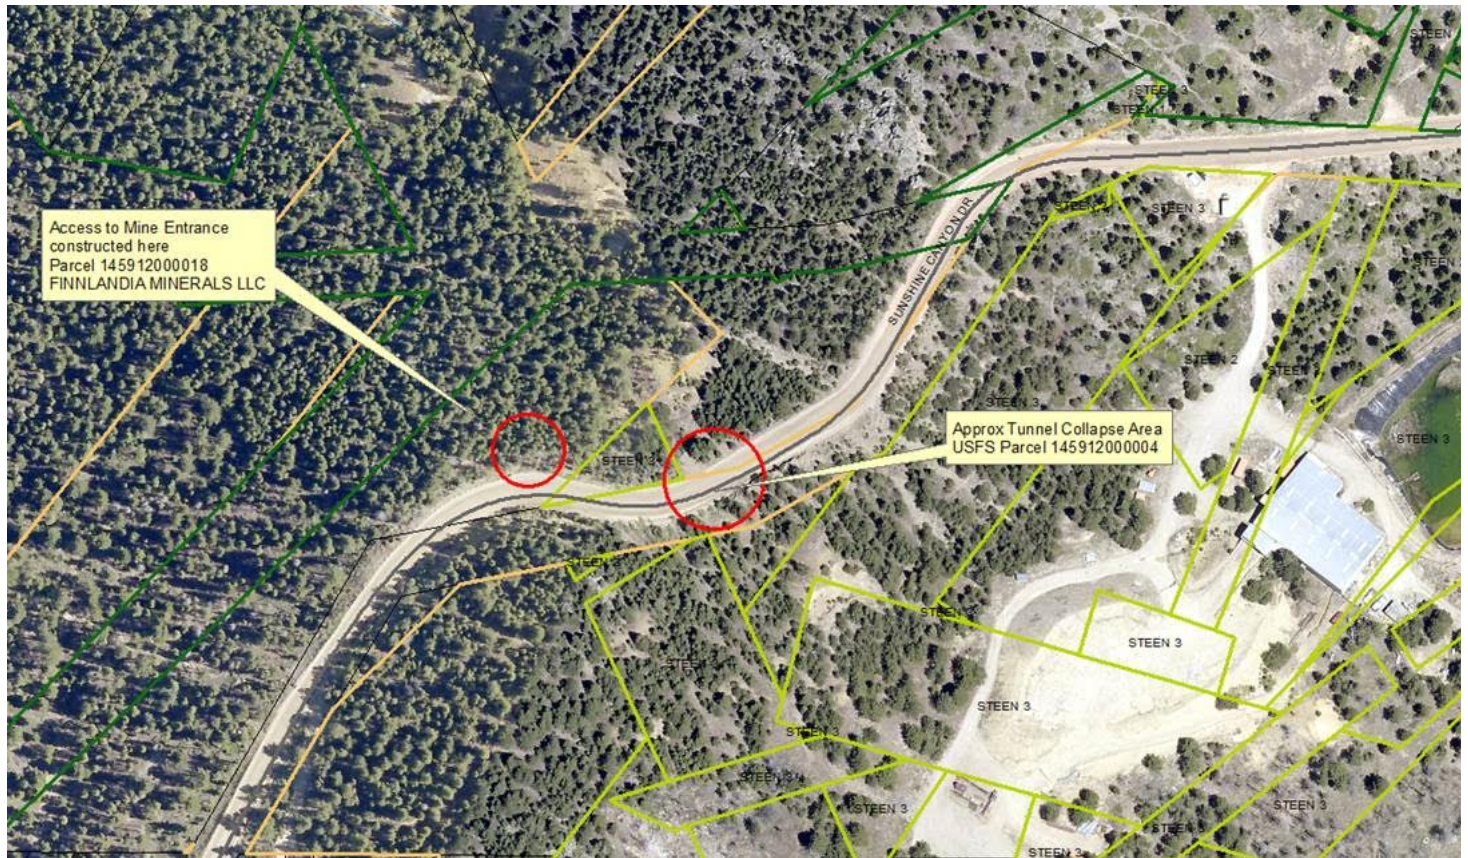
Map #1

The location the tunnel caved under Sunshine Canyon Drive is shown generally on Map #1. Mr. Steen has been working with our Transportation Department on this, and has since installed structures (out of the right of way) to help stabilize the tunnel. Transportation is still working with Mr. Steen on this issue.

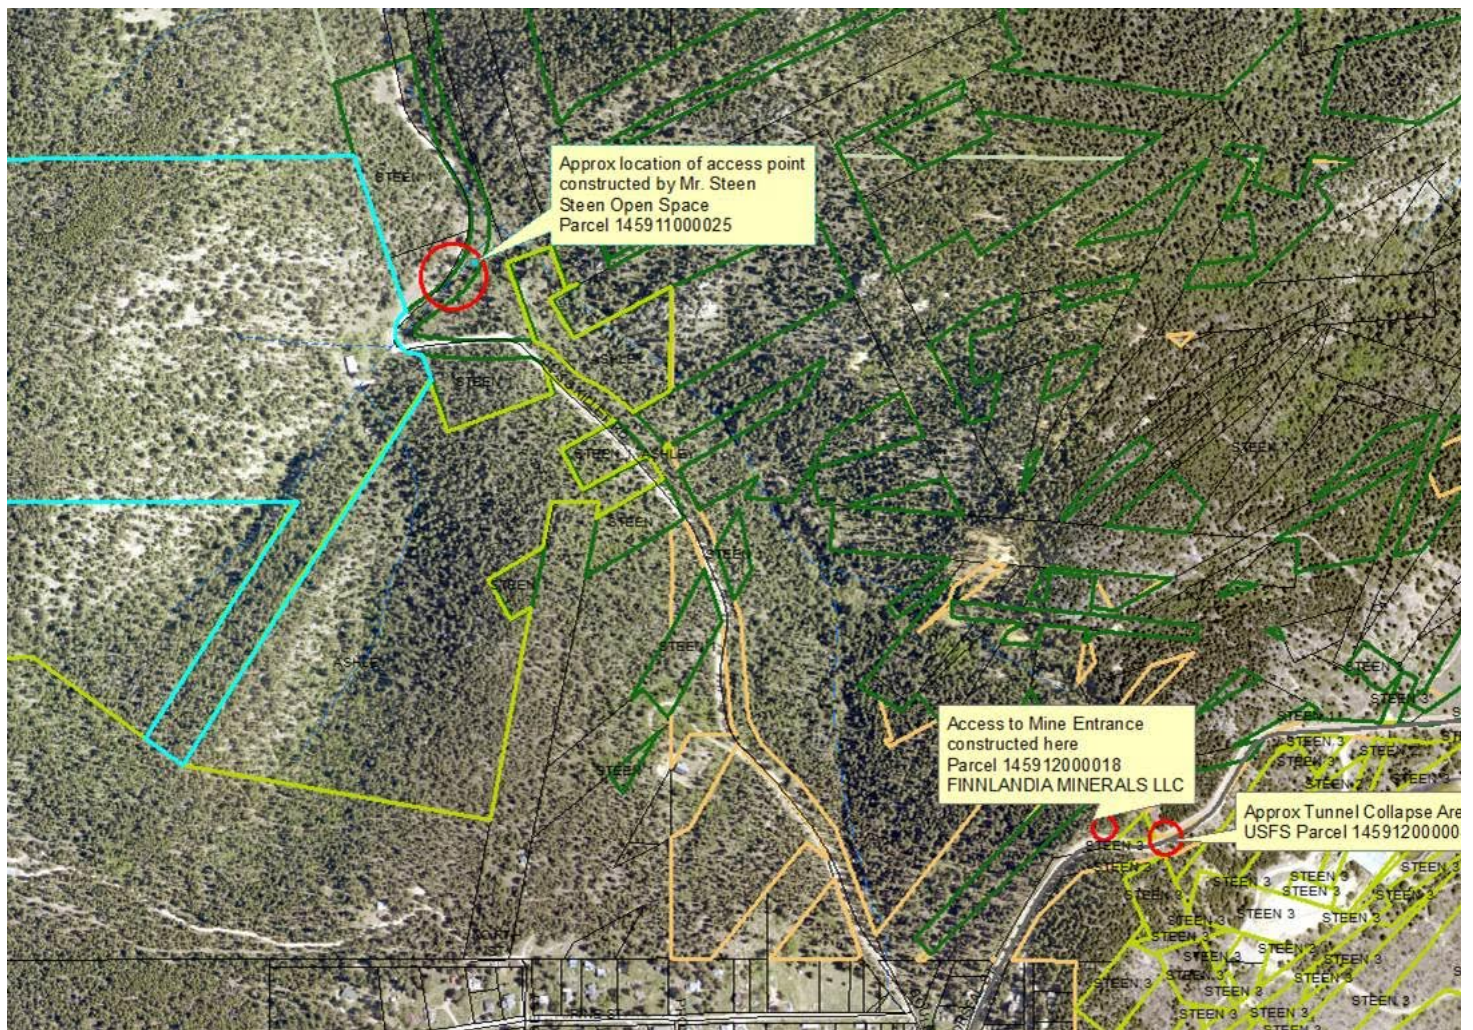
Map #2

An access point to something related to the mine was constructed off of Licksillet Rd and appears to be on open space, generally shown on Map #2.

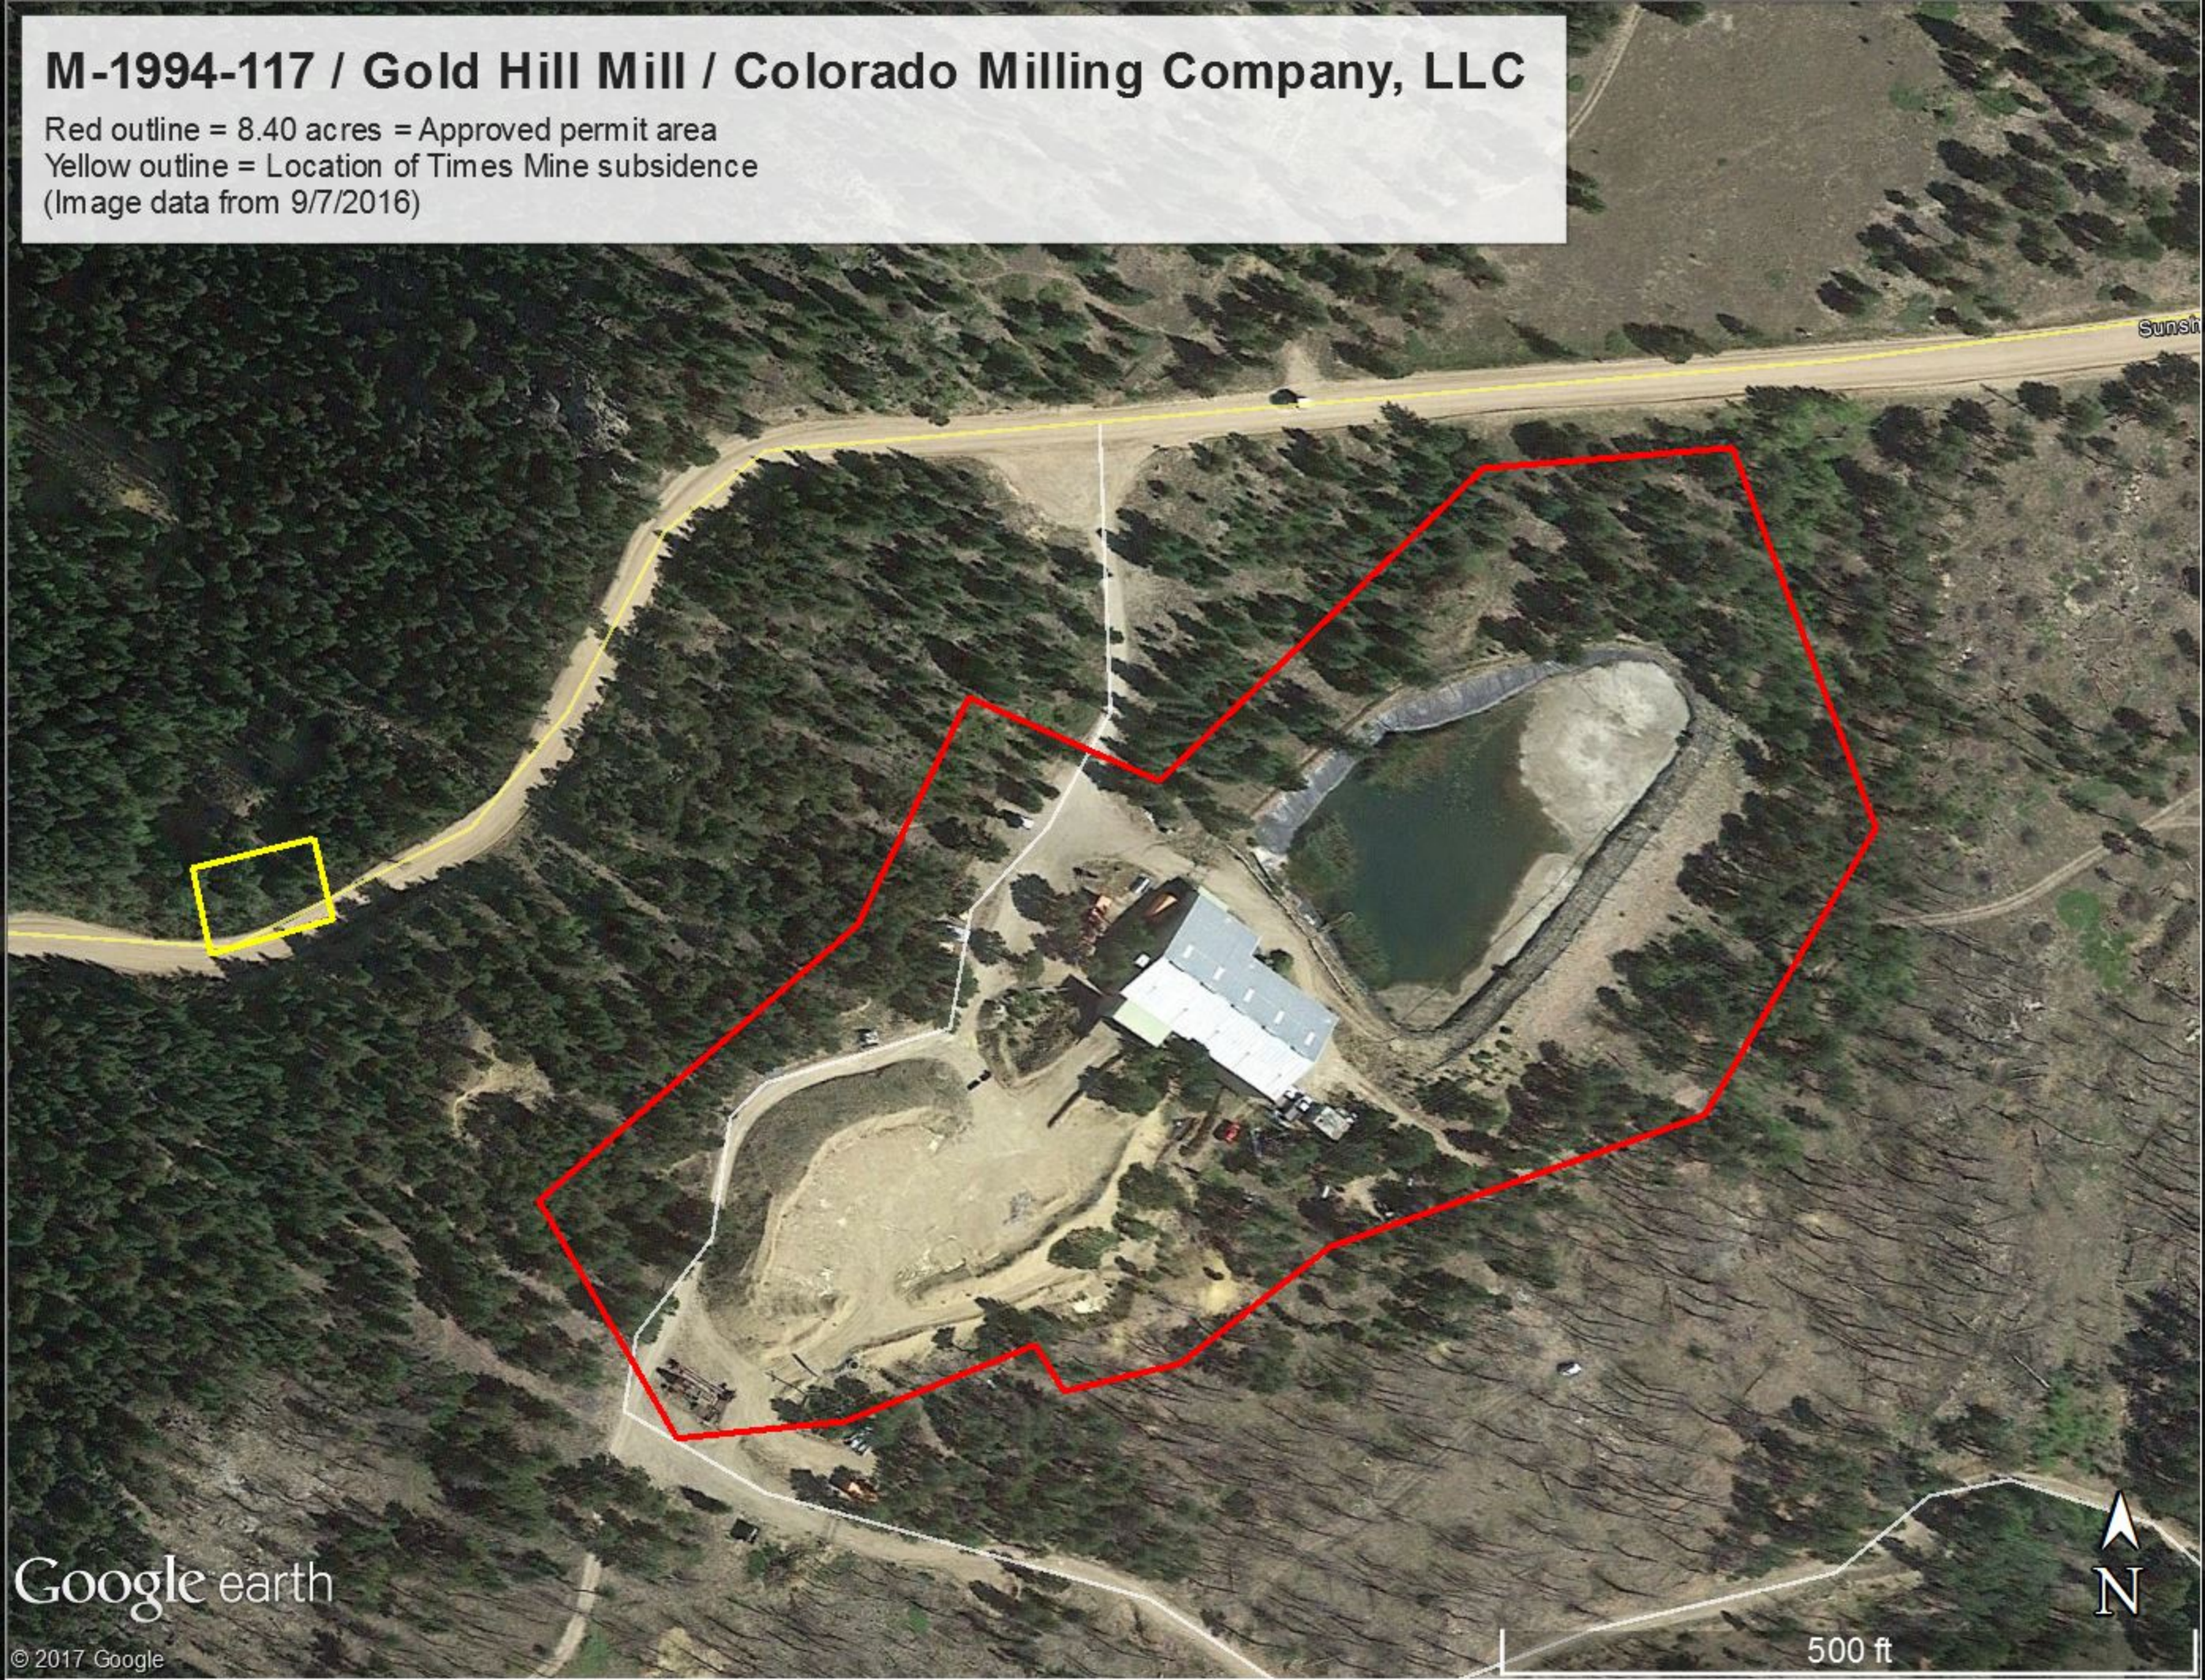
Red outline = 8.40 acres = Approved permit area  
Yellow outline = Location of Times Mine subsidence  
(Image data from 9/7/2016)
